Multi-Phase Debris Investigation at a Former Wood Treatment Facility

WEDA Pacific Chapter Meeting
November 6, 2015

Debris Investigation Overview

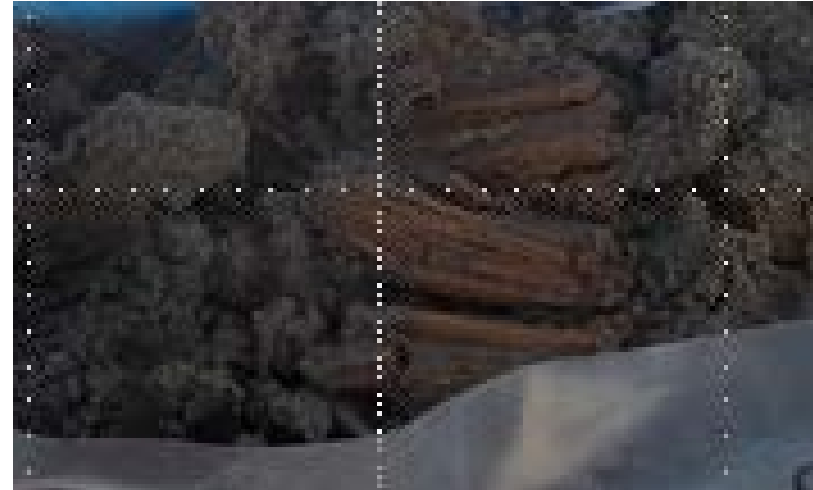
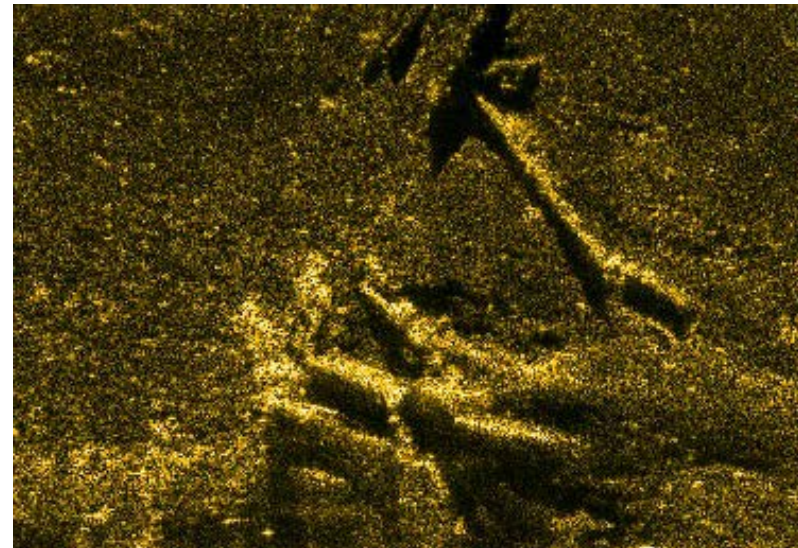
Pre-Design Debris Observations

- **Vibracore Refusal:**
 - 3 refusals at the sediment surface
 - 20 refusals observed at <2 ft bss
 - 37 refusals observed at <4 ft bss
- **Vibracore Observations:** Wood chips and wood fragments were observed at several sampling locations
- **Side Scan Imagery:** Six side scan images of the sediment surface were collected

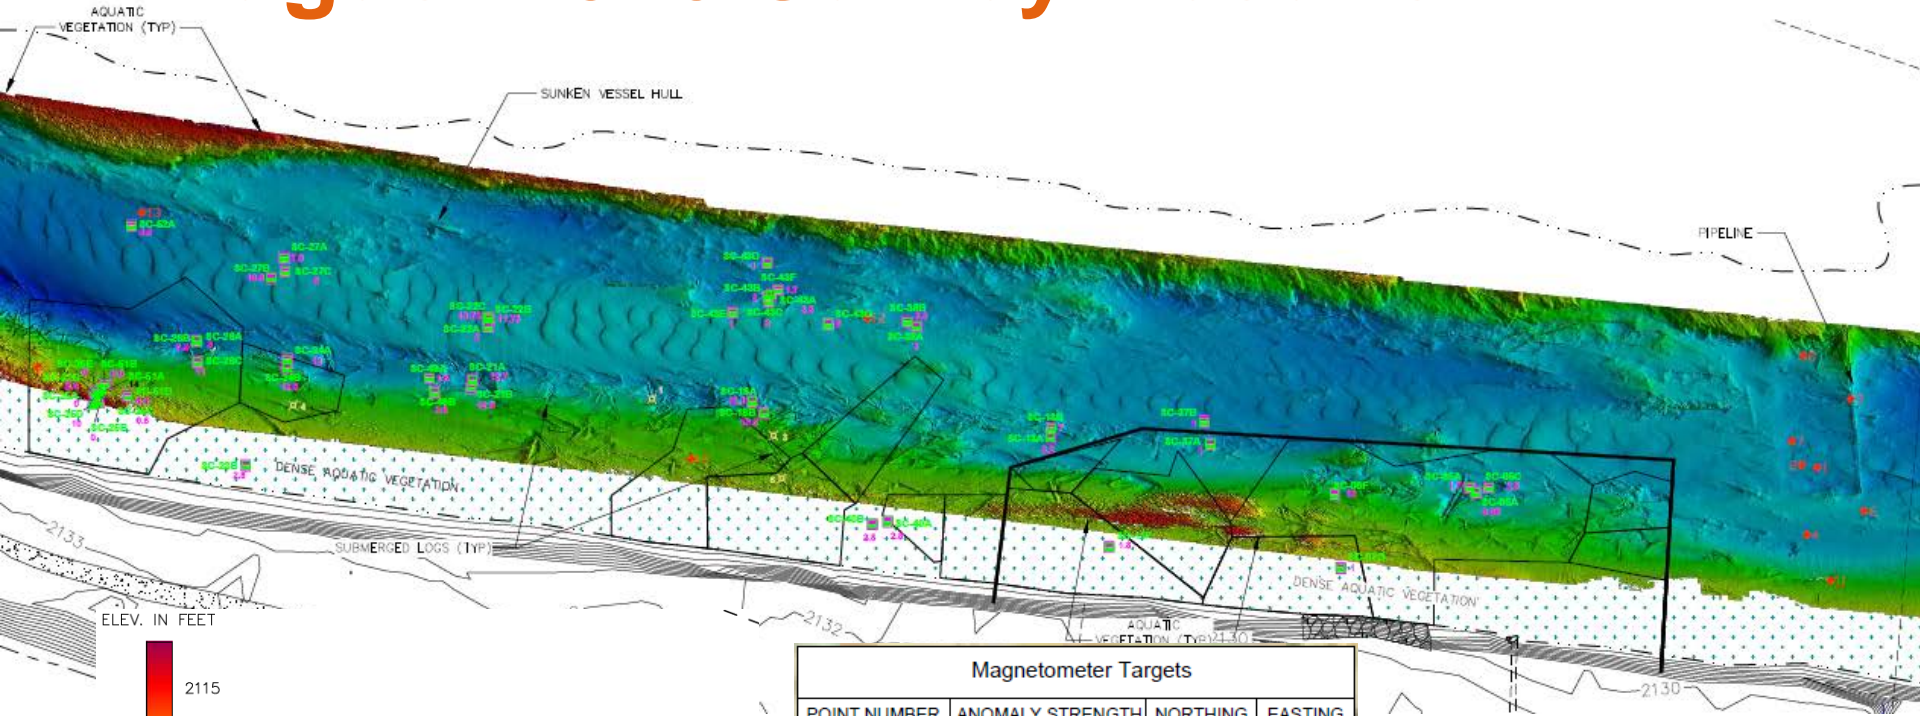
August 2013 Survey Results

- Approximately 1,500 feet of St. Joe River were surveyed
- Bathymetry imagery shows submerged logs in both nearshore and offshore dredge prisms
- 13 magnetometer targets were detected. Two targets were observed within offshore dredge prisms
- Heavy aquatic vegetation extending 60 feet from the southern shoreline resulted in restricted survey coverage

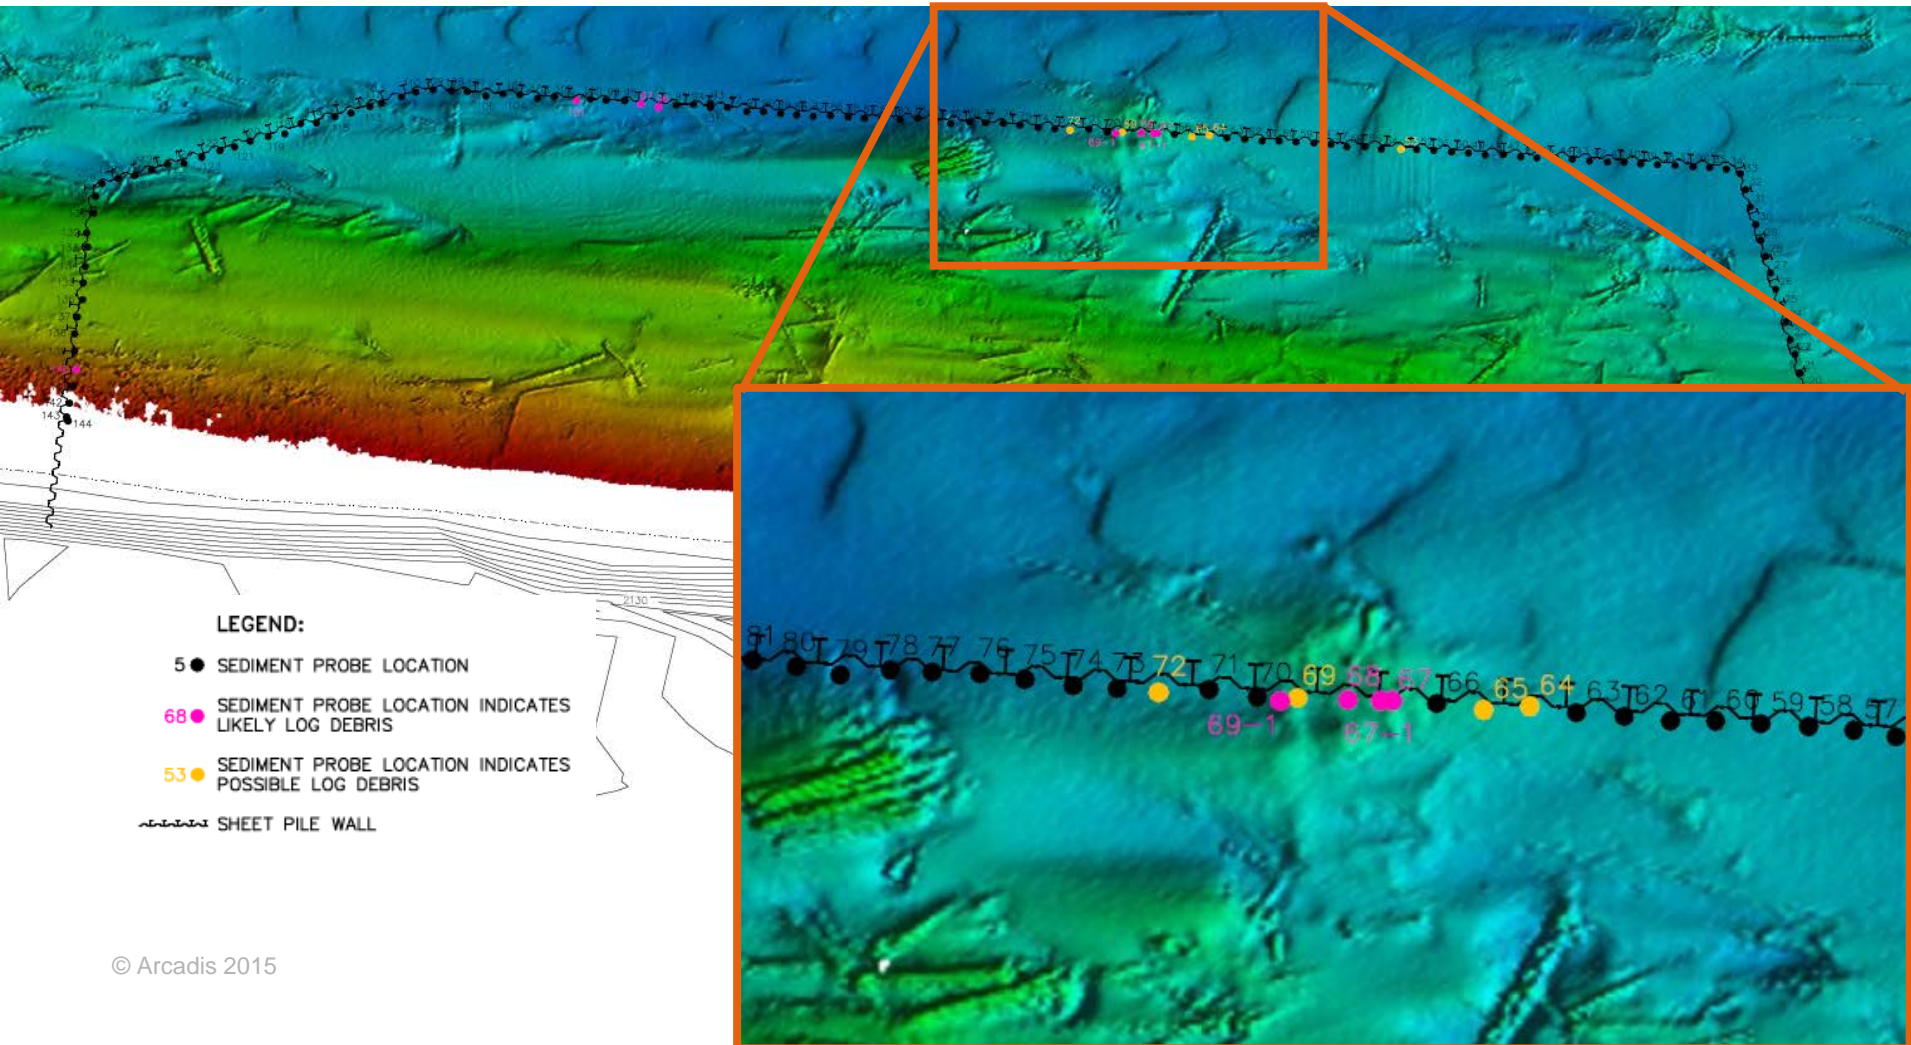
Phase II Results

- 142 probe locations were situated along sheet pile enclosure alignment at ~ 5 ft spacing
- 4-inch steel probe was hydraulically advanced into sediment to 15 ft bss, or until refusal
- Refusal was evaluated at five locations as follows:
 - Vibration was added to the probe at 2 locations
 - Spring force was added to the probe at 3 locations

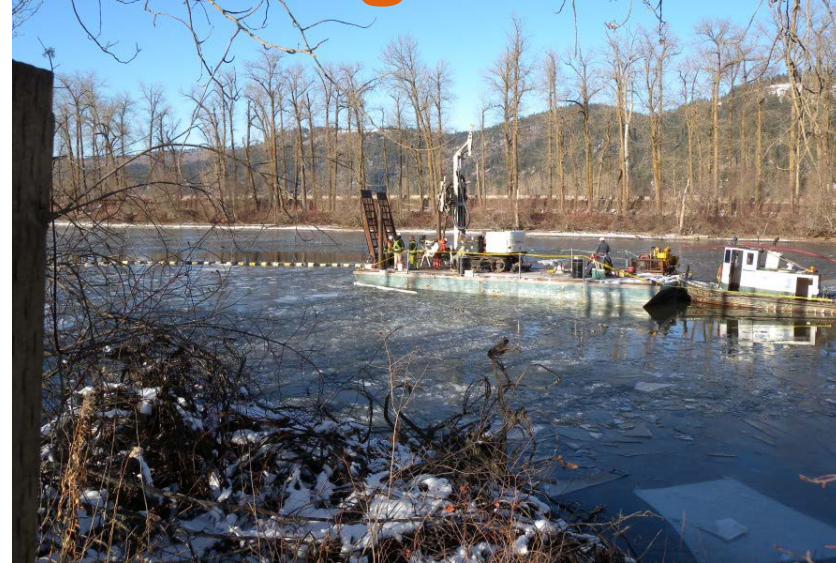
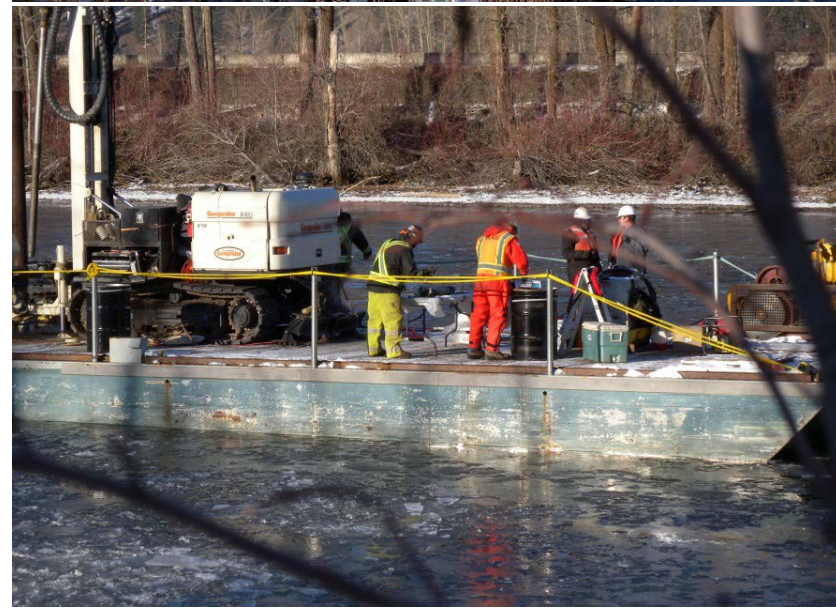
Phase III – Rotosonic Drilling

- Rotosonic boring locations were selected based on the results of the probing investigation
- 15 drilling locations were identified, but inclement weather shortened the scope of work to 6 borings
- Sediment cores were logged and photographed
- Wood debris was observed in three borings
