Recontamination and Remediation of Sediment Underlying the Murray Morgan Bridge in Tacoma, Washington

2015 Pacific Chapter WEDA

Jessi Massingale, P.E., Floyd | Snider
November 6, 2015

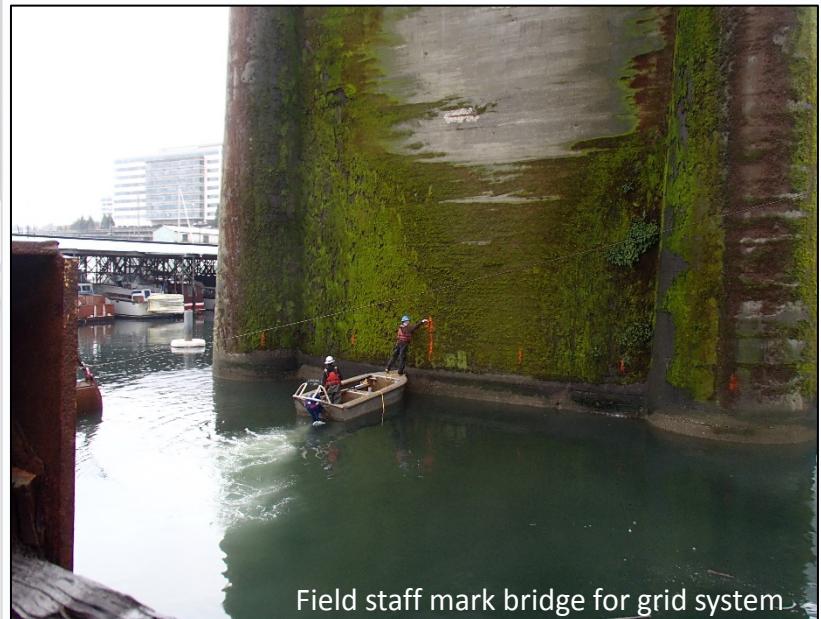
Field staff mark bridge for grid system

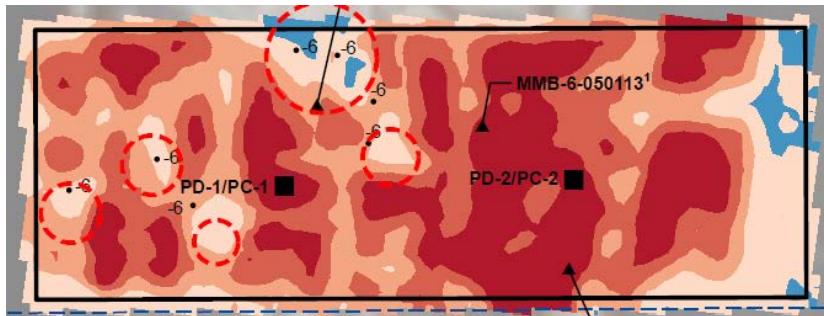
Interim dredge depth

- Hydrographic survey identified five high spots not dredged to the 6-inch minimum
- Re-dredging occurred 3 days before work window closure
- Merger of post-dredge hydrographic survey with post-high spot dredging lead line measurements: removed the need for additional survey and stand-by time

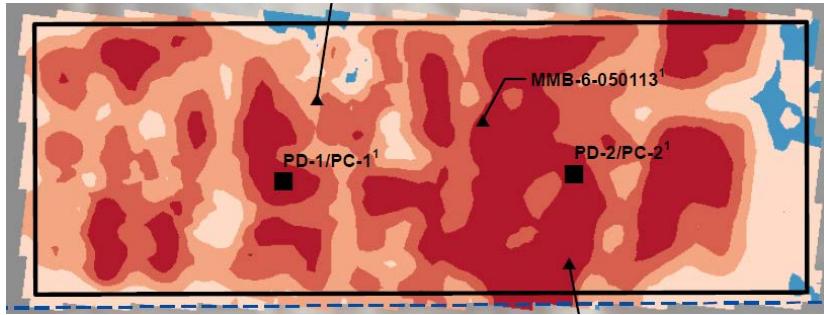
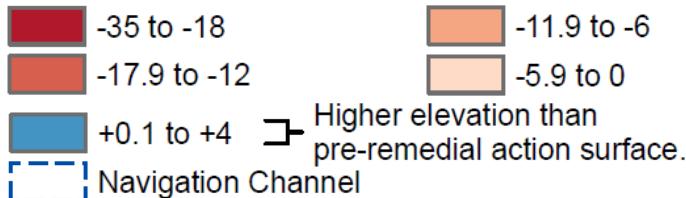
Final dredge depth

Units: Inches of variation from pre-remedial action surface mudline

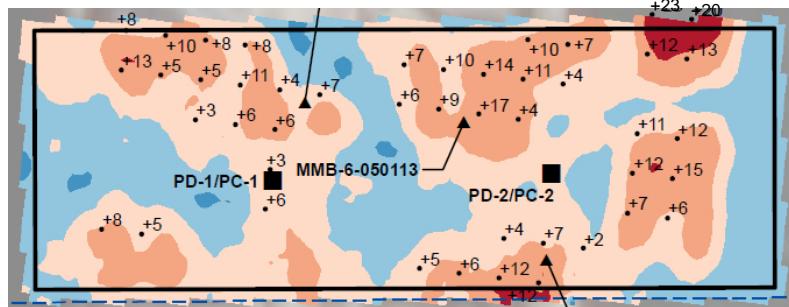
Interim post-remedial action depth changes

- 5-CY rehandle bucket constrained with chains
- Post-cap survey showed areas of less than 6 inches of sand
- Placement of additional sand to achieve pre-action mudline elevations
- Merger of post-cap survey and lead line measurements
- Confirmation of final post-remedial action elevation
