CONTAMINATED SEDIMENTS SUCCESSFULLY REMOVED AND CAPPED, ENABLING WATERFRONT DEVELOPMENT IN BUFFALO, NEW YORK

ABSTRACT

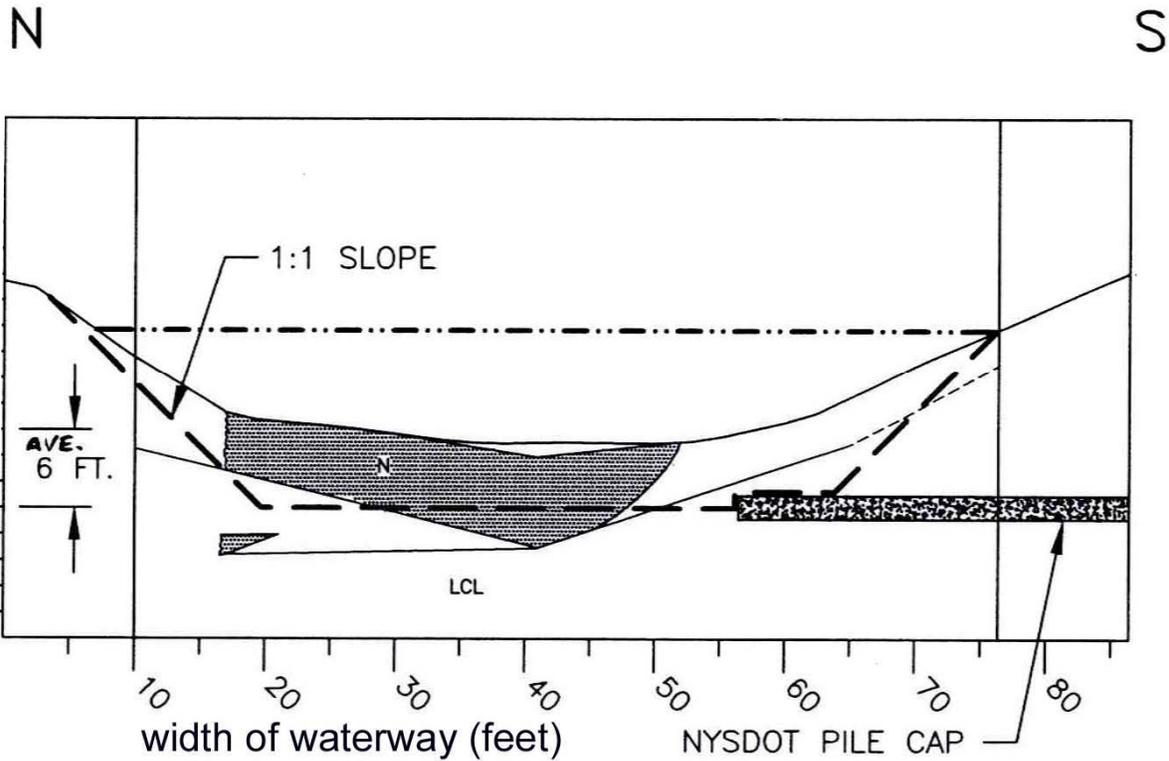
Figure 3. Typical cross section showing constraints to complete removal of impacted sediments.
 [Unit conversion: 1 foot = 0.3048 meters]

During the remedy selection process it was recognized that the complete removal of the grossly impacted materials could not be accomplished, due primarily to the presence of pile-supported highway columns, and also due to the steep banks and nearby buildings. In order to protect the structural integrity of the pile-supported highway columns, the New York State Department of Transportation imposed restrictions which effectively limited the removal to a maximum depth of 1.8 meters (6 feet). Figure 2 is a plan view of the waterway, showing the locations of the highway columns in the midst of the remediation area. These design constraints are depicted in a typical cross section provided in Figure 3.

A cap was therefore required to isolate the impacted materials which would remain after removing the top 1.8 meters (6 feet). The cap would need to be effective in isolating grossly impacted materials, and would need to be limited in thickness to allow for habitat restoration while not increasing the flood stage. The cap would need to be constructable under wet, or nearly wet conditions, and would need to be sufficiently resistant to the forces of extreme storm events and ice scour to remain intact for at least 30 years.

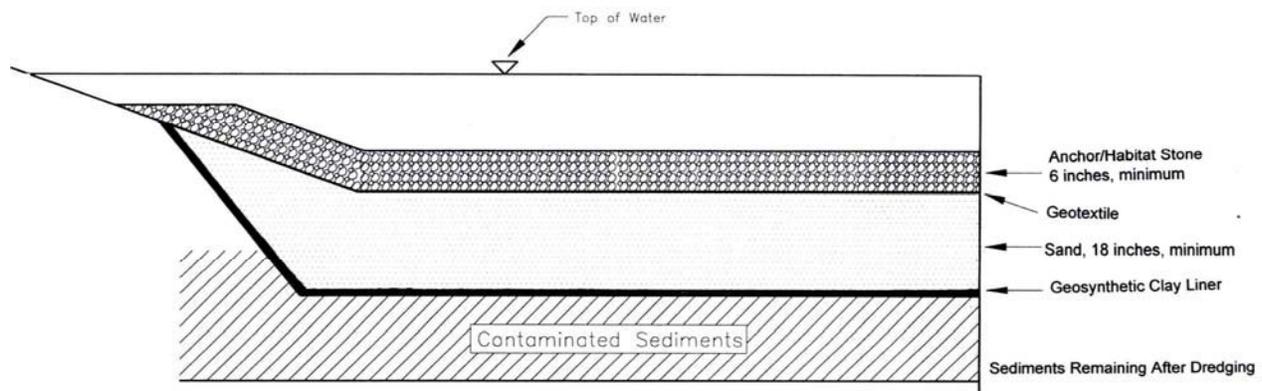
Figure 4. Cap schematic cross section.

The cap must provide resistance to erosion caused by ice scour, stream currents, groundwater forces, and waves, as well as a barrier to the effects of burrowing by bottom dwelling organisms (bioturbation). Waves and groundwater forces were determined not to be of sufficient magnitude to cause cap erosion. Propeller wash will not be a problem since large ships are not, and are not likely to become, common in this reach of the waterway. Although bioturbation can be a significant problem in salt water environments, in freshwater systems burrowing organisms are generally limited to the top 10 cm (4 inches) of the sediments (USEPA, 1994). The major causes of potential erosion will be ice scour and stream flows. To resist these forces, we specified a D_{30} (the 30th percentile of the stone diameter) of 7.5 cm (3 inches) with a maximum of 15 cm (6 inches).

Figure 4 shows a schematic cross section of the cap. This specification was designed to be protective for the flow velocity associated with the 50-year storm, as based on US Army Corps of Engineers standards (USACE, 1994). Rounded stone was used on the bottom of the channel, and angular stone was used along the steeper backs to prevent sloughing.

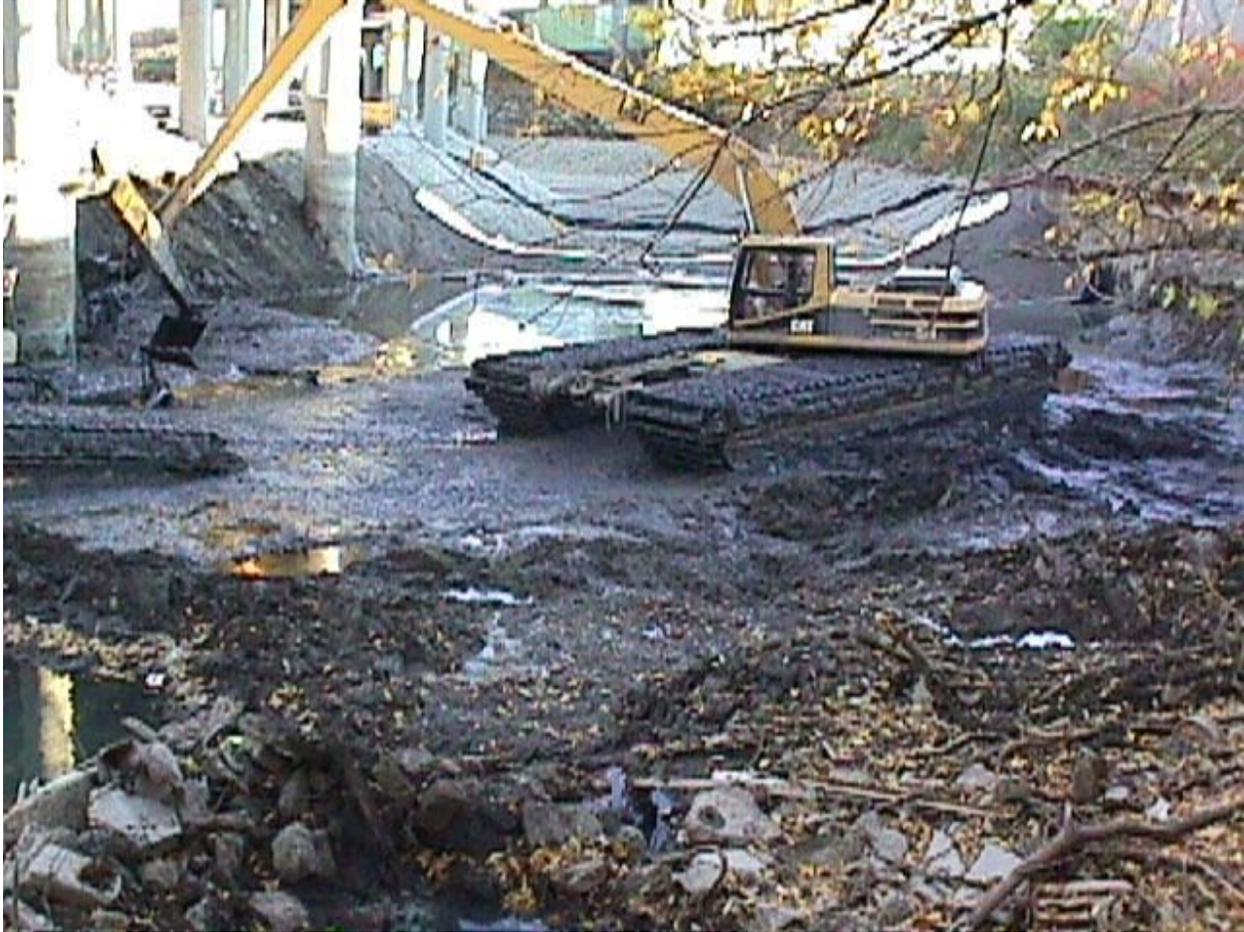
Figure 5. Photograph of amphibious excavator removing impacted sediment.

A specialized amphibious excavator was used to remove the sediments. It had a reach of 12 meters (40 feet) and was supported by large pontoon tracks which prevented the vehicle from sinking. Excavated material was stabilized with Portland cement so that it would be dry enough for truck transport to a secure landfill facility. A total of 25,400 metric tons (28,000 tons) were shipped from the site, constituting the 15,290 cubic meters (20,000 cubic yards) of contaminated sediment and debris that were removed from the waterway. Figure 5 shows the excavation of grossly impacted sediment.

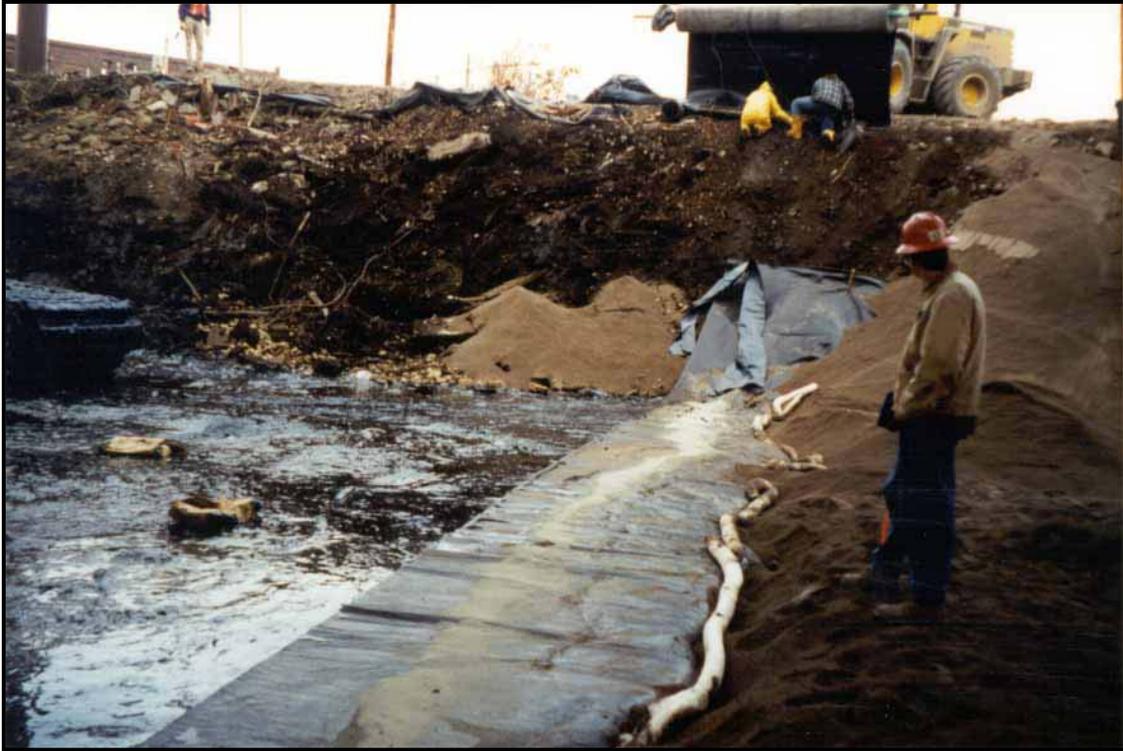
Figure 6. Placement of the geosynthetic clay liner.

The work proceeded from upstream to downstream, to prevent re-contamination of the completed cap. The excavation and capping operations were performed in a controlled sequence, such that dredging proceeded a maximum of 30 meters (100 feet) downstream ahead of capping. The layers of cap materials were placed using equipment stationed on the banks and in the channel. The GCL was placed in overlapping 4.4 meter (14.5-foot) wide strips across the width of the channel. Granulated bentonite was placed between a 0.6 meter (2-foot) overlap as specified for the seaming of the GCL strips. A total of 8,826 square meters (95,000 square feet) of GCL were placed. The sand used was angular limestone screenings from stone milling, which allowed steep design slopes of the banks to be achieved without sloughing. Placement of the cap is shown in Figures 6 and 7.

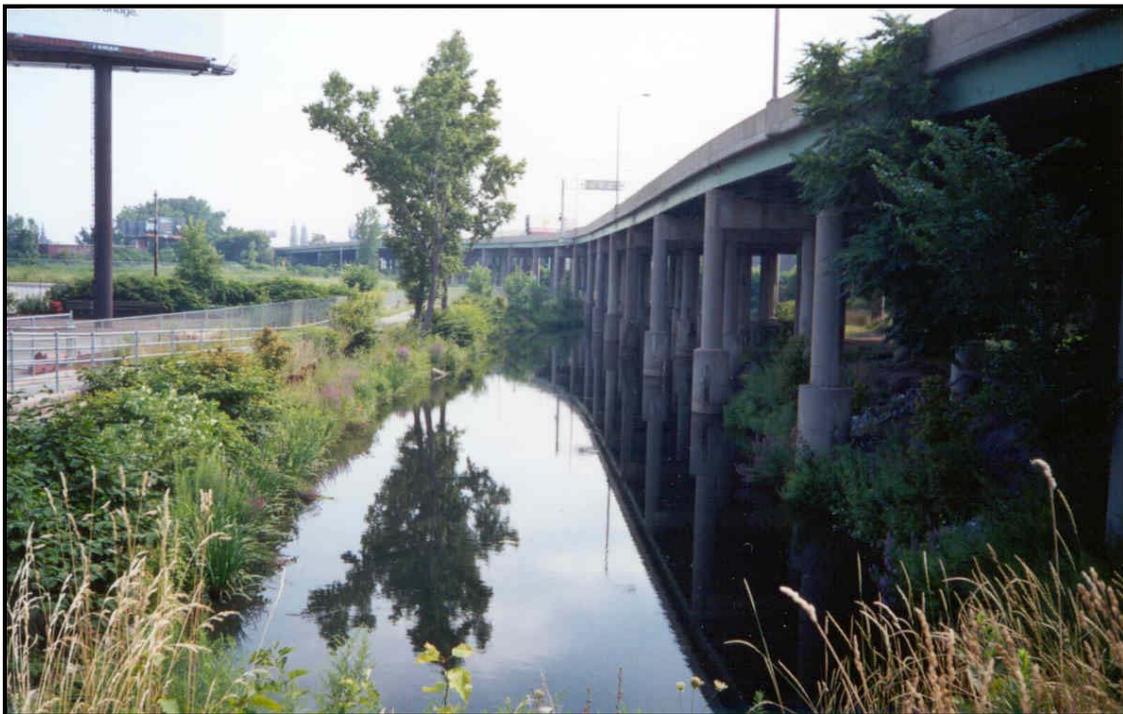
Figure 8. Restored waterway with recreational path and greenway.

Figure 8 shows the condition of the area 3 years after the restoration was complete.
