Own It: Our Role in Man Overboard Near Deaths

Presented at WEDA East Coast Chapter Meeting
October 17-18, 2019
The Dupont Hotel, Wilmington, DE

SAFETY ALERT

Replacing
Dredge
Carolina
No. 2
pump shaft

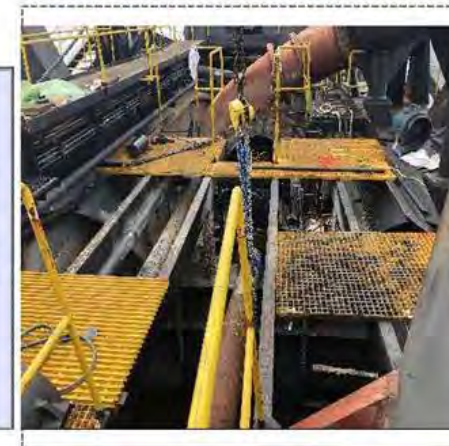
The crew had setup to remove a shaft from the underwater pump. Due to the layout of the grating, 4(four) pieces of grating were removed in order to gain access to allow the shaft to be rigged. Upon removal of the grating, it was not identified that the grating was secured by interlocking with other pieces as compared to independently secured on the supports. As the deckhand was positioning himself to be closer to the chain fall to lift No. 2 shaft, he stepped across from one piece of grating to another that was not secured. The unsecured grating slid from under his feet; as result he went over board. During the incident the deckhand incurred minor scratches / skin irritation.

The crew immediately placed all grating back in place and locked/secured them together. The entire crew held a stand down and discussed the incident. Afterwards the crew cut out grating directly above the No. 2 shaft. All grating was back in place except for the portion over the shaft. Axiom was contacted to document the scratches and address any concerns.
