A STICK IN THE MUD: U.S. COAST GUARD, SLIP 36 DREDGING AND REBUILD, SEATTLE, WASHINGTON

P. Leon¹, and S. Stirling²

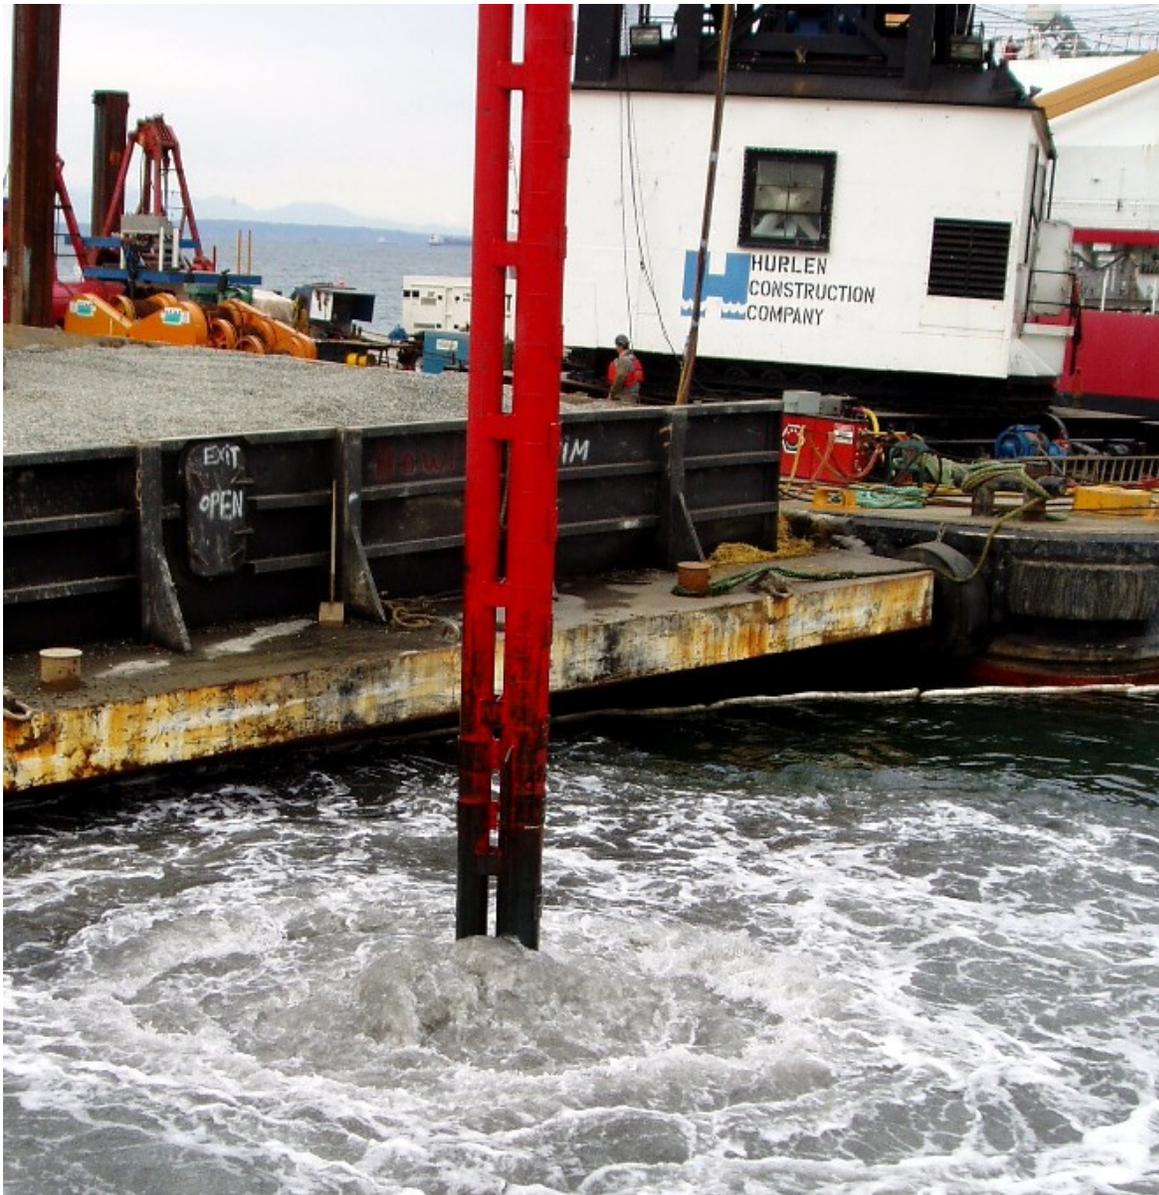
Figure 2: Gravel column construction is underway, as gravel is injected deep into the sediments. Note the water disturbance in the immediate vicinity of the probe.

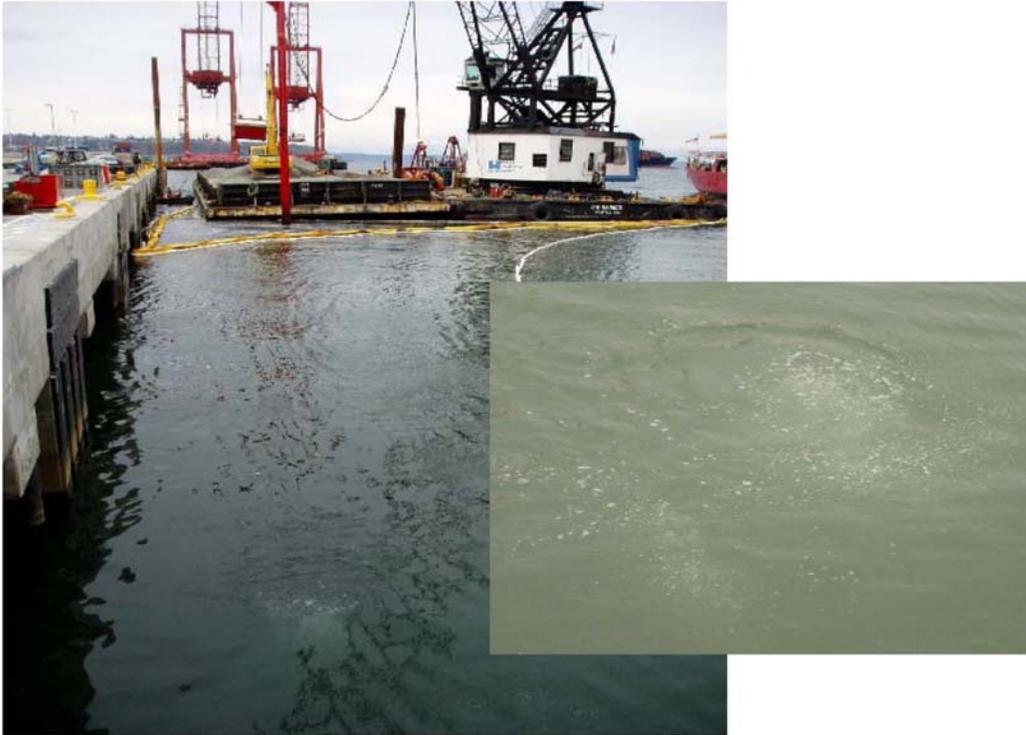
The gravel column construction process sends significant vibrations through the sediment substrate. These vibrations propagate to sediments well outside of the immediate work vicinity, as noted by observers of bubble columns rising to the surface a distance on the order of 100 feet from immediate construction activities [Figures 2 and 3]. Presumably, these bubbles are mobilized from low-density voids in the sediments left behind following piling removal.

Figure 3: Columns of air bubbles mobilized from the sediments are rising to the water surface during and immediately following construction. [Insert is a close up of the rising bubble columns.]

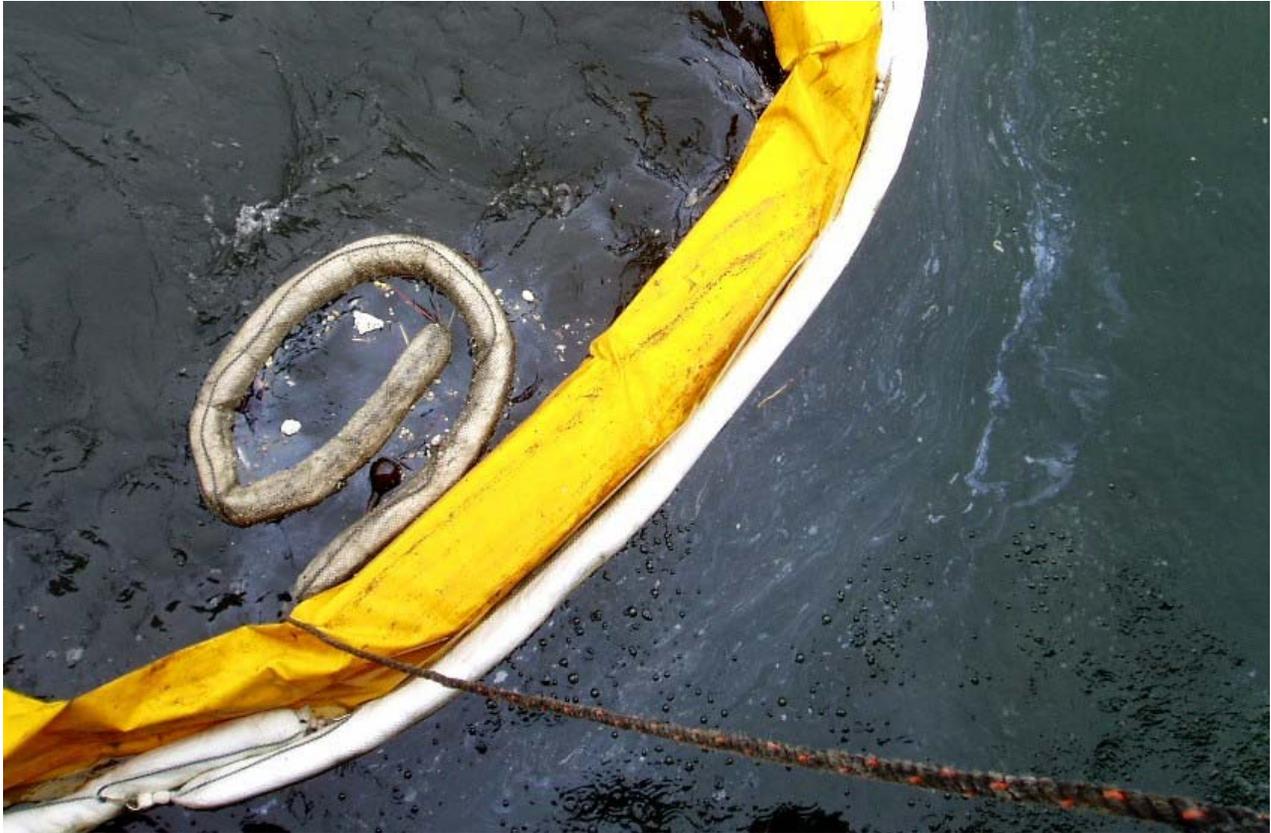
During the gravel column installation phase of construction, USCG observers noted a significant sheen rising to the surface in the immediate construction areas, with lesser sheens rising with the bubble columns further from immediate construction activities. The USCG immediately contained the sheen and notified the DMMP agencies [Figure 4].

Figure 4: Creosote sheen rising from the sediments is contained by boom.

The USCG and DMMP agencies initially considered one hypothesis to explain the source of the sheen. Hypothesis 1: The initial PSSDA sediment screening process did not accurately characterize the sediments and creosote residuals remaining after the old wooden pilings were being remobilized into the water column by the vibrations of gravel column installation.

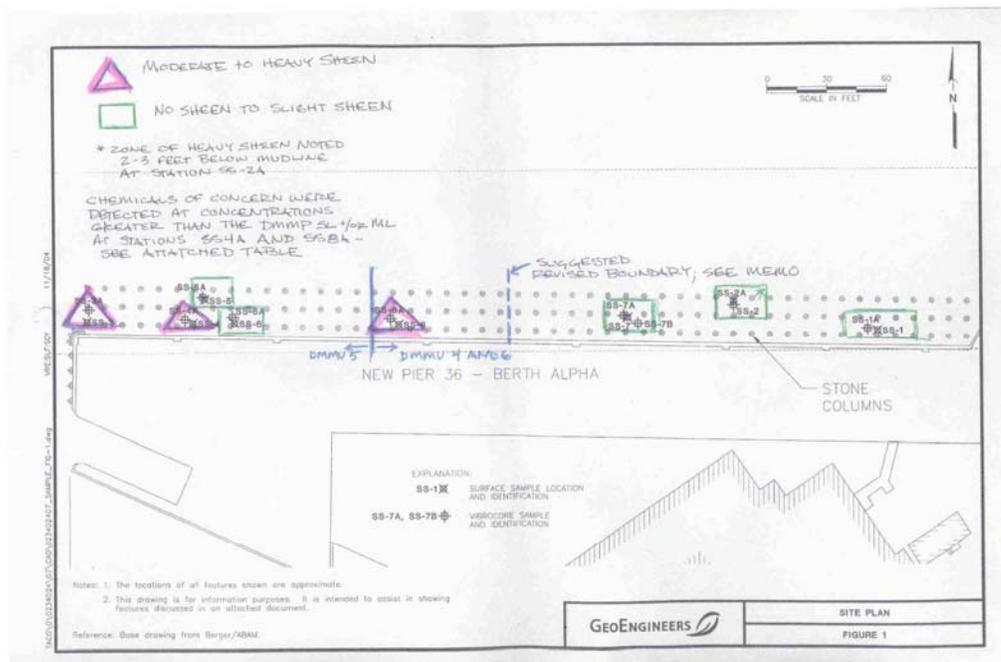
Figure 5. Sampling location schematic.

Sampling locations, as initially proposed, had to be modified to accommodate construction barges on site, however the DMMP agencies subsequently approved the modified plan to collect eight surface grabs identified as “SS-1” through “SS-8” [Figure 5]. In all of the samples collected observers noted moderate to heavy sheens. The USCG submitted four of these samples for PAH-analyses (SS-2, SS-4, SS-6 and SS-7). PAHs were detected in all samples analyzed, and one or more PAHs exceeding DMMP Screening Levels (SL) were detected in samples SS-2, SS-4 and SS-6. Basing their decision upon both the visual and chemical analyses, the USCG and DMMP agencies agreed that the surface sediments were unsuitable for open water disposal.

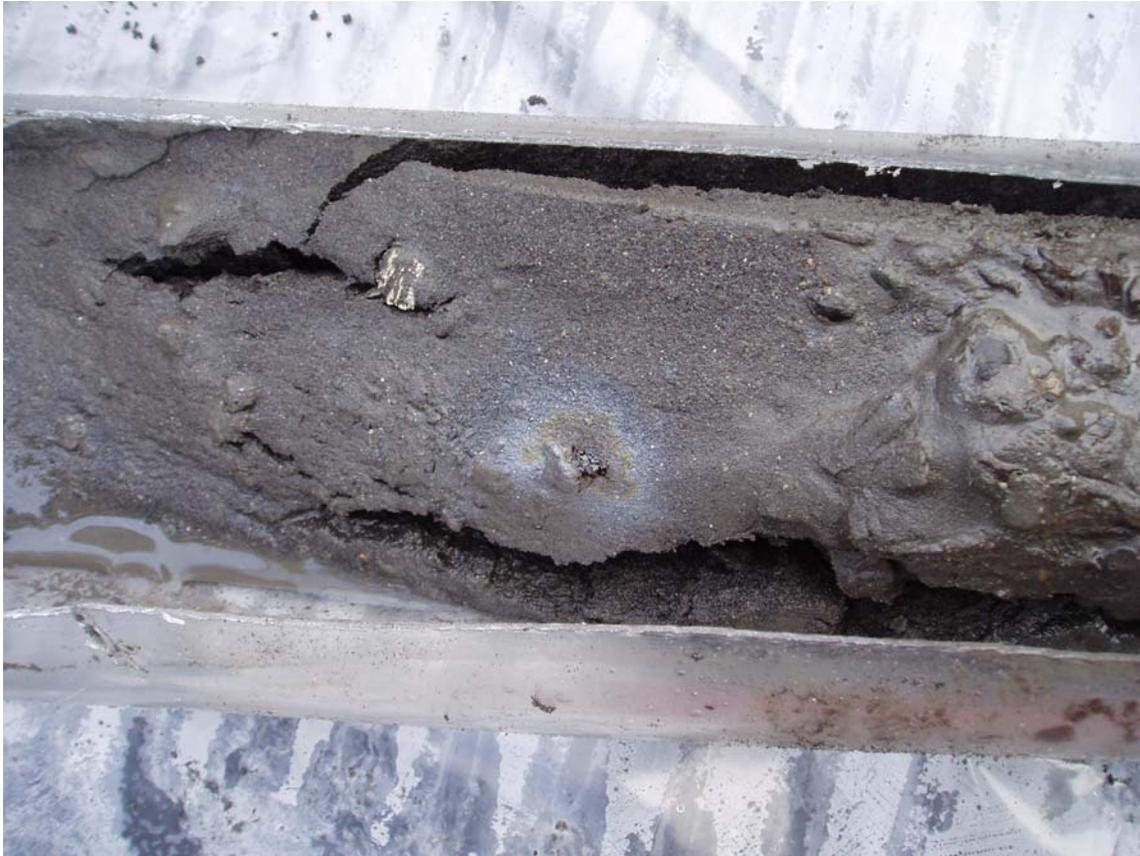
Visually inspection [Figure 6] of the cores revealed moderate to heavy sheen on the upper sections of cores SS-3A, SS-4A and SS-8A, and also in the lower sections of cores SS-4A and SS-2A. Inspection also revealed a heavy sheen associated with creosote-coated wood debris on the surface of cores SS-3A, SS-7A and SS-2A. The wood debris extended from the surface of these cores to a depth of 0.5 to 1 foot. In the remaining sections observers noted little to no sheen.

Figure 6: Note the sheen present in the sediment core.

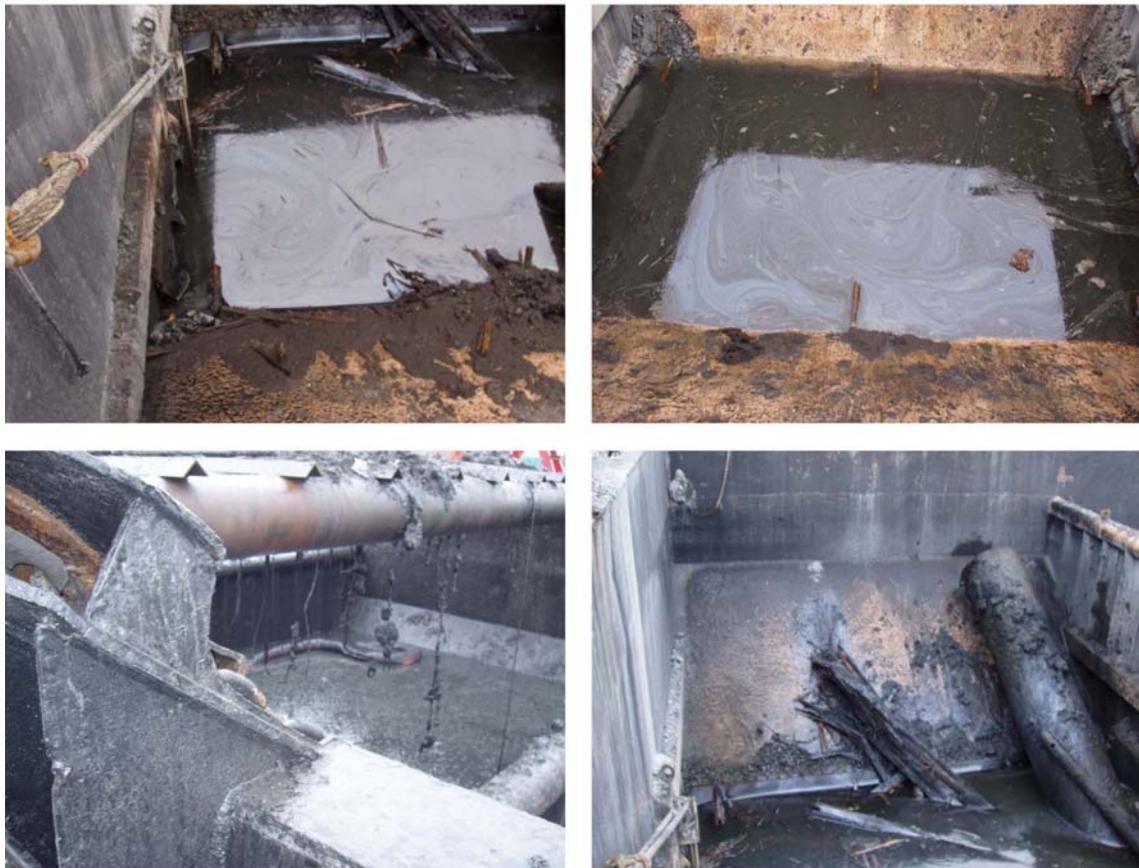
As dredging of the suitable material began, however, USCG observers noted the dredge bucket pulling both large sections and small, splintered shards of remnant pilings from the remaining “suitable” material [Figure 7]. A heavy sheen accompanied this mixture of creosote-treated woody debris and sediment in the disposal barge, prompting the USCG to submit the situation to the DMMP agencies for another reevaluation. Ultimately, the USCG and DMMP agencies agreed that none of this material could be disposed in the DMMP Elliott Bay unconfined open water dredged material disposal site.

Figure 7: Photos documenting creosote-treated piling remnants and sheen accumulating in the disposal barge.
