# Navigational Dredging in the Detroit Harbor, Washington Island, Wisconsin Permitting and Management

**WEDA 2015 Midwest Chapter Conference**

**Ken Potrykus**, D. Roznowski, K. Aukerman, S. Kozicki of Foth Infrastructure & Environment, LLC; J. Gunnlaugsson of Town of Washington; and T. Drager of Roen Salvage Company.

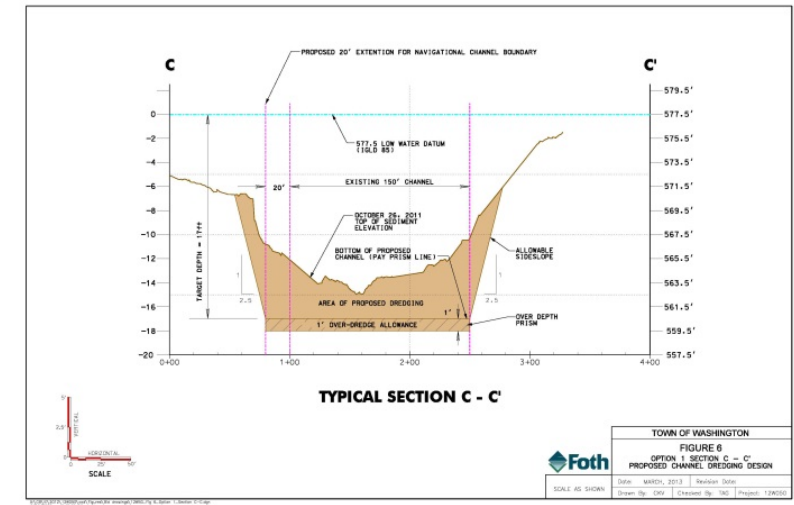
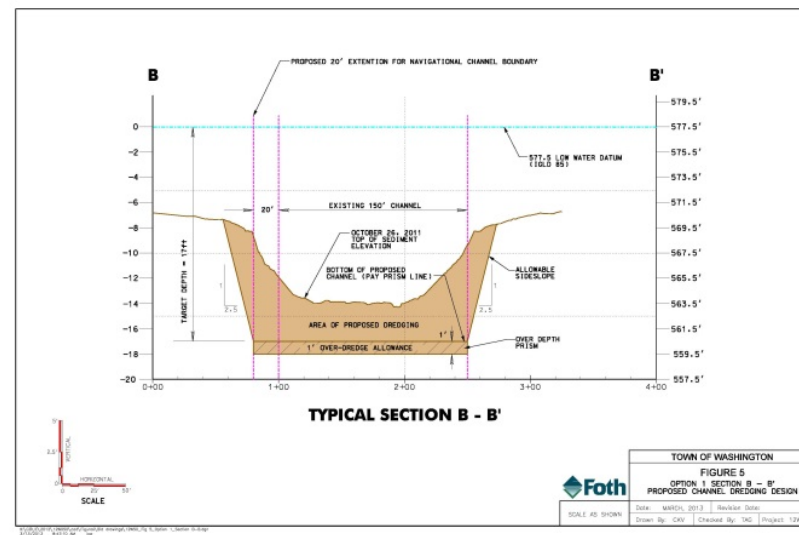
# Dredge Prism

- ❖ Pre-dredge survey identified dredge prism and material to be removed
- ❖ Roen Salvage selected project contractor
- ❖ No dredging during tourist season (Memorial Day to Labor Day)
- ❖ Intent to complete work in fall of 2013
- ❖ Dredge 134,500 cubic yards

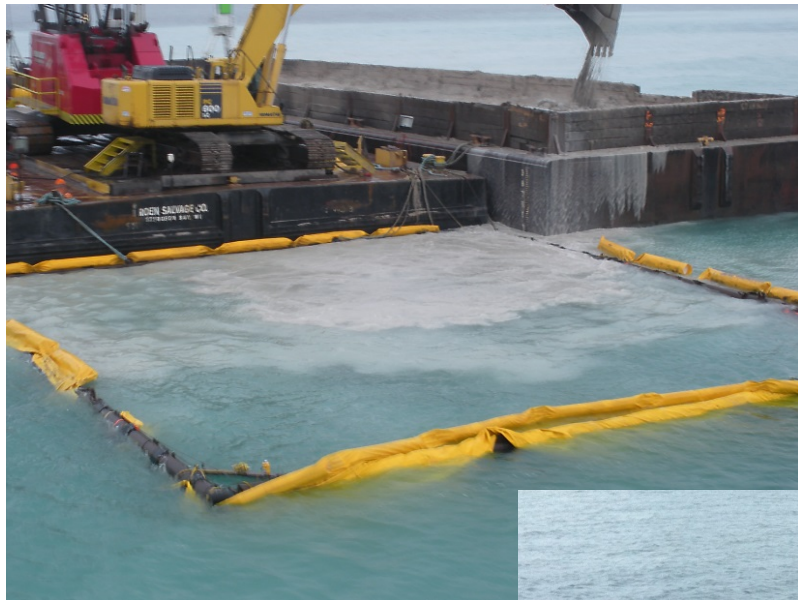
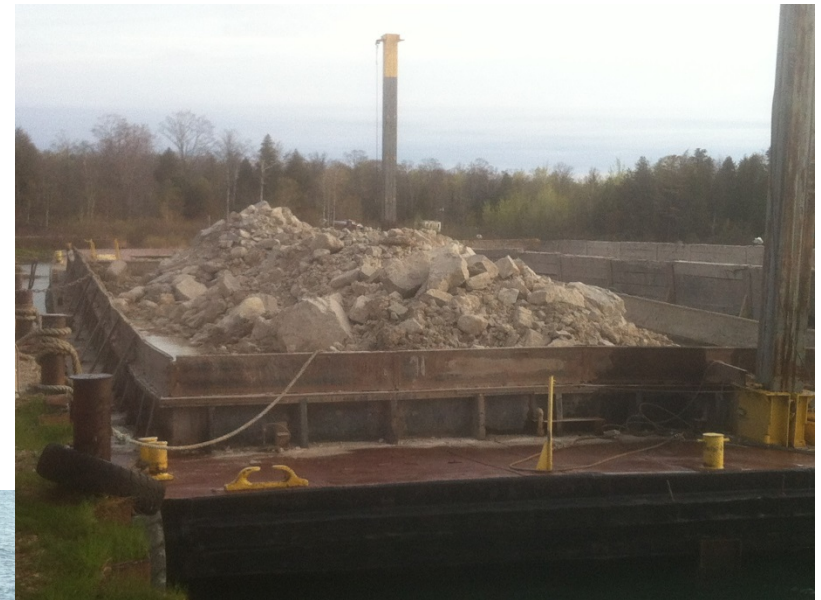
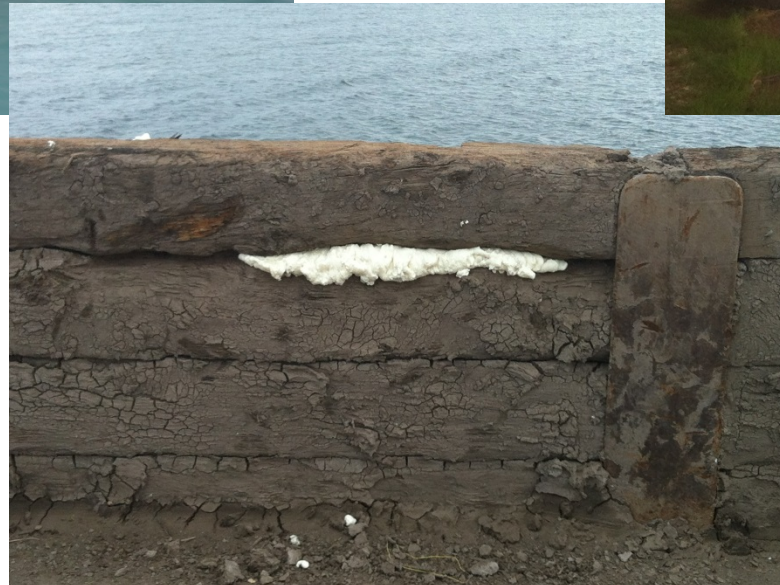
# Challenges – Fall 2013

- ❖ Dredged material – rock and residuals
- ❖ Water conditions – clear water and seiche effect
- ❖ Permit compliance
  - ▶ Turbidity barriers
  - ▶ Visual effect
- ❖ Weather
  - ▶ Ice and cold
  - ▶ Need to dredge in 2014

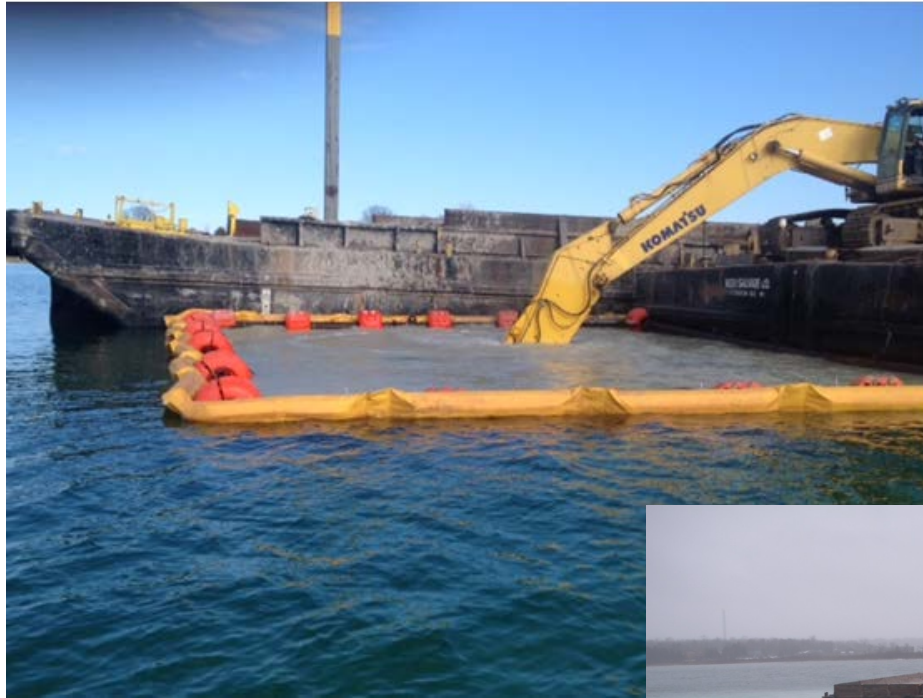
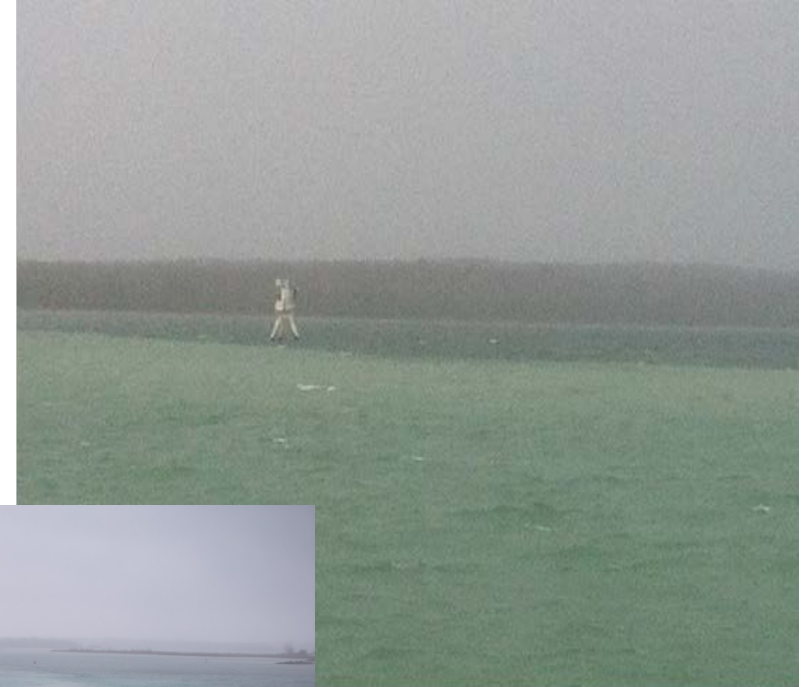
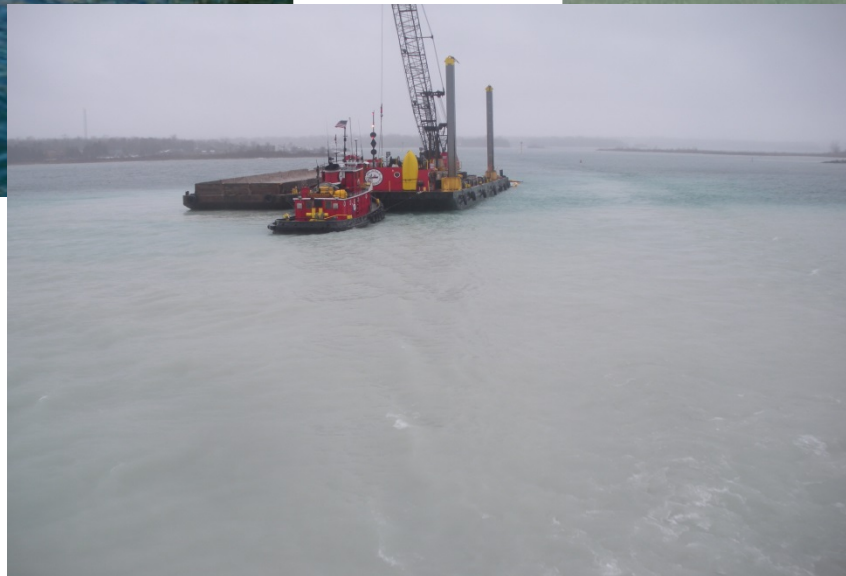
# Visual Turbidity Sight

- ❖ Production shortcomings and early winter
- ❖ Spring/Summer of 2014
- ❖ Turbidity Monitoring Plan
  - ▶ Trigger level criteria
    - ◆ Inspect BMPs
  - ▶ Specific areas to monitor twice daily
- ❖ Amendment 2 – Turbidity Monitoring
  - ▶ Multiple monitoring points

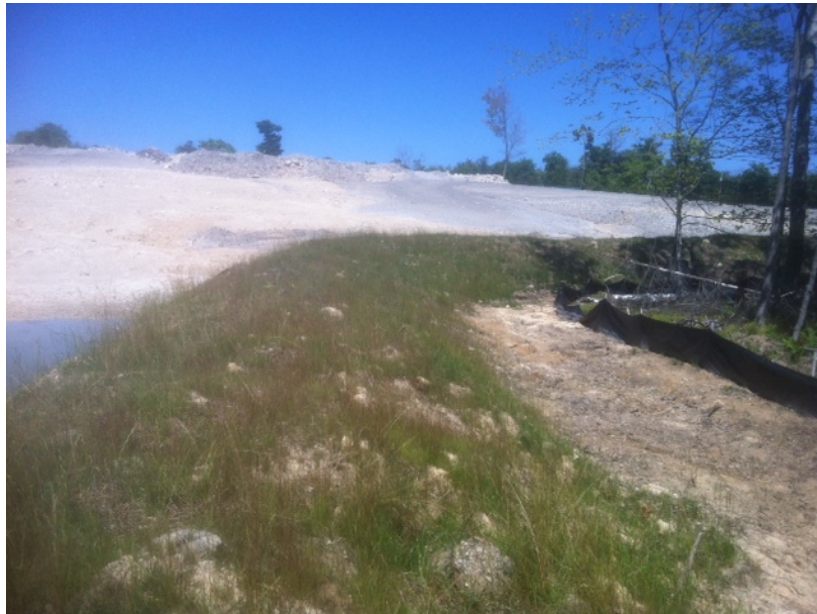
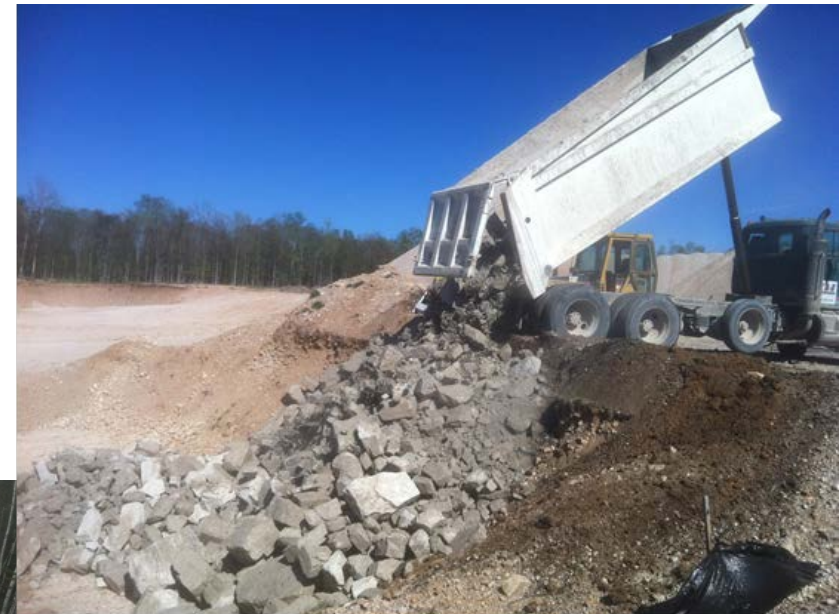
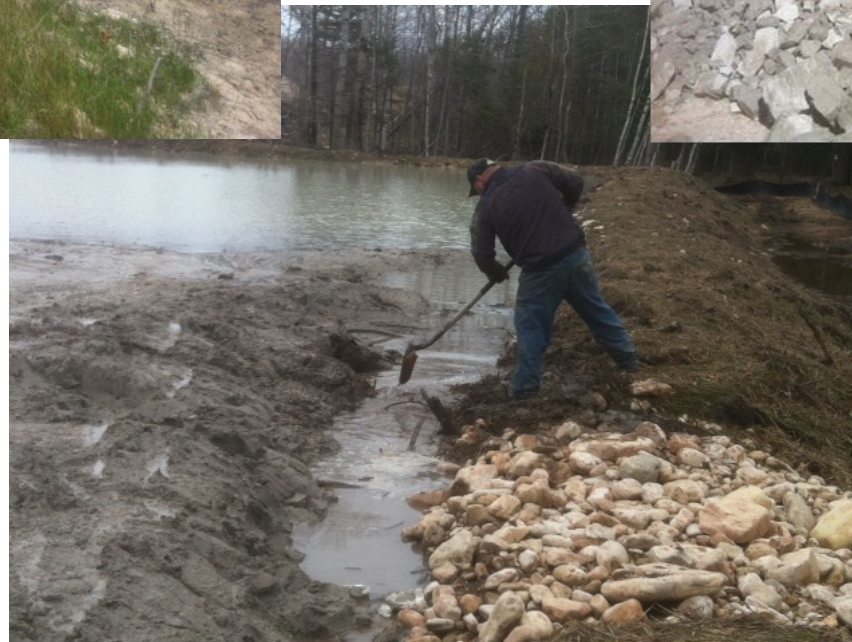
# Disposal Cell

- ❖ Distant from existing disposal cell
- ❖ Designed and constructed disposal cell on island
- ❖ Beneficially re-use material
  - ▶ Rocks used for breaker
  - ▶ Sand used for roads or concrete
