Prime Hook National Wildlife Refuge Restoration Project (FWS) WEDA Eastern Chapter Annual Meeting

Presentation Overview

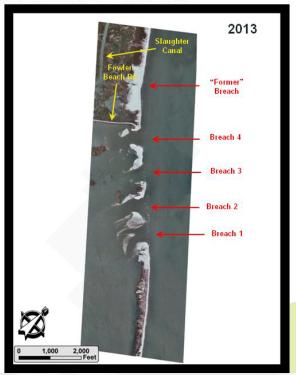
Historical Aerials - 2013

Changes to the Refuge over Time: Hurricane Sandy

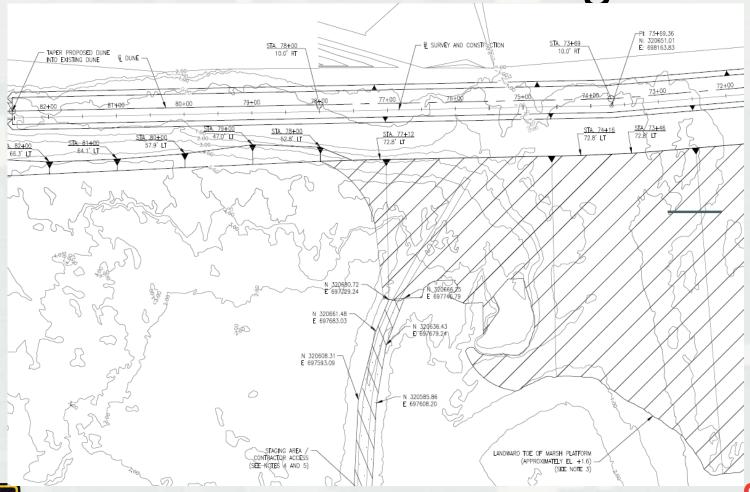
Planned Fix: Design

Platform, Berm and Dune System

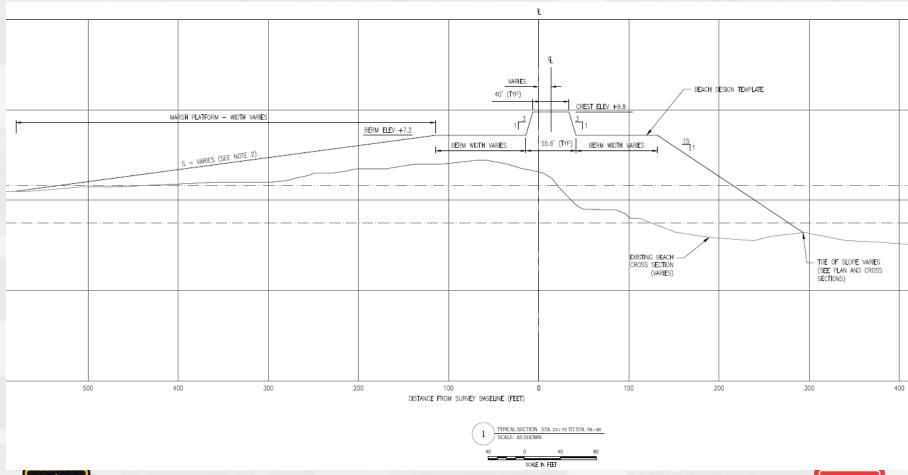
Planned Fix: Design

Platform, Berm and Dune System

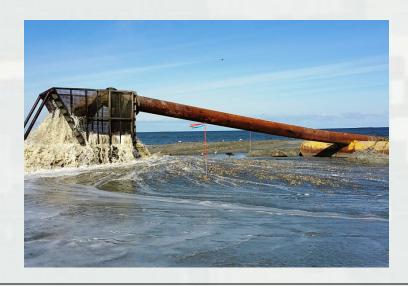
Current Status

- Mobilization and all Preparatory work completed
- Dredging started Wed., 21 Oct and scheduled to end in Mar 2016
