WAIKIKI BEACH EMERGENCY EROSION CONTROL USING RAPID DEPLOYMENT SAND FILLED MATTRESSES

**Dolan Everson – University of Hawaii Sea Grant Program and Waikiki Beach Special
Improvement District**

Troy Ogasawara - GeoTech Solutions

Tom Stephens - TenCate Geosynthetics

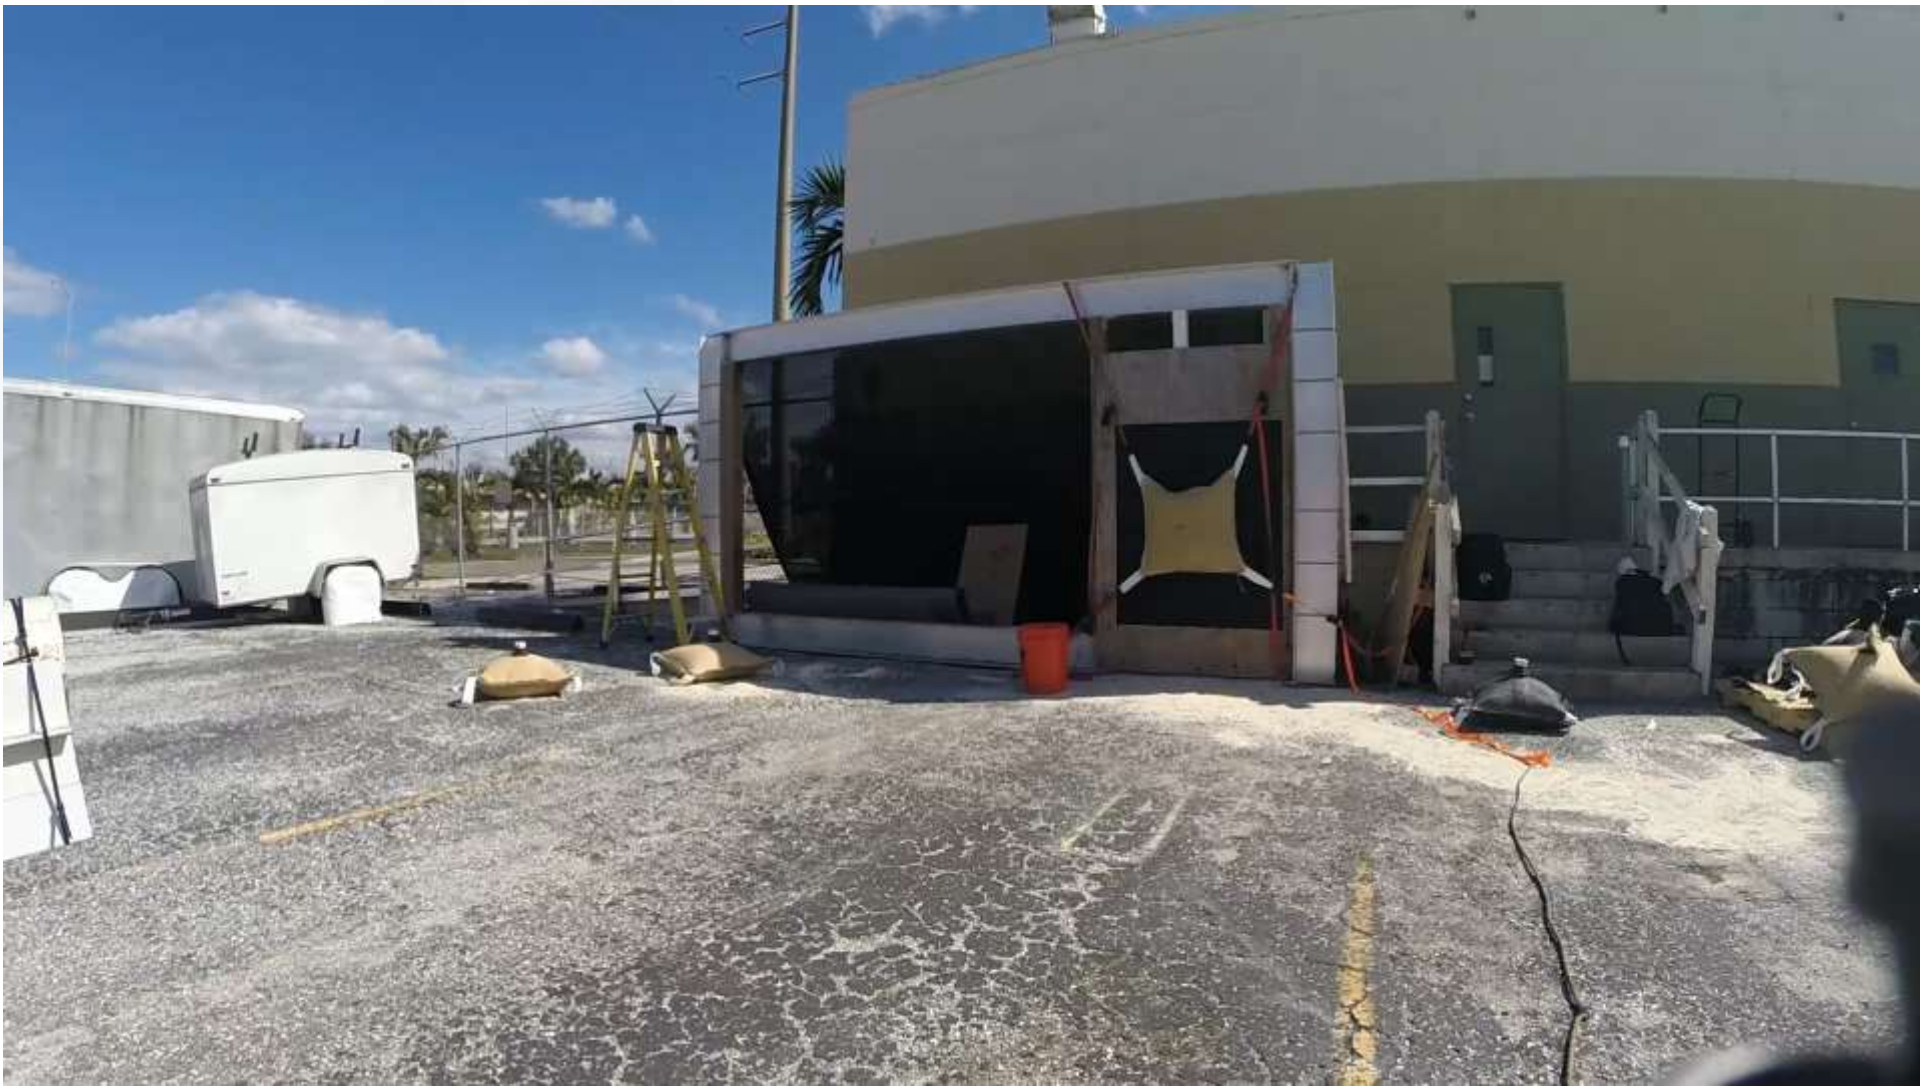
GC1200MB – 1ST IMPACT

be Impact Testing Overview
