Rock Blasting

Columbia River Channel Improvements
(Channel Deepening)

Karen Garmire, P.E.
Resident Engineer

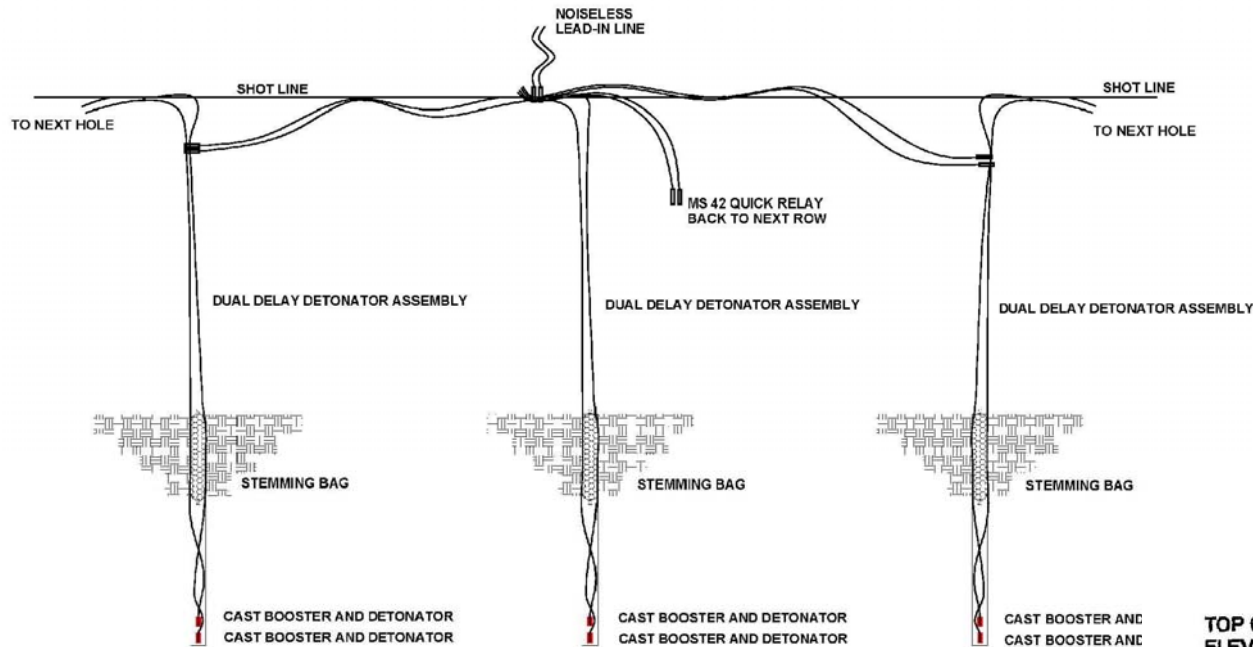
Typical Blast Pattern And Hole Configuration

10 FT. SPACING
10 FT. BURDEN
TO
12 FT. SPACING
12 FT. BURDEN
AS DETERMINED BY TEST BLASTS

TYPICAL BLAST PATTERN

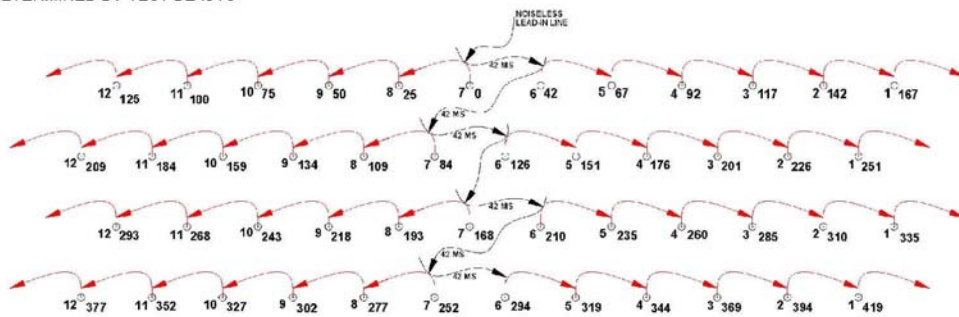
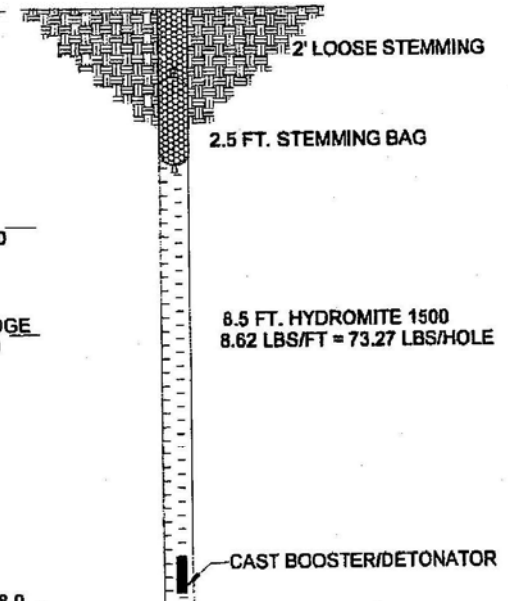
TOP OF ROCK
ELEV. -45.0

GRADE
ELEV. -49.0

OVERDREDGE
ELEV. -51.0

ELEV. -58.0

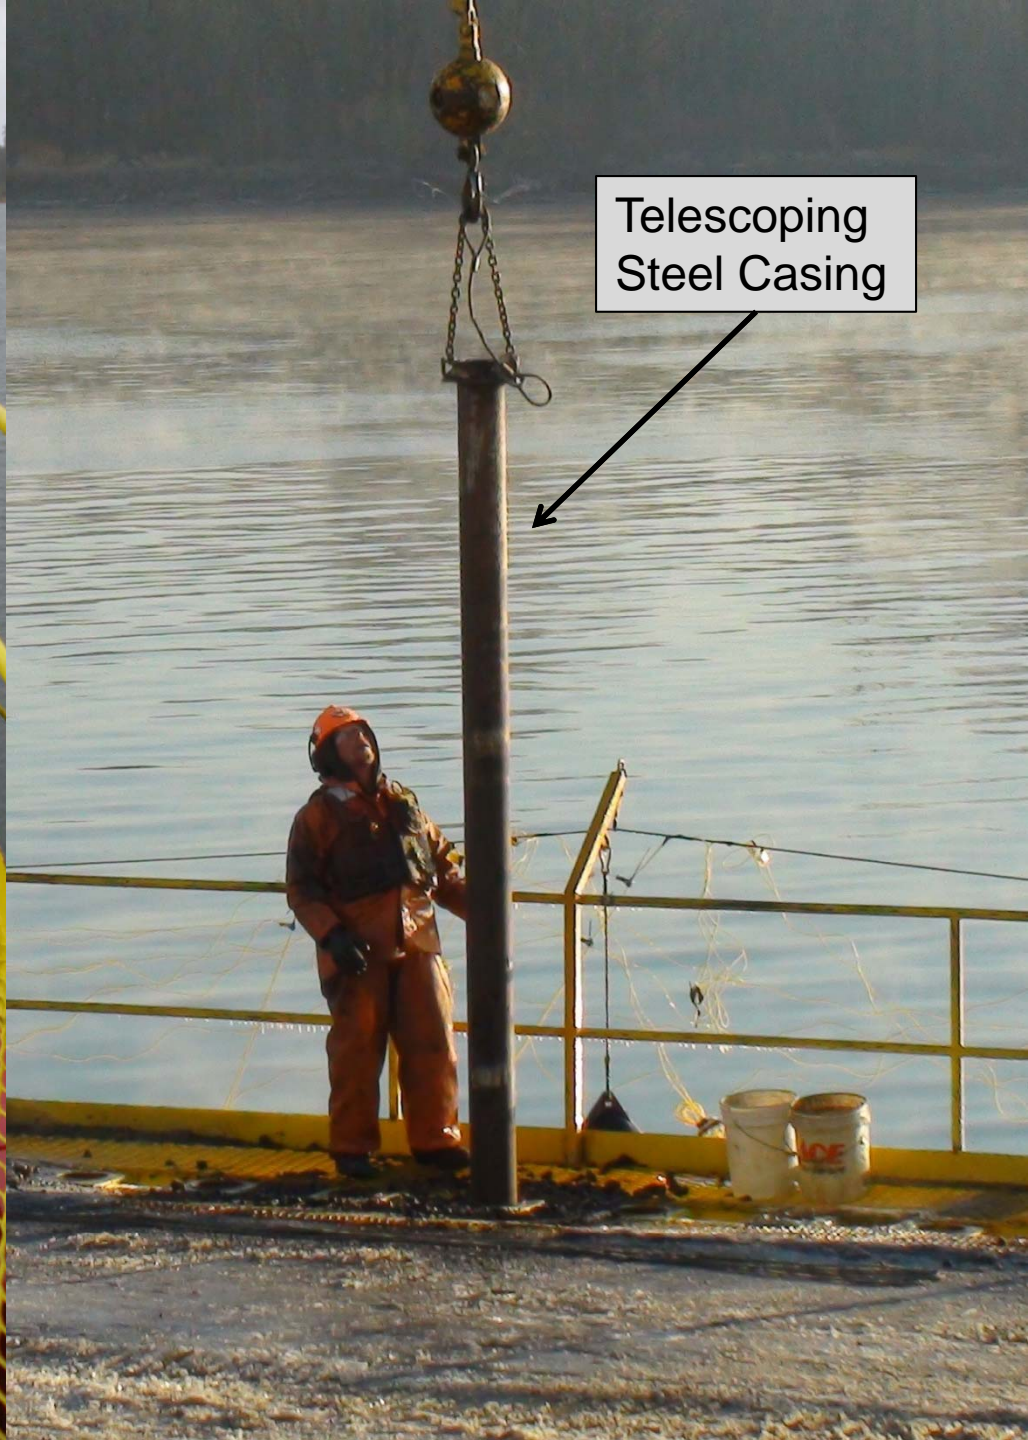
**Telescoping
Steel Casing**

Tri-Core Carbide Drill Bits

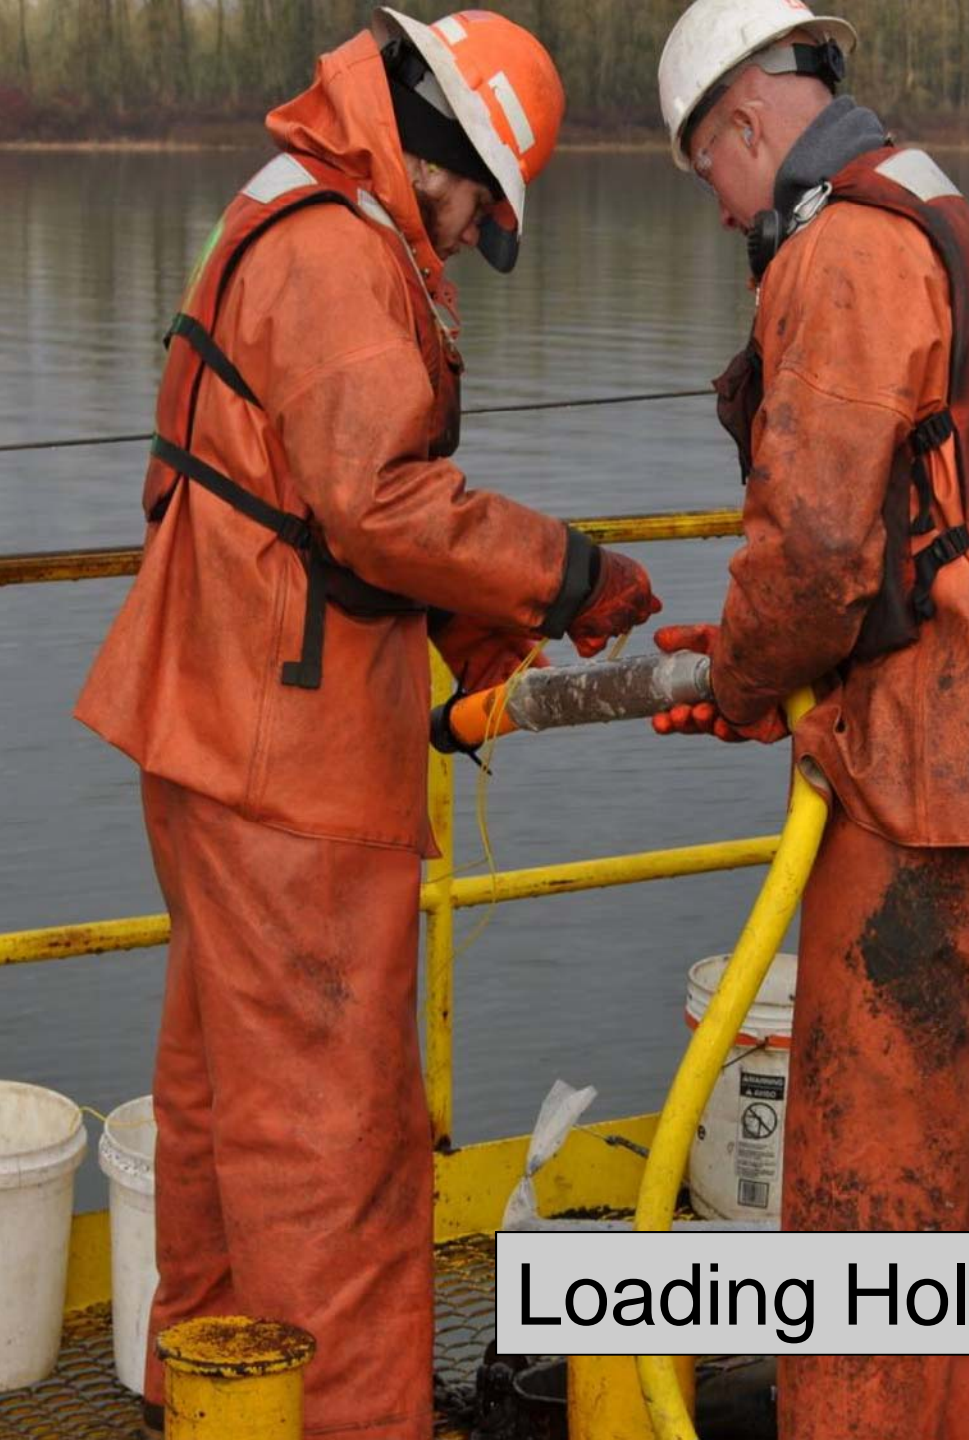
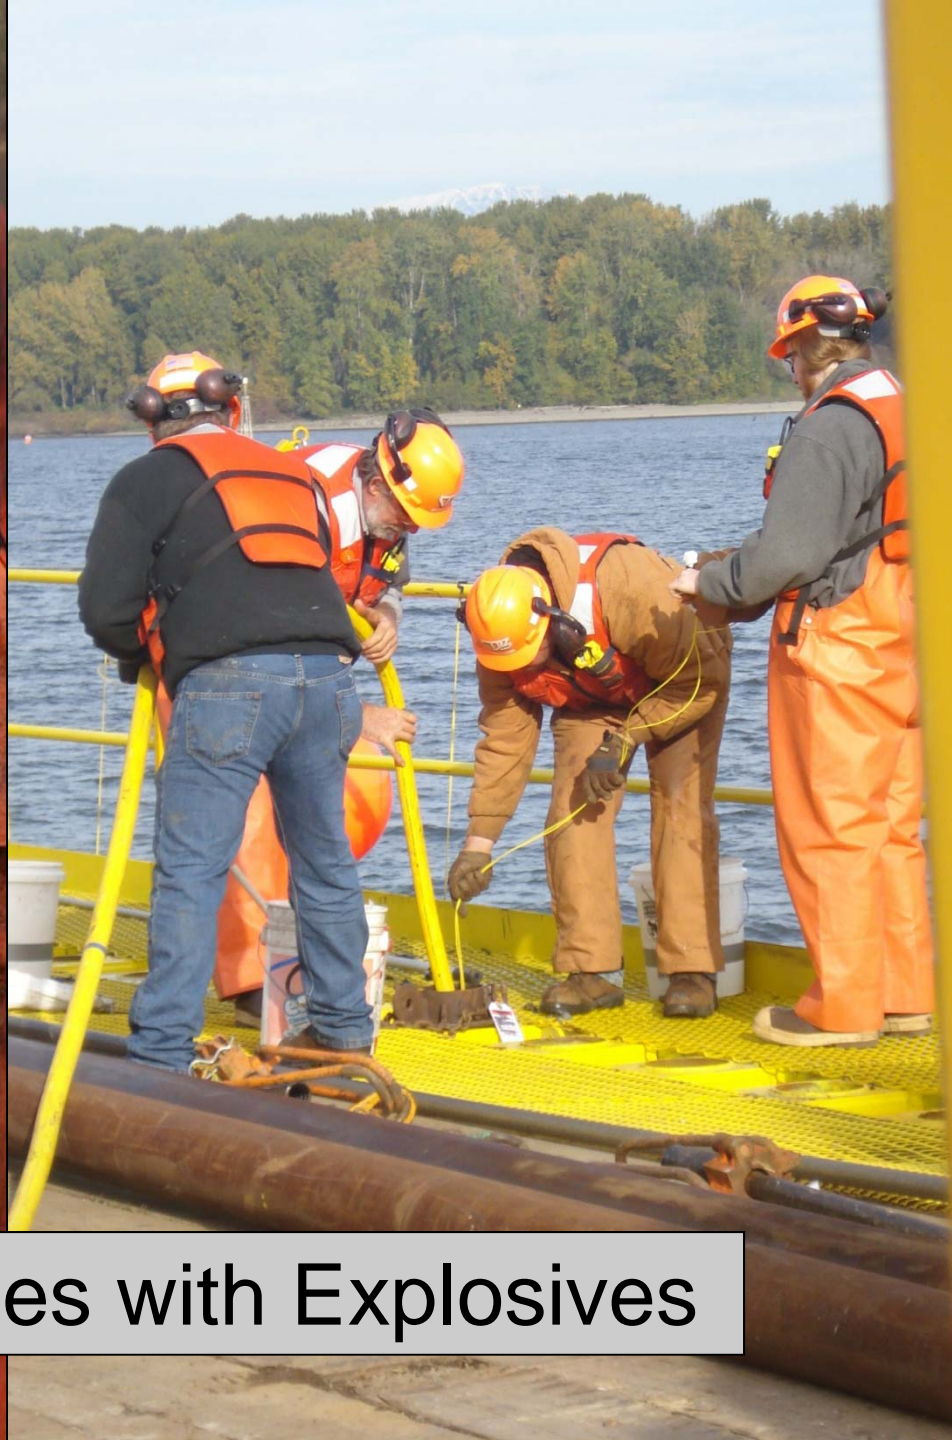
Loading Holes with Explosives

Stemming

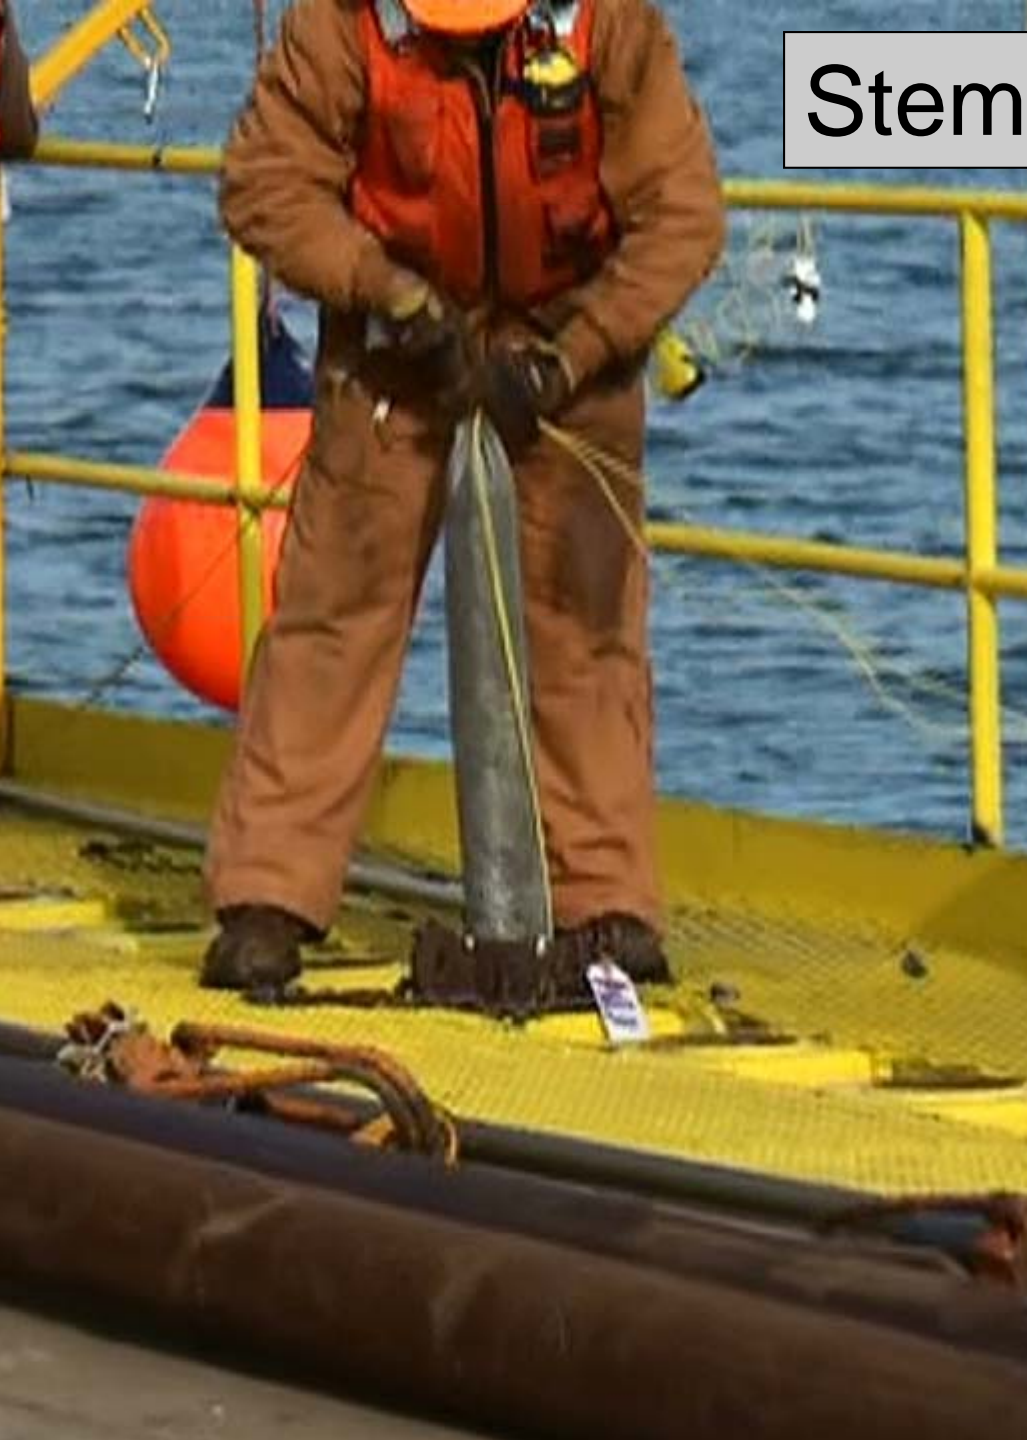
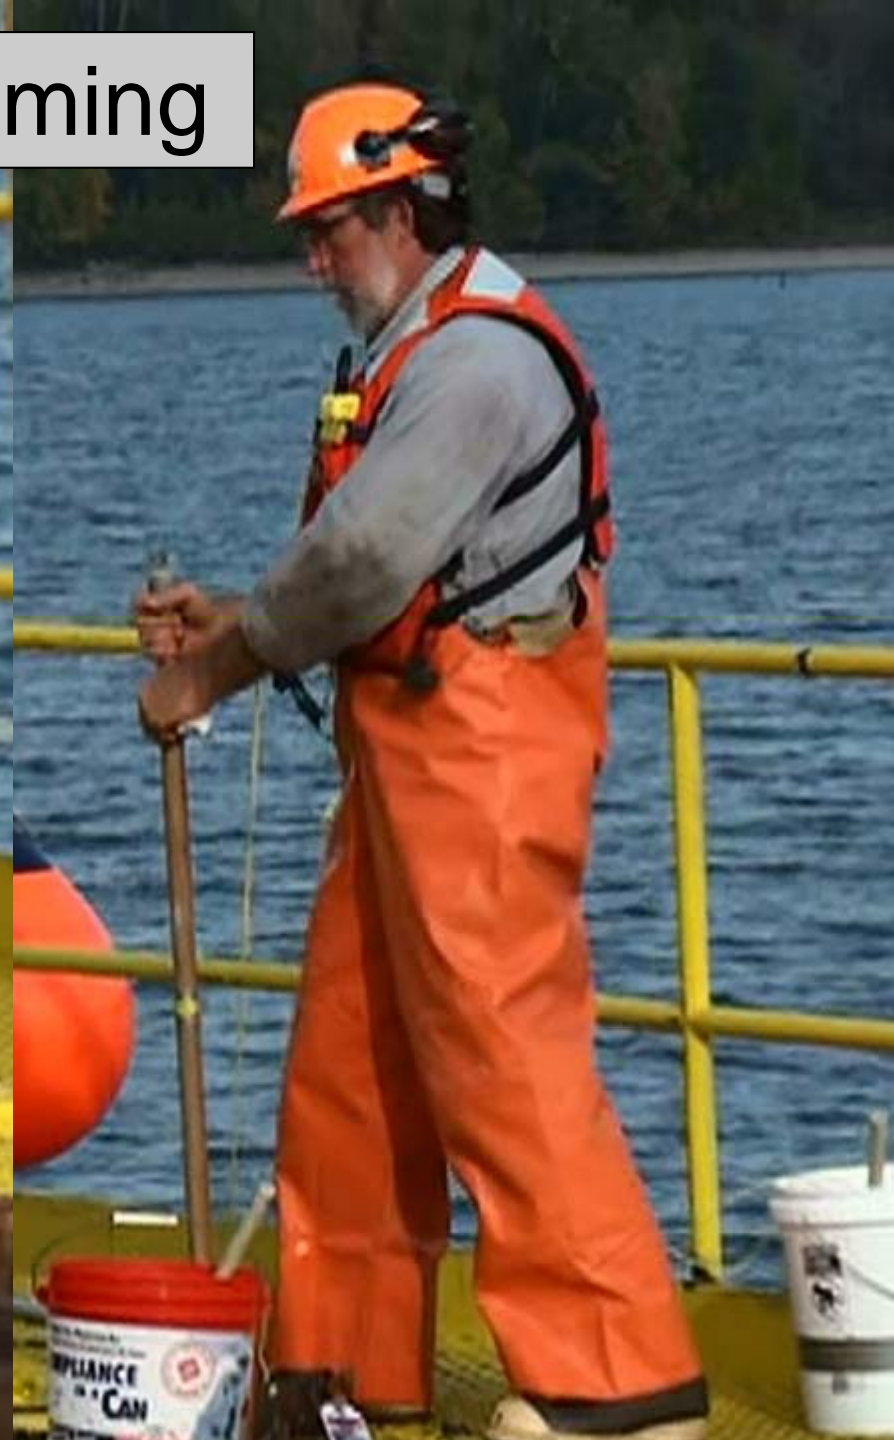
Tying shot together with
surface detonators and delays

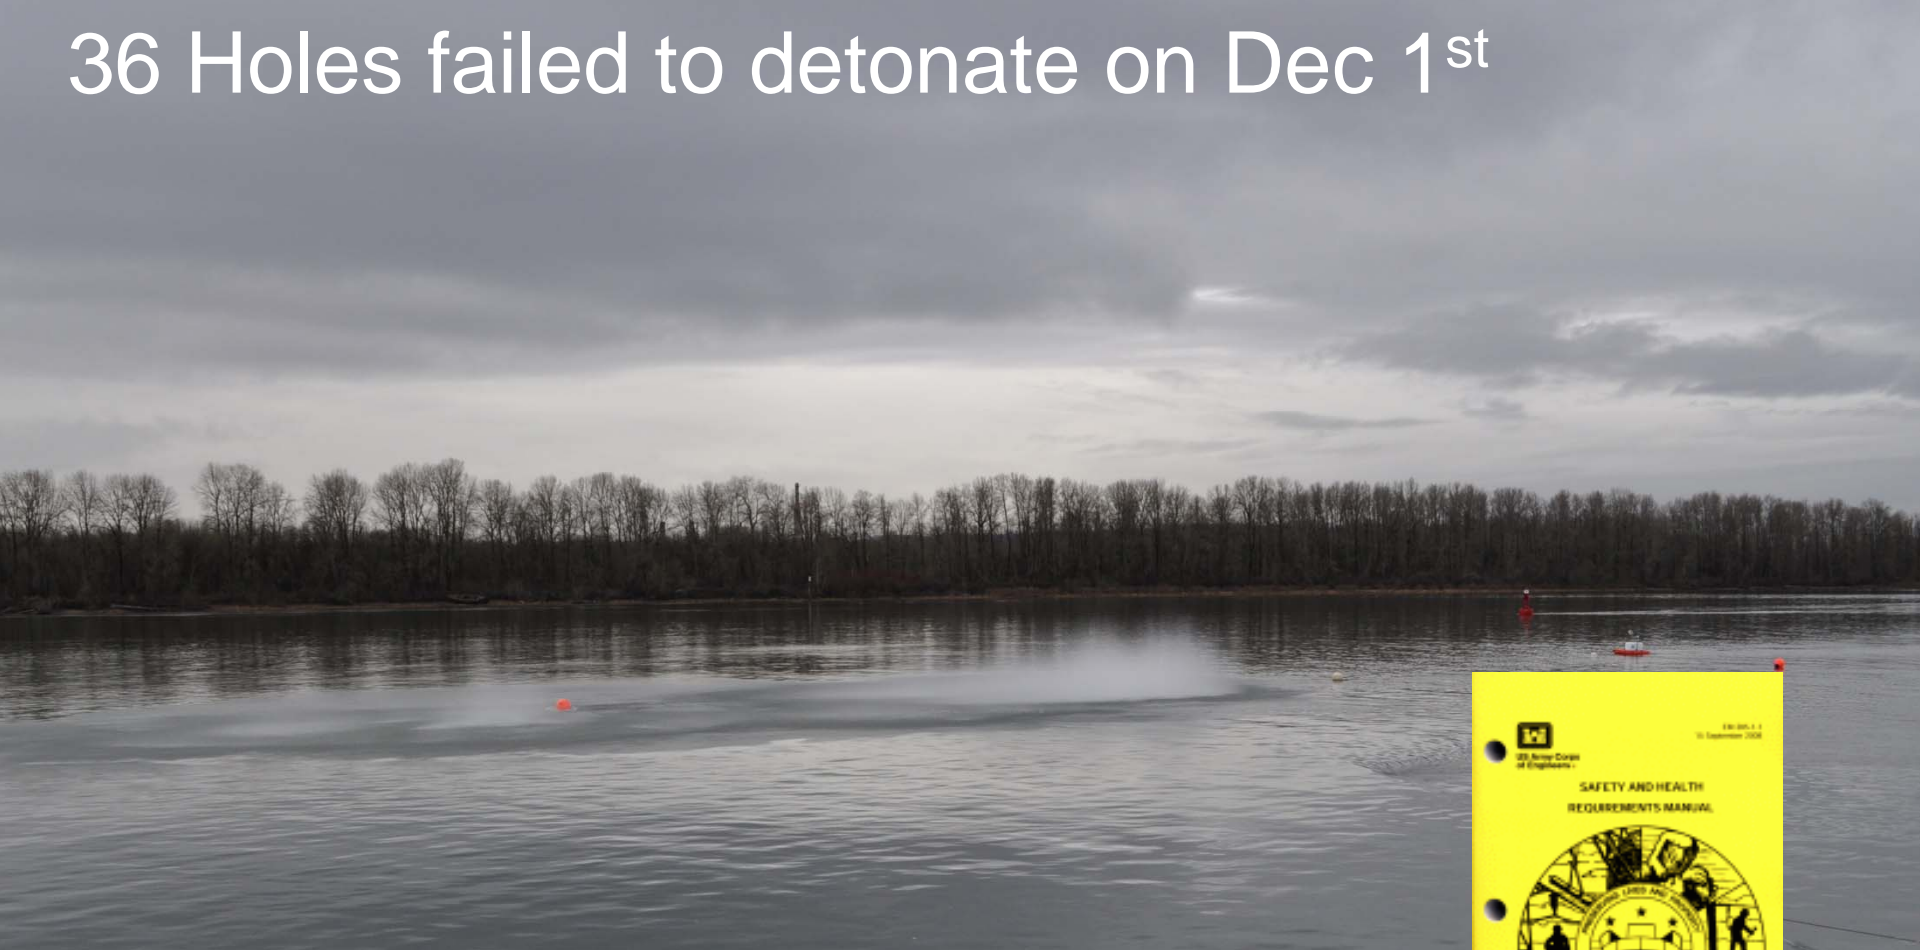
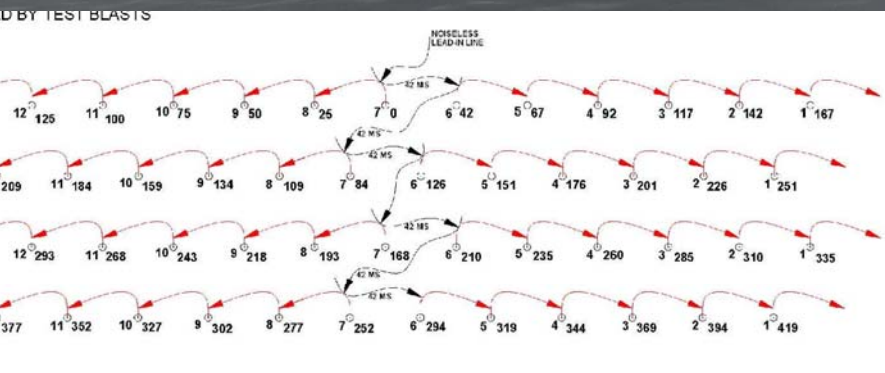
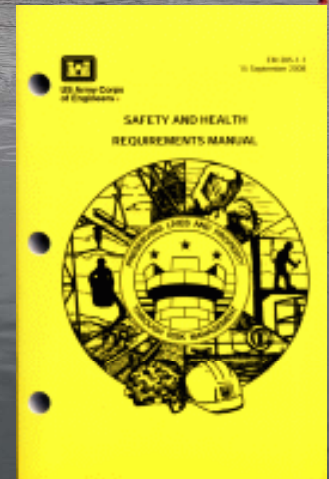
36 Holes failed to detonate on Dec 1st

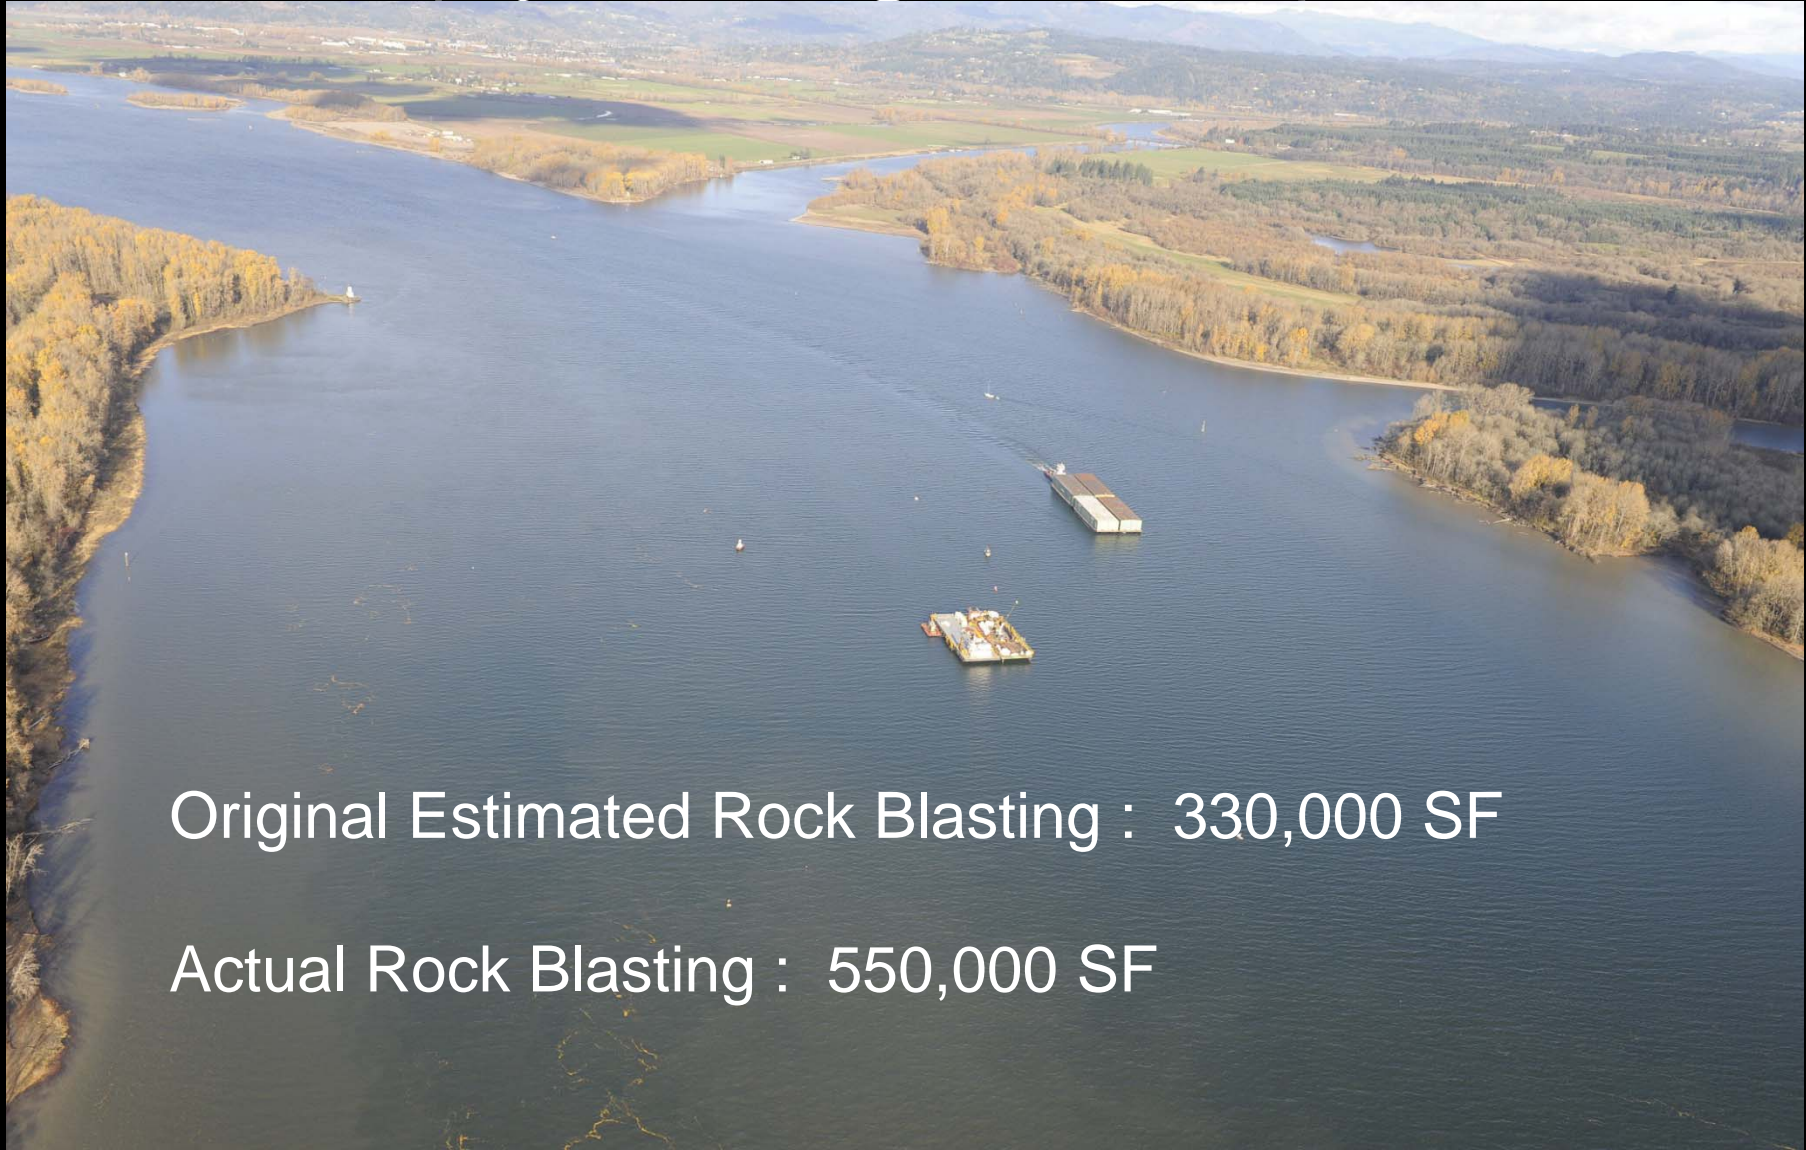
Additional Rock Blasting (by change order)

Original Estimated Rock Blasting : 330,000 SF

Actual Rock Blasting : 550,000 SF
