Mapping Dredged Material and a Sand Cap at Douglas Harbor, Juneau, AK, using Sediment-Profile Imaging (SPI) and a Semi-automated Image Processing System

Gene Revelas
Ian Stupakoff
Brandon Sackmann

Integral Consulting Inc.
Olympia, WA

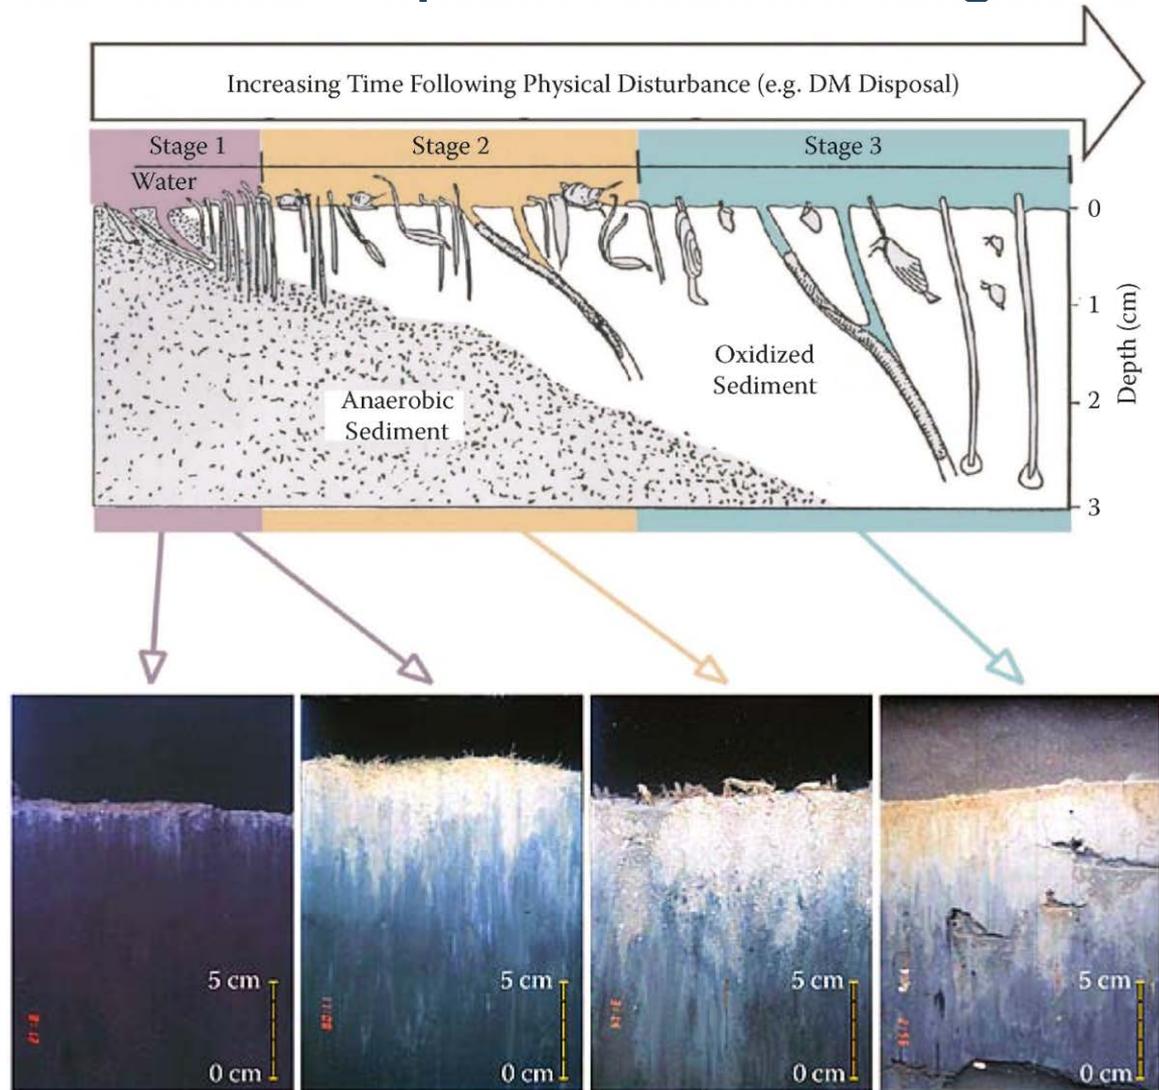
SPI Interpretive Paradigm

From Germano et al. 2011. The use of sediment profile imaging (SPI) for environmental impact assessments and monitoring studies – lessons learned from the past four decades. *Oceanography and Marine Biology: An Annual Review* 49: 247-310.

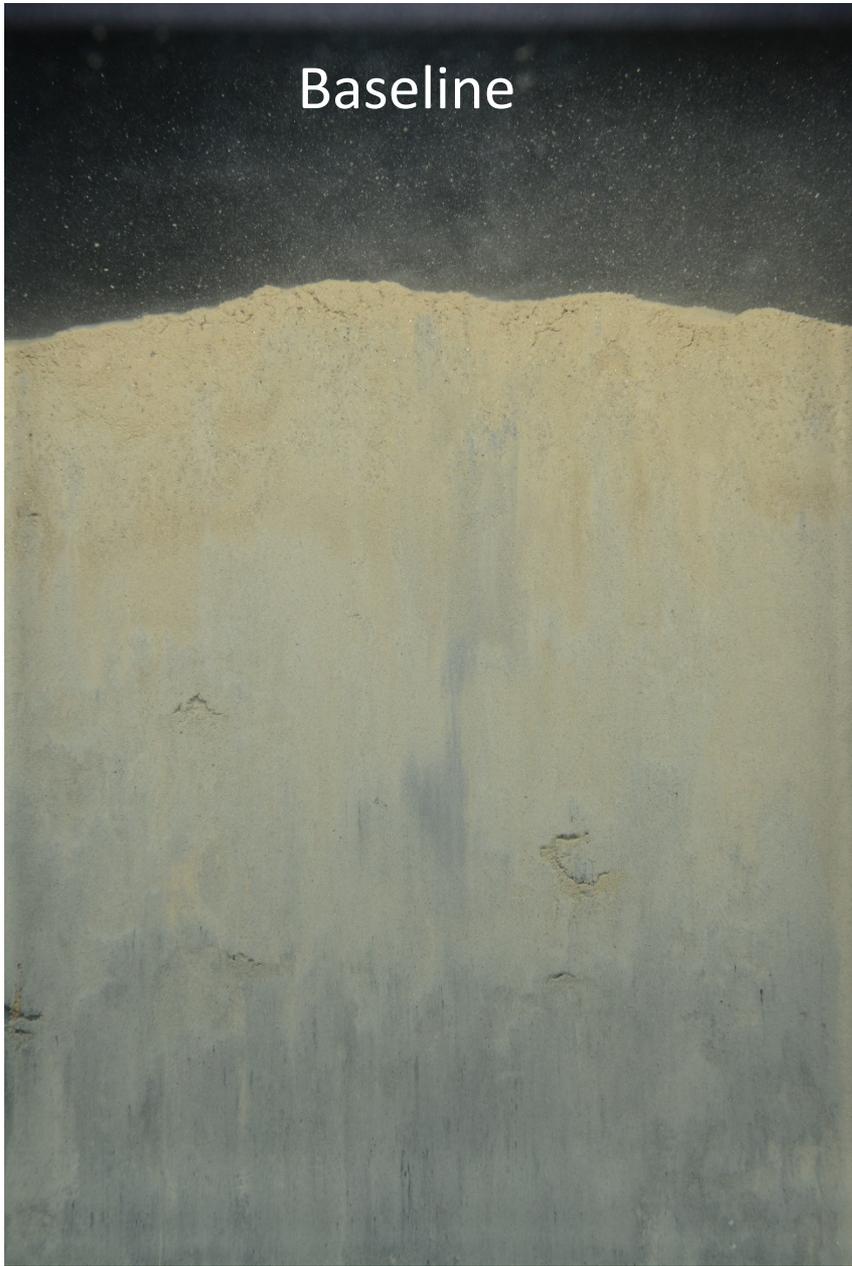
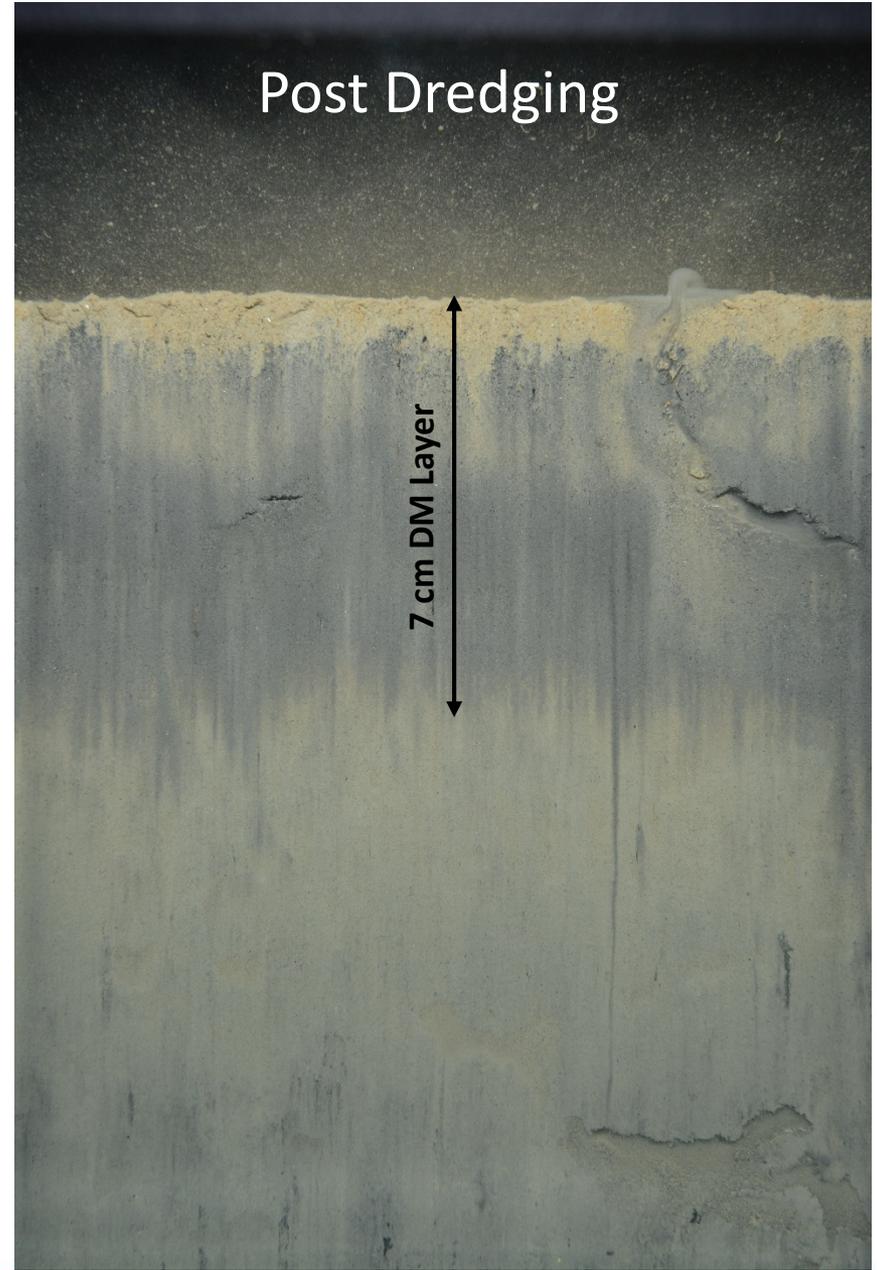
Disposal Site—Post-dredge Survey

Baseline

Post Dredging

7 cm DM Layer

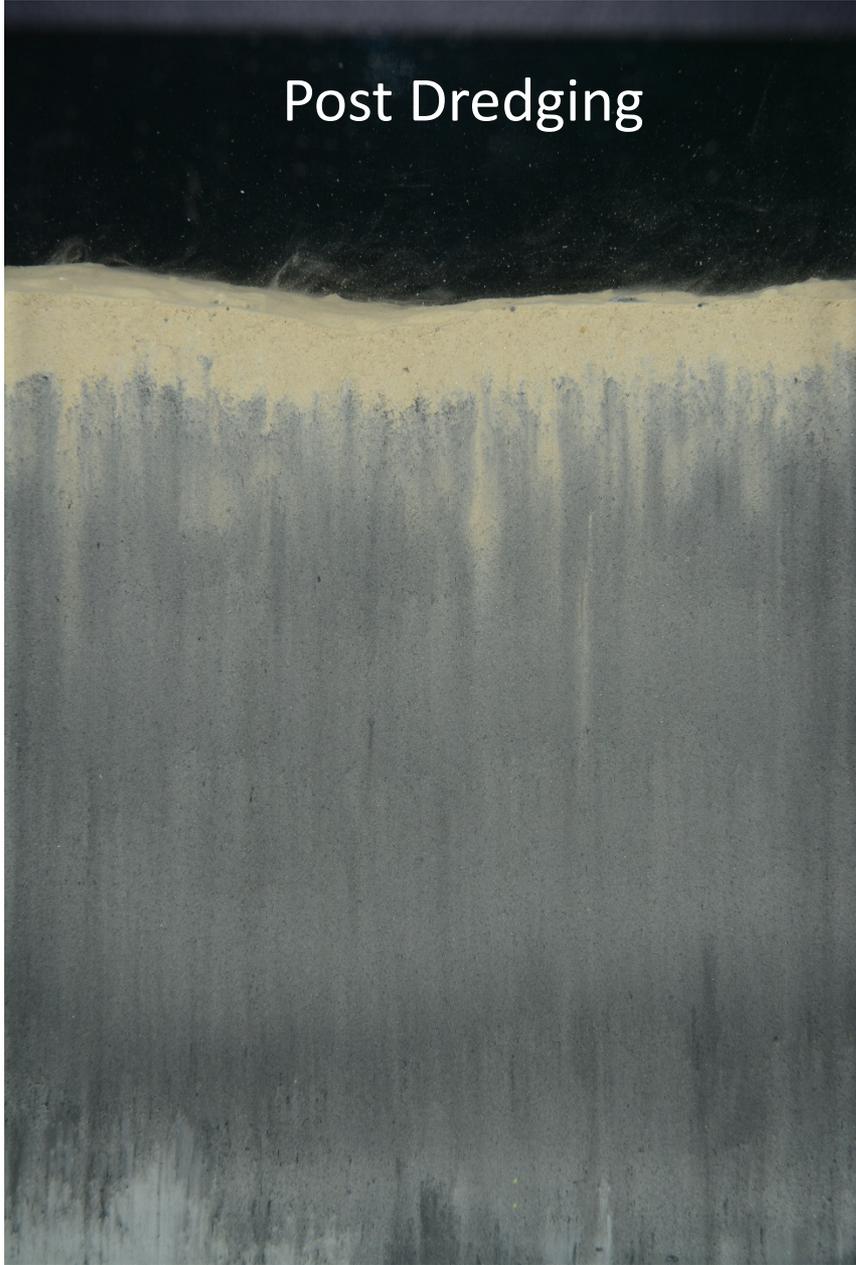
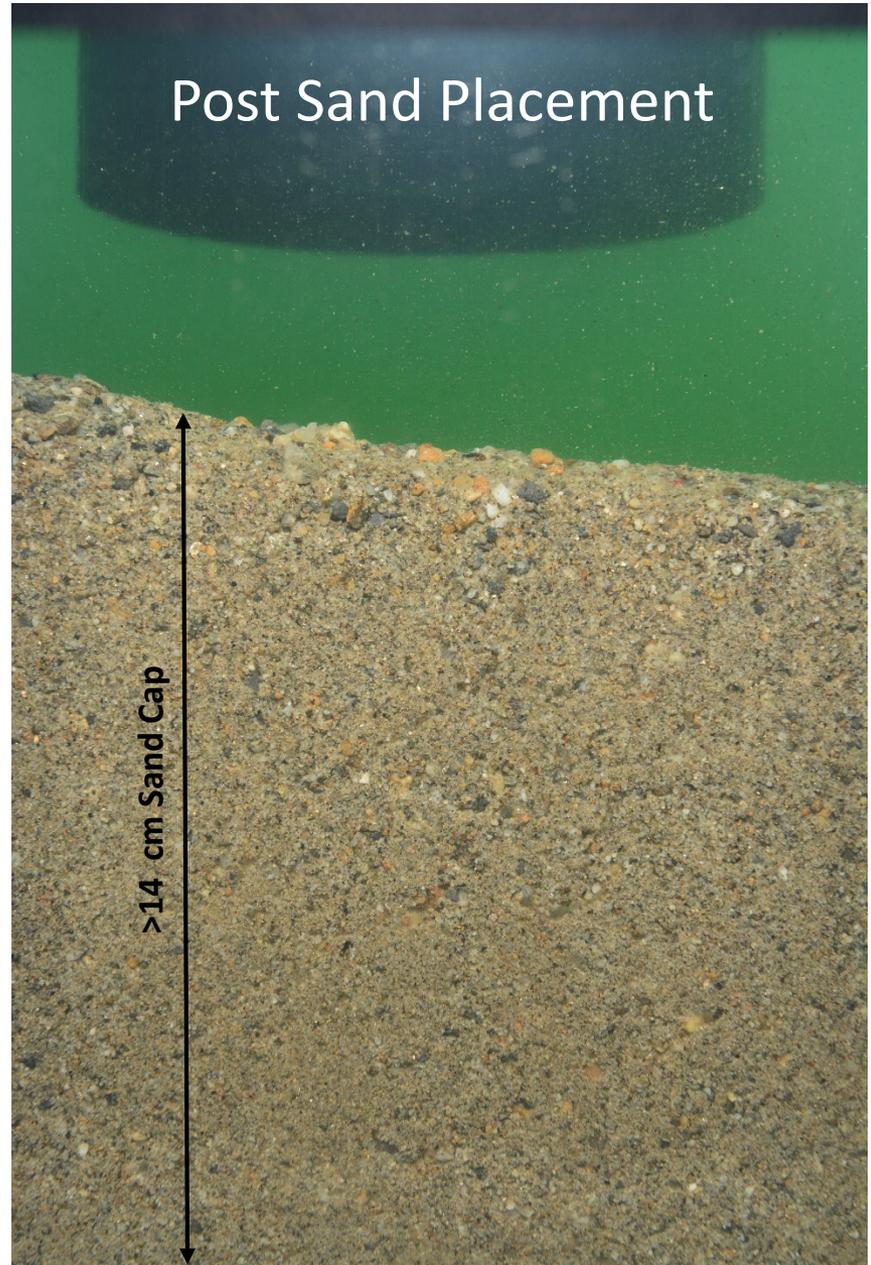
Douglas Harbor—Post-capping Survey

Post Dredging

Post Sand Placement

>14 cm Sand Cap

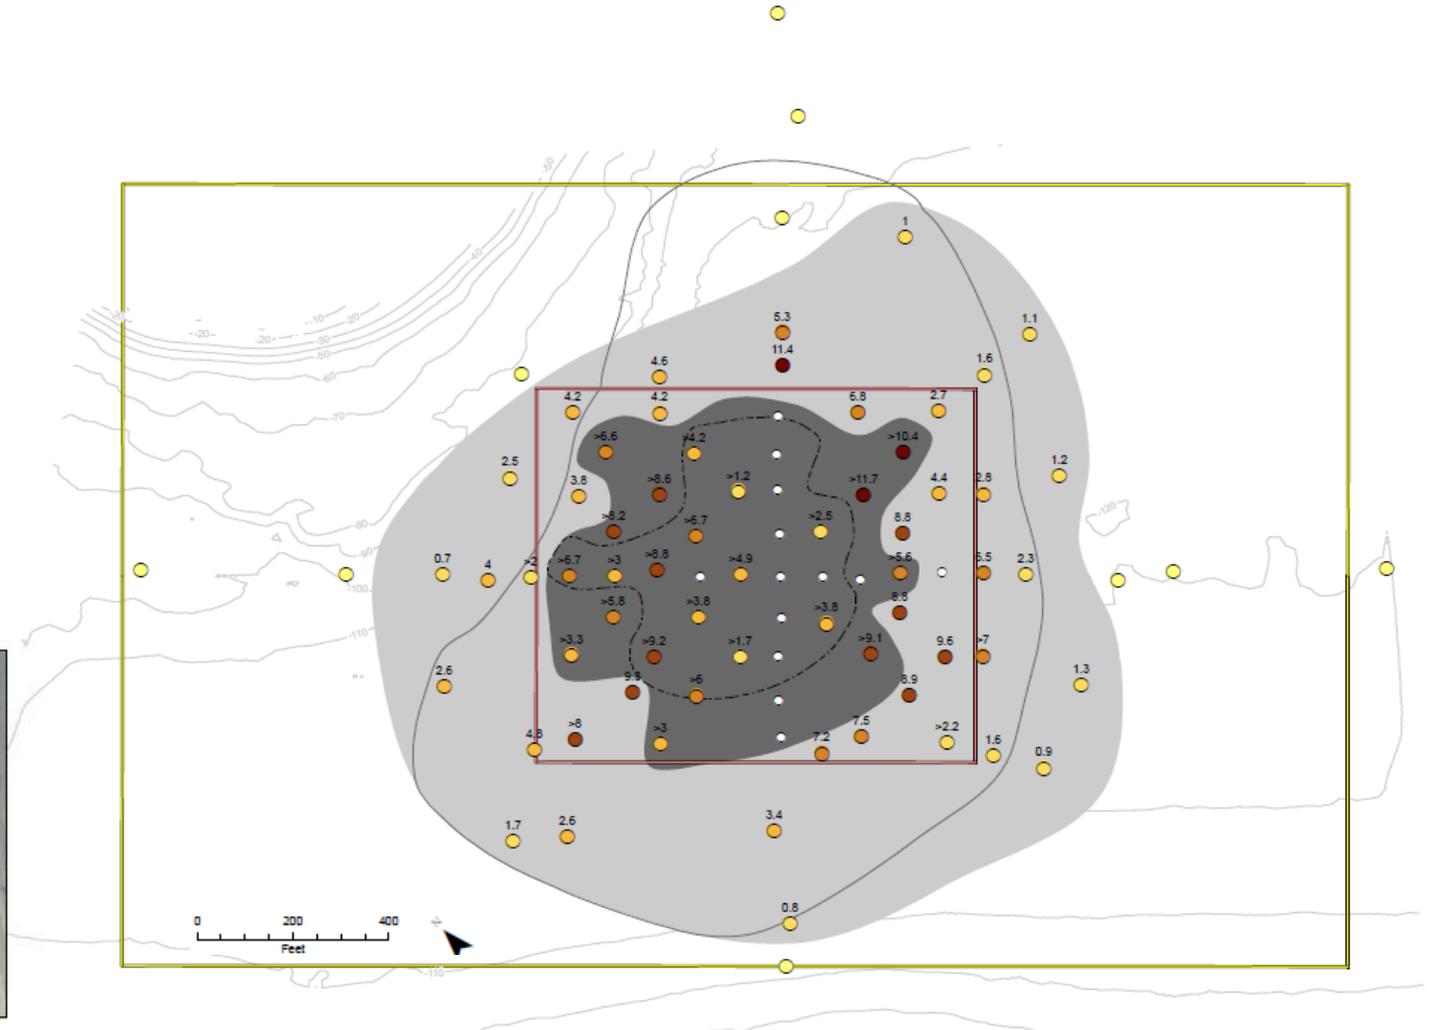
Post Sand Cap Survey—Disposal Site

Sand Cap Thickness (cm)

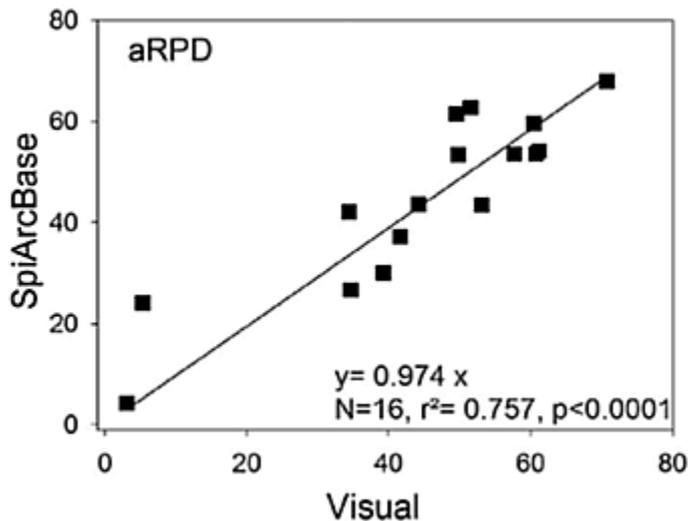
Comparison of the mean depths of aRPD assessed automatically (SpiArcBase) and visually, by two independent operators (Romero-Ramirez et al. 2013)

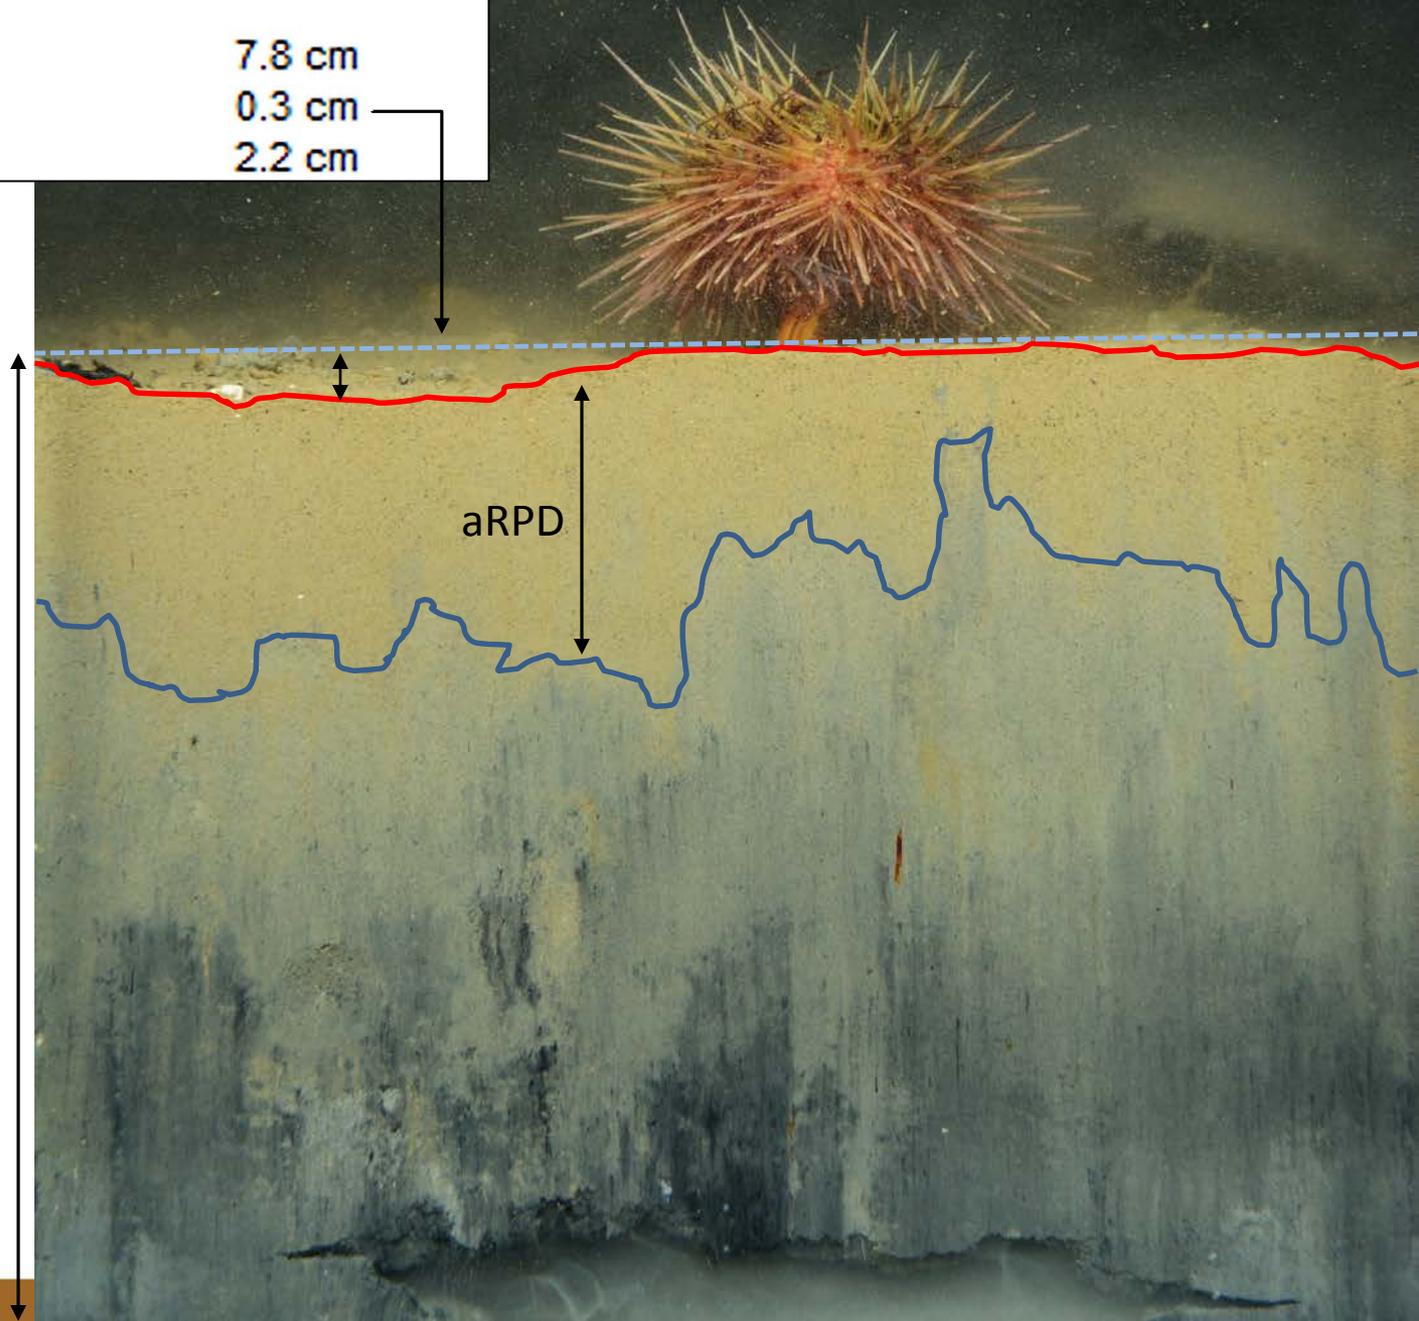
Penetration Depth:	7.8 cm
Boundary Roughness:	0.3 cm
RPD Depth:	2.2 cm

Penetration Depth

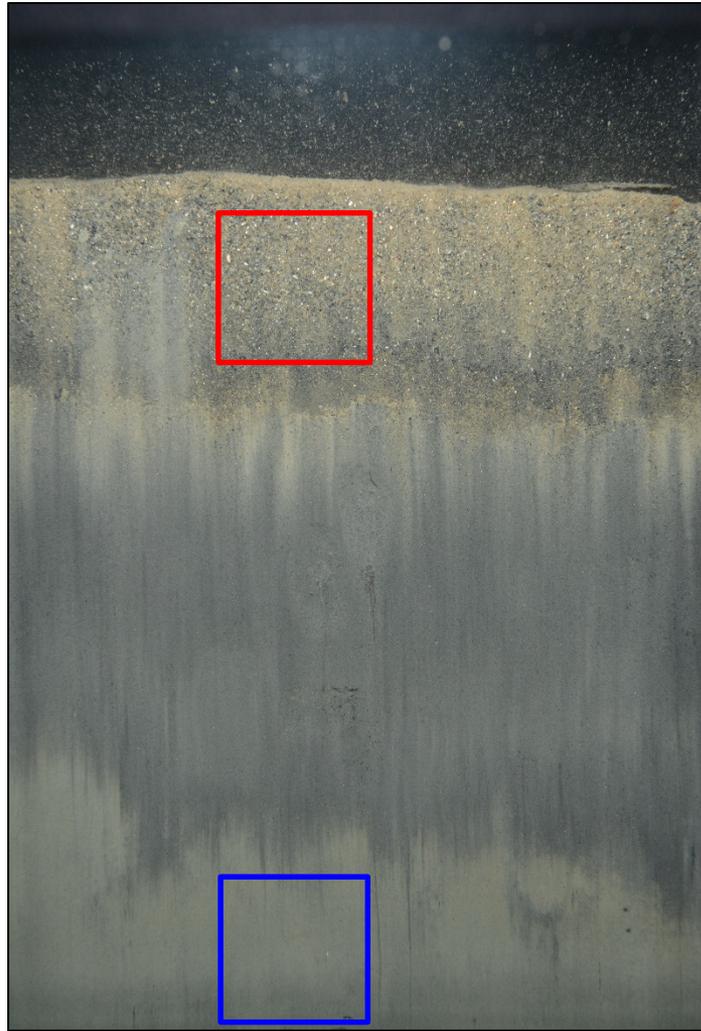
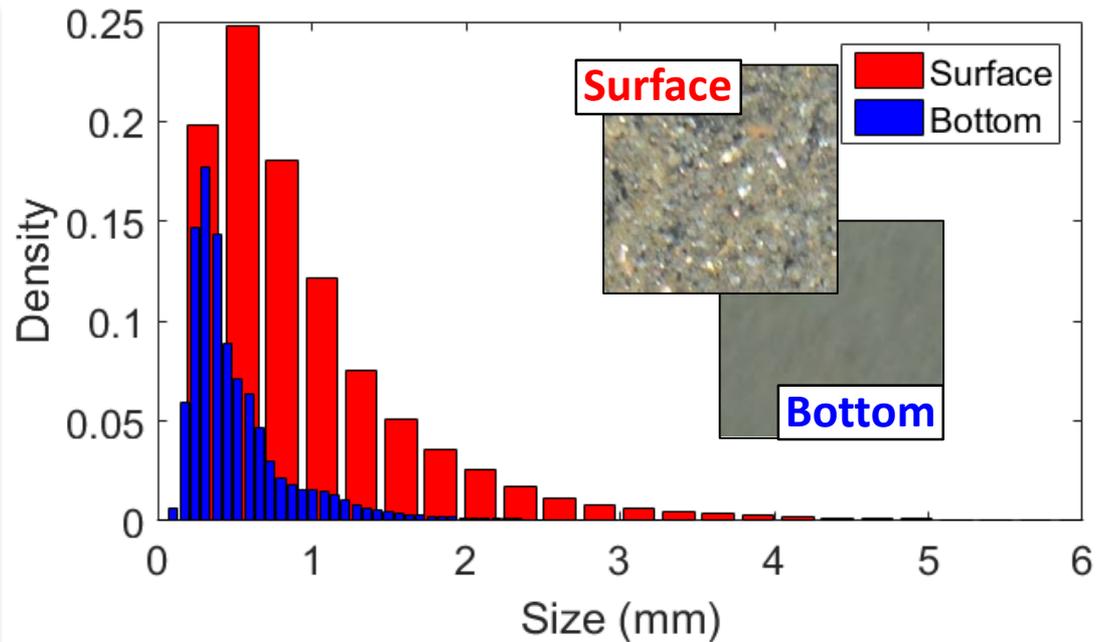
Grain Size Analysis*

*Buscombe, D. 2013. Transferable wavelet method for grain-size distribution from images of sediment surface and thin sections, and other natural granular patterns. *Sedimentology* 60:1709–1732. http://dbuscombe-usgs.github.io/DGS_Project/
