Northwest Oil Drain Canal: Sediment Remediation Using Bypass and Excavation

TEAL DREHER, ROB WEBB, PAUL FUGLEVAND
DALTON, OLMSTED & FUGLEVAND, INC.

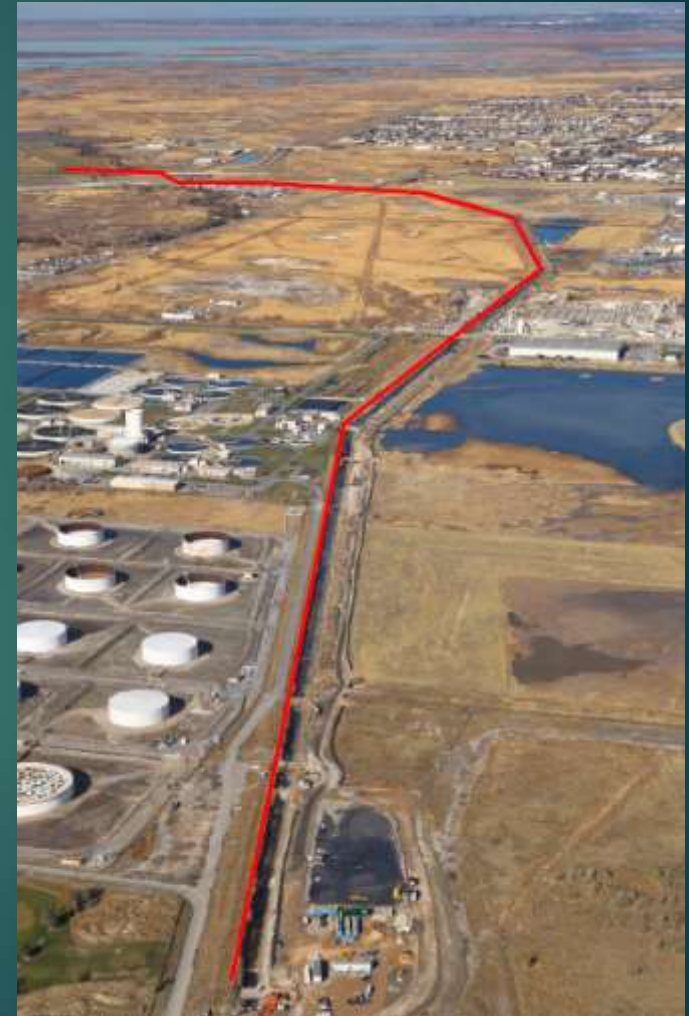
NWOD Canal

- ▶ NWOD canal is located in northern Salt Lake County, Utah
- ▶ 3 miles long
- ▶ Canal was originally constructed in the 1920s by Salt Lake City
- ▶ NWOD canal is critical City infrastructure receives up to 30-35 MGD discharge from Salt Lake City's Wastewater Reclamation Facility (WRF)
- ▶ Part of the stormwater conveyance system which brings peak flows to near 75 cfs on average
- ▶ Peak Canal Flows: 2-yr 100 cfs; 25 yr 400 cfs. Peak flows in summer

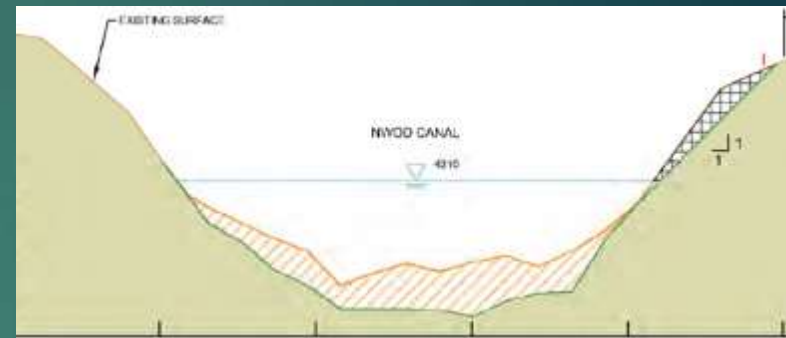
U-shaped canal cross section

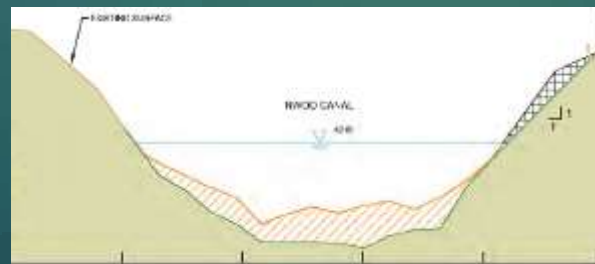
Technology Ranking

– Bypass and Excavate - high

Equipment and Removal Method	Effectiveness			
	Residuals Control	Sheen Control	Aquitard Protection	Overall Effectiveness
Mechanical Dredge				
Conventional clamshell – wire rope	Low	Low-medium	Low	Low
Enclosed level cut bucket – wire rope	Low-medium	Low	Low-medium	Low-medium
Articulated bucket (excavator)	Medium	Medium	Low-medium	Medium
Hydraulic Dredge				
Conventional cutterhead	Low	Low	Low	Low
Swinging ladder cutterhead	Low	Low	Low	Low
Horizontal auger	Low	Low	Low	Low
Bypass and Excavation				
Mechanical excavator	High	High	High	High

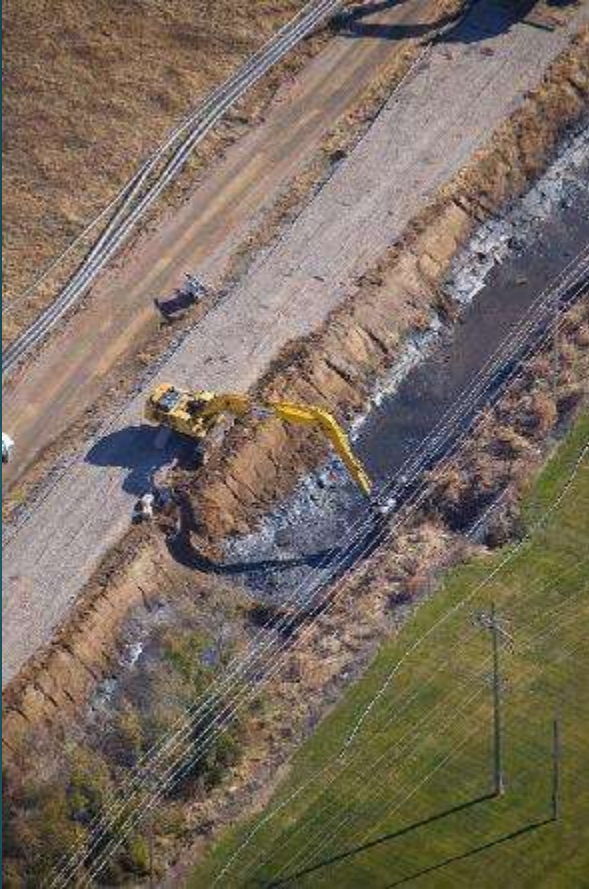
Bypass and Excavation

- ▶ Install diversion dams at each end of segment
- ▶ Flatten bank on working side of canal to improve bank stability
- ▶ Install high-capacity bypass pumps
- ▶ Pump water from work area to drain canal and expose bottom of canal
- ▶ Install sump pumps for seepage water
- ▶ Remove sediment from canal with long reach excavator
- ▶ Confirm and document successful removal of sediment with visual observation and post removal sampling

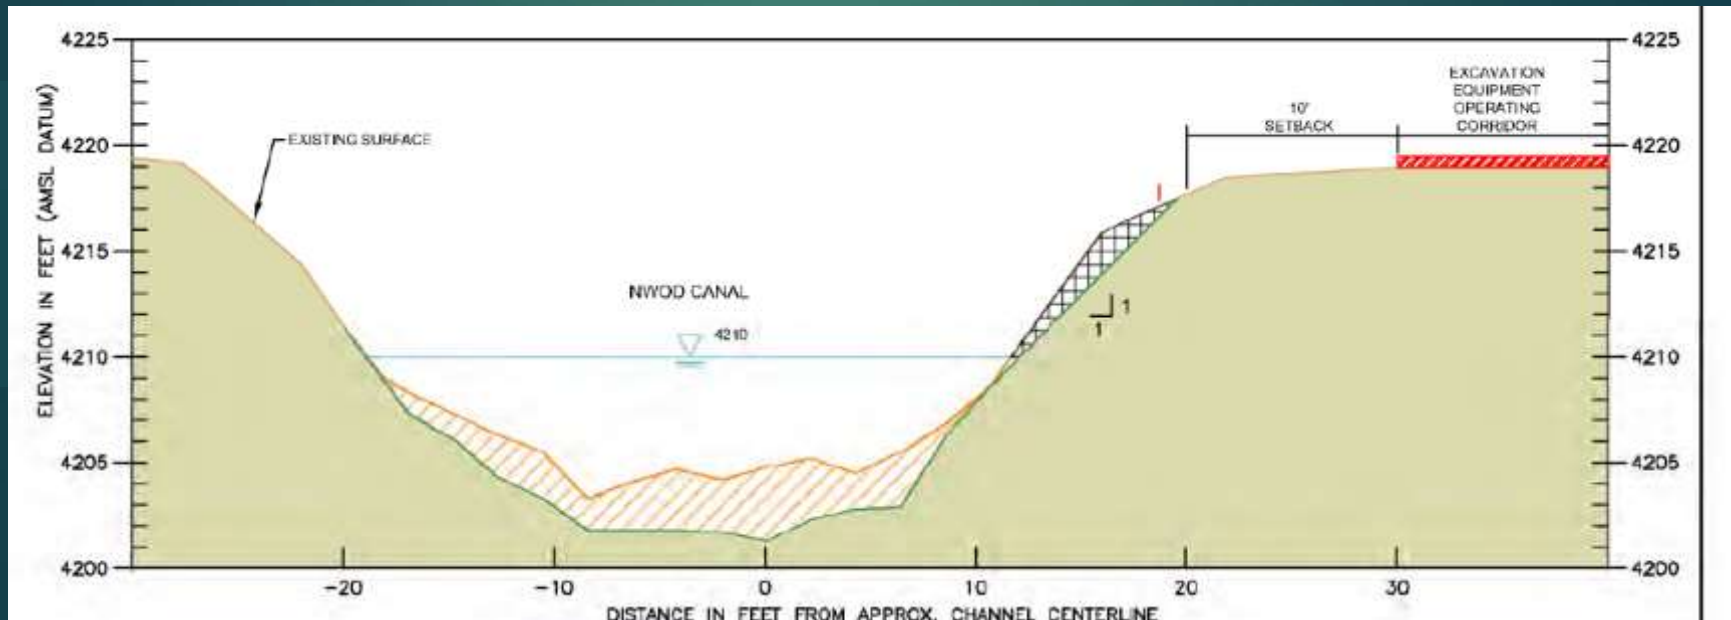
Bank Instability - BMPs

- ▶ Unstable side slopes
- ▶ Controlled drawdown of canal, 2-4 ft per day
- ▶ Bank flattening before sediment excavation
- ▶ Equipment setback for bank stability

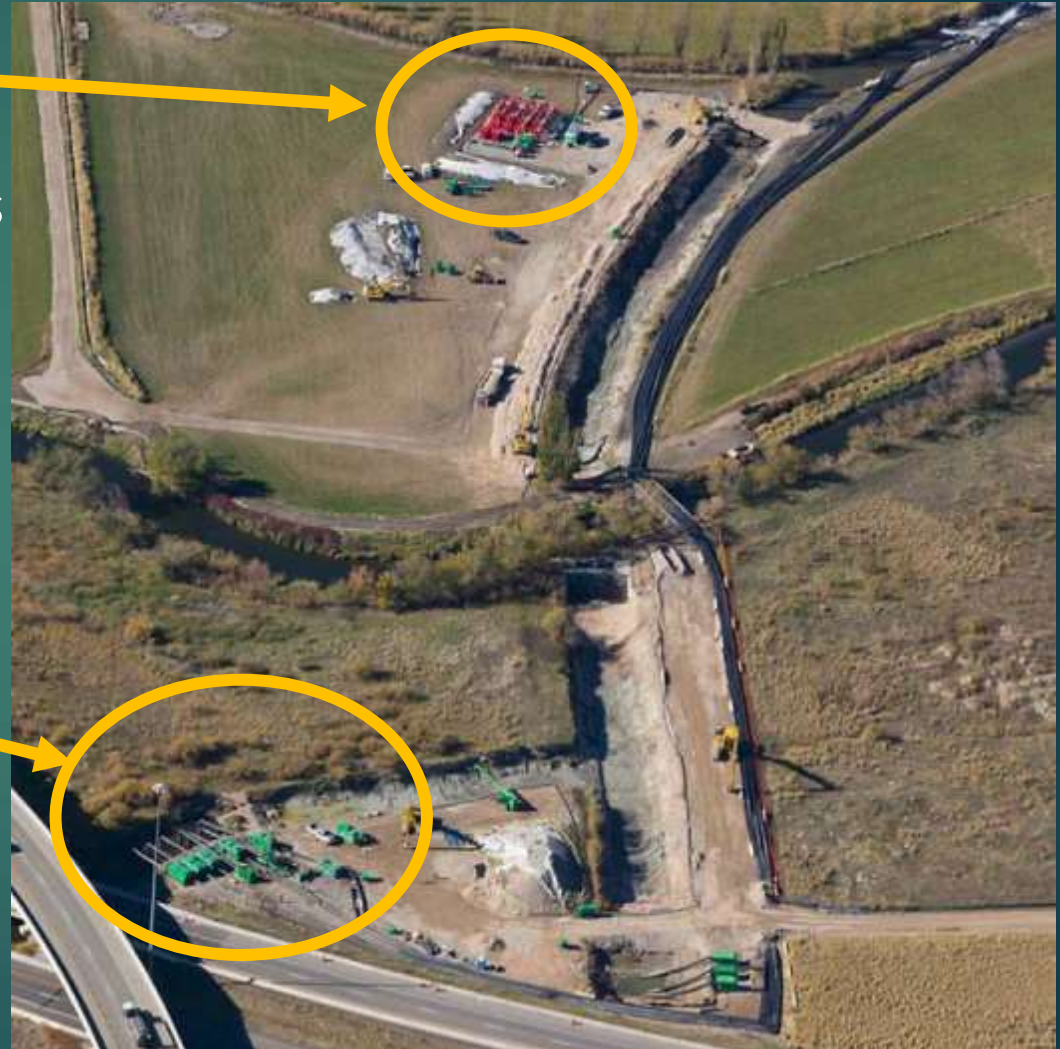
Water Management

Contact Water Treatment

- Seepage water
- Four 21,000 gal. Weir tanks
- Two Oil/Water Separators
- Two Particulate Filters
- 1,000 gpm

Bypass Pumps –

- 140 cfs main channel
- 25 cfs secondary channel

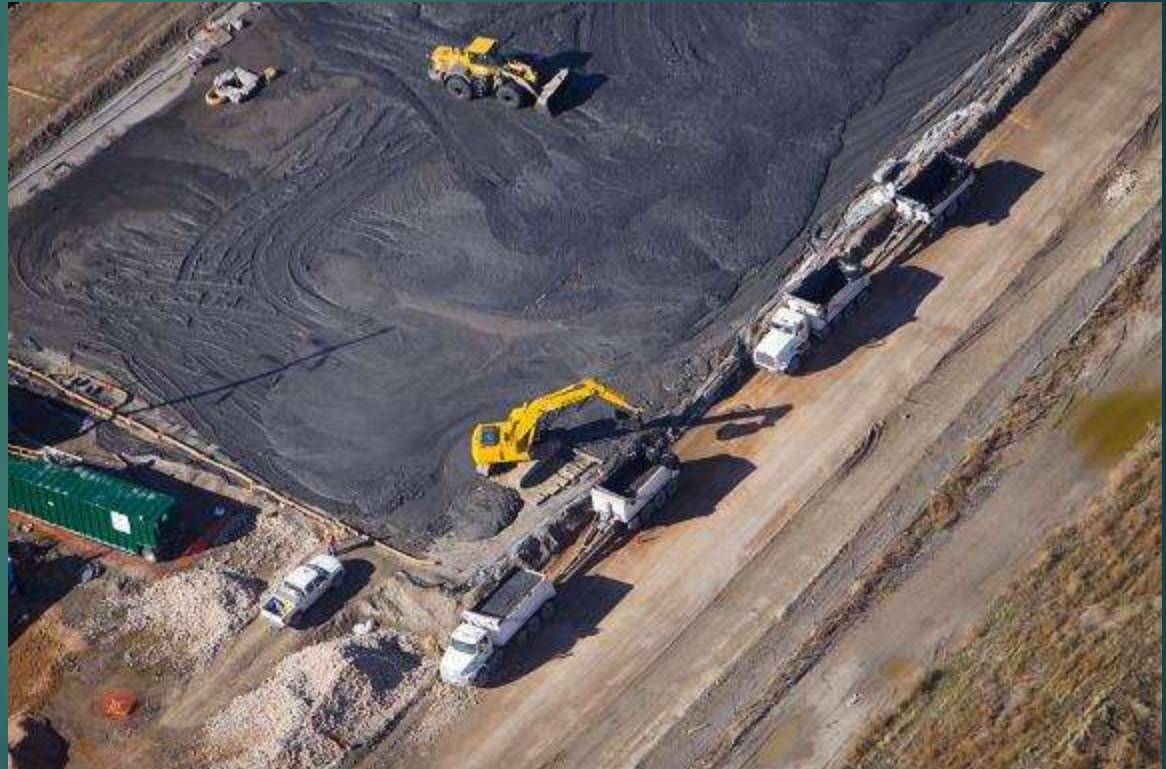
- ▶ Removed sediment trucked to Sediment Processing Area (SPA)
- ▶ Asphalt paved and HDPE lined basin
- ▶ Material stabilized with drying agent as needed to pass the paint filter test
- ▶ Zap-Zorb ~0.2% by wt.
- ▶ Loaded into trucks for offsite disposal

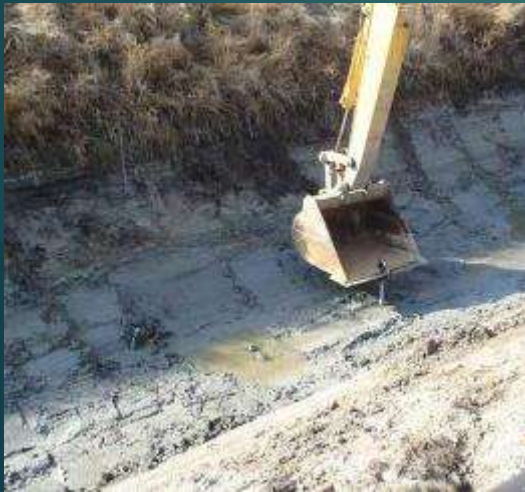
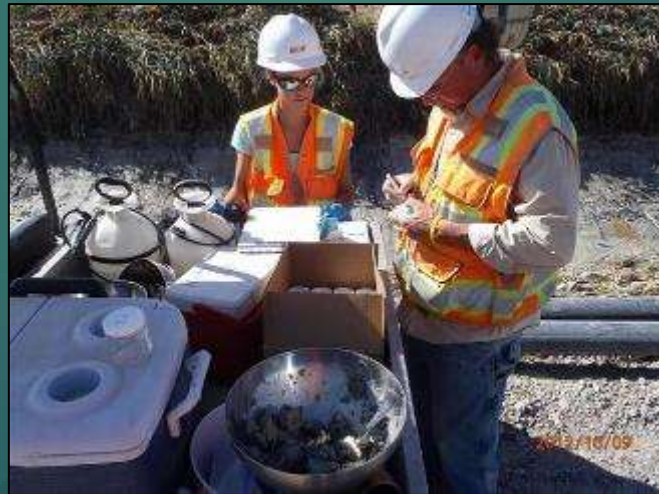
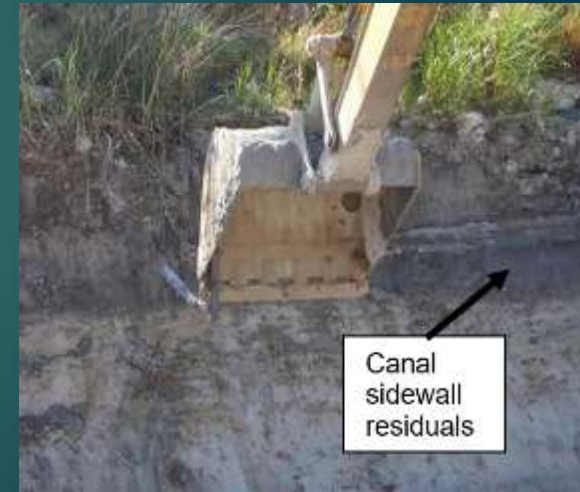
Confirmation Sampling

- ▶ Visual confirmation of removal of dark, soft, and wet sediment
- ▶ 6-point composite sample from 200-ft-long confirmation zones
- ▶ Canal bottom residuals – impacted soil left in place with Agency approval – further excavation threatened utilities.
- ▶ Canal sidewall residuals – along length of canal

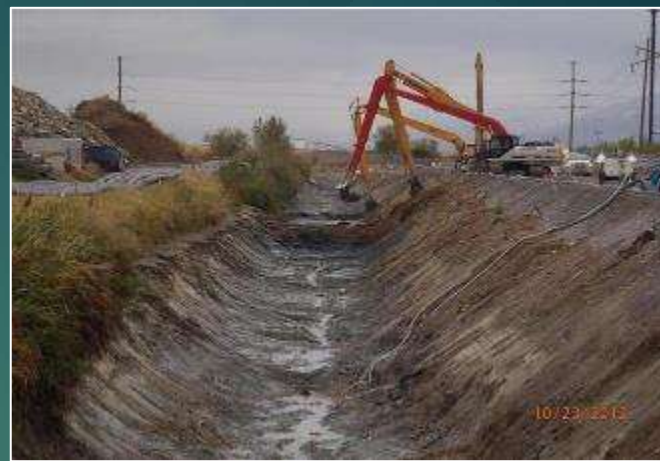
Results

- ▶ 95% of Canal passed cleanup criteria
- ▶ Exceptions – pipeline crossings, road abutments, bank stability
- ▶ Agency approval
