#### Port of Everett Pacific Terminal Dredging Project

An integrated navigational and environmental cleanup dredging project

Presented by: Abhijit Joshi

Date: October 24, 2018

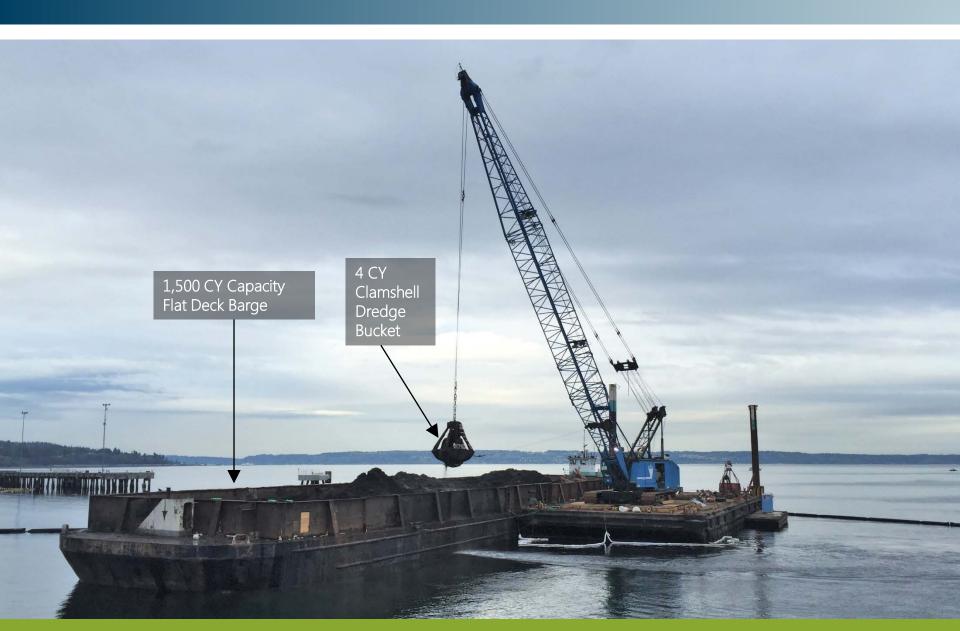
## Contaminated Material Dredging

- > Approximately 22,200 CY dredged.
- Dredge rate of approximately 800 CY/day.
- Contaminated material estimated bulk density of 1.04 Tons/CY.
- Dredging Cost: \$20/CY
- Offload Cost: \$12/CY
- Upland Transport and Disposal: \$50/Ton
