MAXIMIZING STREAKED HORNED LARK SUCCESS USING THE STRATEGIC PLACEMENT OF DREDGED MATERIAL IN THE COLUMBIA RIVER

Kristine Lightner Environmental Resource Specialist Portland District 24 October 2018

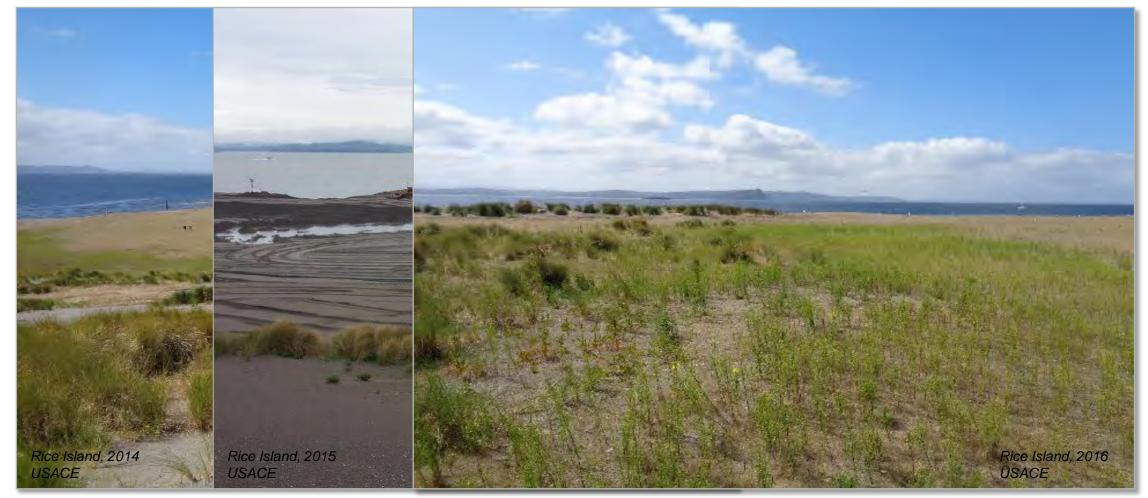
DREDGING AND HABITAT SUCCESSION: MAXIMIZING SUCCESS

How does SHLA habitat transition from nesting habitat to newly placed dredged material back into suitable nesting habitat.
