REMEDICATION OF SEAFOOD WASTE ACCUMULATIONS

DANIEL J. PICKERING, PE
DALTON, OLMSTED, & FUGLEVAND INC. (DOF)

WEDA PACIFIC CHAPTER
2019 ANNUAL MEETING
OCTOBER 29 – 31, 2019
NEWPORT BEACH, CA

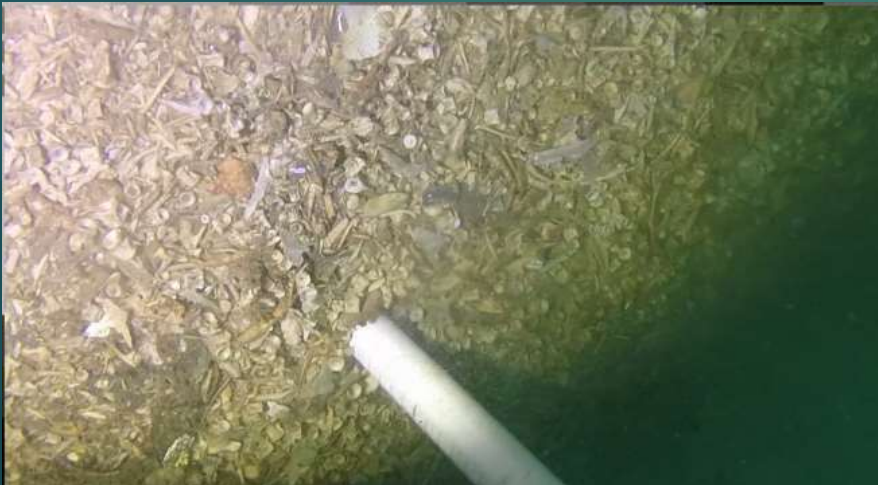
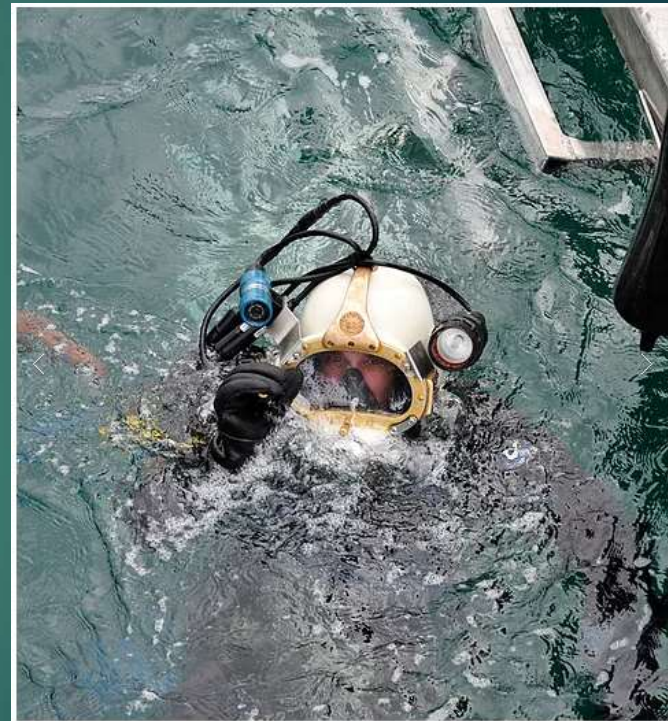
- ▶ Annual Seafloor Monitoring Surveys
 - Performed by Commercial Divers
 - Visual Assessment
 - Probes
 - Push Cores
- ▶ Zone of Deposit between 3 acres and 5 acres

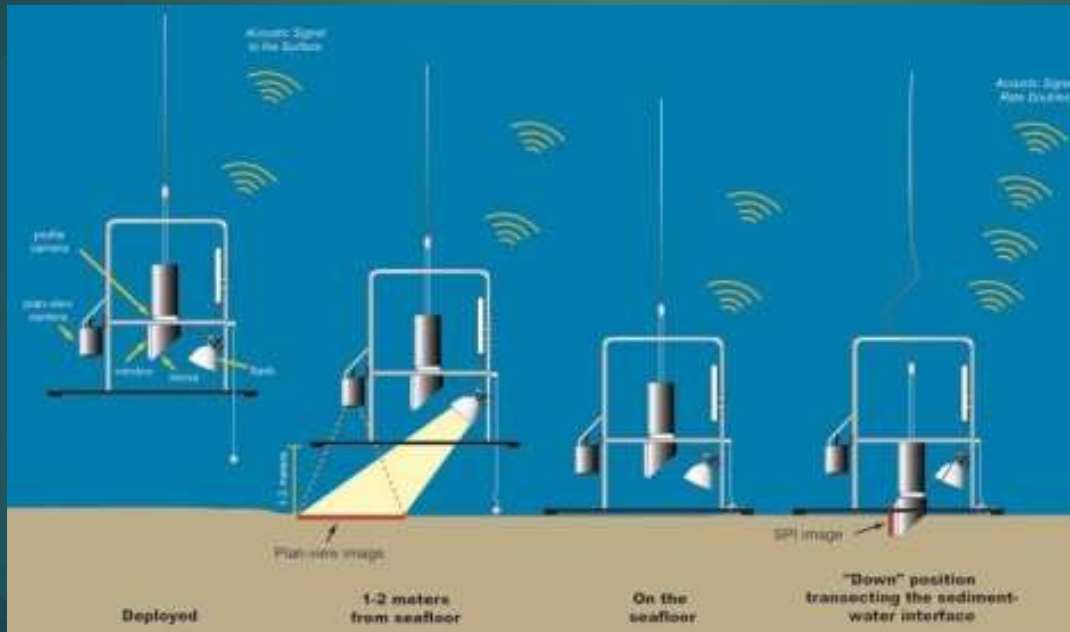
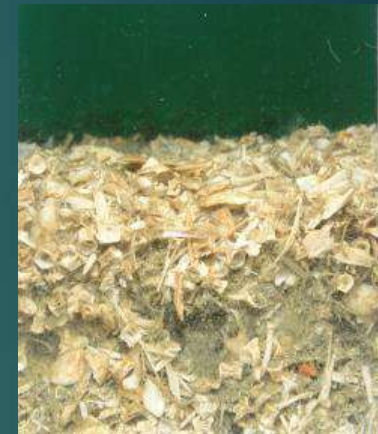
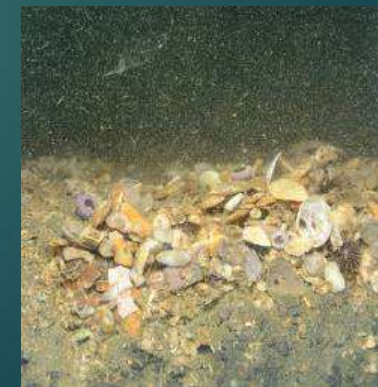
Background (2014)

- ▶ 2014: Benthic Habitat Assessment & Sediment Coring Survey
 - Sediment Profile Images (SPI)
 - Sediment Coring Survey
 - Vibracore Sampling
 - Box Core Sampling
- ▶ Zone of Deposit: ~3.0 Acres

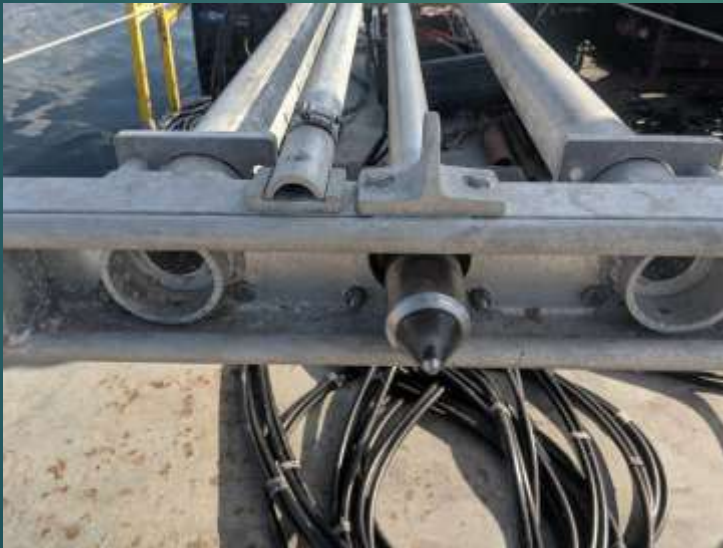
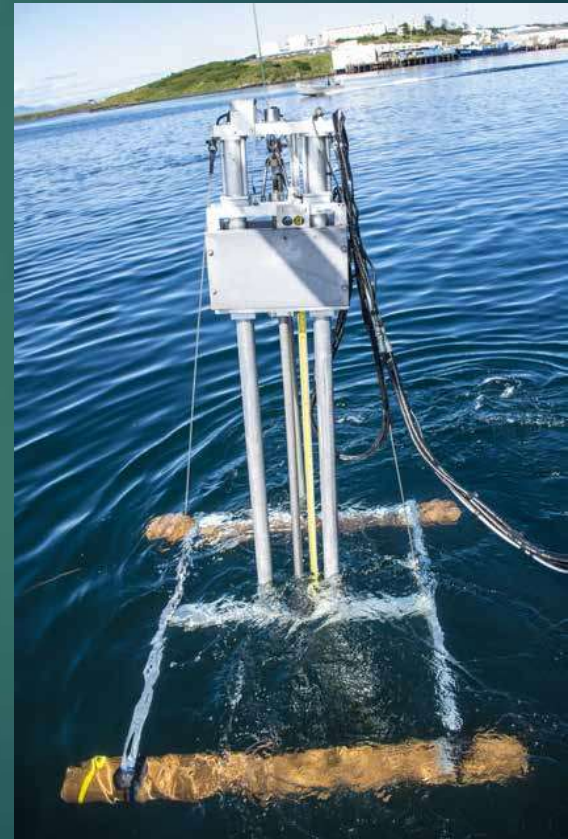
Background (2016)

- ▶ 2016: Bathymetric Survey & Benthic Habitat Asses
 - Multibeam Survey
 - Sediment Profile Images (SPI)
 - Sediment Coring Survey
 - Vibracore Sampling
 - Video Probe
- ▶ Zone of Deposit: ~3.5 Acres

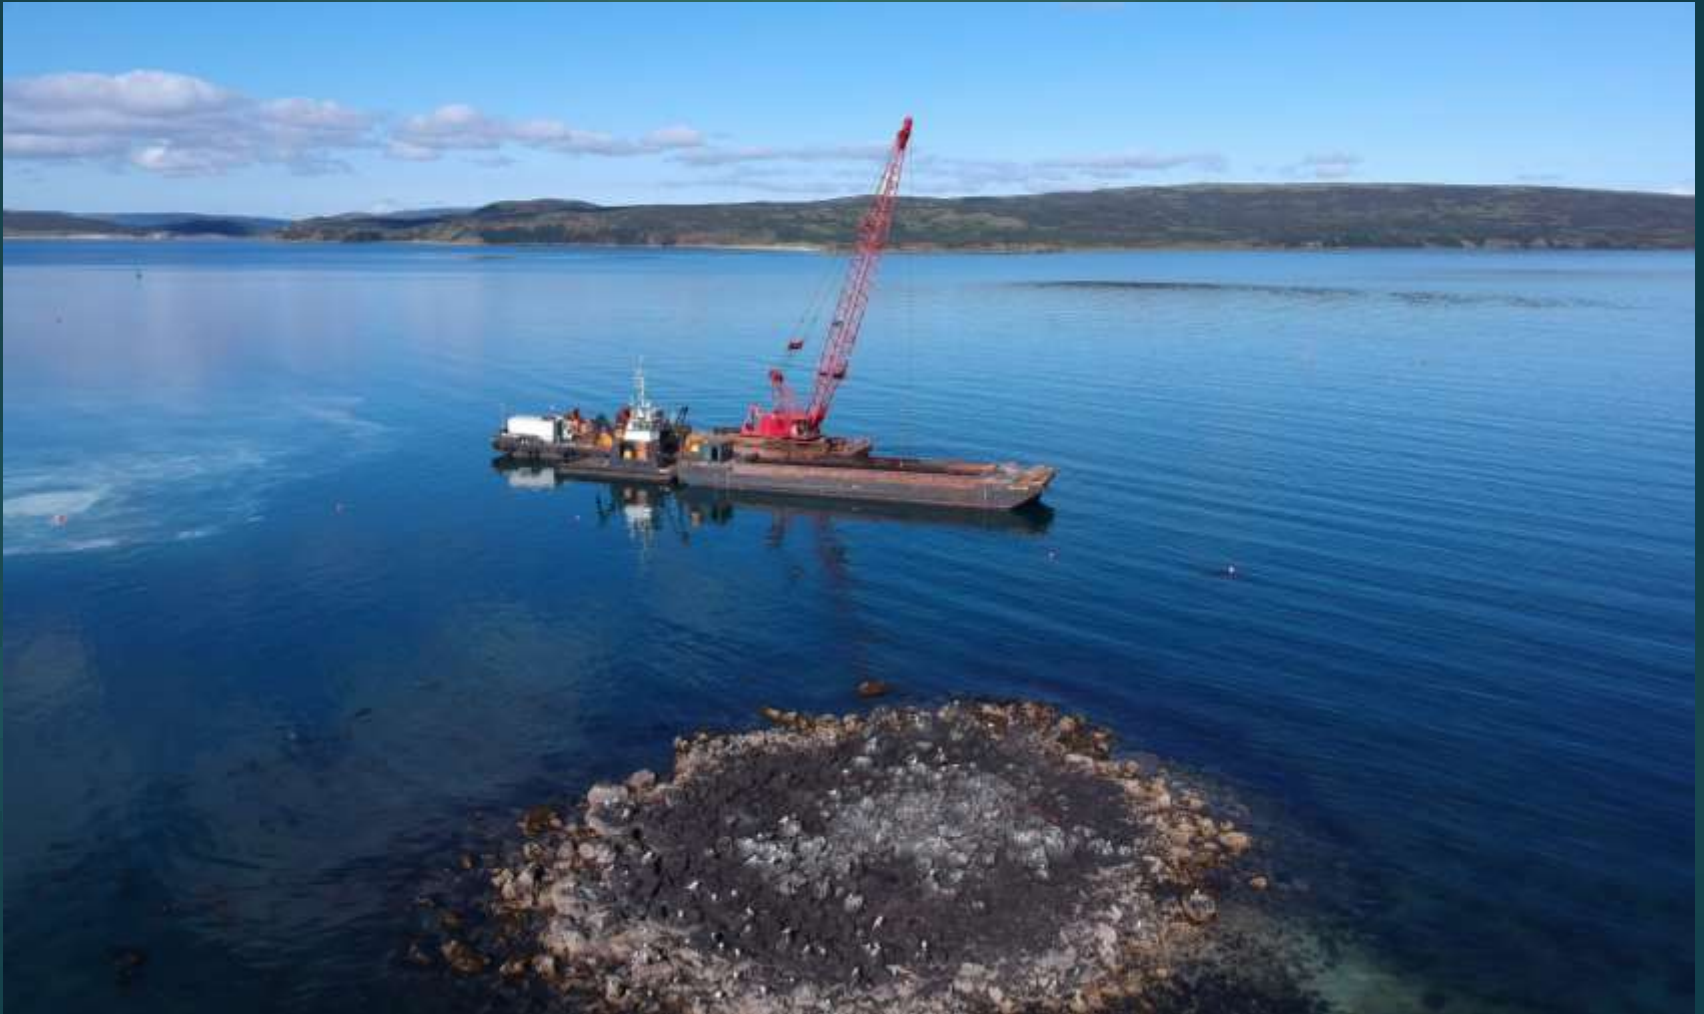
12

- ▶ Seafood waste was mechanically removed utilizing either the Anvil material rehandling bucket or CableArm environmental level cut bucket.
- ▶ Recovered material was placed in a split hull material barge.

▶ Anvil Bucket:

- Closed Top (Prior to start of removal)
- Additional Weight Added (~1.8k lbs)

▶ CableArm Bucket:

- Additional Weight Added (~5k lbs)
- Lower Vents Blocked

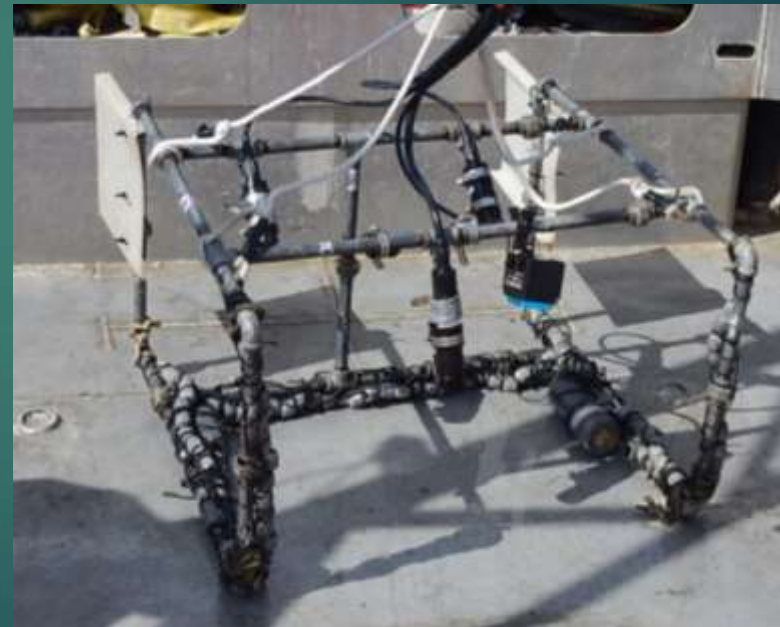
Progress Surveys

- ▶ Conducted two visual surveys; at 25% and 50% completion stages of removal operations
- ▶ Utilized a drop camera for seafloor in progress inspections throughout duration of the removal operations.
- ▶ Equipment and methods were modified based on visual surveys and inspections.

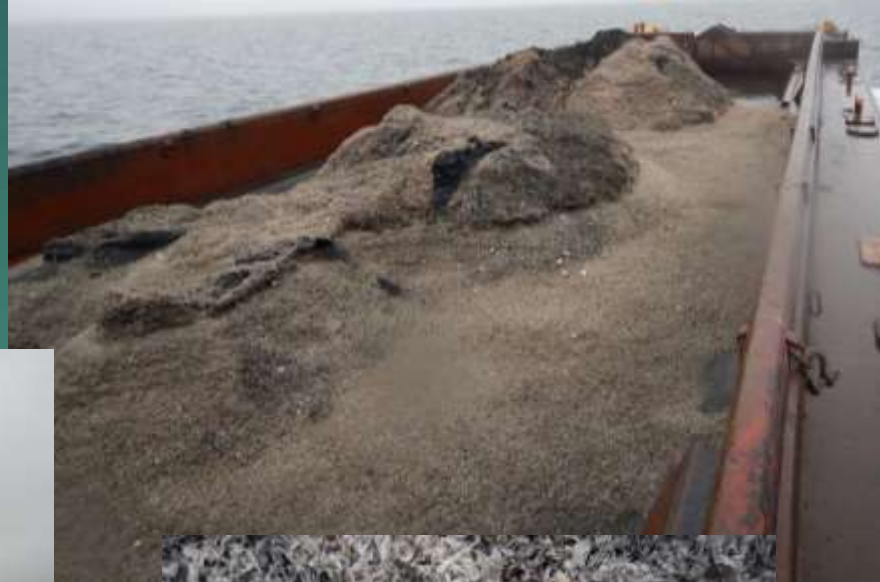
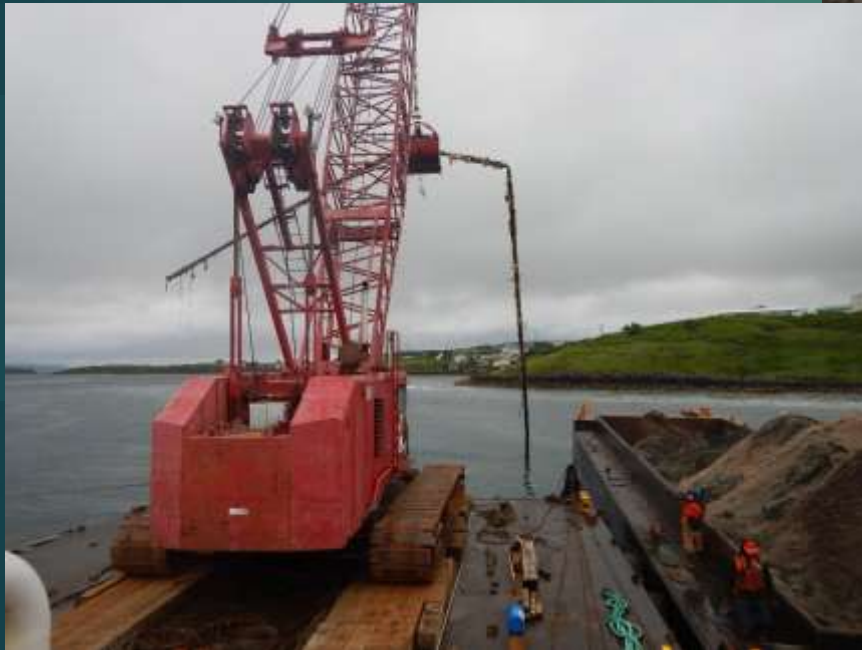
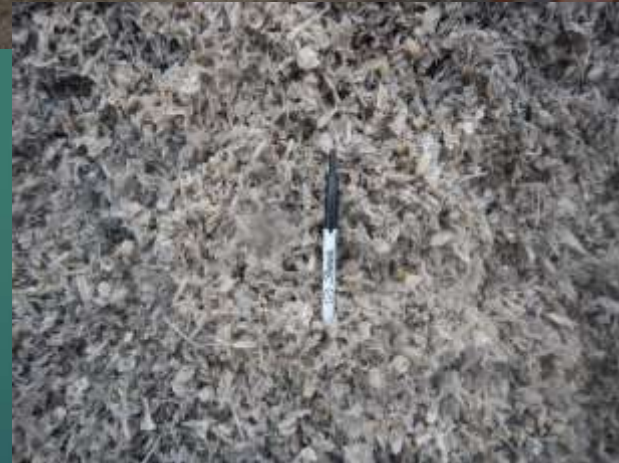
Recovered Material

- ▶ Primarily Seafood Waste
- ▶ Entrained Sediment
- ▶ Debris

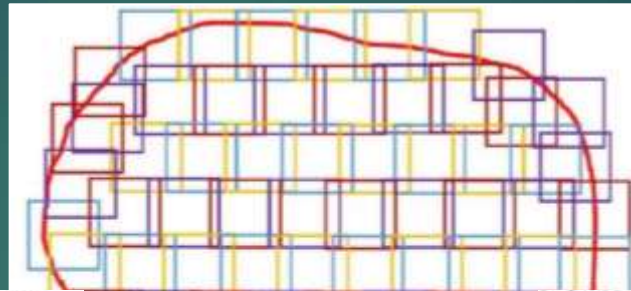
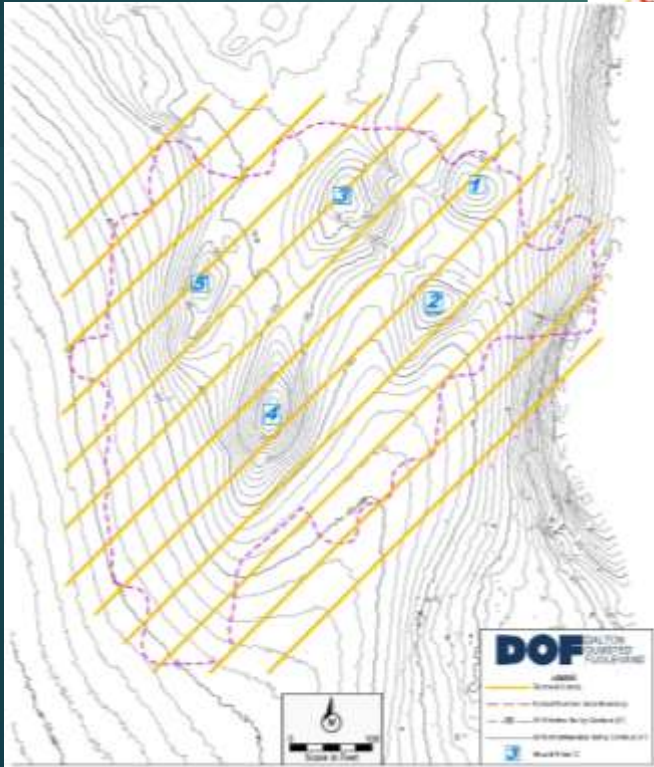
Removal Sequencing

- ▶ Hill Topping
- ▶ Bulk Removal
- ▶ Cleanup Pass

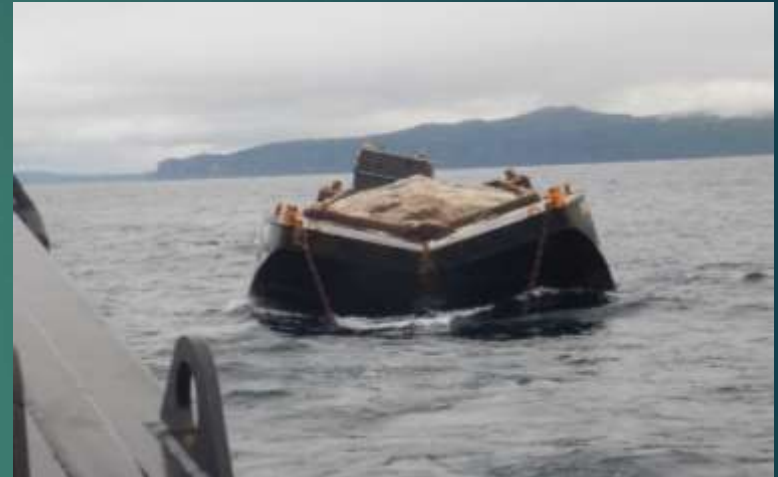
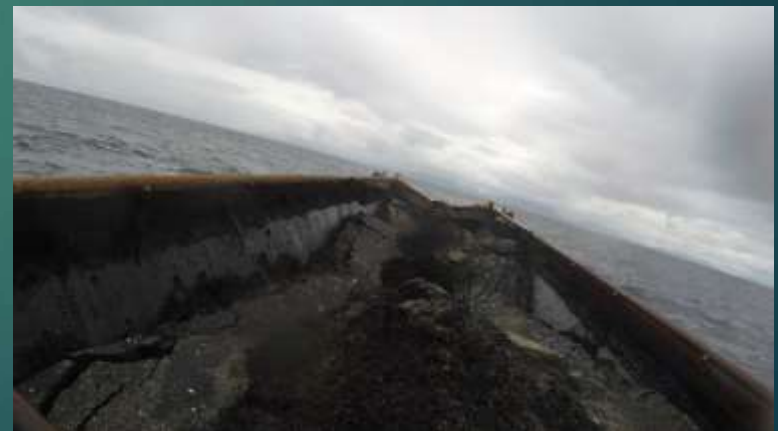
Material Placement

- Placement Site ~8 NM from Removal Site.
