Priest Lake Water Management Project

WEDA, October 29, 2021

Shane Phillips, P.E., D.PE, D.CE
John Dawson, P.E.

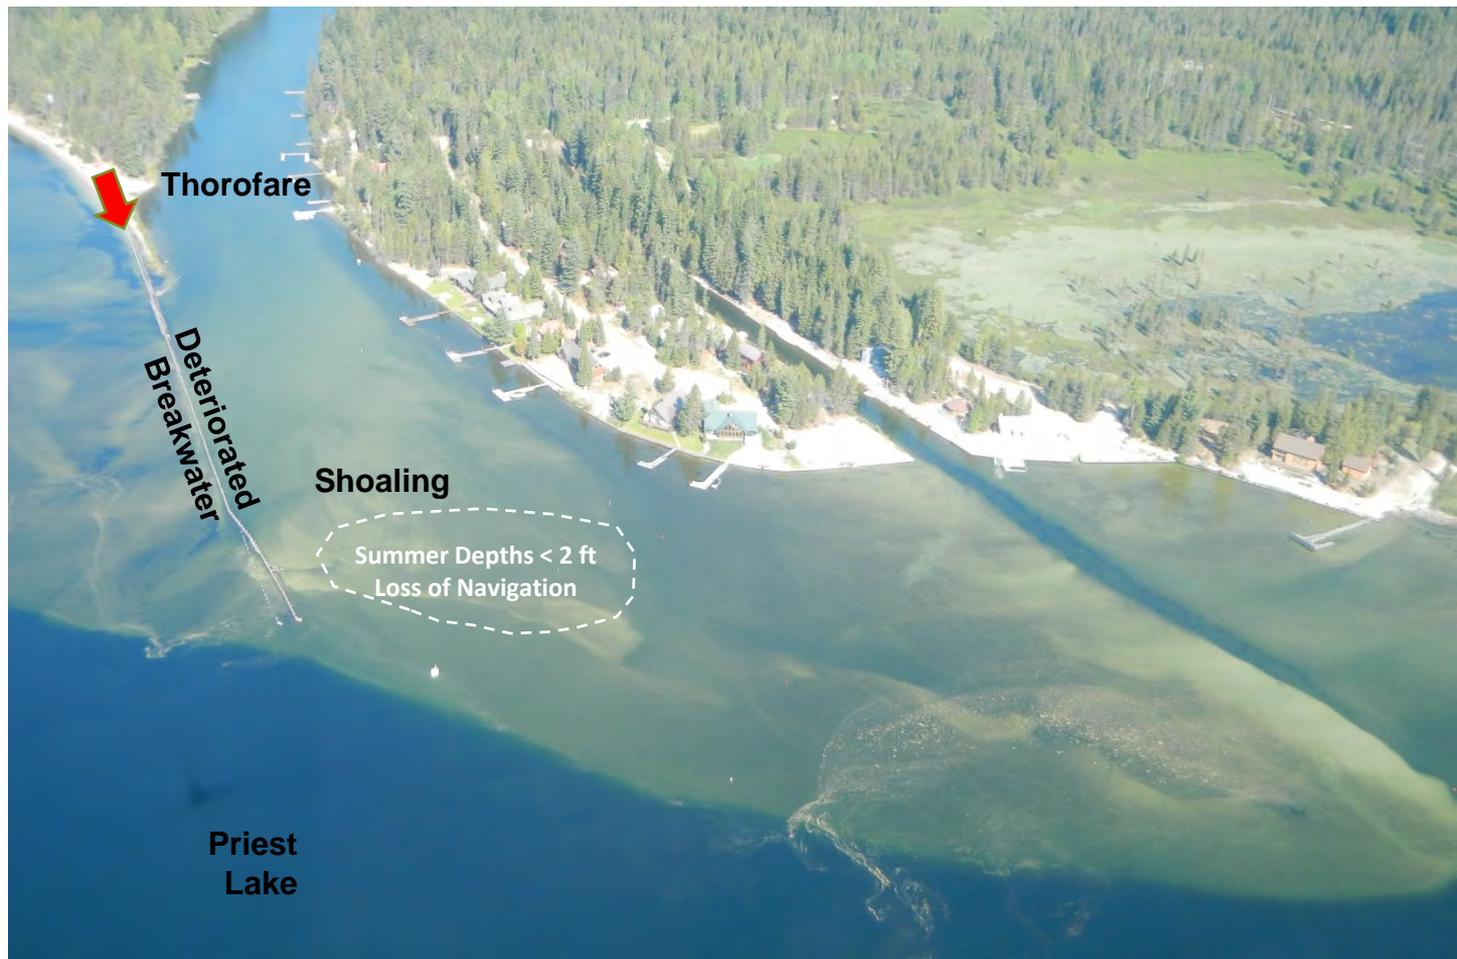
Thorofare Conditions & Project Objectives

Objective: Provide sustainable recreational vessel navigation into Thorofare for access between lower and upper Priest Lake

Condition: Combination riverine and coastal delta processes

Approach: Assess Coastal & Riverine hydrodynamic conditions to evaluate alternatives

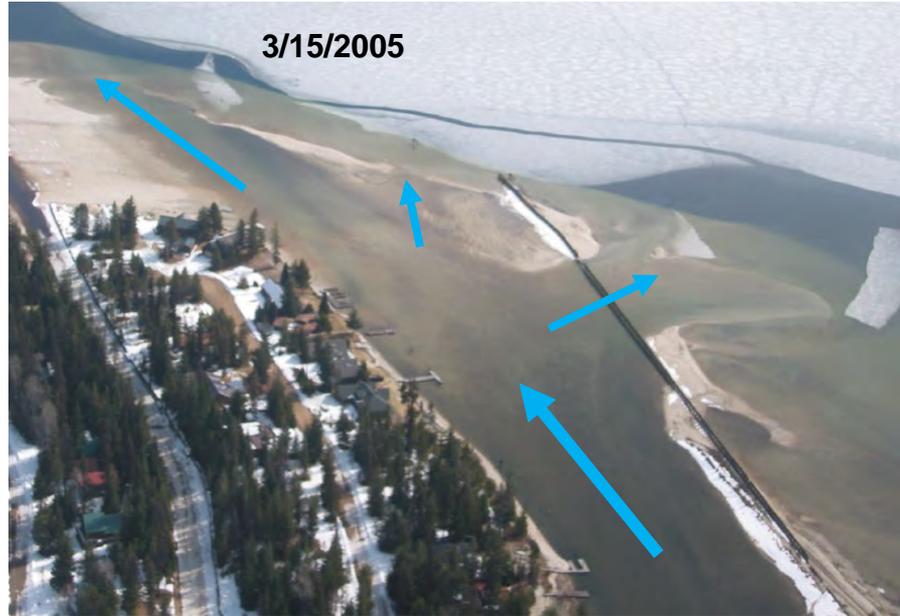
Wind Waves

- Winds aligned with longest fetch
- South-Westerly winds drive lake shoreline longshore sediment transport (south to north) at project site
- Susceptible to Seiche
- Varying seasonal water levels ~ 5ft low to high

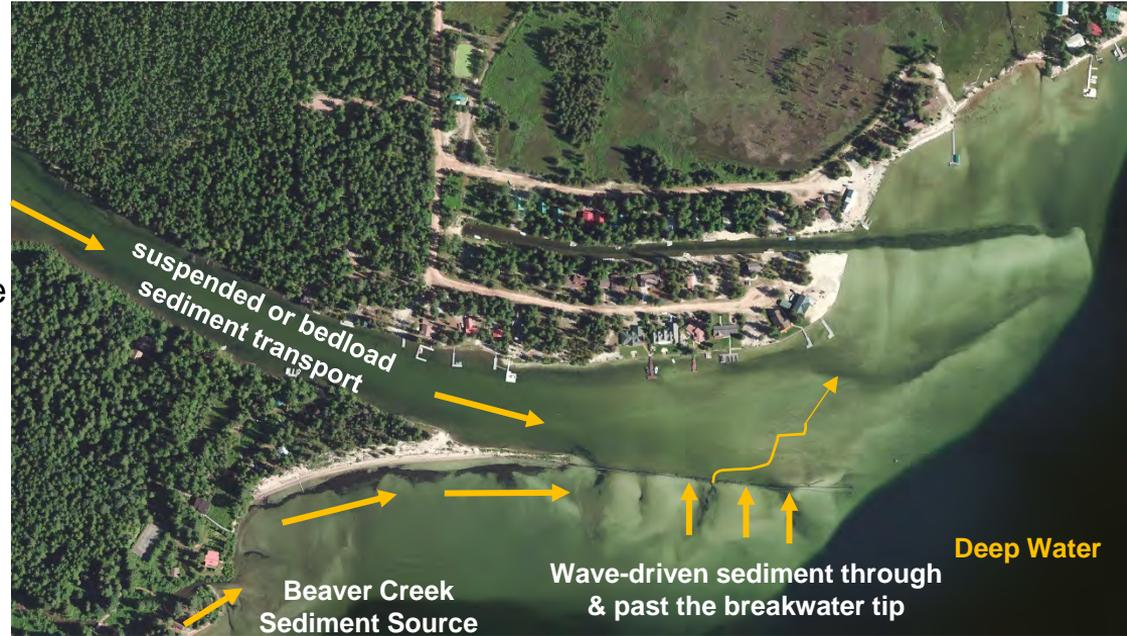
Low Pool

Longshore Sediment Transport

Location varies based on seasonal water level

Red areas on hydrographic survey

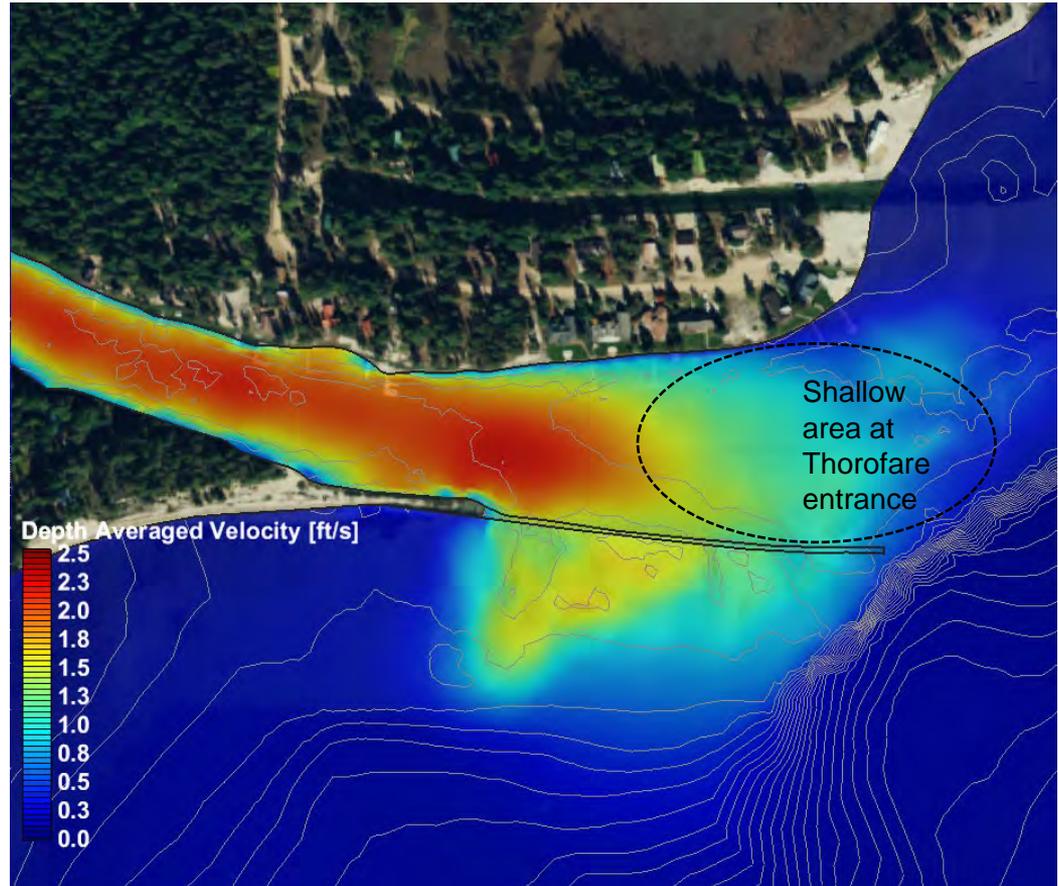
Modeling Results – Existing Conditions (Velocity)

- Delft3D Modeling
- Flow spreading along breakwater is represented in model results
- Significant drop in velocity at approximately $\frac{1}{2}$ the length of the breakwater
- Velocity reduction zone corresponds with area of reduced depth (shoal) at entrance to Thorofare
- Increased flow velocity during spring runoff needed for improved channel condition

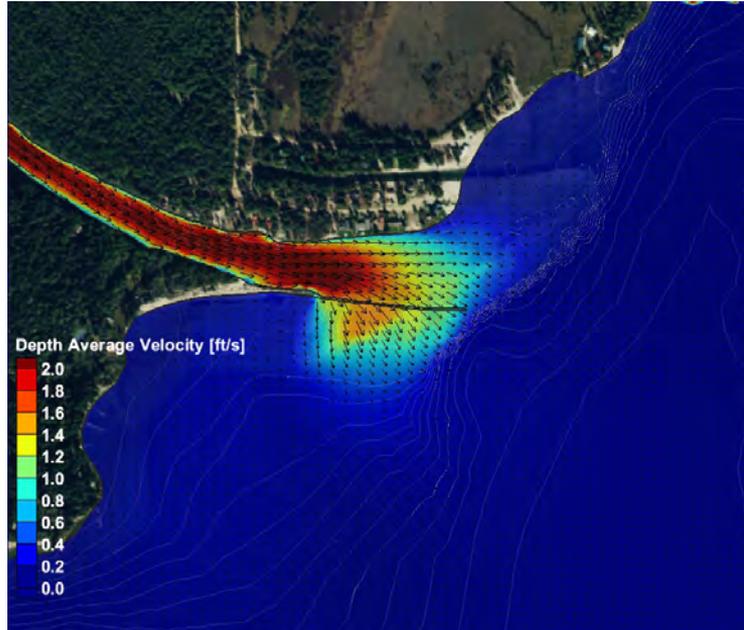
Snapshot of depth-averaged velocity for
Porous Breakwater vs. Solid Feature

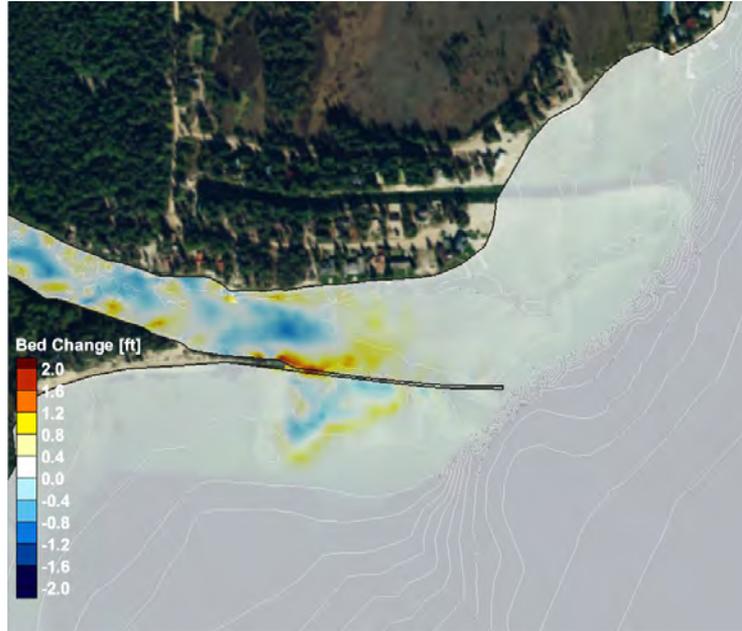
Porous Breakwater

Maximum Bed Change (sedimentation/erosion) during the simulation period

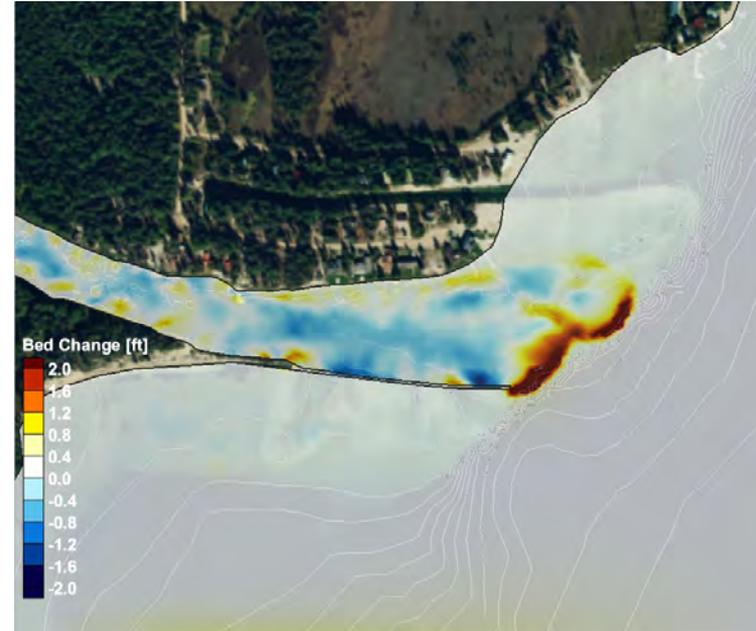
Solid Breakwater

Solid Feature: transports material and deposits them in deeper water past the feature end.

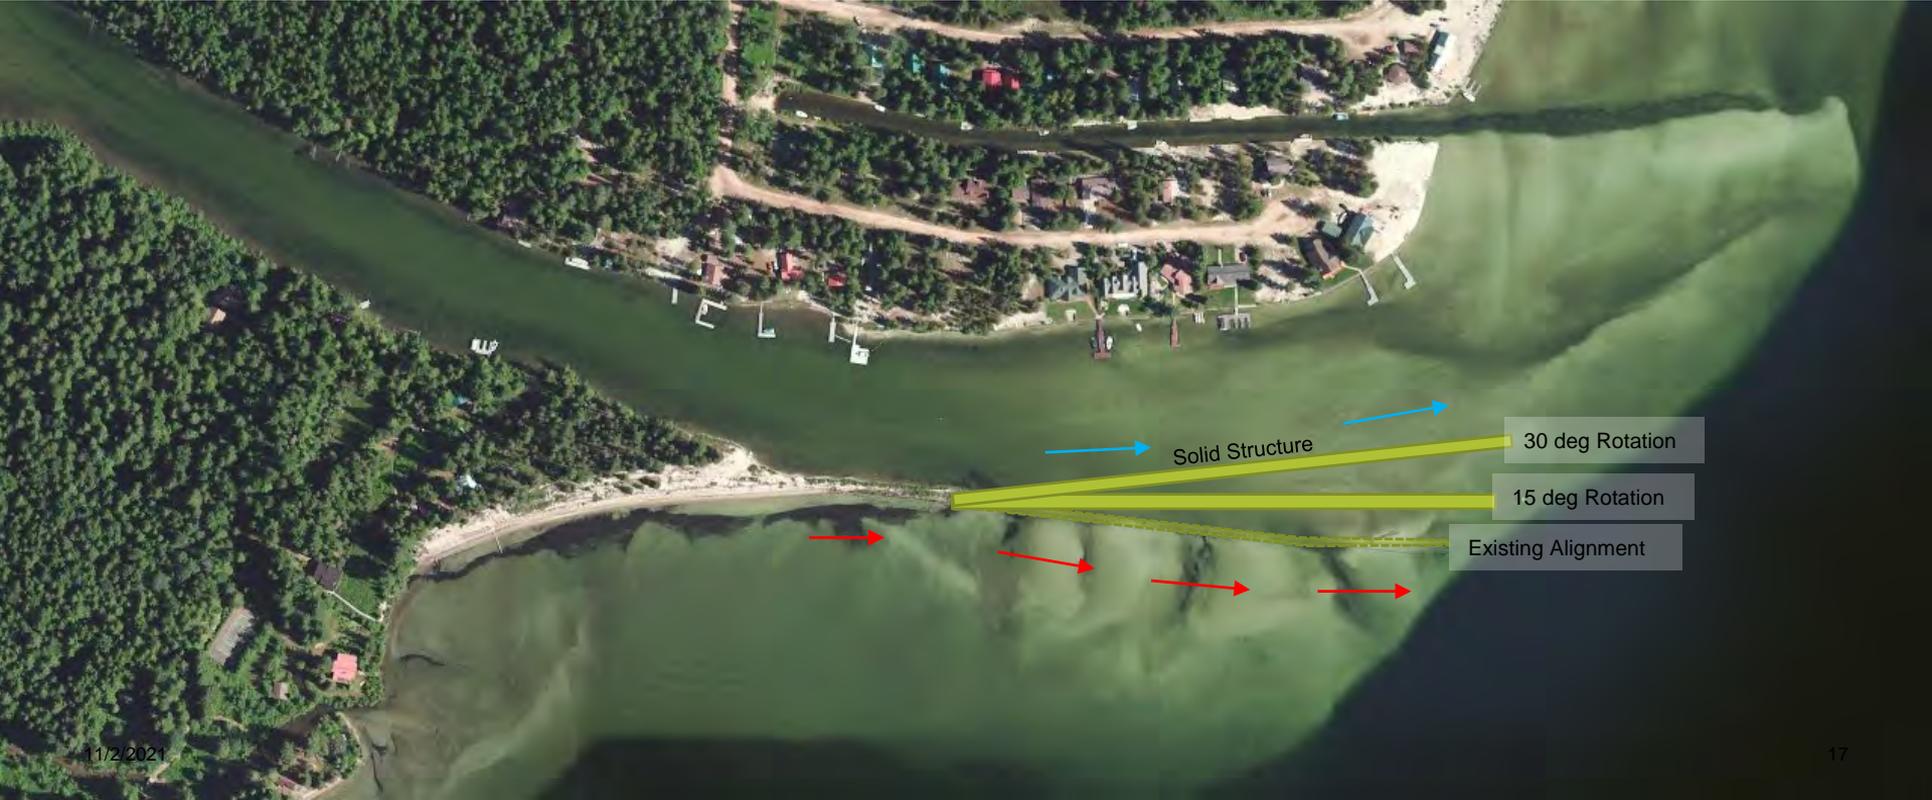
Solid Structure – Alignment Assessment

Existing, 15 degree, 30 degree

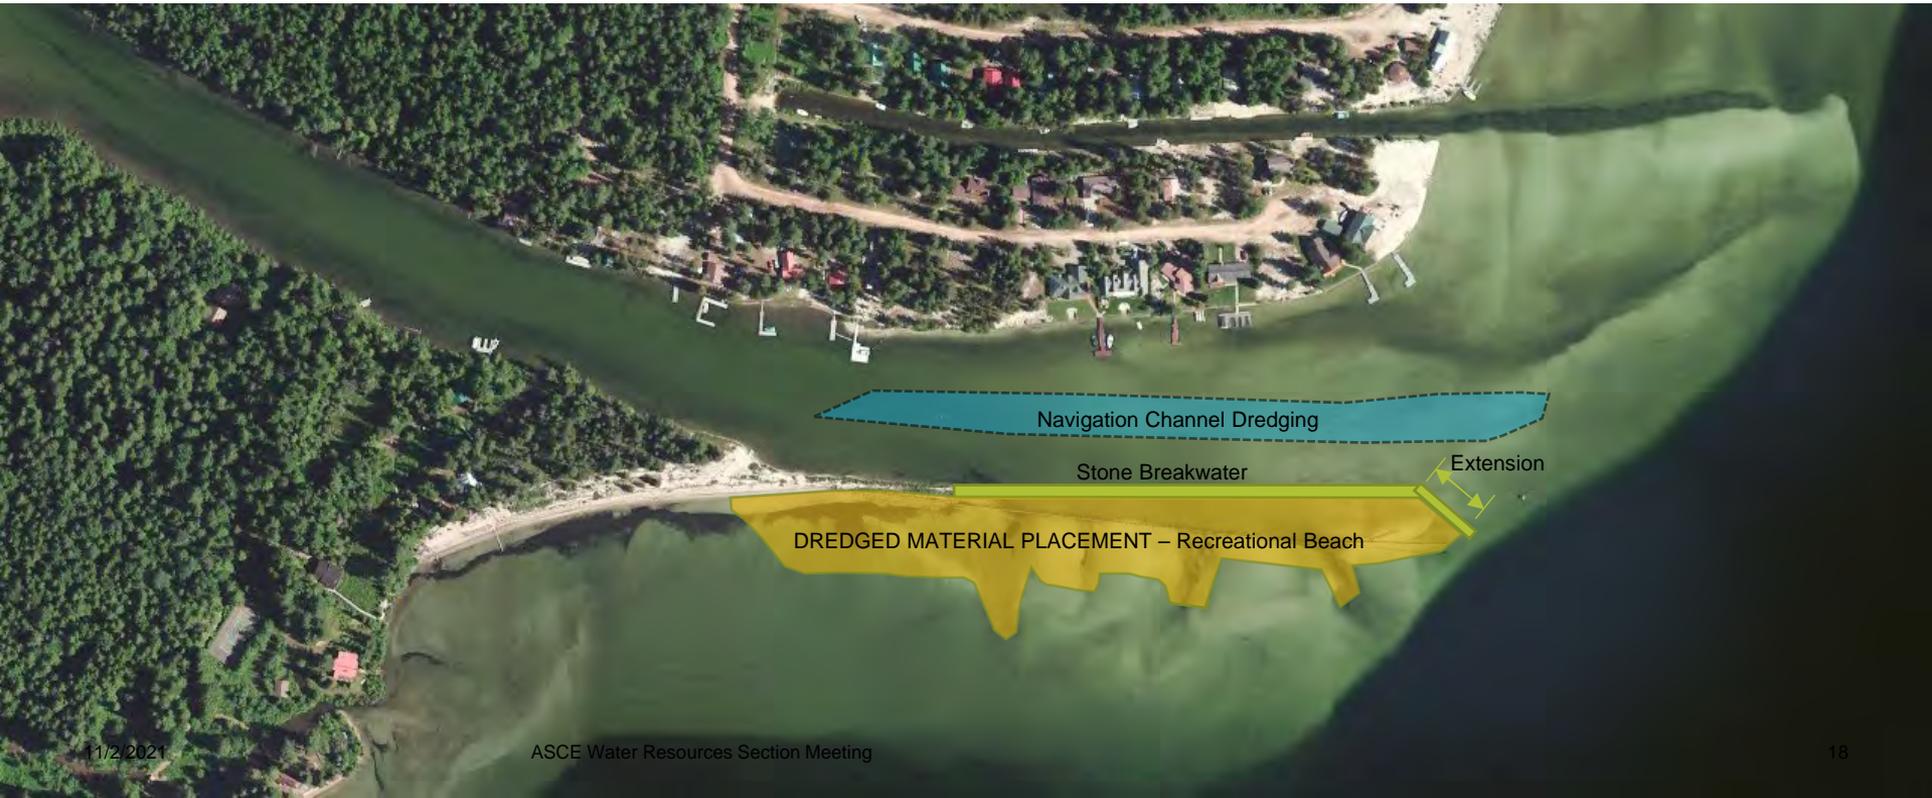
Preferred Concept

Solid Breakwater Structure, Dredging, Beneficial Re-use Dredged Materials
10 degree rotation from existing alignment

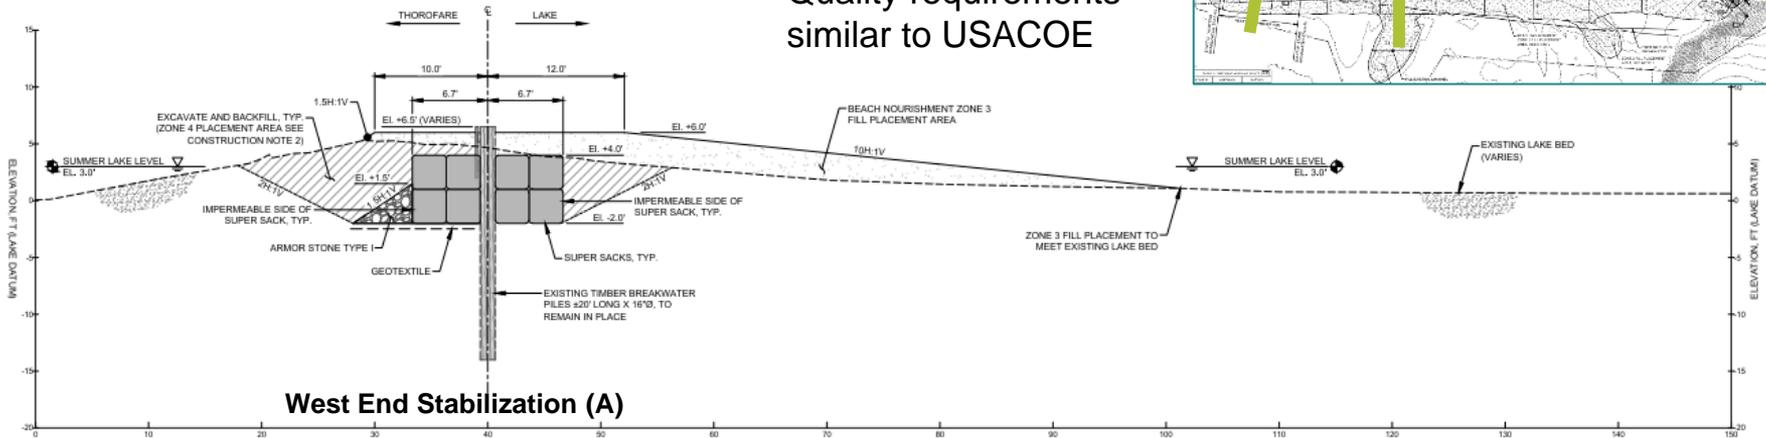
West End Stabilization (A)

Stone

- 3 gradations
- Quality requirements similar to USACOE

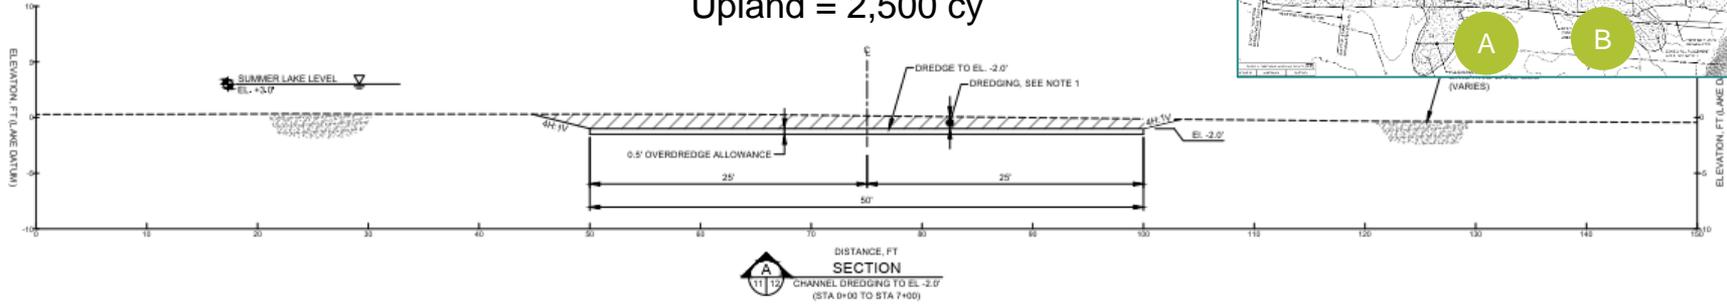
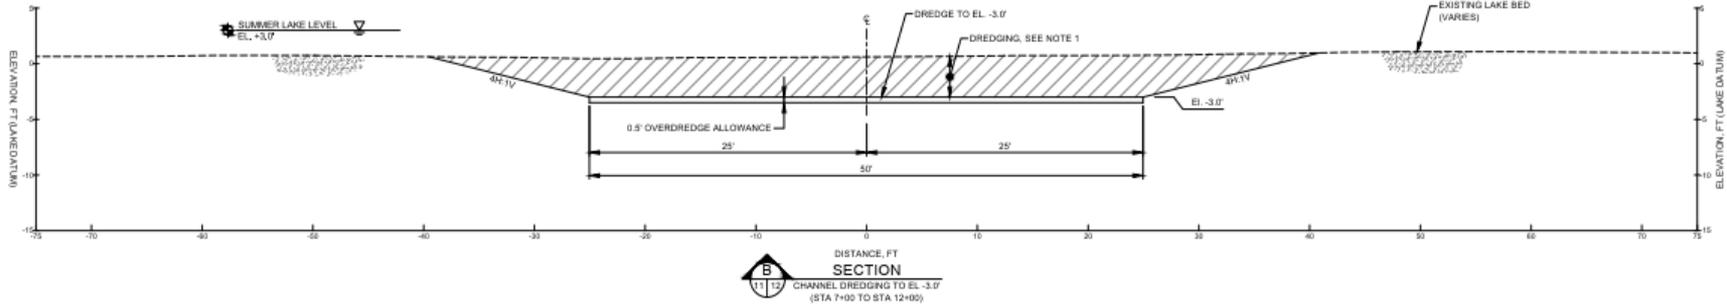
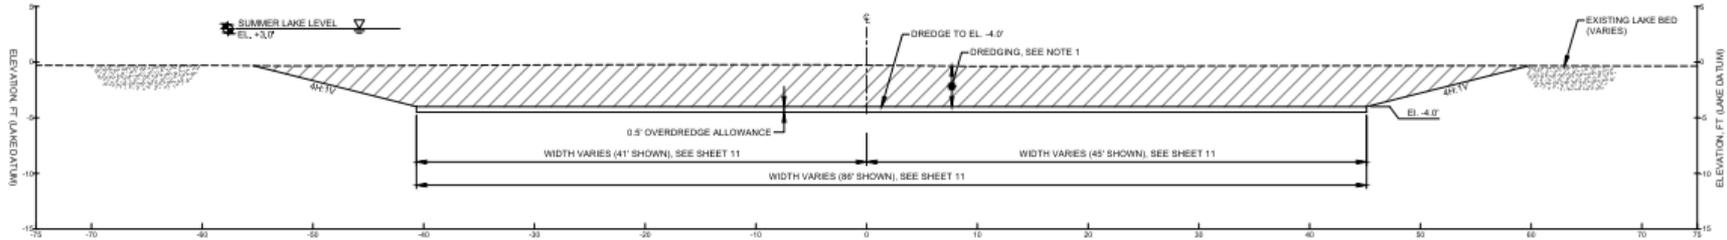
Dredging Sections

Disposal
 Aquatic = 9,700 cy
 Upland = 2,500 cy

1. DREDGE ELEVATION VARIES FROM -2.0' TO -4.0' (SEE SHEET 11). DREDGED MATERIAL SHALL BE PLACED AS FILL WITHIN ZONE 3 - BEACH NOURISHMENT.

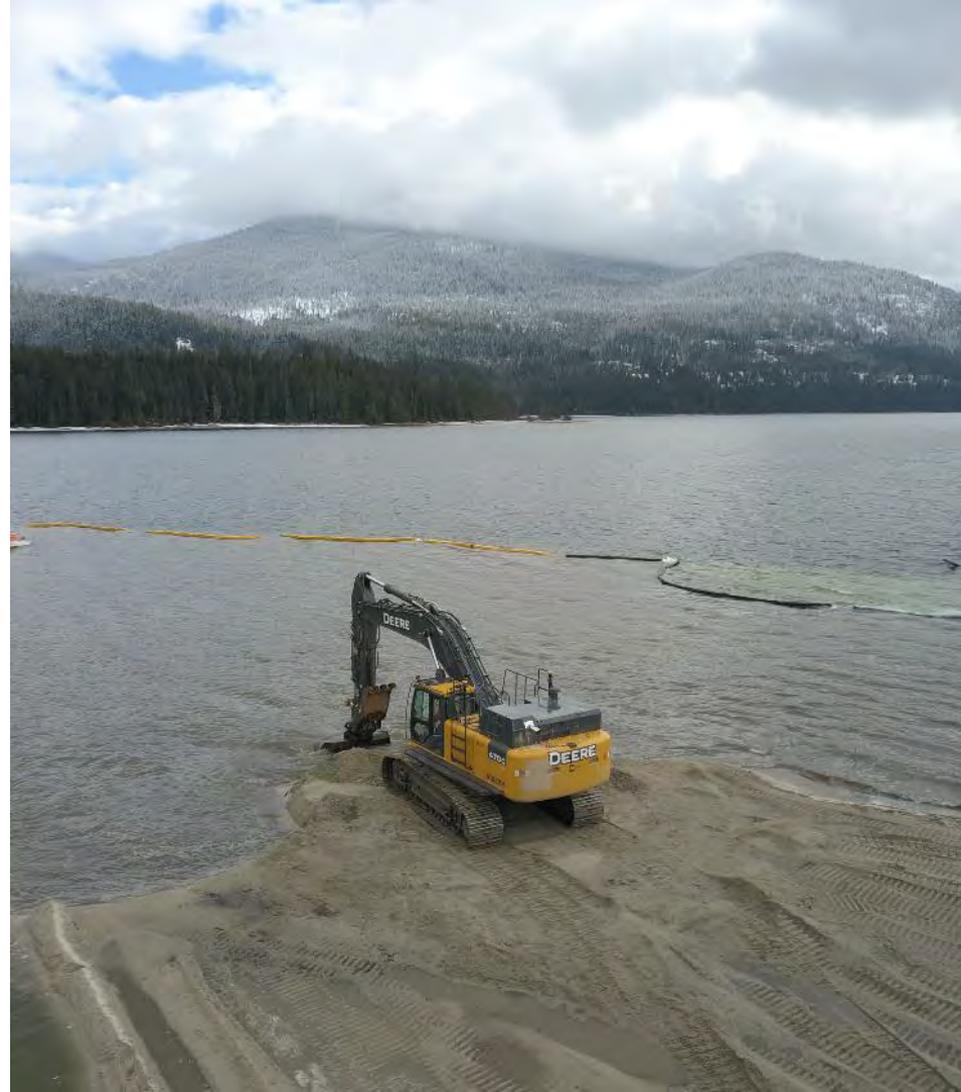
Dredging

- Stair-stepped dredging construction progressed from downstream end to upstream end of the Thorofare in coordination with flow diversion and demolition works
- Hydraulic excavators operated predominately in the dry.
- Material stockpiled via “yo-yo” scheme within the approximate footprint of the beach nourishment
