Oyster Reef Mitigation for the Bayport Ship Channel Improvement Project

Western Dredging Association, Dredging Summit & Expo 2015
June 23, 2015

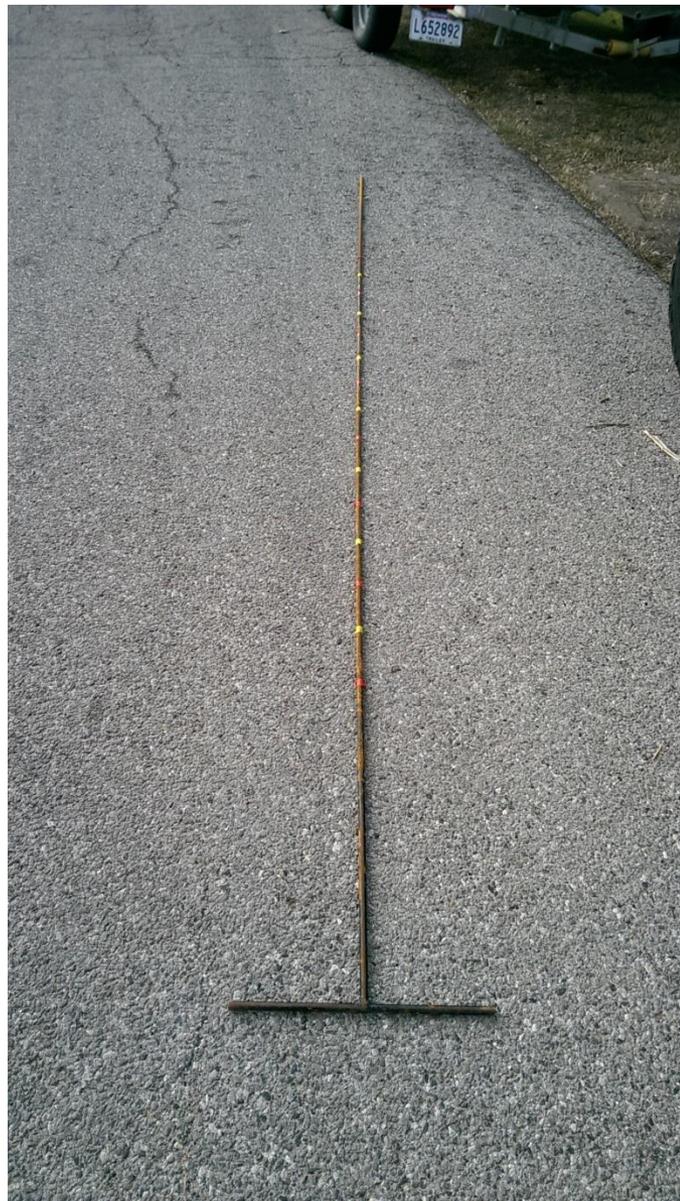
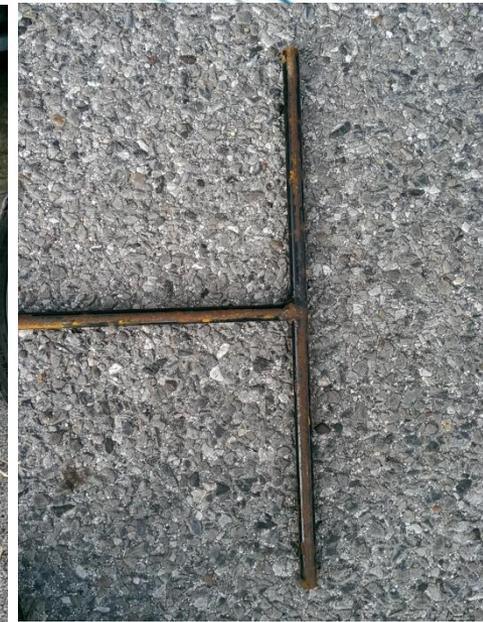
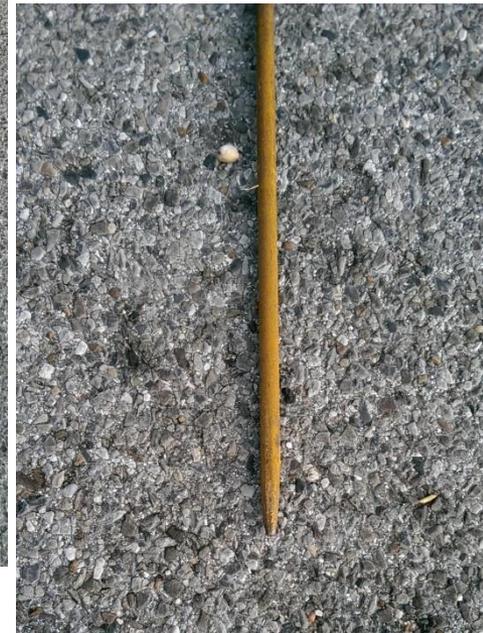
Thickness Probing Rod

- ½ inch steel smooth rod
- Welded handle
- Tip tapered by table grinder
- Alternate color taping every ½ ft
- Length determined by
 - Water depth over site & planned pad
 - How much survey boat will draft
 - Use avg. tide info at time of year
 - Ours was 10' at top tape mark for ~6-8 ft of water depth
- Probing by:
 - Let probe drop to resting at top of cultch
 - Read mark at water
 - Take several small successive jabs penetrating cultch rock until hard impact not felt
 - Keep focus on tape marks during jabs
 - Note tape mark for jab that broke through to soft stuff
 - Practice to get hang of it
 - Repeat for a few readings within 10'
 - Take avg. and subtract from top of cultch = cultch thickness
 - ½ ft accuracy expected
