Western Dredging Association
Summit and Expo 2015

*Turning Failure into Success with Innovative
Dredging Solutions for Aquatic Preserve
Restoration*

Aquatic System Restoration, Stevenson Creek, Clearwater, Florida

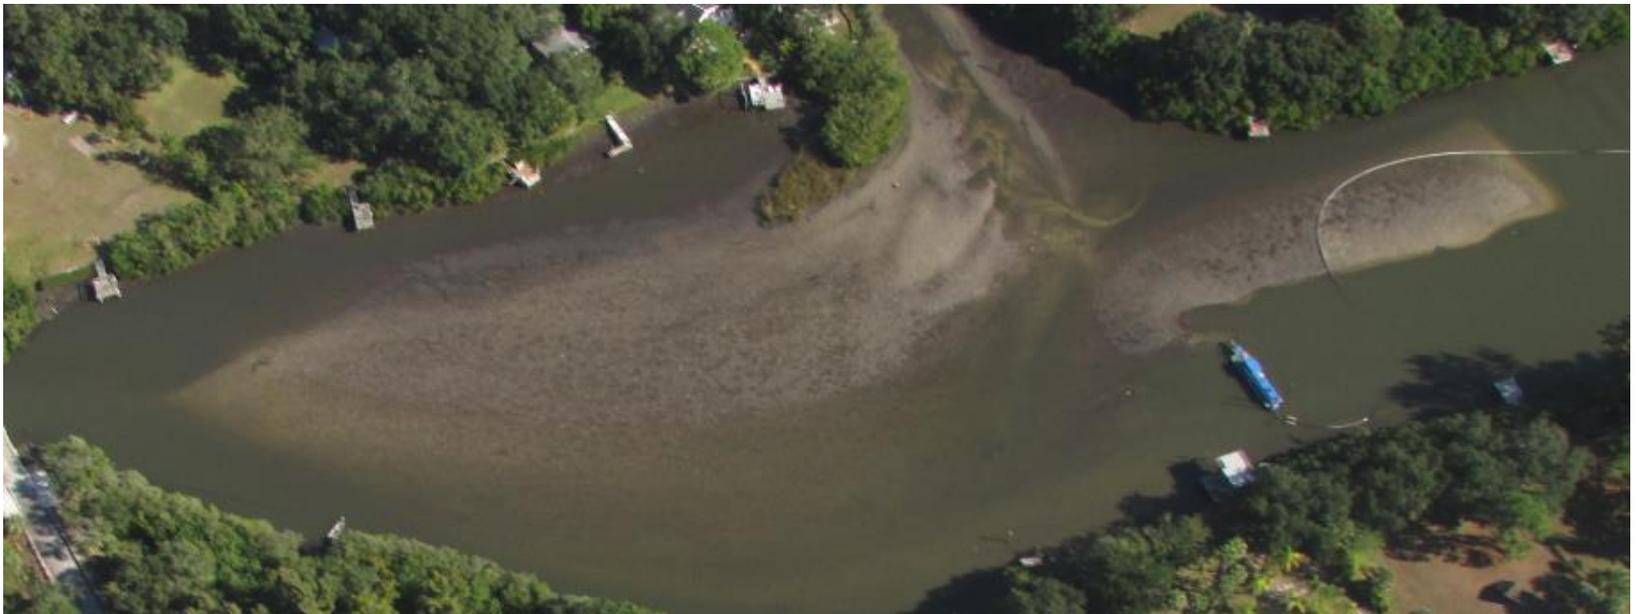
Estuary Conditions Prior to Dredging

- Shallow waters, less than 1-ft water depths at Mean Low Water (MLW)
- High organic content muck sediments
- Significant debris deposited from upstream
- Unpleasant smell for residents
- Little tidal flushing
- Loss of mangrove habitat and marine wildlife

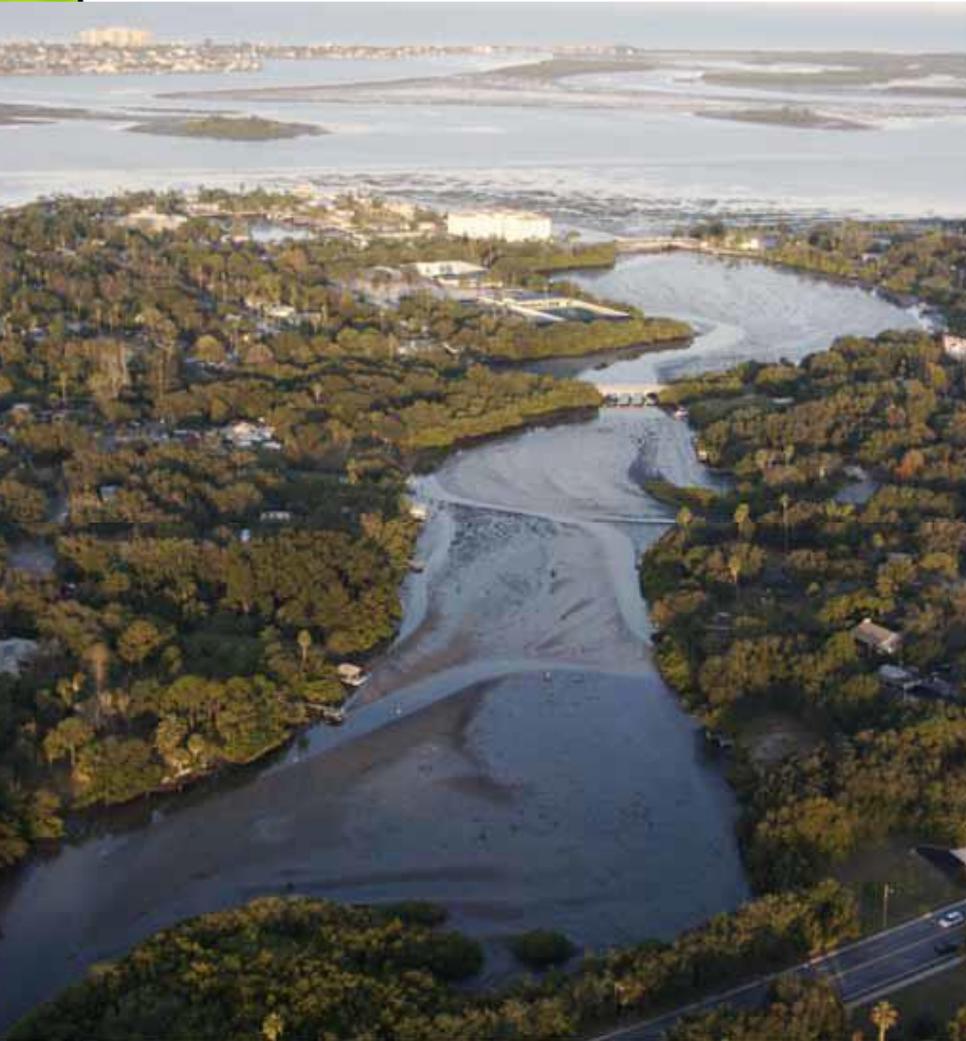
Original Project Summary

- Cooperatively Funded Project with the City of Clearwater & US Army Corps of Engineers
- Hydraulic dredging of 115,000 cy of muck and sand sediments
- Separation of sand and organic sediments
- Dewatering at 2-ac City Brownfields Site
- Sand disposal 8 mi haul distance
- Muck disposal 21 mi haul distance
- 3.2 acres of Mangrove Habitat Area creation areas with dredged sands
- Restoration of Dewatering Site
- \$5,500,000 Project Budget
- Contract originally awarded June 2010

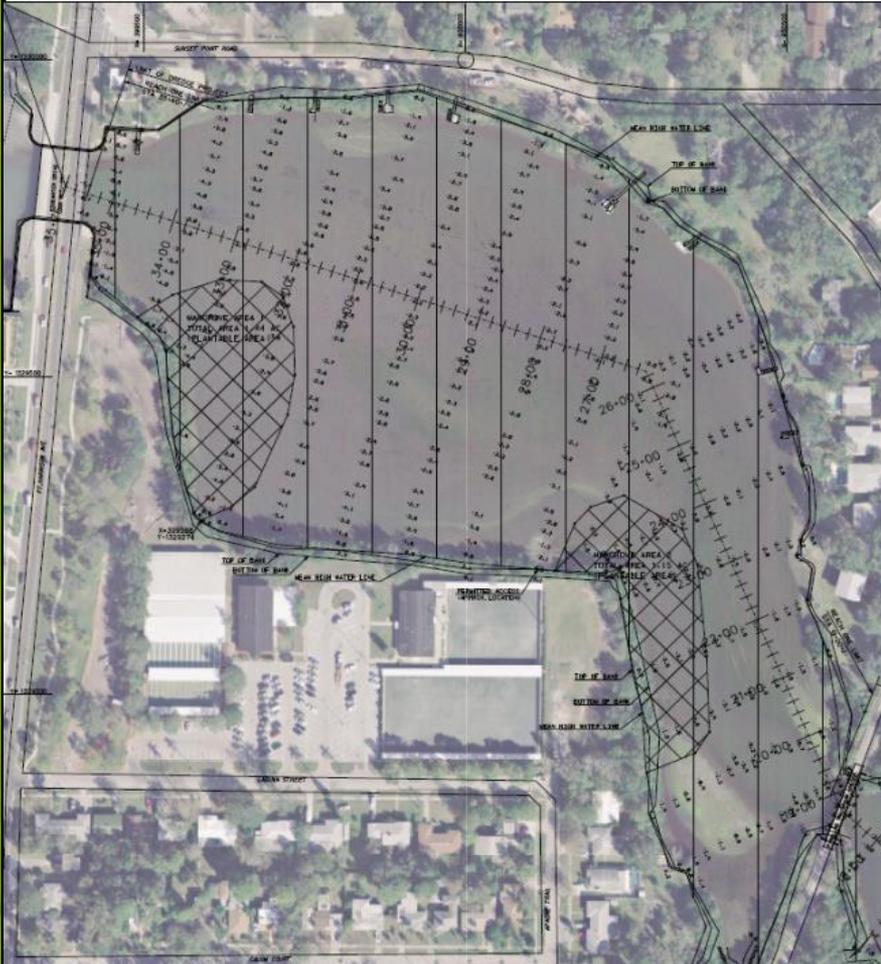
Dredge Scope – Reach 1

- Reach 1: Northwest portion of the Estuary.
- 1,700 feet
- 38,000m³ (63,000 cy)
- -4.4 feet NGVD

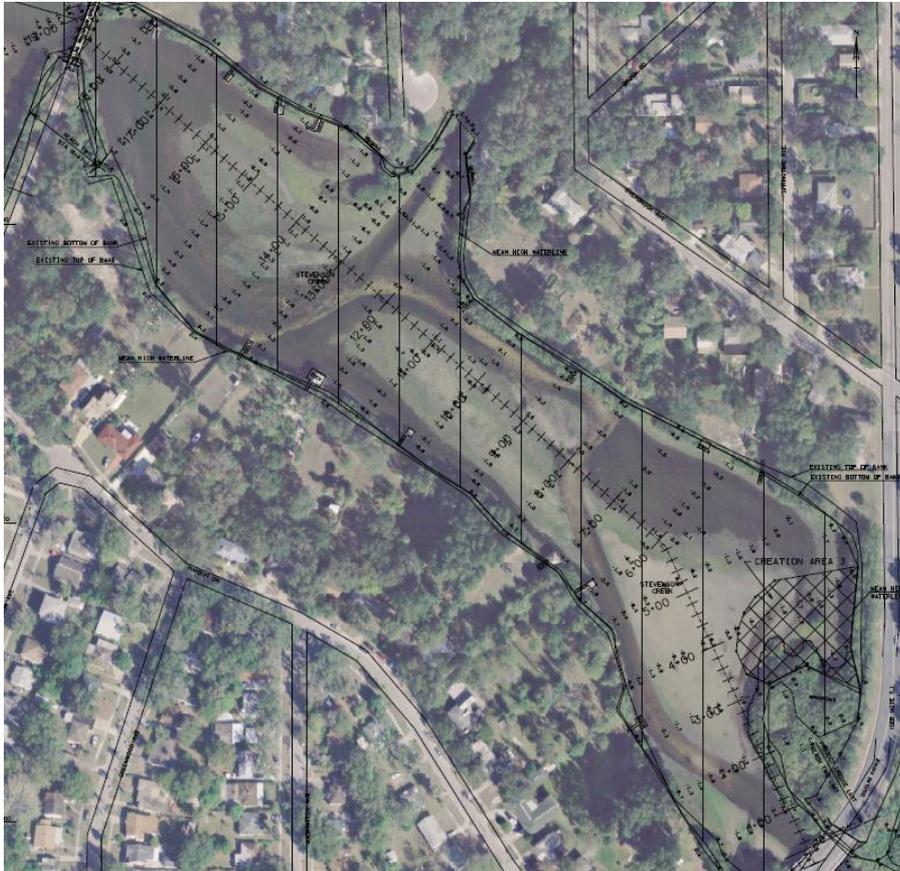
Dredge Scope – Reach 2

- Reach 2: Southeast portion of the Estuary
- 1,900 feet
- 30,500 m³ (42,000 cy)
- -3.5 feet NGVD

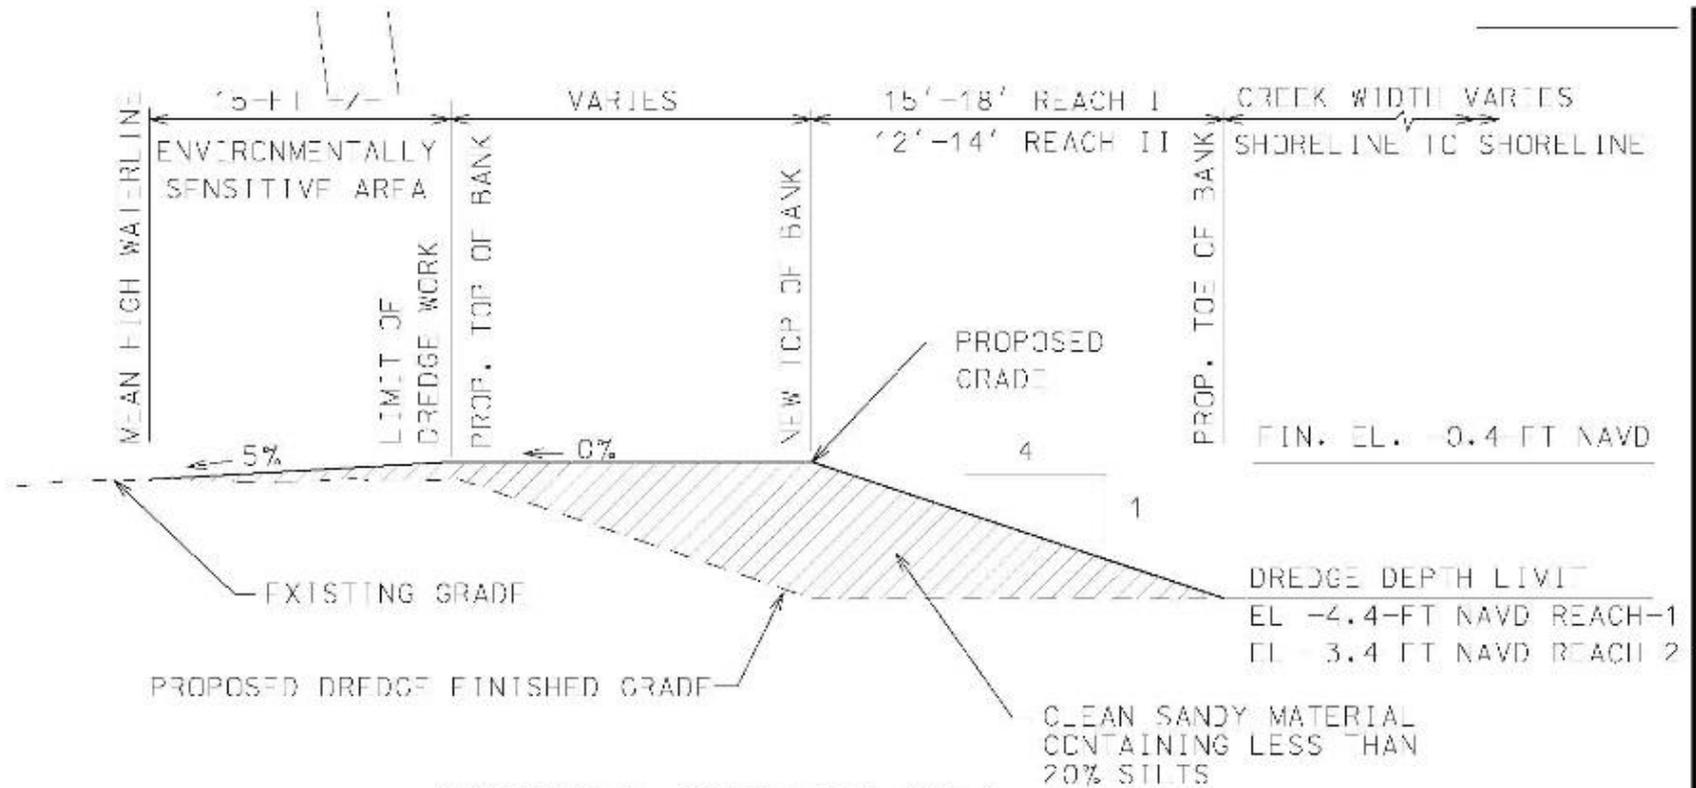
Mangrove Area Creation

MANROVE CREATION AREA
TYPICAL SECTION
 N.T.S.

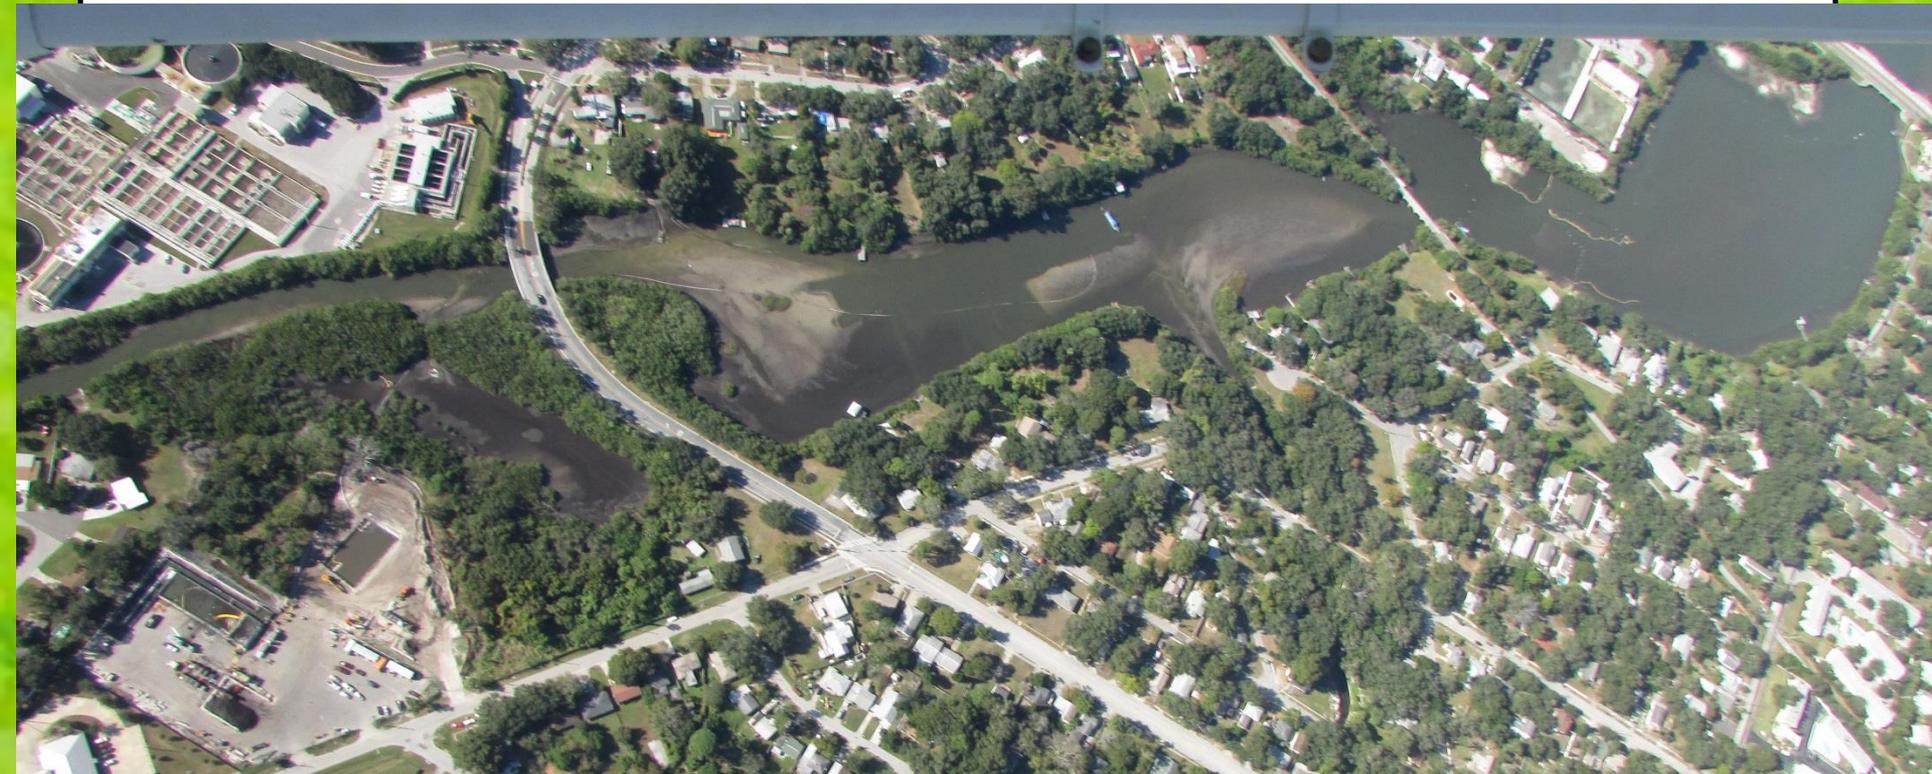
- Modification of Existing Environmental Permits
- Additional Geotechnical Sampling and Classification of Sediments
- Obtain Use of City Property Adjacent to Existing Dewatering Area
- Acute / Chronic Elutriate Testing for Polymer Approval to Enhance Dewatering/Settling
- 2, 8-in Hydraulic Cutterhead Dredges; One in Each Reach
- Dredge Reach 1 (Muck Reach) to Tri-Flo DSS2000 Dewatering System (2,000 gpm) for sand scalping Overflow to Fines/Silt Dewatering Process
- Dredge Reach 2 (Sand Reach) to Open Dewatering Cell with Overflow to Fines/Silt Dewatering Process
- Mangrove Creation Areas Constructed by Direct Pumping from Dredges in Suitable Areas of the Creek
- Consistent Turbidity Monitoring

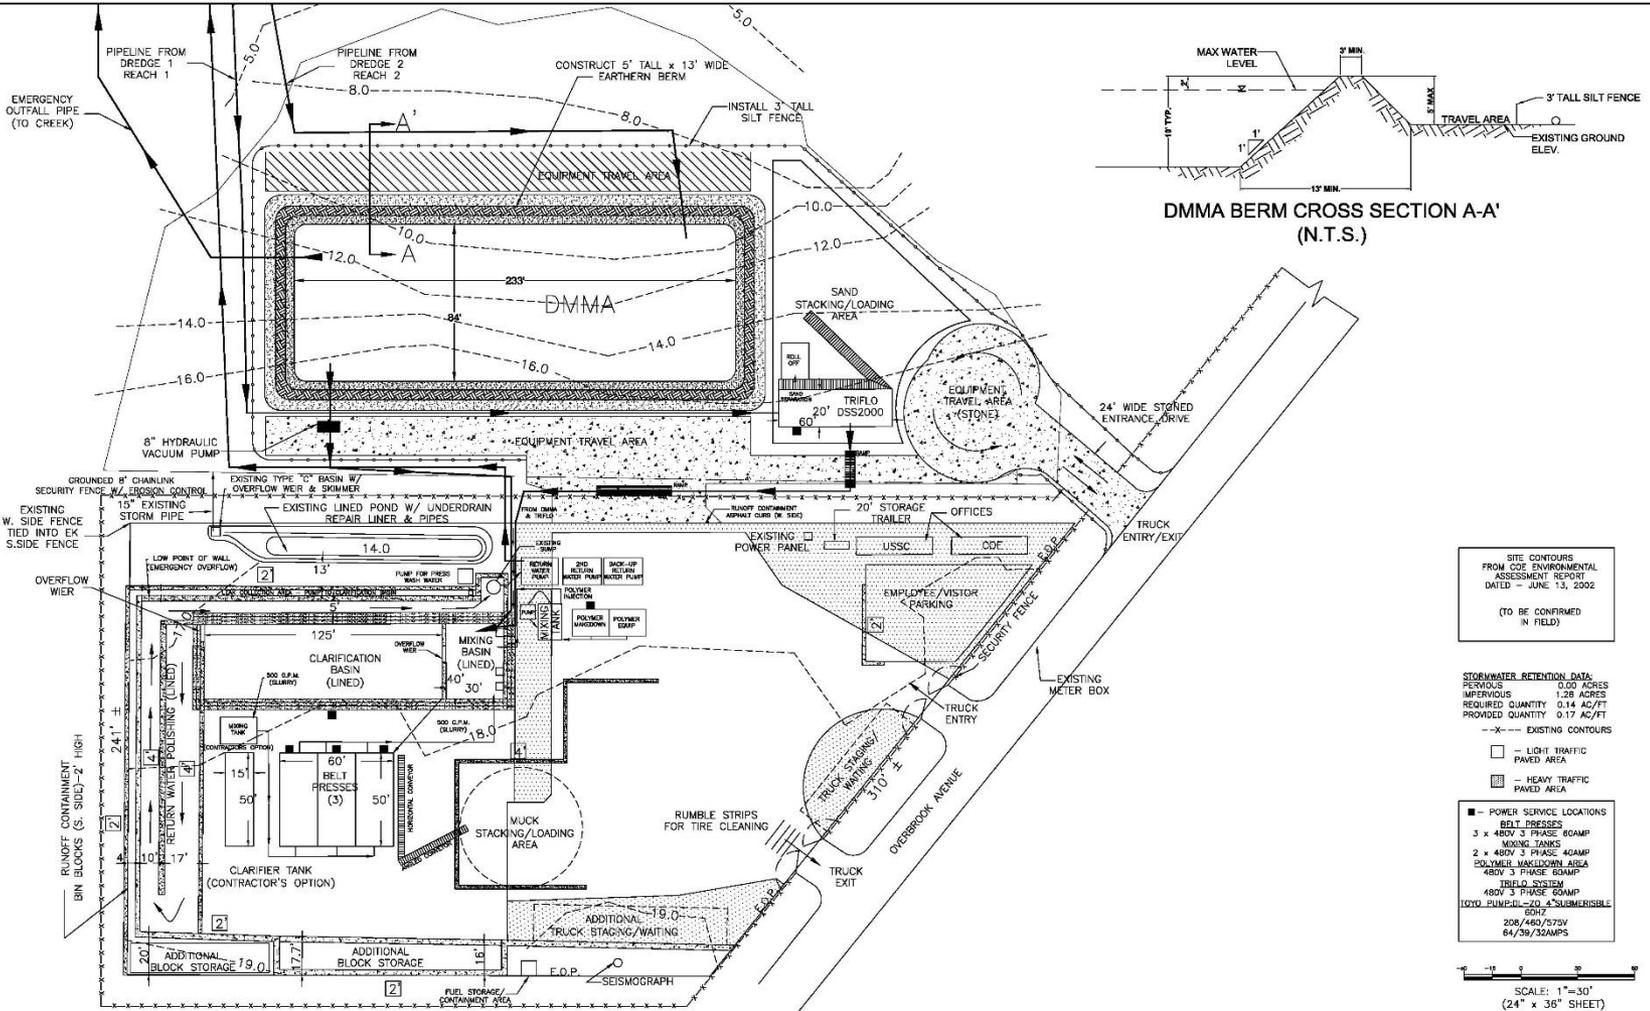
EXHIBIT 3

**DREDGED MATERIAL PROCESSING
AREA & DEWATERING SITE PLAN**

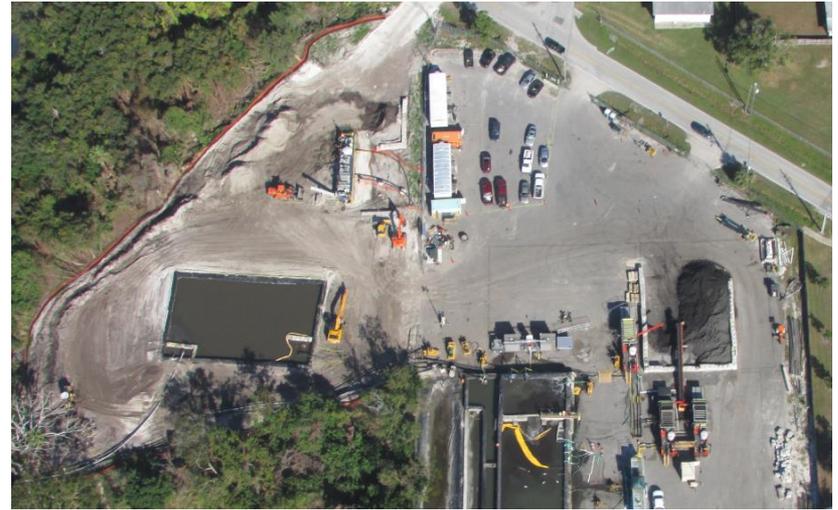
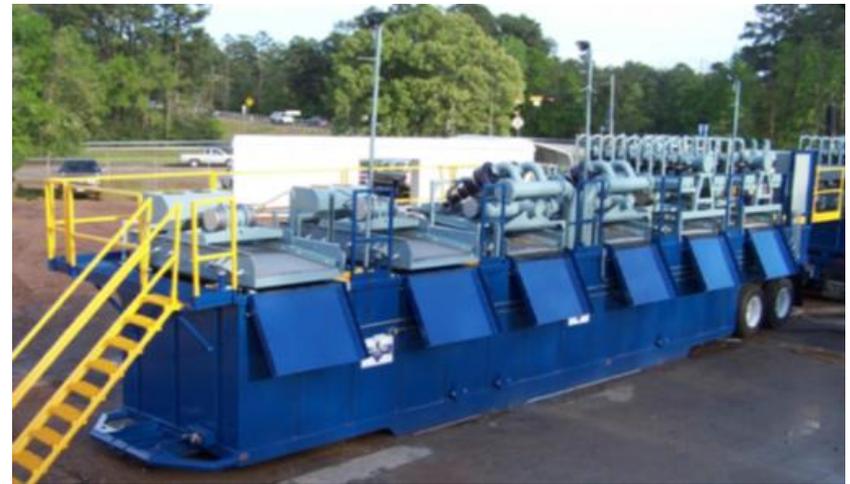
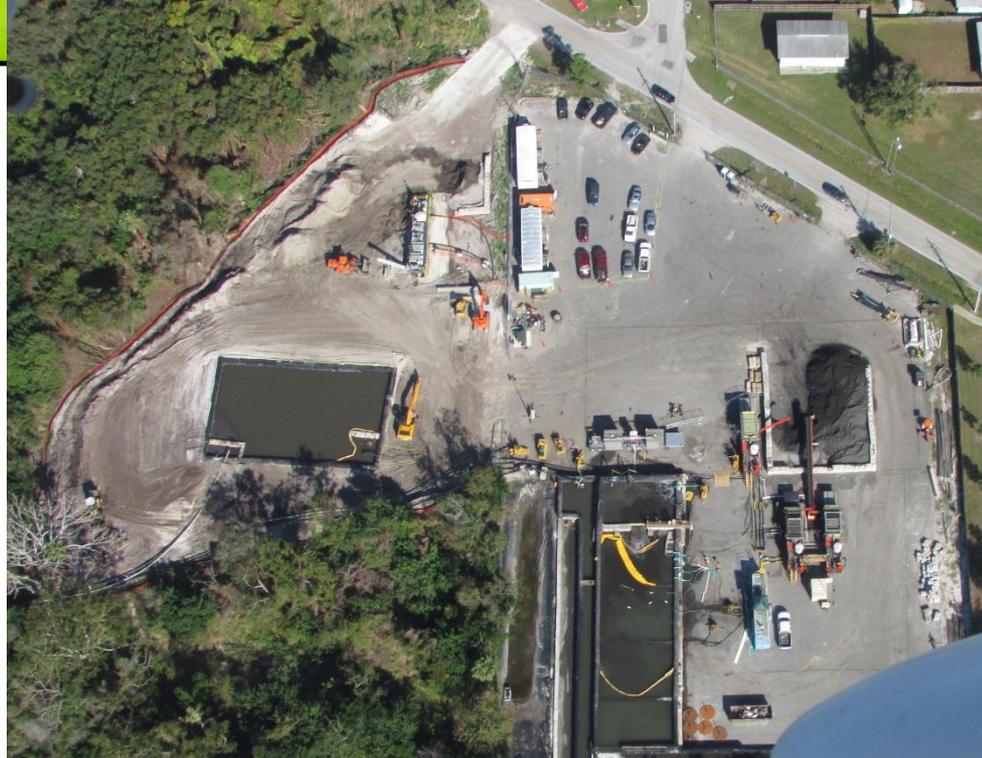
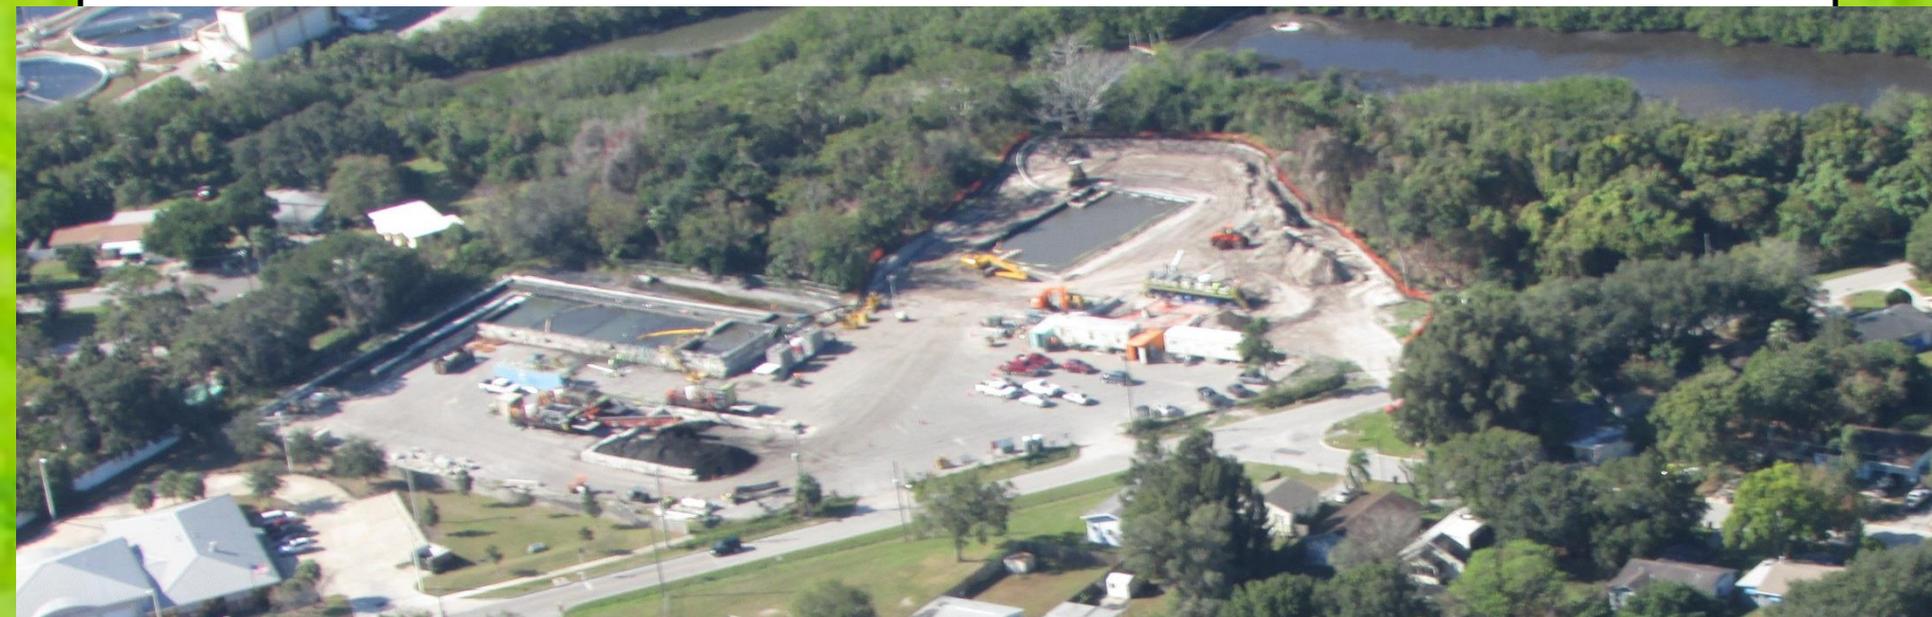
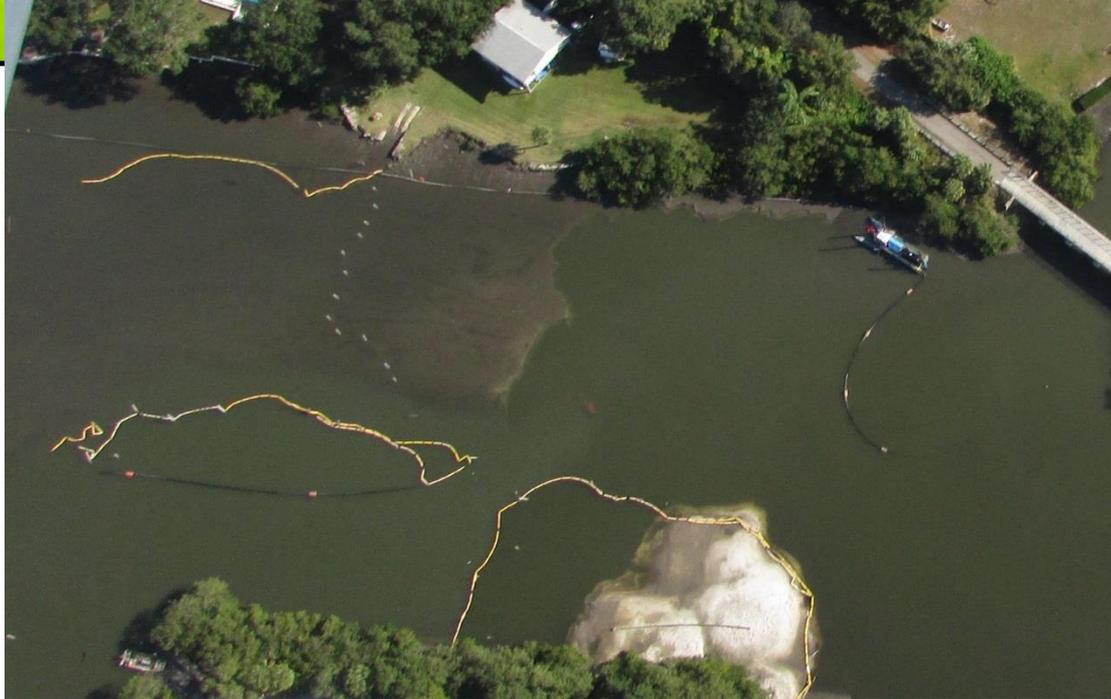
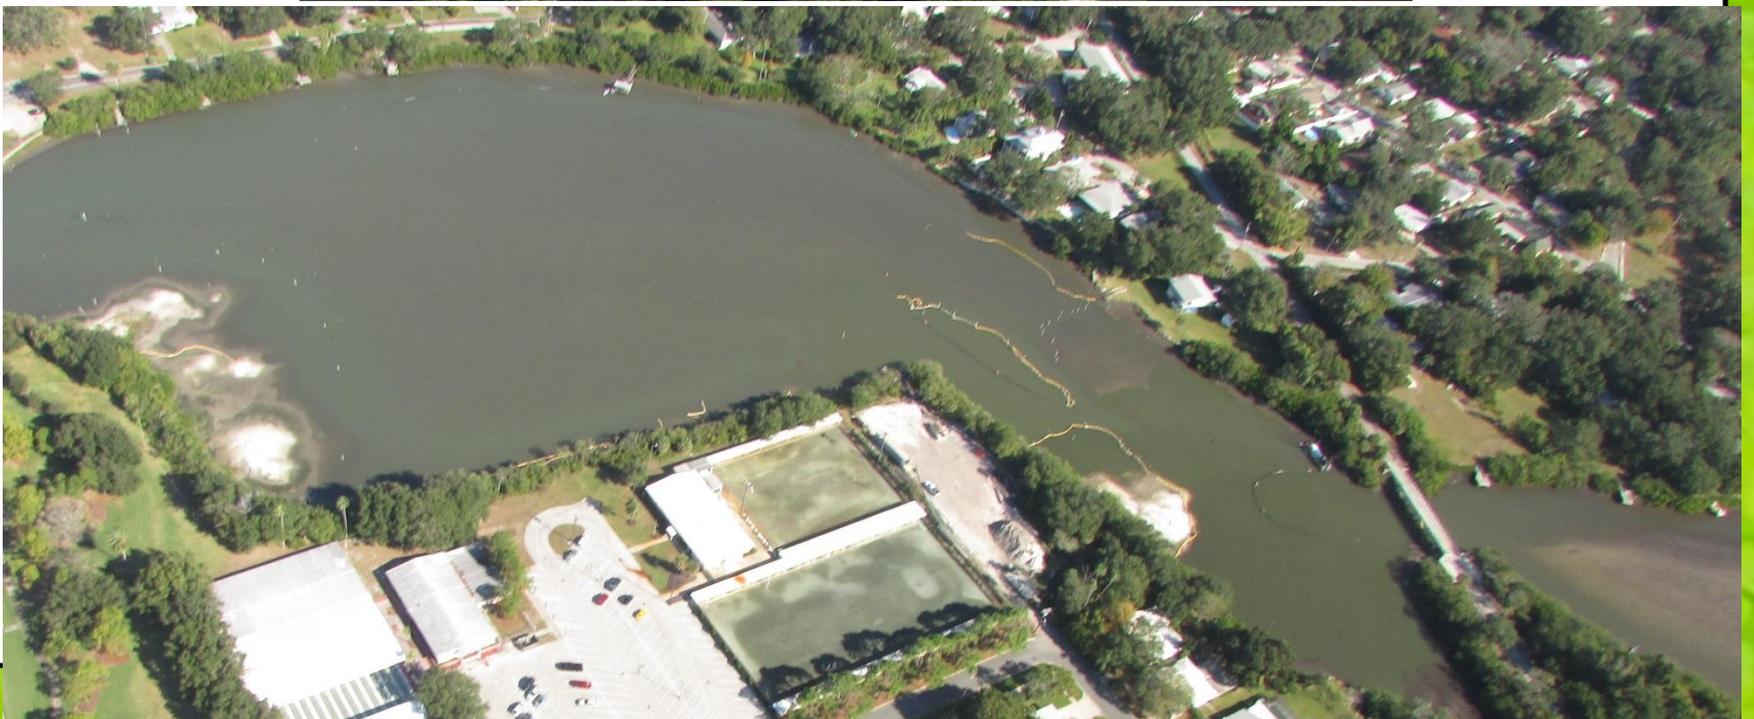
Dewatering Methods

- Tri-Flo DSS2000, separated sand & debris up to 2,000 gpm
- Dewatering of fines in mixing, clarification and polishing basins (5,000 gpm, 30 min residence time)
- 500 gpm pumped to each belt filter press
- Polymer injection to enhance dewatering of silts
- Clean sand saved for mangrove creation
- Dewatered sediment disposed at an approved spoil site

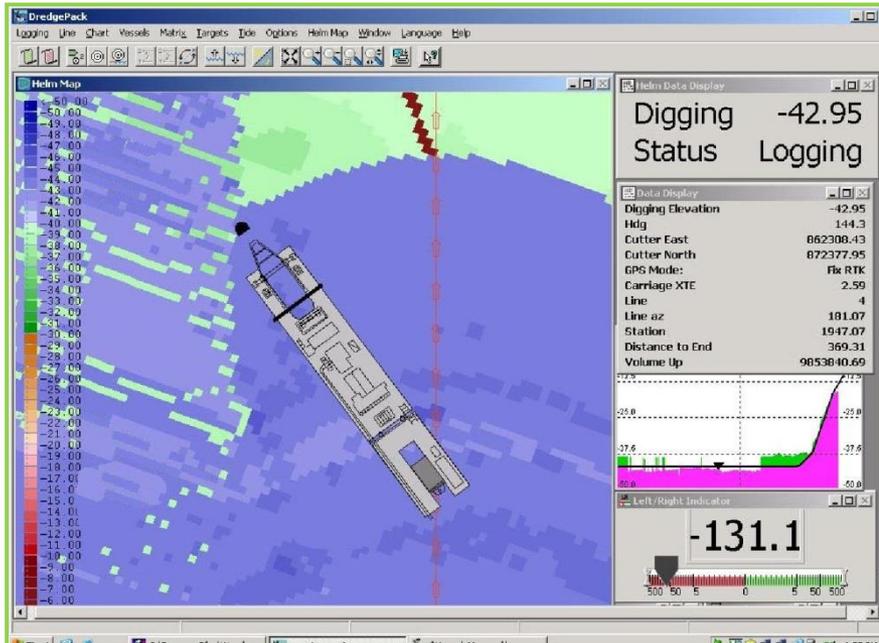
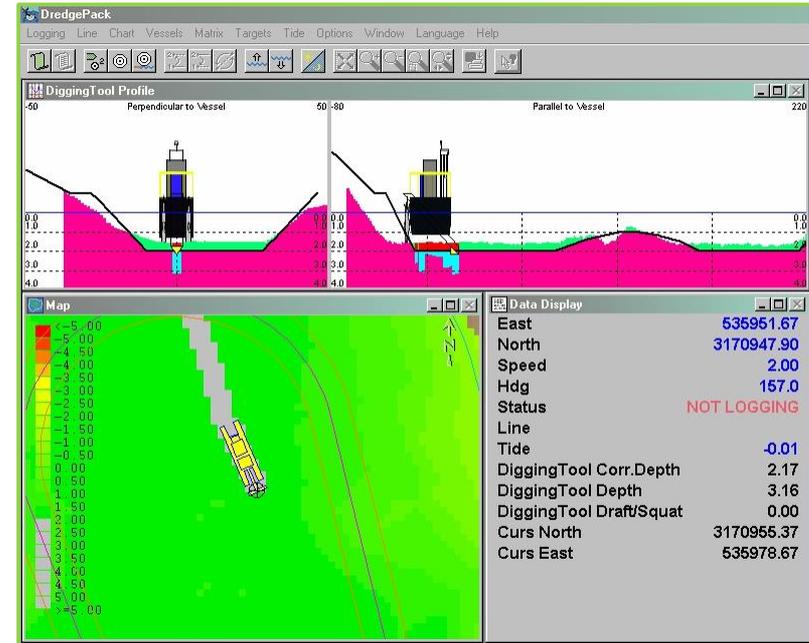
Hy-Pack Technology

- Allowed for accurate dredging & calculation of dredged sediment volumes
