Remediation of the San Diego Shipyard Sediment Site –

A Tale of Two Shipyards

Michael Whelan, P.E., Kyle King, P.E., and Nick Kennedy October 20, 2016

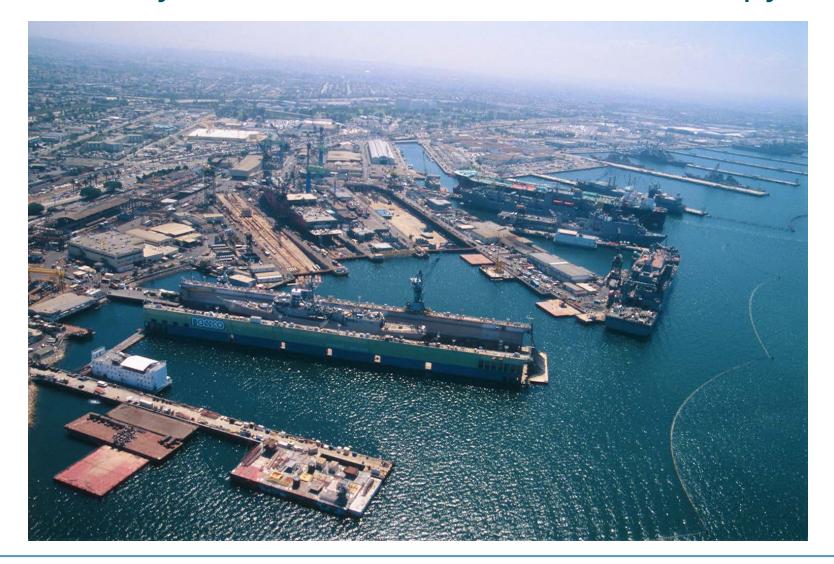
General Dynamics NASSCO: The "South Shipyard"

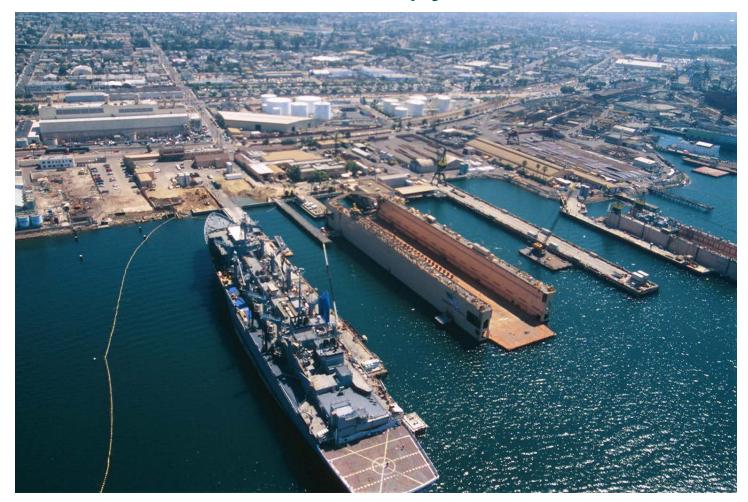
BAE Systems San Diego Ship Repair : The "North Shipyard"

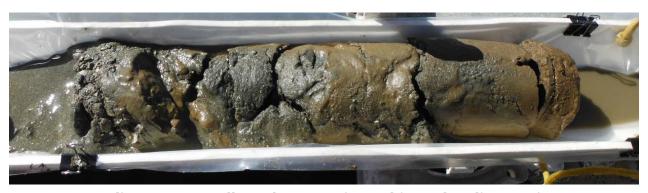
Sediment Core Collected at San Diego Shipyard Sediment Site

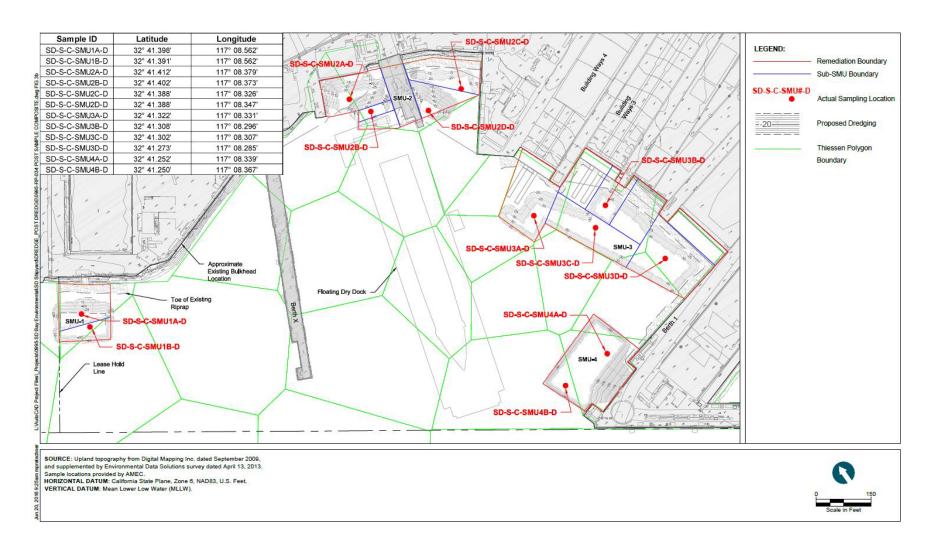
Dredging Areas at South Shipyard

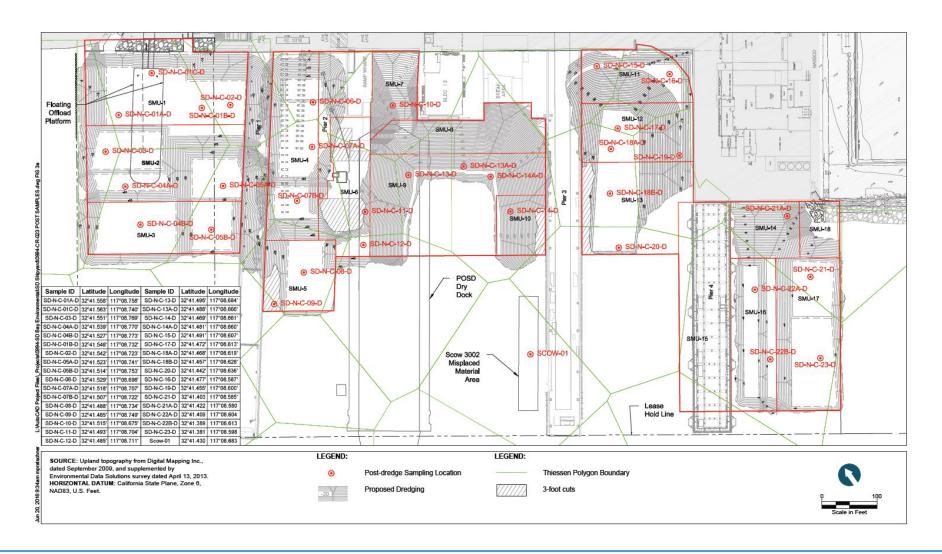
Dredging Areas at North Shipyard

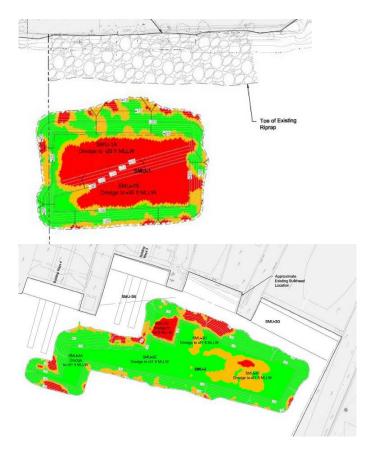
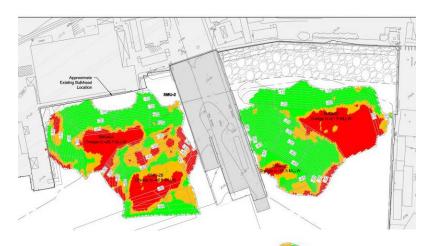
Sediment Removal at South Shipyard

Notes:

Green = above design elevation Red = below allowable overdredge

Yellow = between design elevation and allowable overdredge
