Dredging Over a Reactive Cap – Two Case Studies

Two projects to remove cap contamination

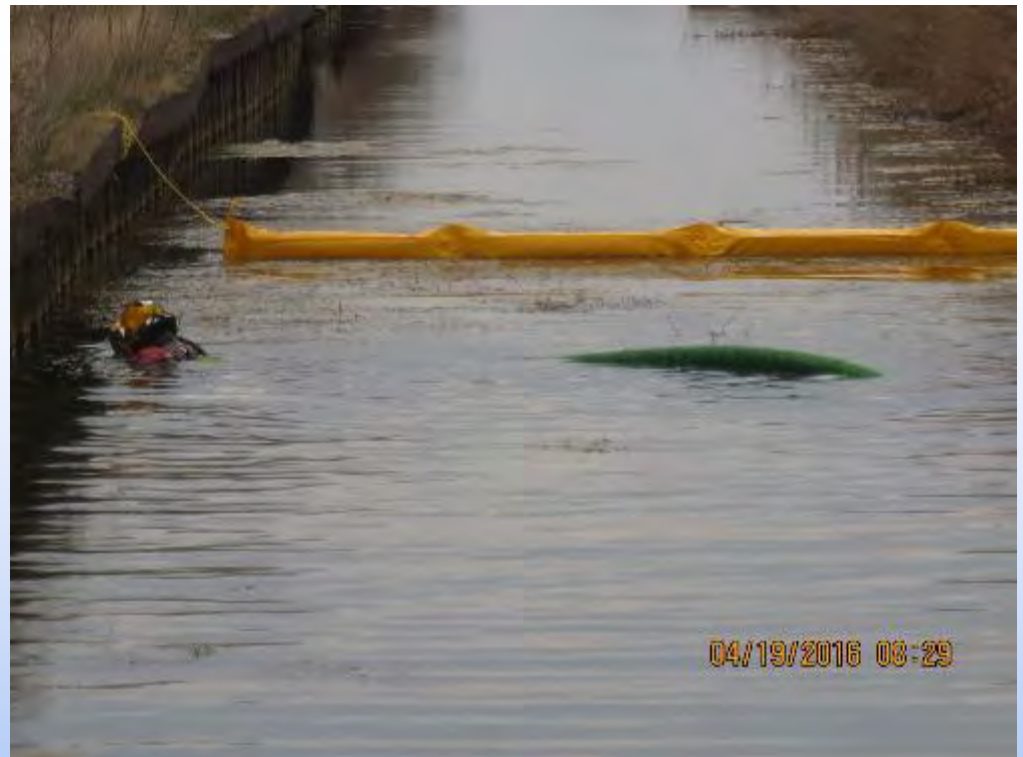
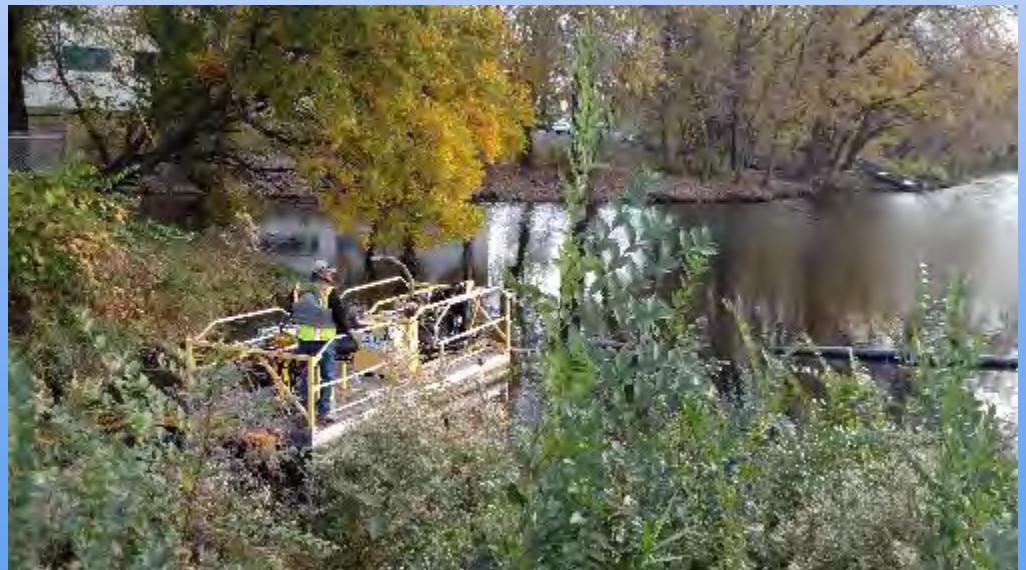
- Engineered caps installed over impacted sediments
 - OMC site in Waukegan, IL
 - Grand Calumet River, NW IN
- Sites impacted with PCBS and PAHs
- Both caps re-contaminated from above
 - OMC by PCB source outside of cap area
 - HSD from CSO
- Goal: remove contamination from surface of cap while minimizing loss of cap material

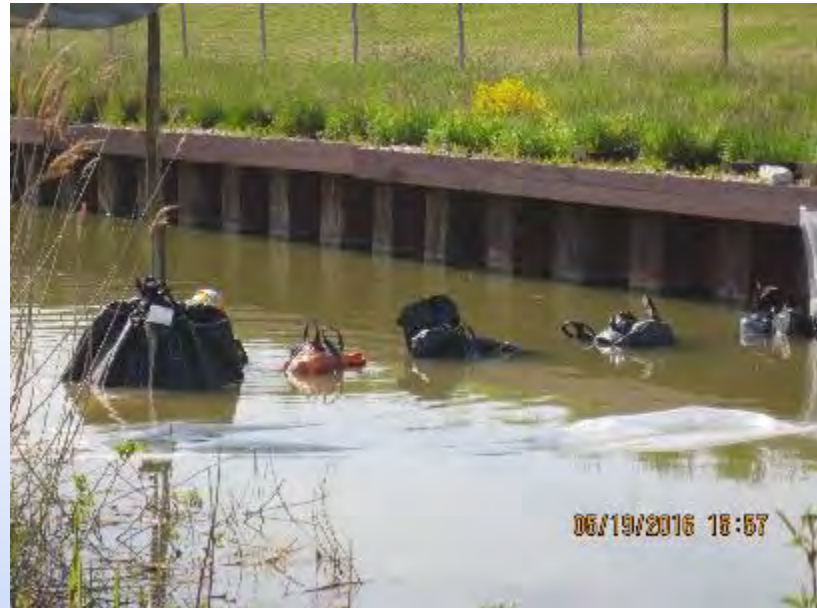
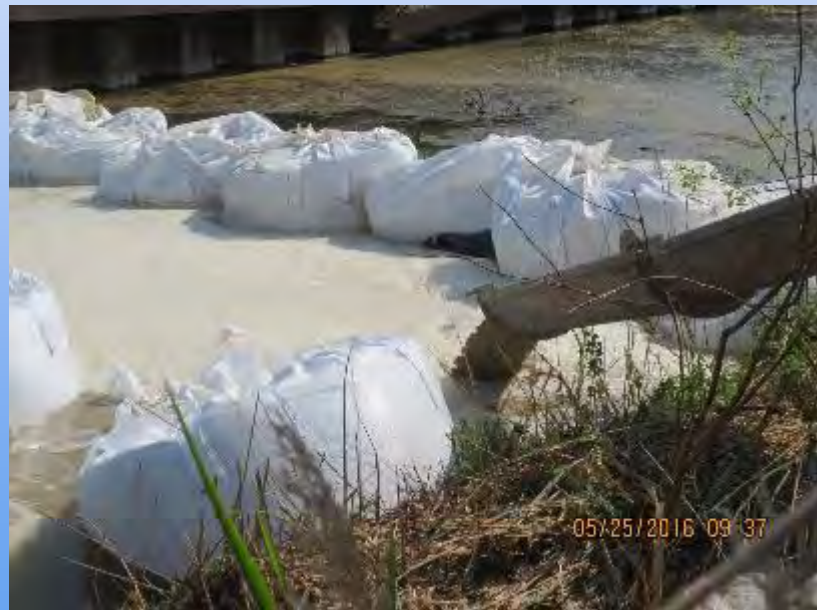
Amended Concrete Cap

- RAO of 1 PPM not met in 5 100-ft sections
- Concrete placed over cap in sections
- Concrete also served as better resistance to storm water flow into channel

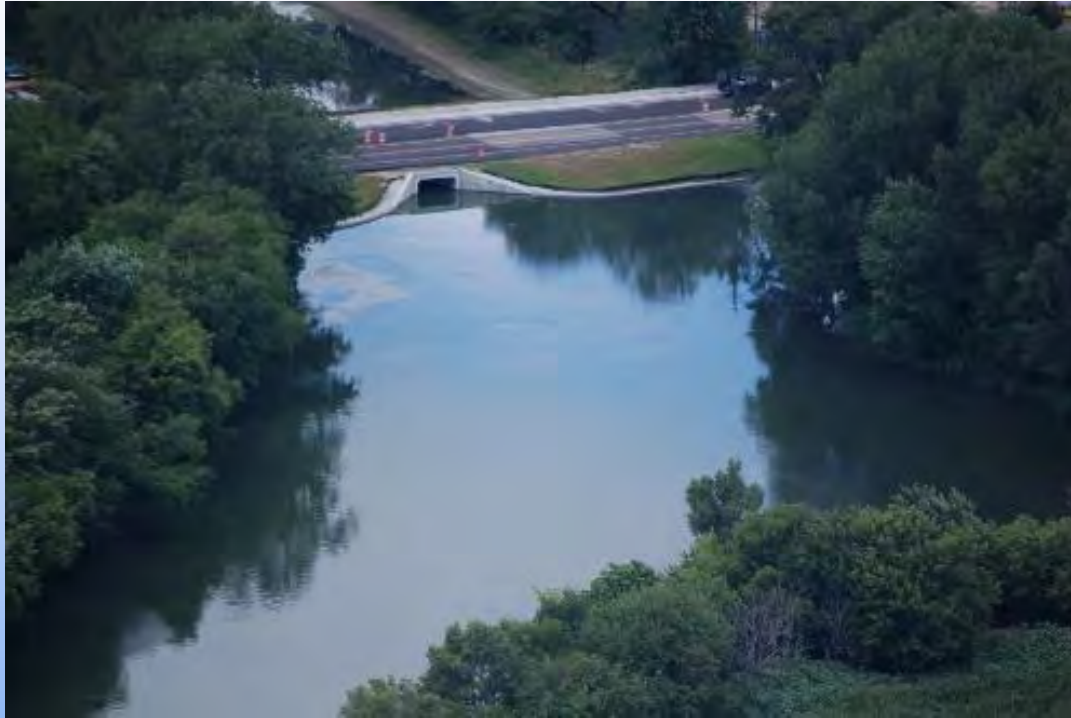
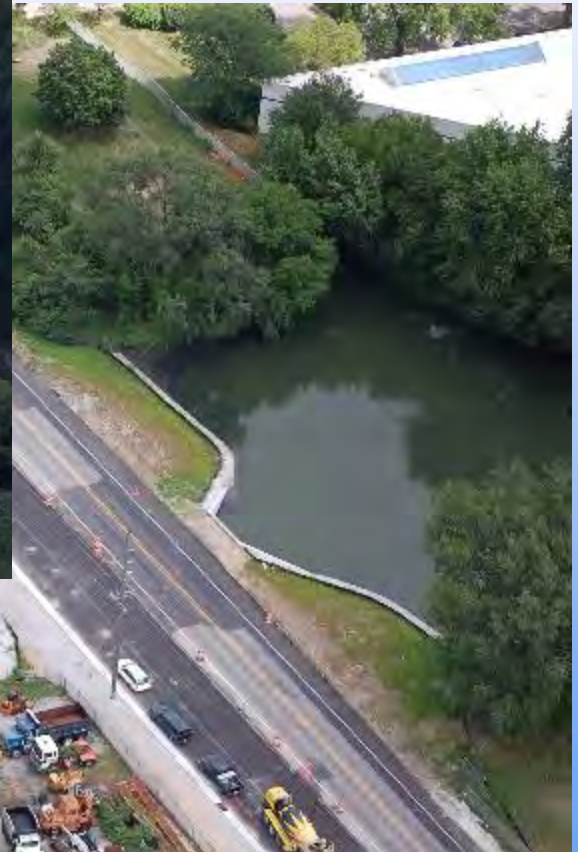
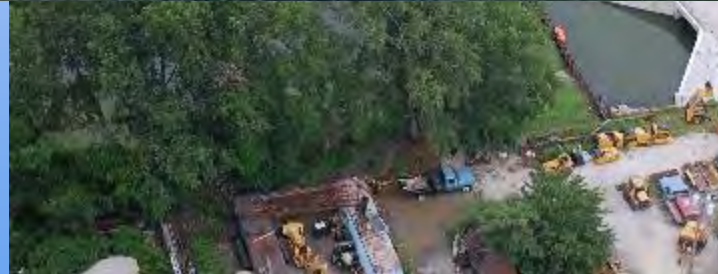
Hammond CSO Reach 2 GCR

- Cap placed Jan - April 2012
- CSO abandoned Fall 2014
- Cap sampled Nov 2014
- 3-12 inches material on top of engineered cap
- Thicker closer to CSO

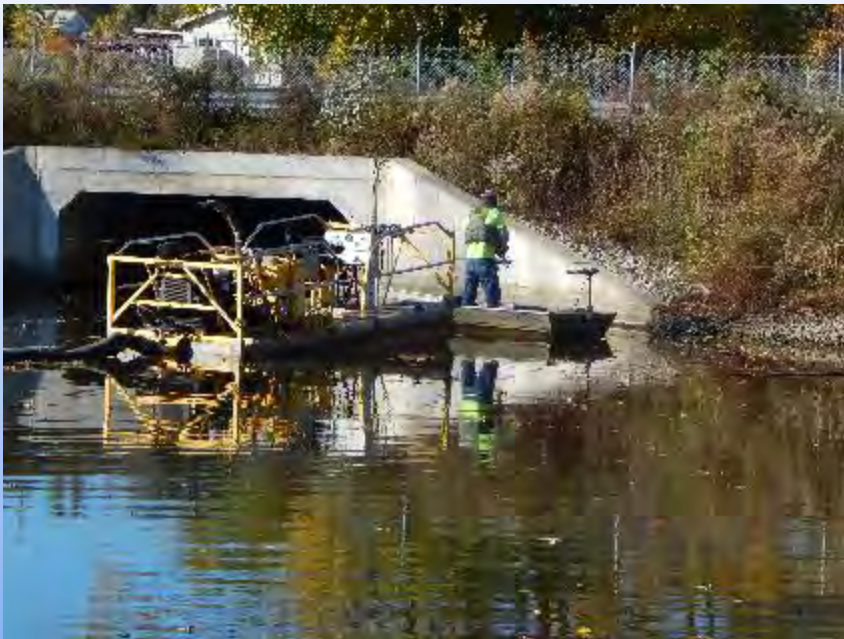
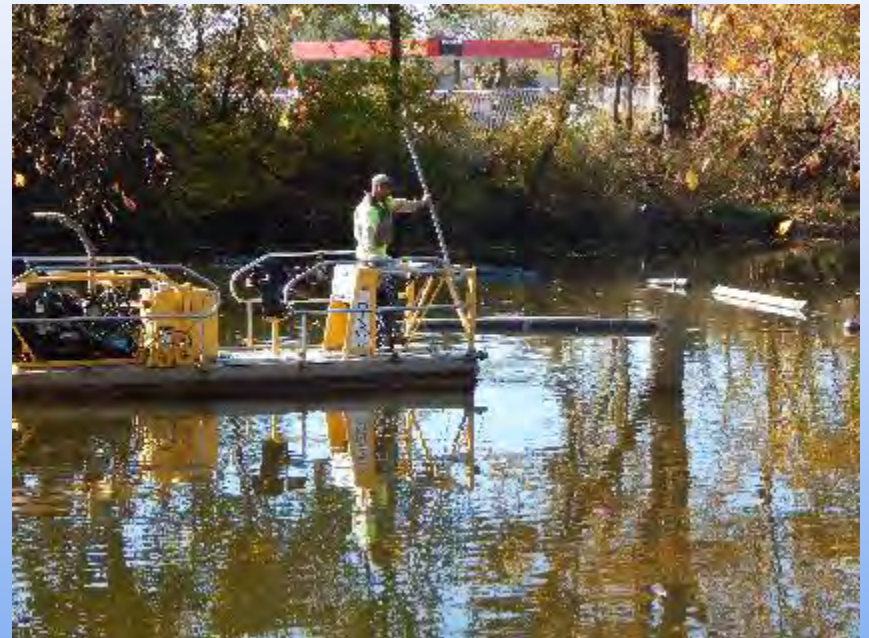
Fall 2016

- Removing/Thinning Cap
- Cost
- Discharge Location
- HSD Acceptance
 - Flow rate
 - Solids content
 - Phosphorous

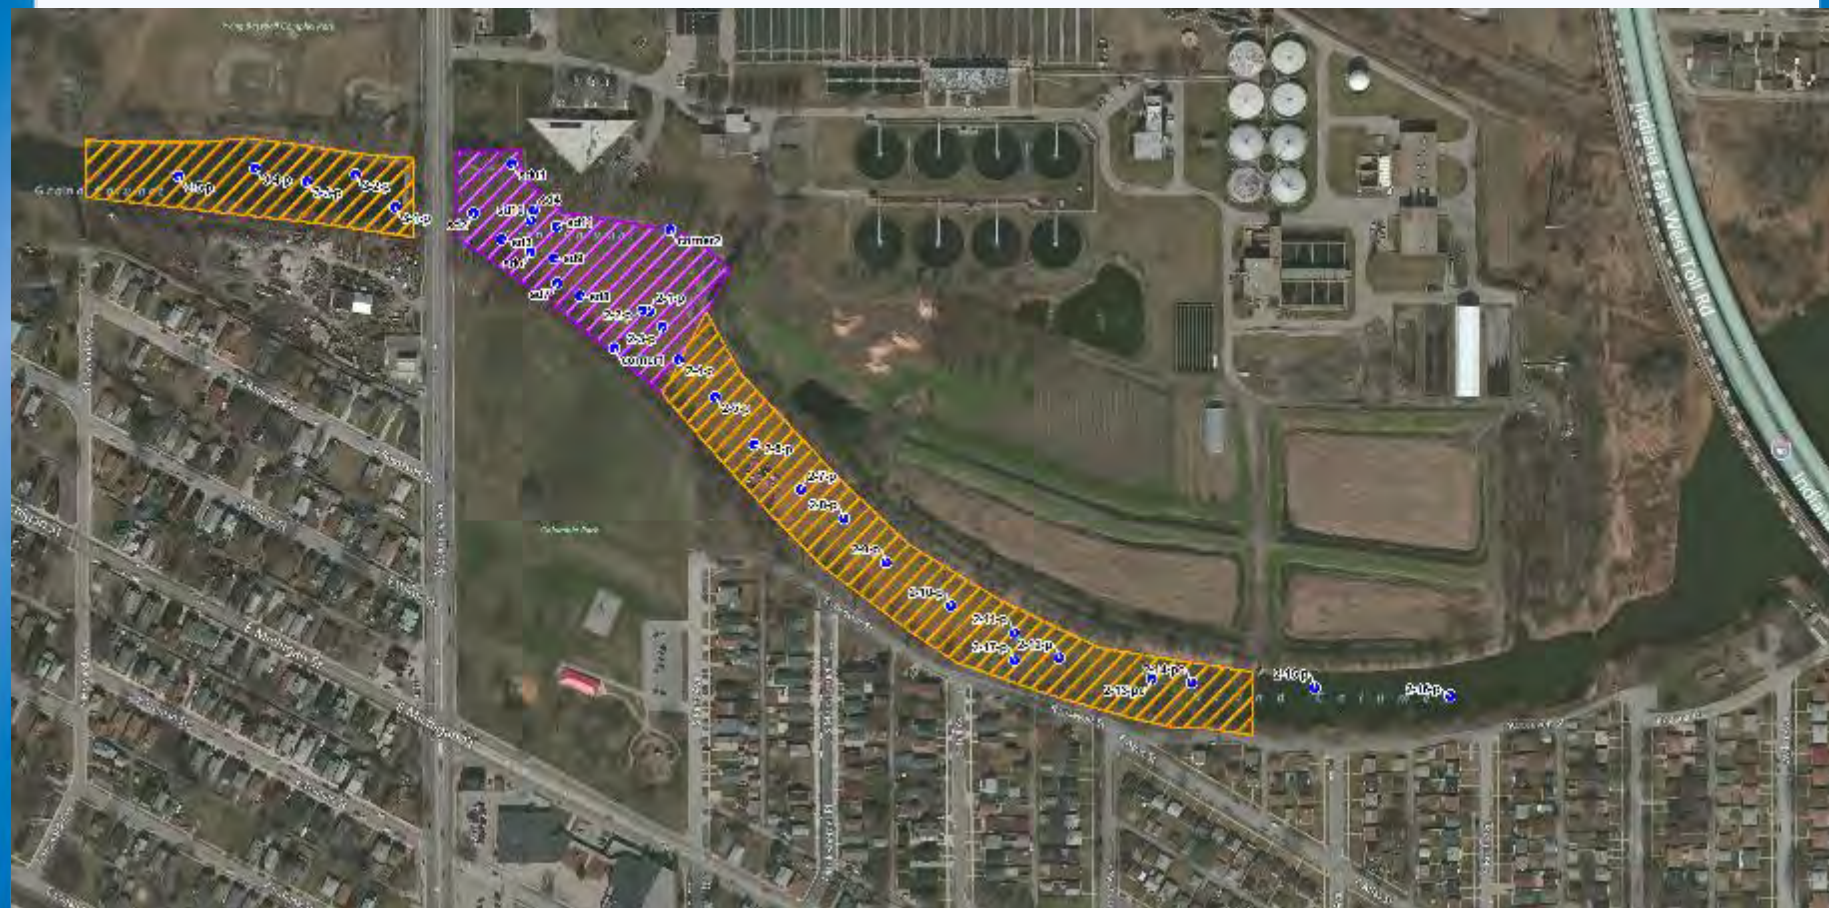
HSD CSO Dredging Summary

- ~ 800 CY of sediment removed
- Total cost ~\$100,000
- 1-3 inches soft sediment remaining
- Cap thickness 16.5-23 inches
