DREDGED SEDIMENT CHARACTERISTICS AFTER TREATMENT BY GEOSYNTHETIC DEWATERING TUBES

Dipl.-Ing. Markus Wilke

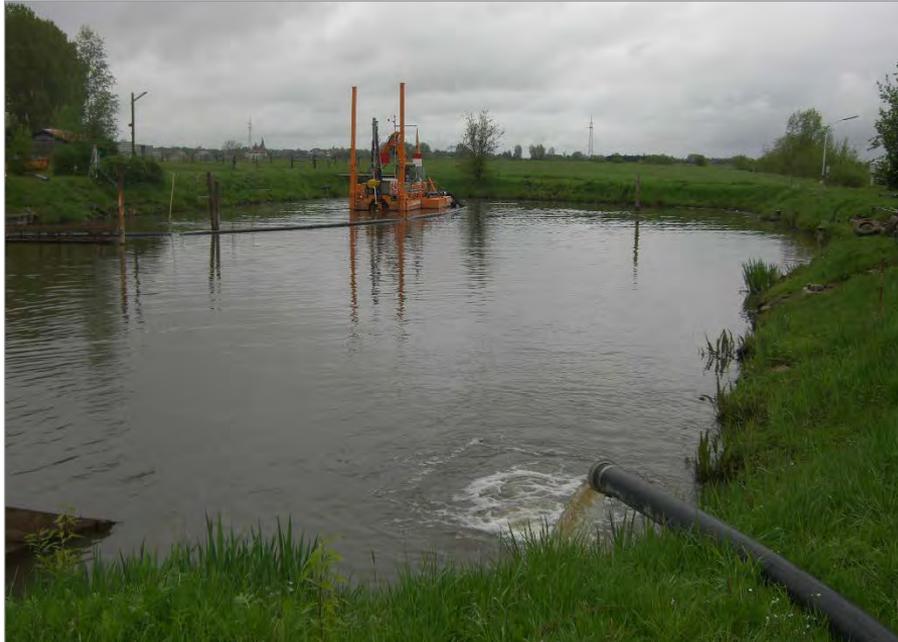
Small Marina: 1,000 m³ of sediment to be removed

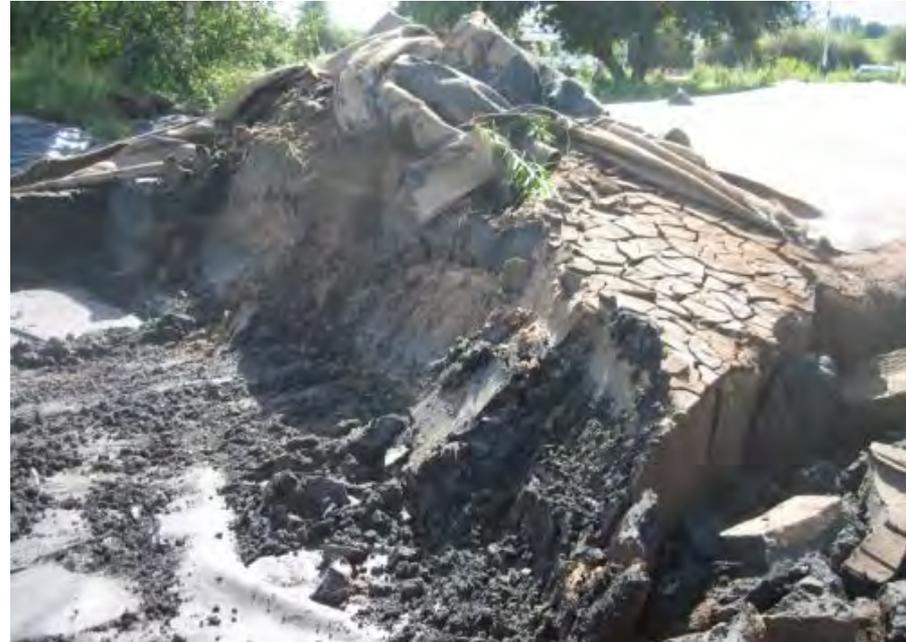
The dewatered material

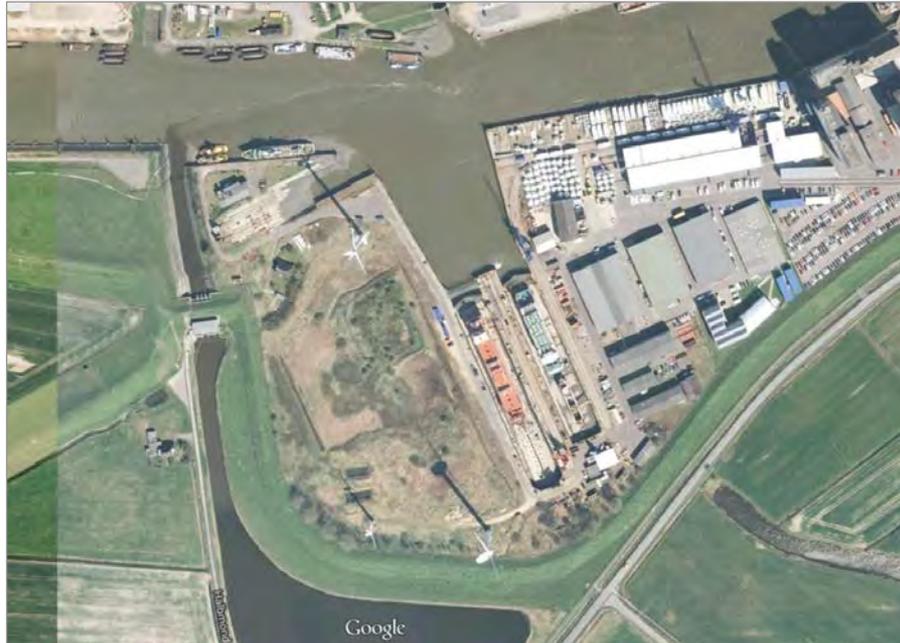
Approx. 50,000 m³ sediment, heavily contaminated with TBT, heavy metals, PCB's (source: google earth)

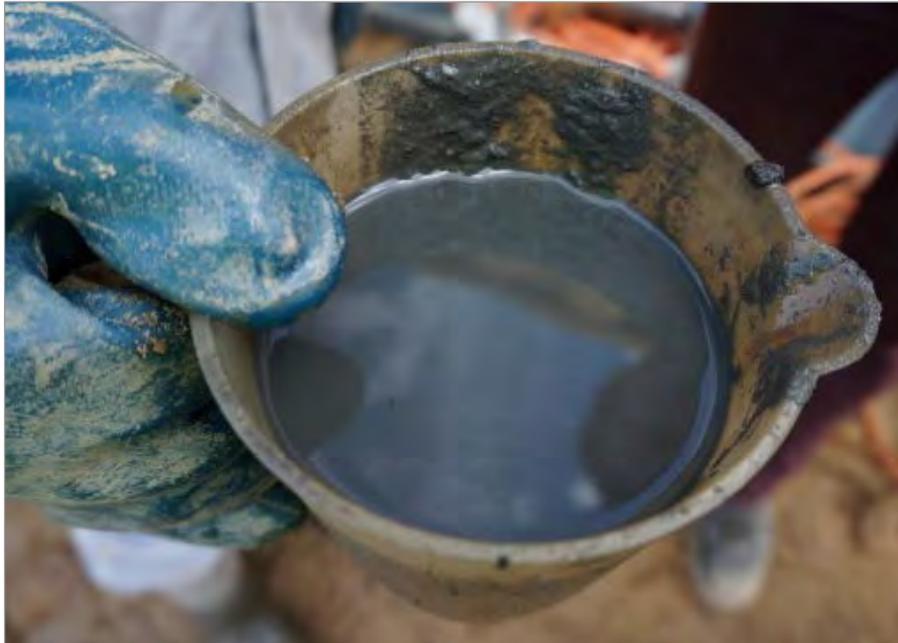
Untreated sediment

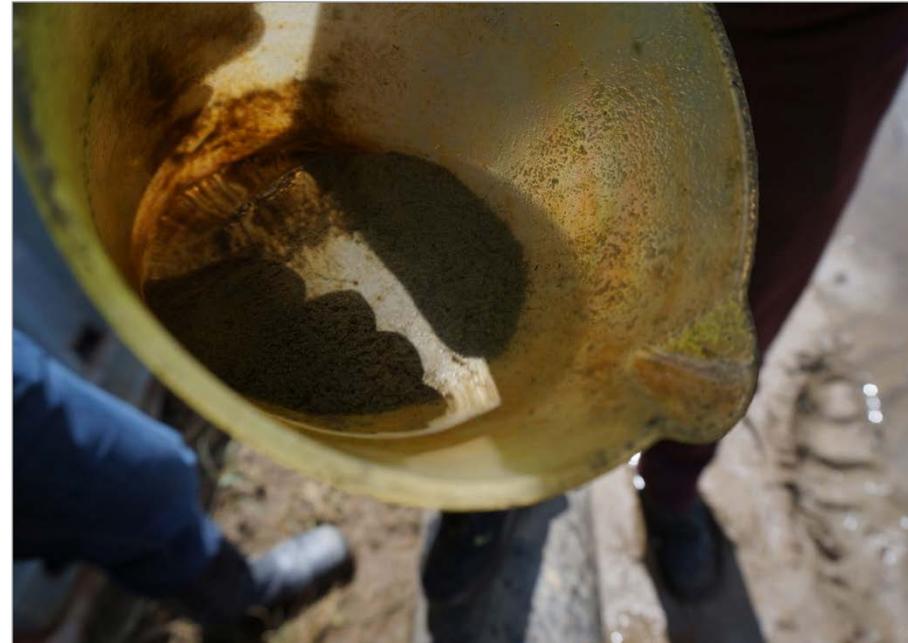
Flocculated sediment

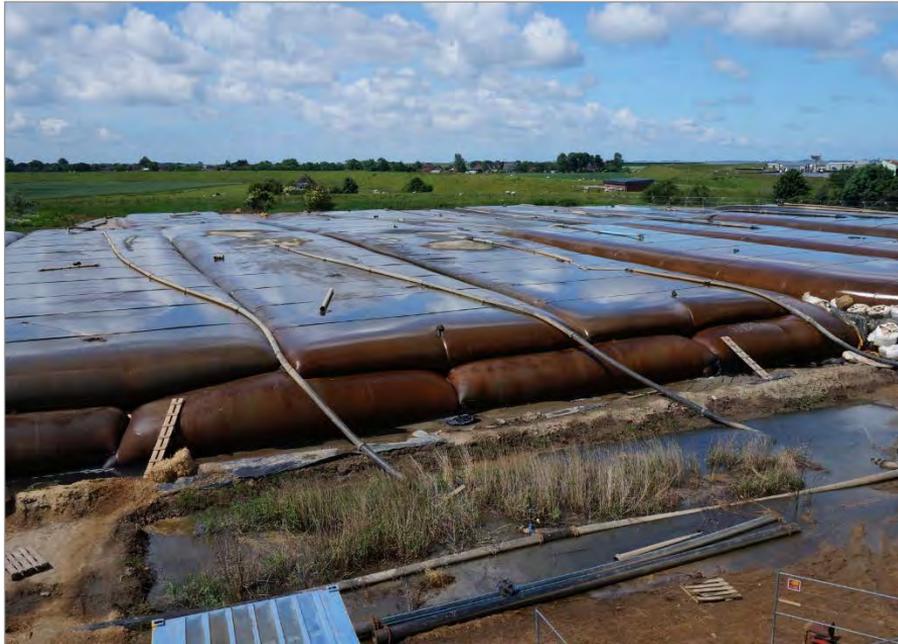
The dewatering field

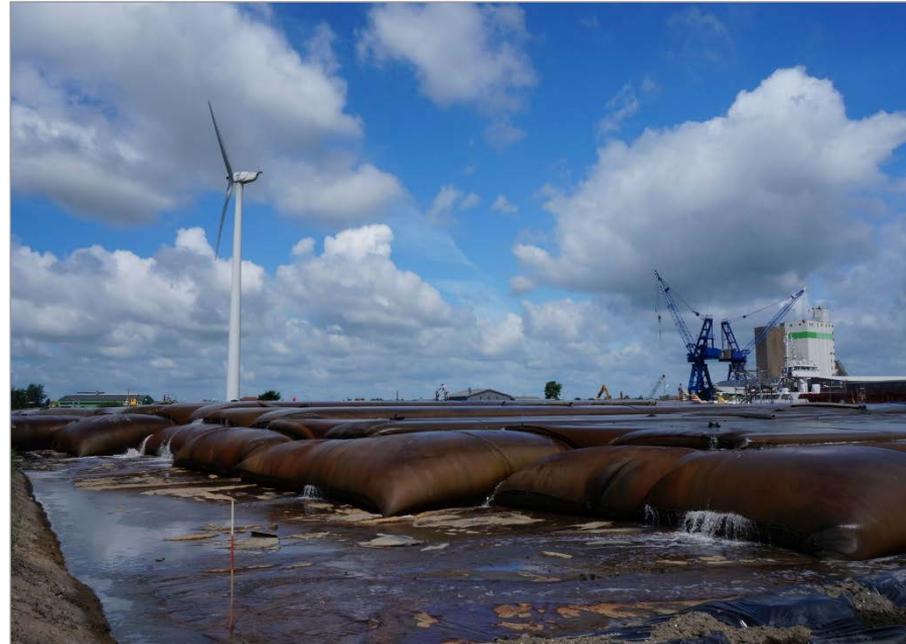
The dewatering field

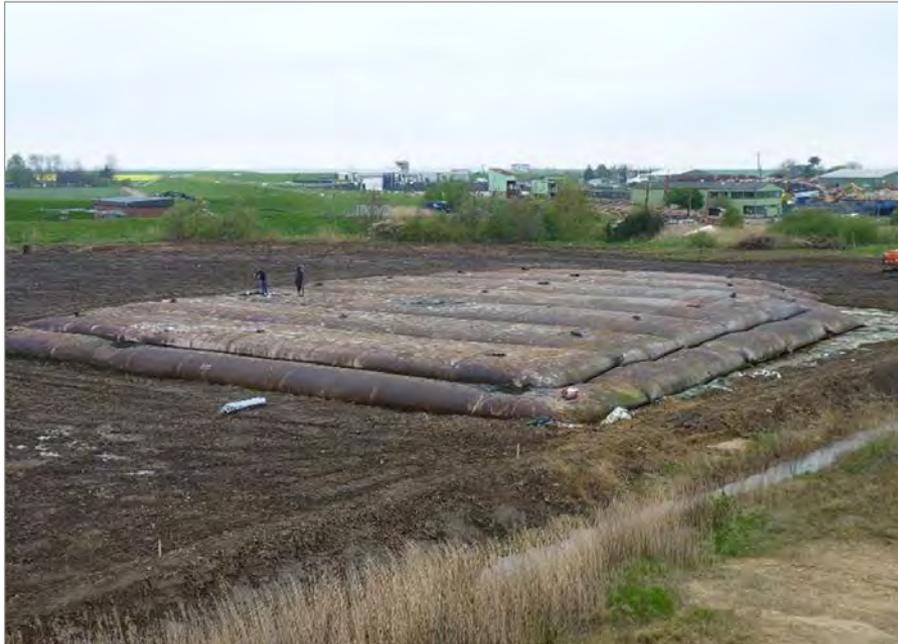
Trial section

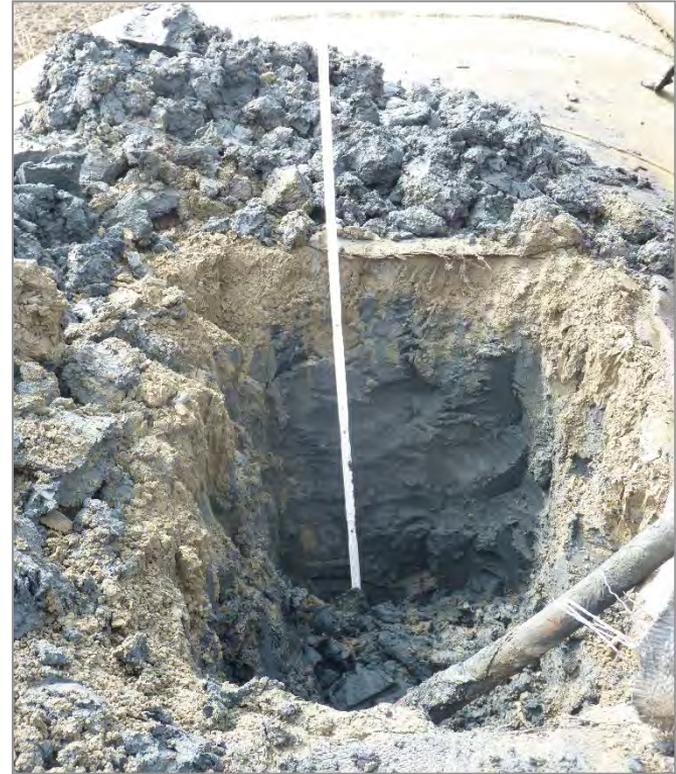
Sampling pit on the tube

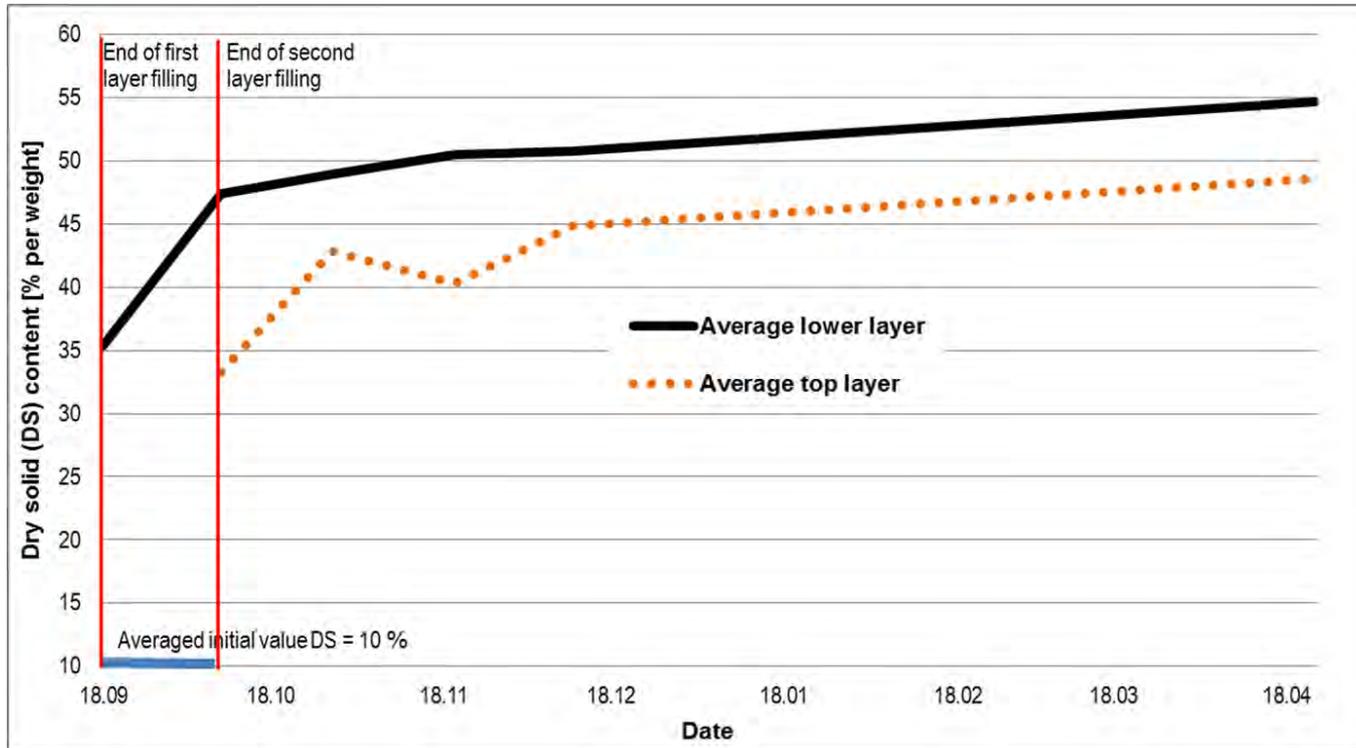
Processed DS data

- # The principal trend of the derived DS curves is similar for both projects and all analyzed locations, independent from tube layer or project.
- # The absolute values of the DS contents vary. Main variations are due to the different sediment characteristics of the two projects.
- # The “dewatering process” for the Verden project seems to be complete whereas it is still ongoing for the Husum project.
- # Stacking of tubes (application of a surcharge load) results in an increase in the DS content and the undrained vane shear strength in the lower layer.
- # The curve of the dry solid content development approaches a horizontal asymptote. As the projects are located in quite rainy regions, it can definitely be concluded that overall rainfall does not negatively affect the dry solid contents of materials encapsulated within geosynthetic dewatering tubes.

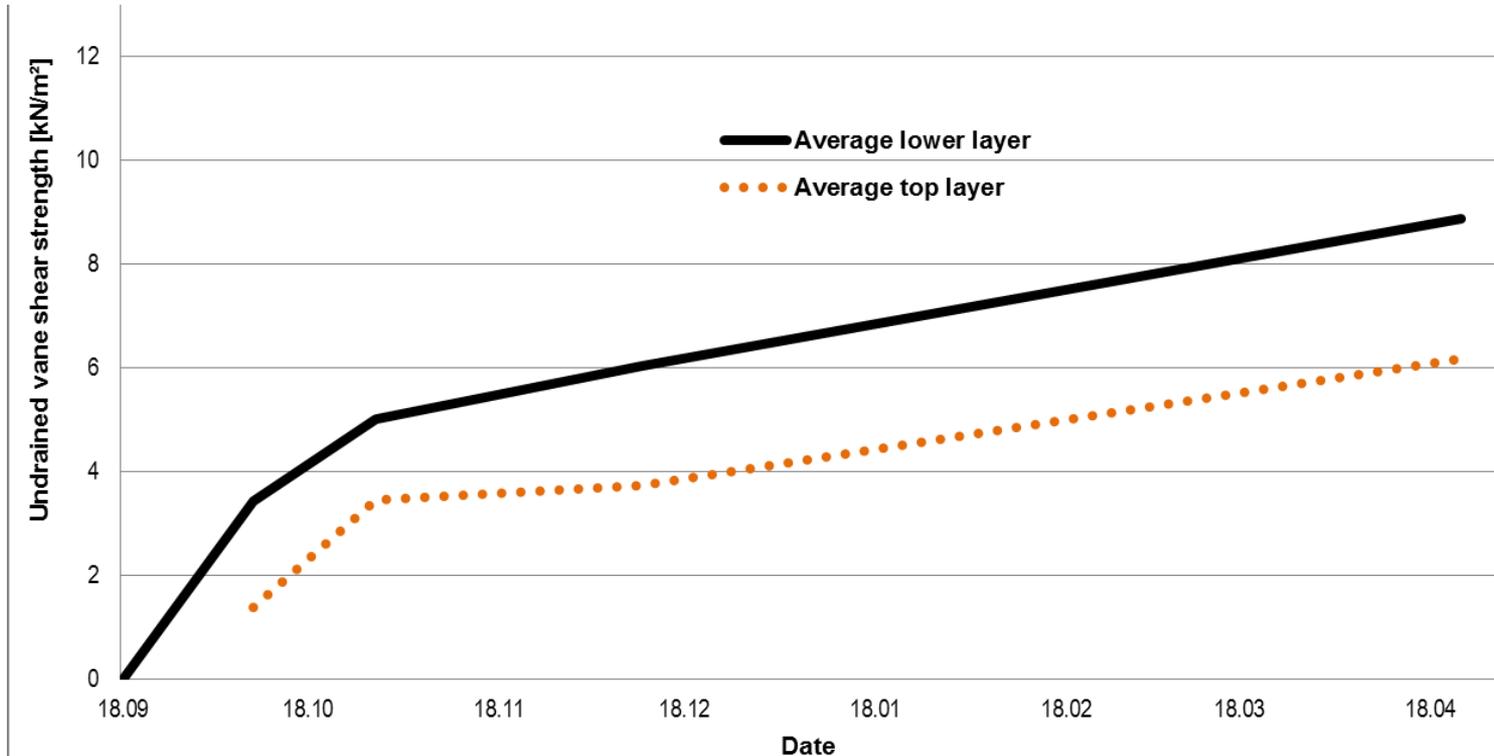
Processed un-drained vane shear strength data

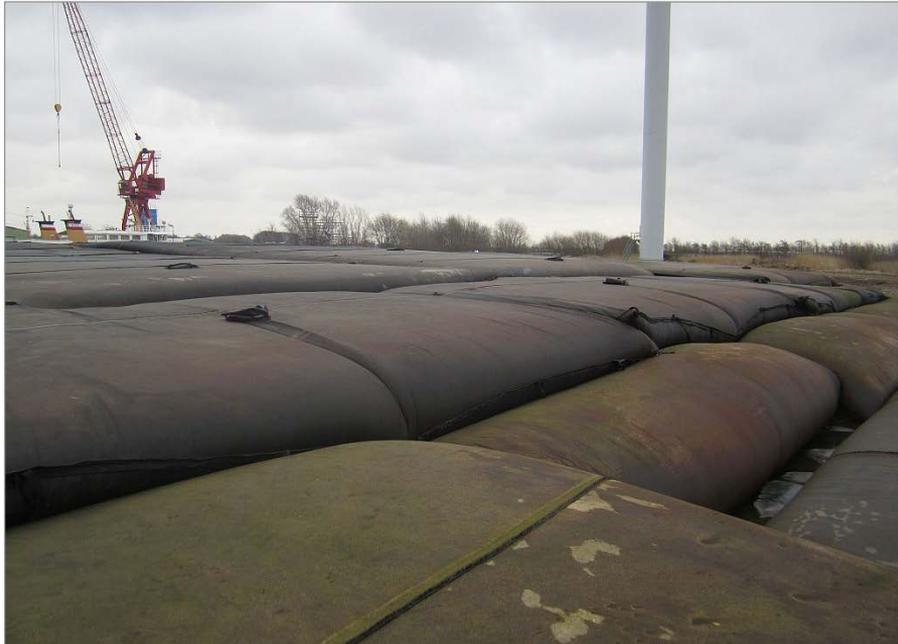
Finally a three layer stack

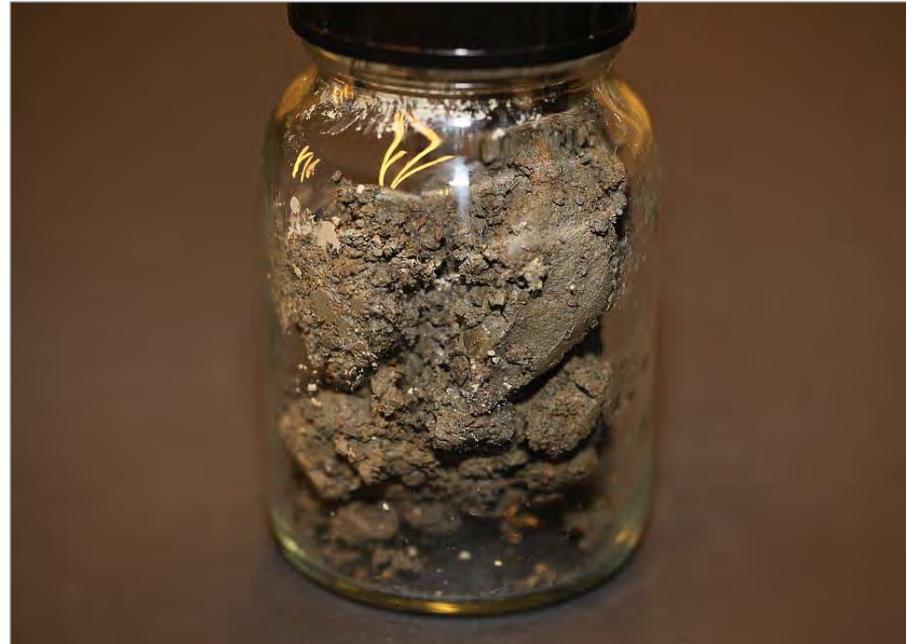
Harbour sediment after dewatering (DS after 6 month between 46 % to 56 %)
