INFRASTRUCTURE
ALTERNATIVES

MILE POINT TRAINING WALL
JACKSONVILLE, FL

Geotextile Tube Installation

MILE POINT TRAINING WALL RECONFIGURATION
JACKSONVILLE, FLORIDA
DREDGING SUMMIT & EXPO '17

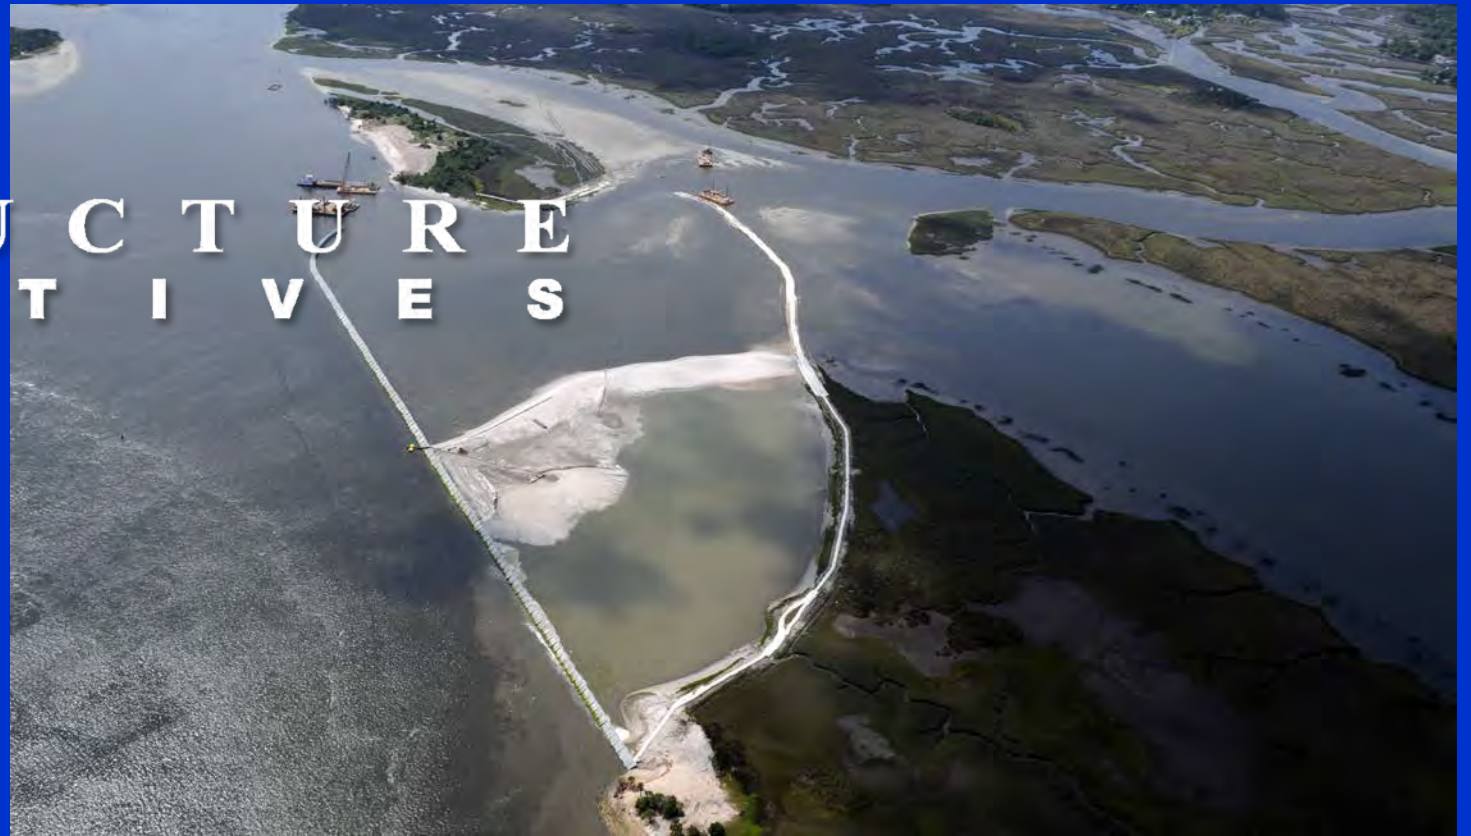
- Remove portion of existing training wall
- Construct new eastern and western training walls
- Deepen new flow improvement channel
- Restore Great Marsh Island

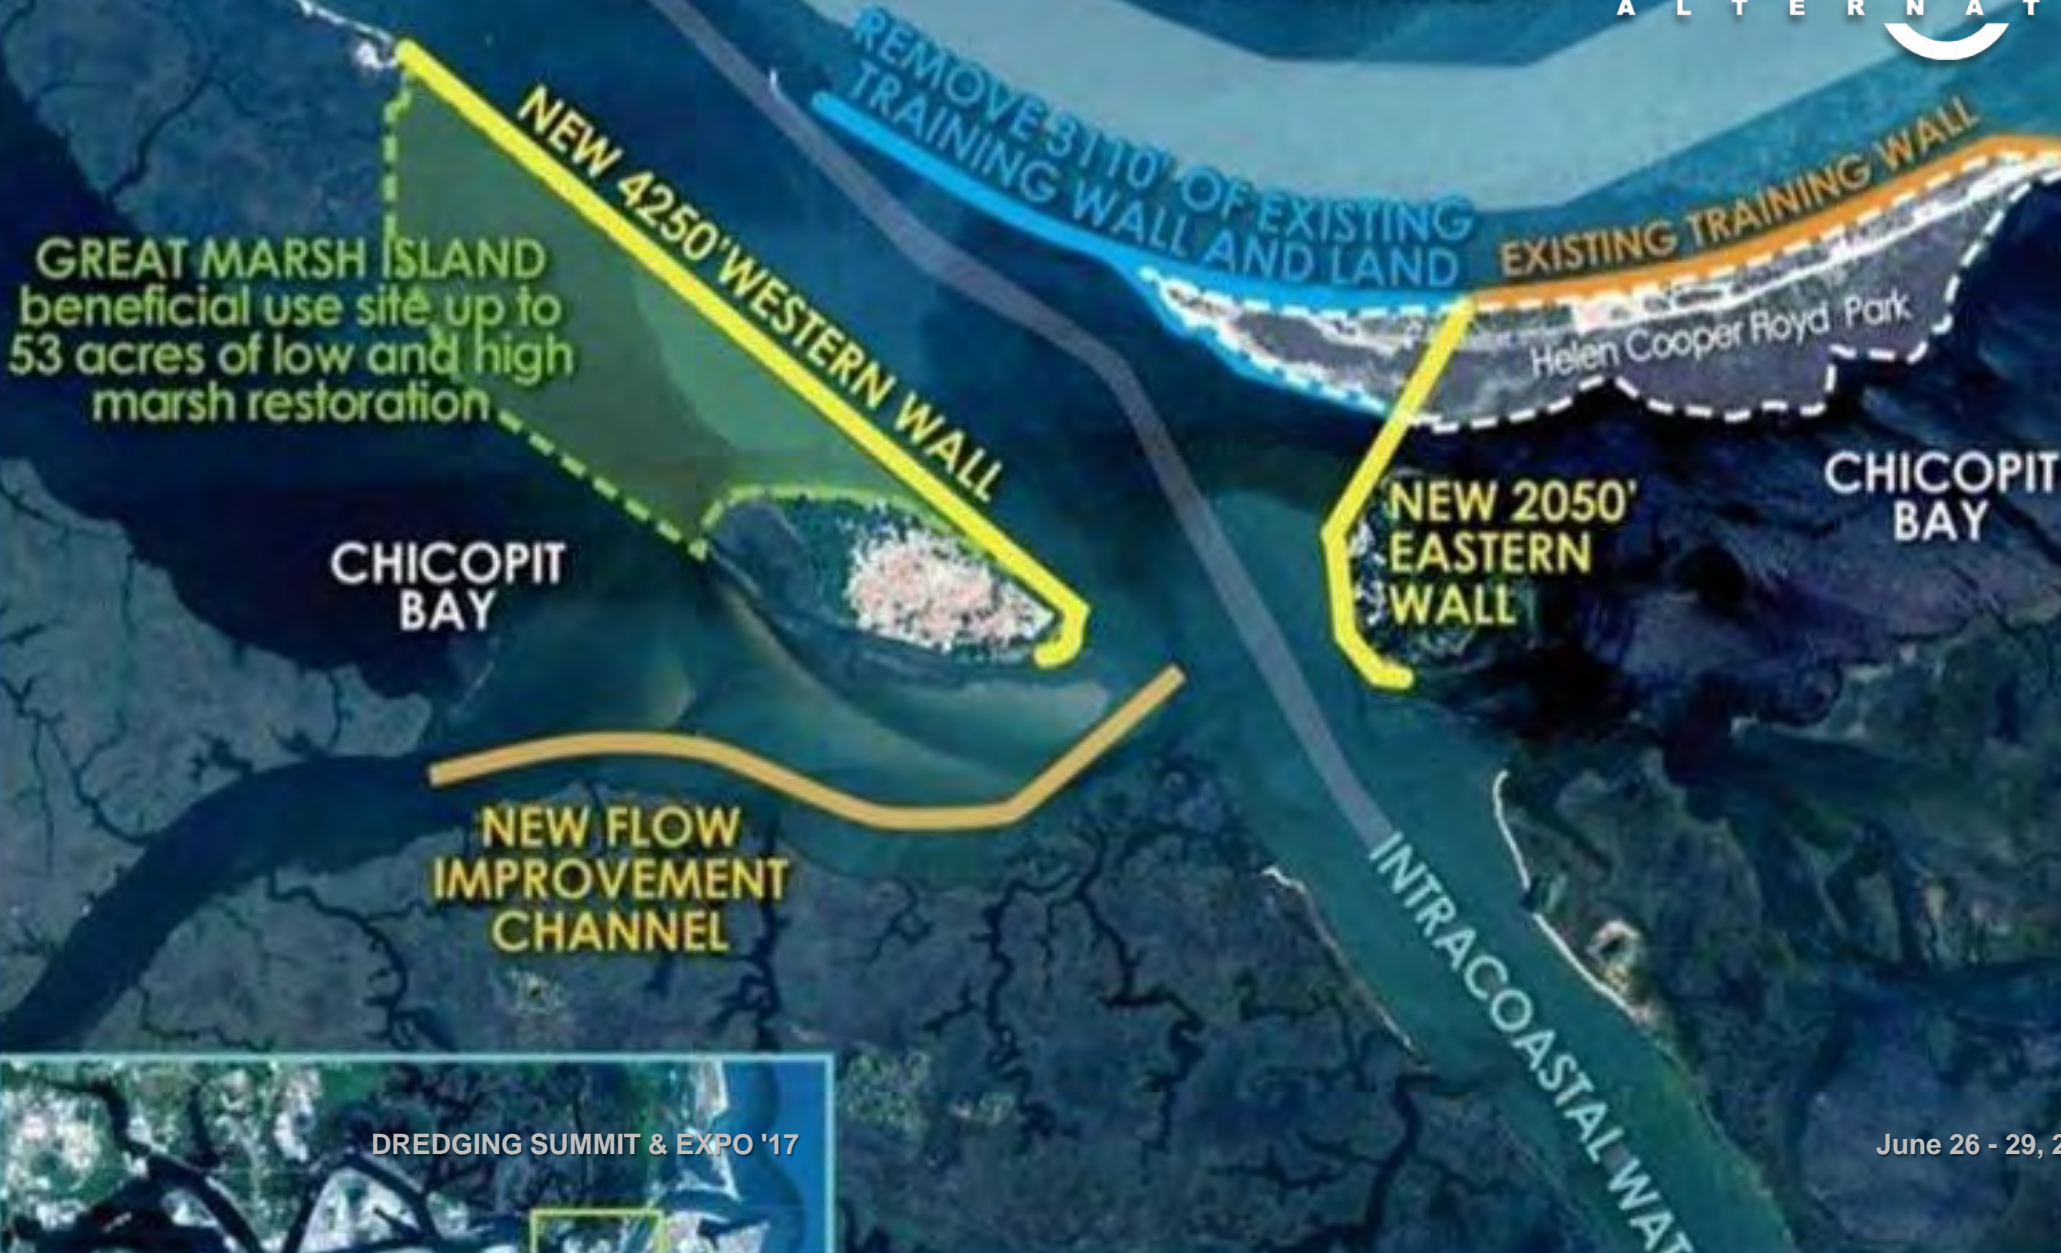
PROJECT DESIGN

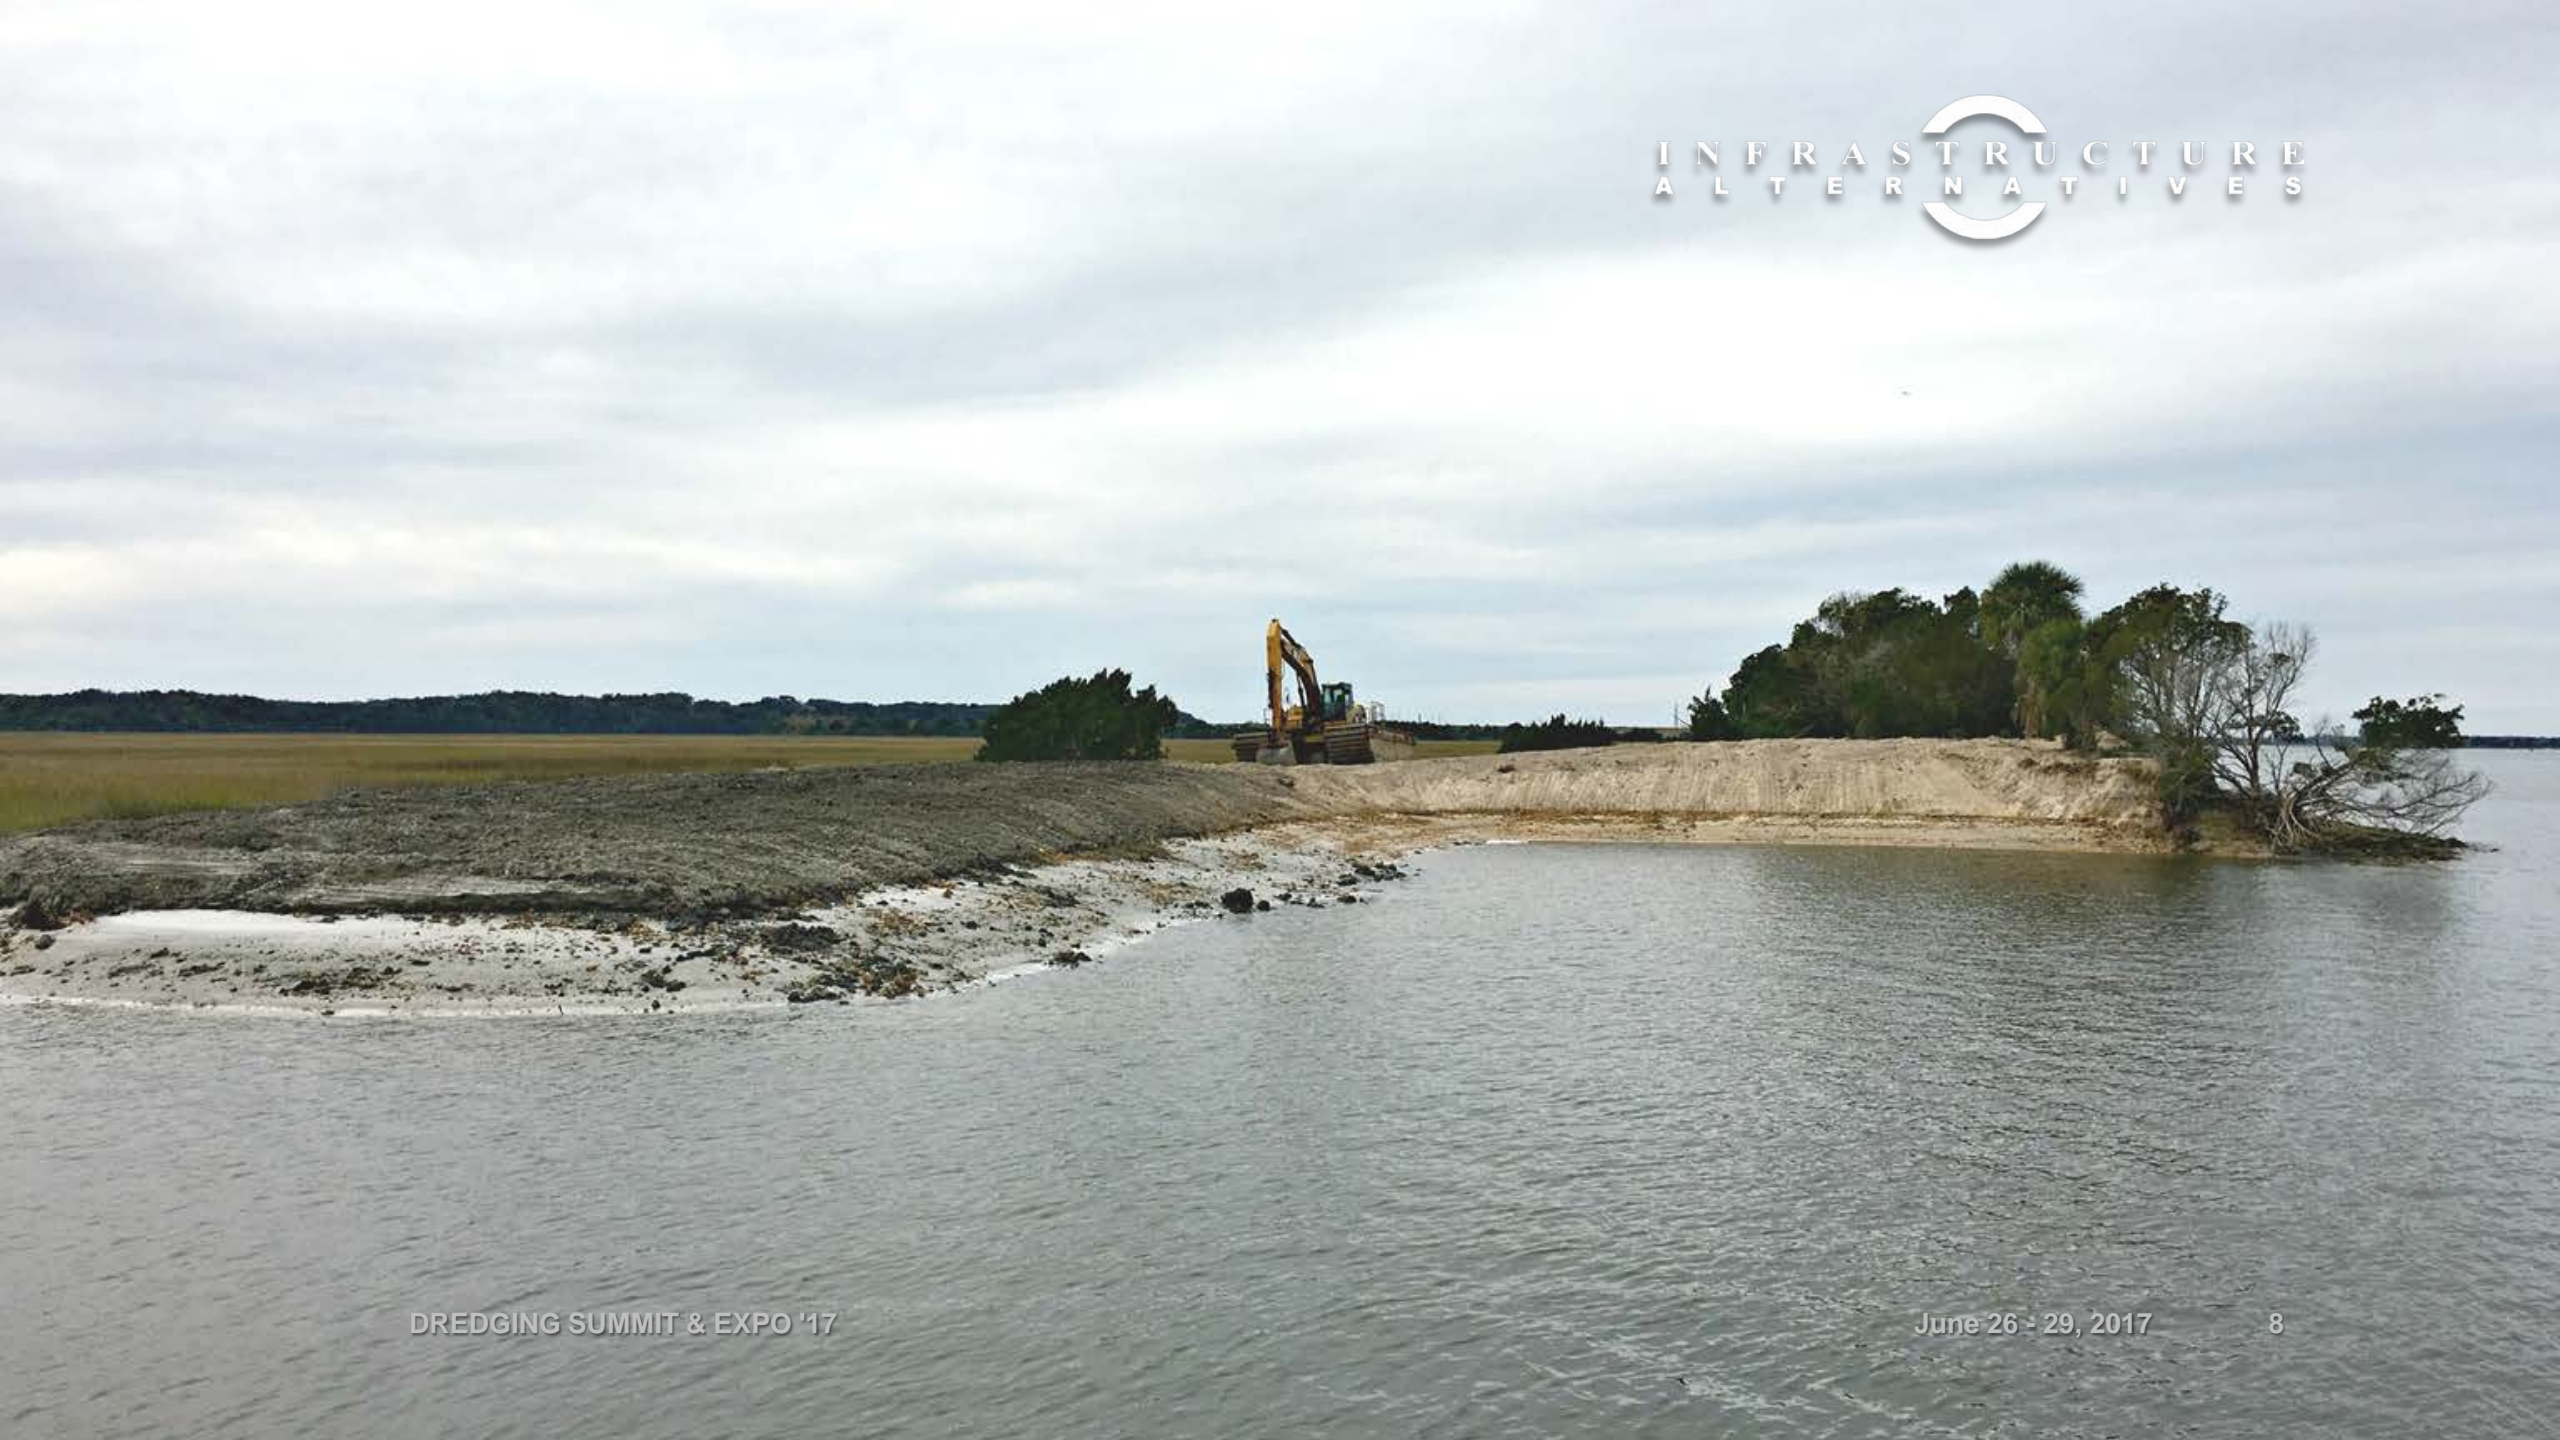
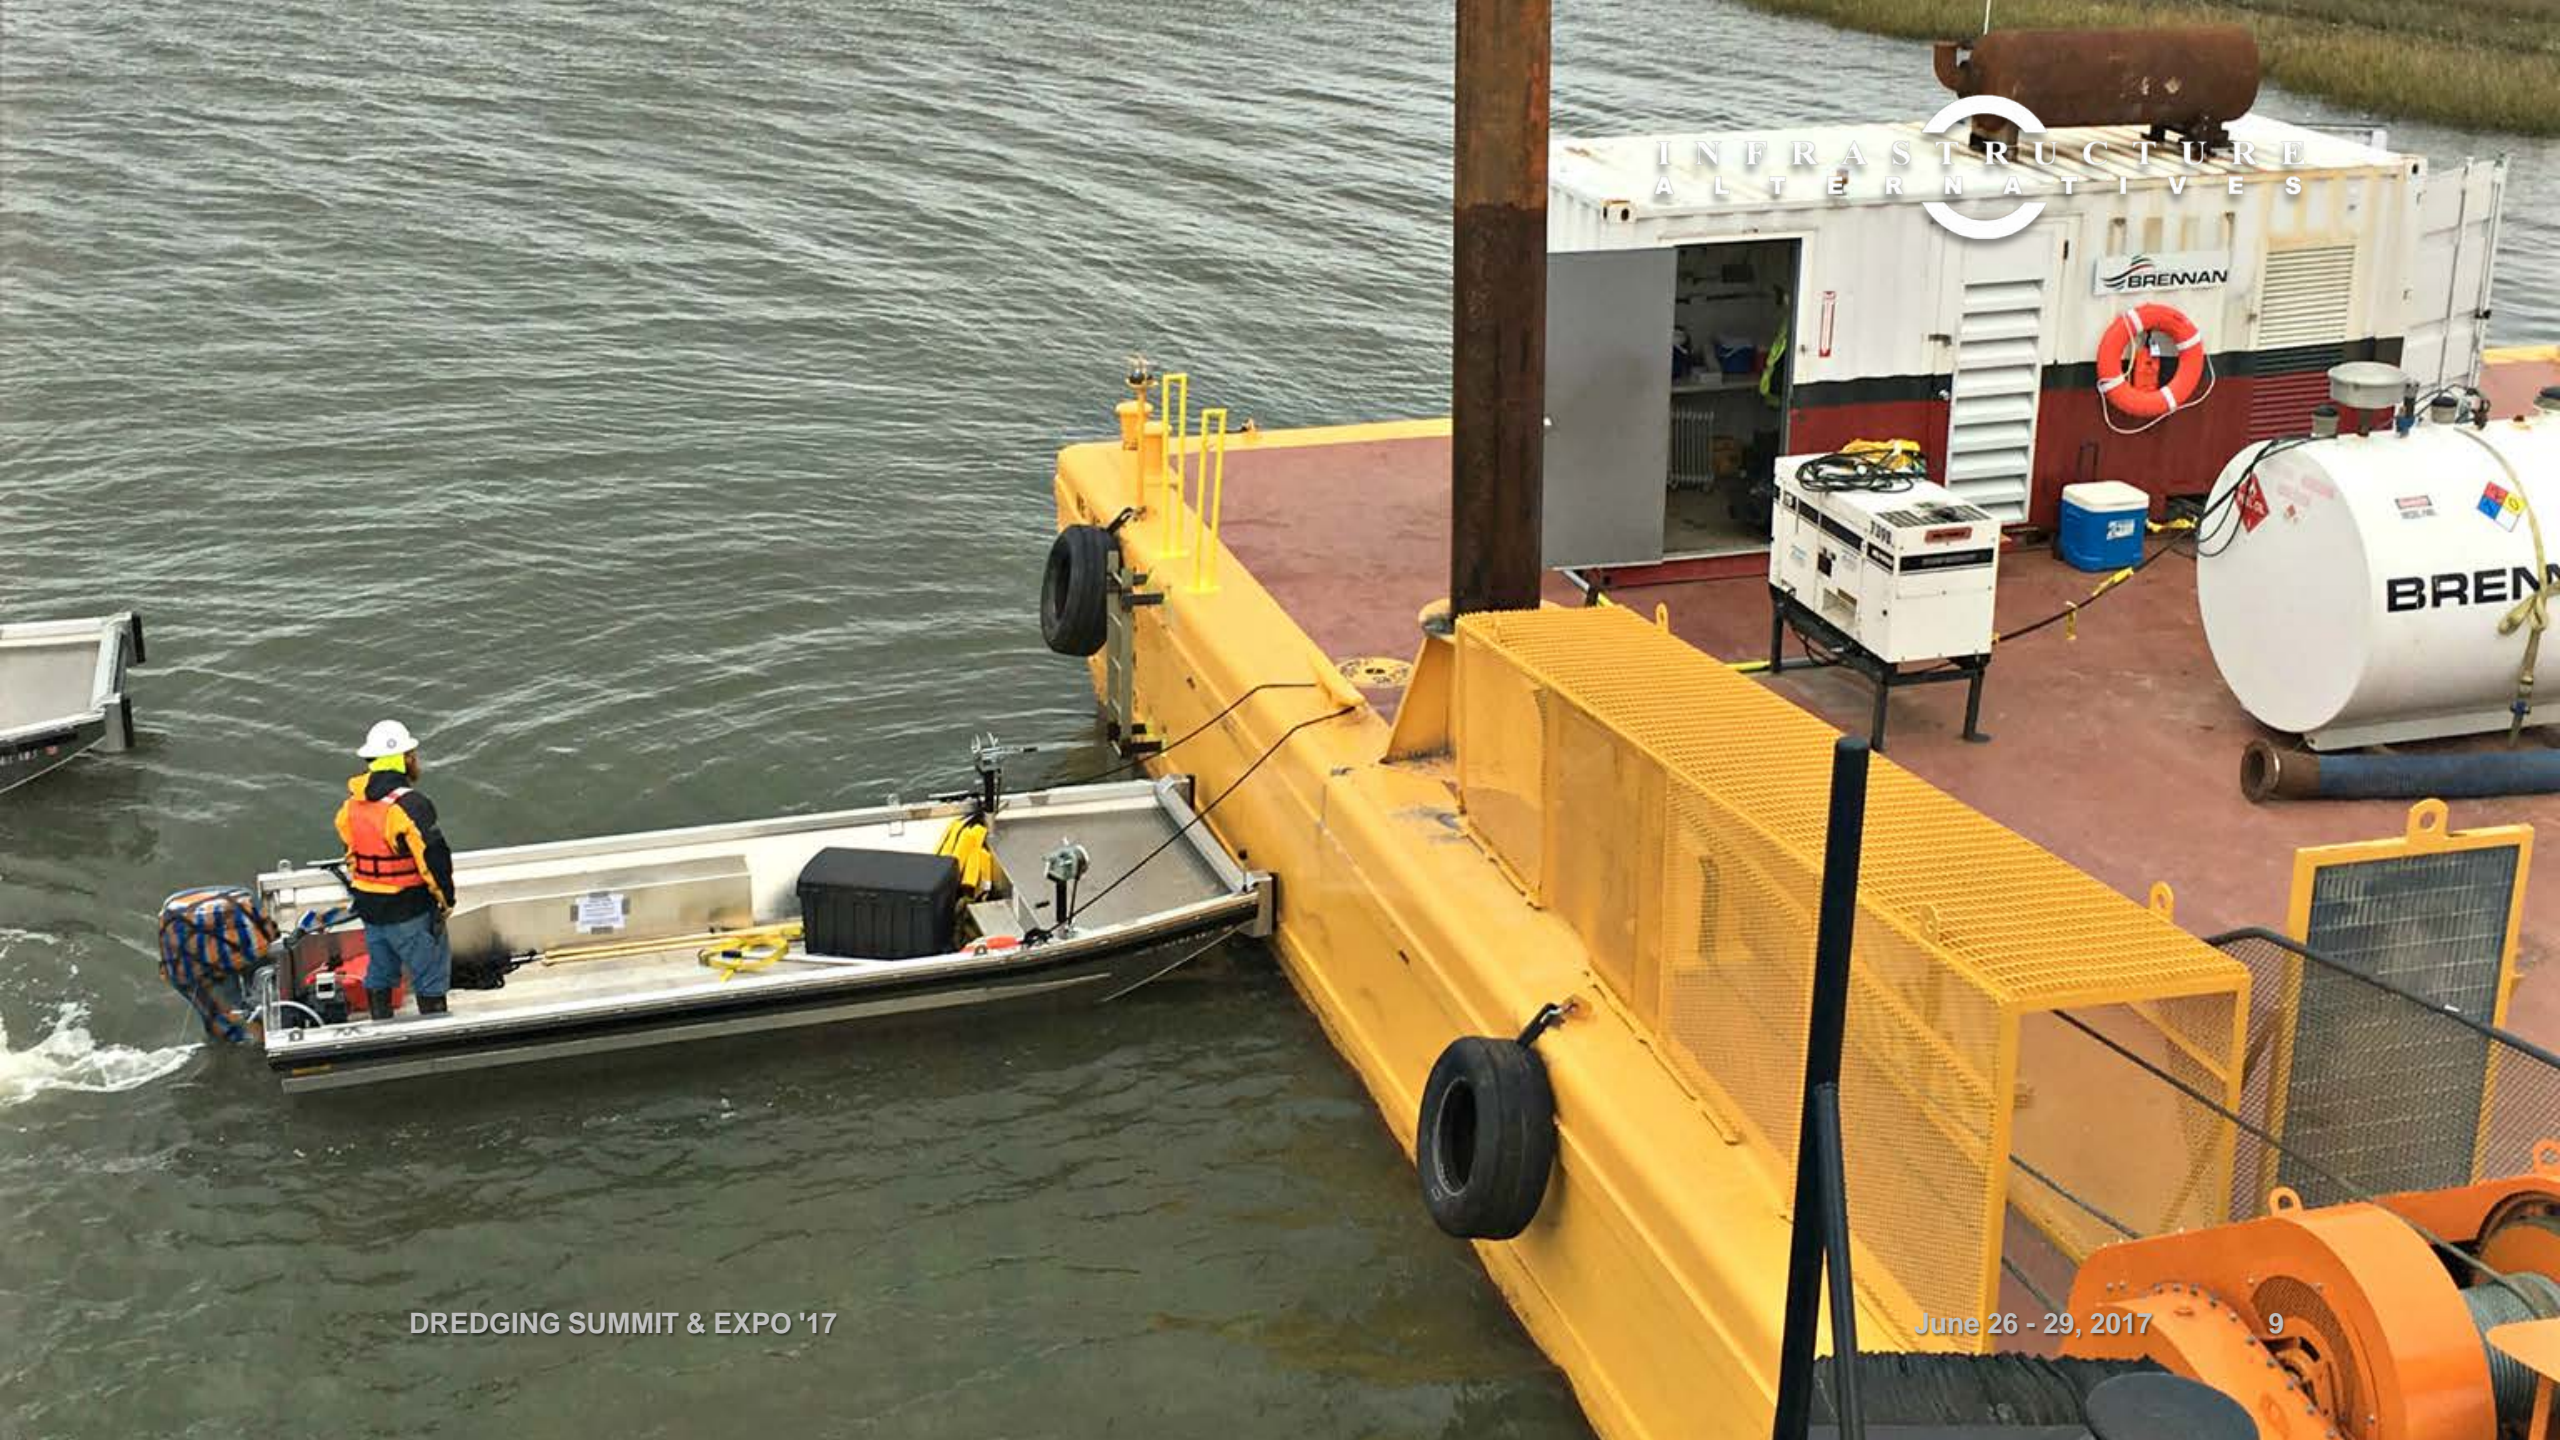
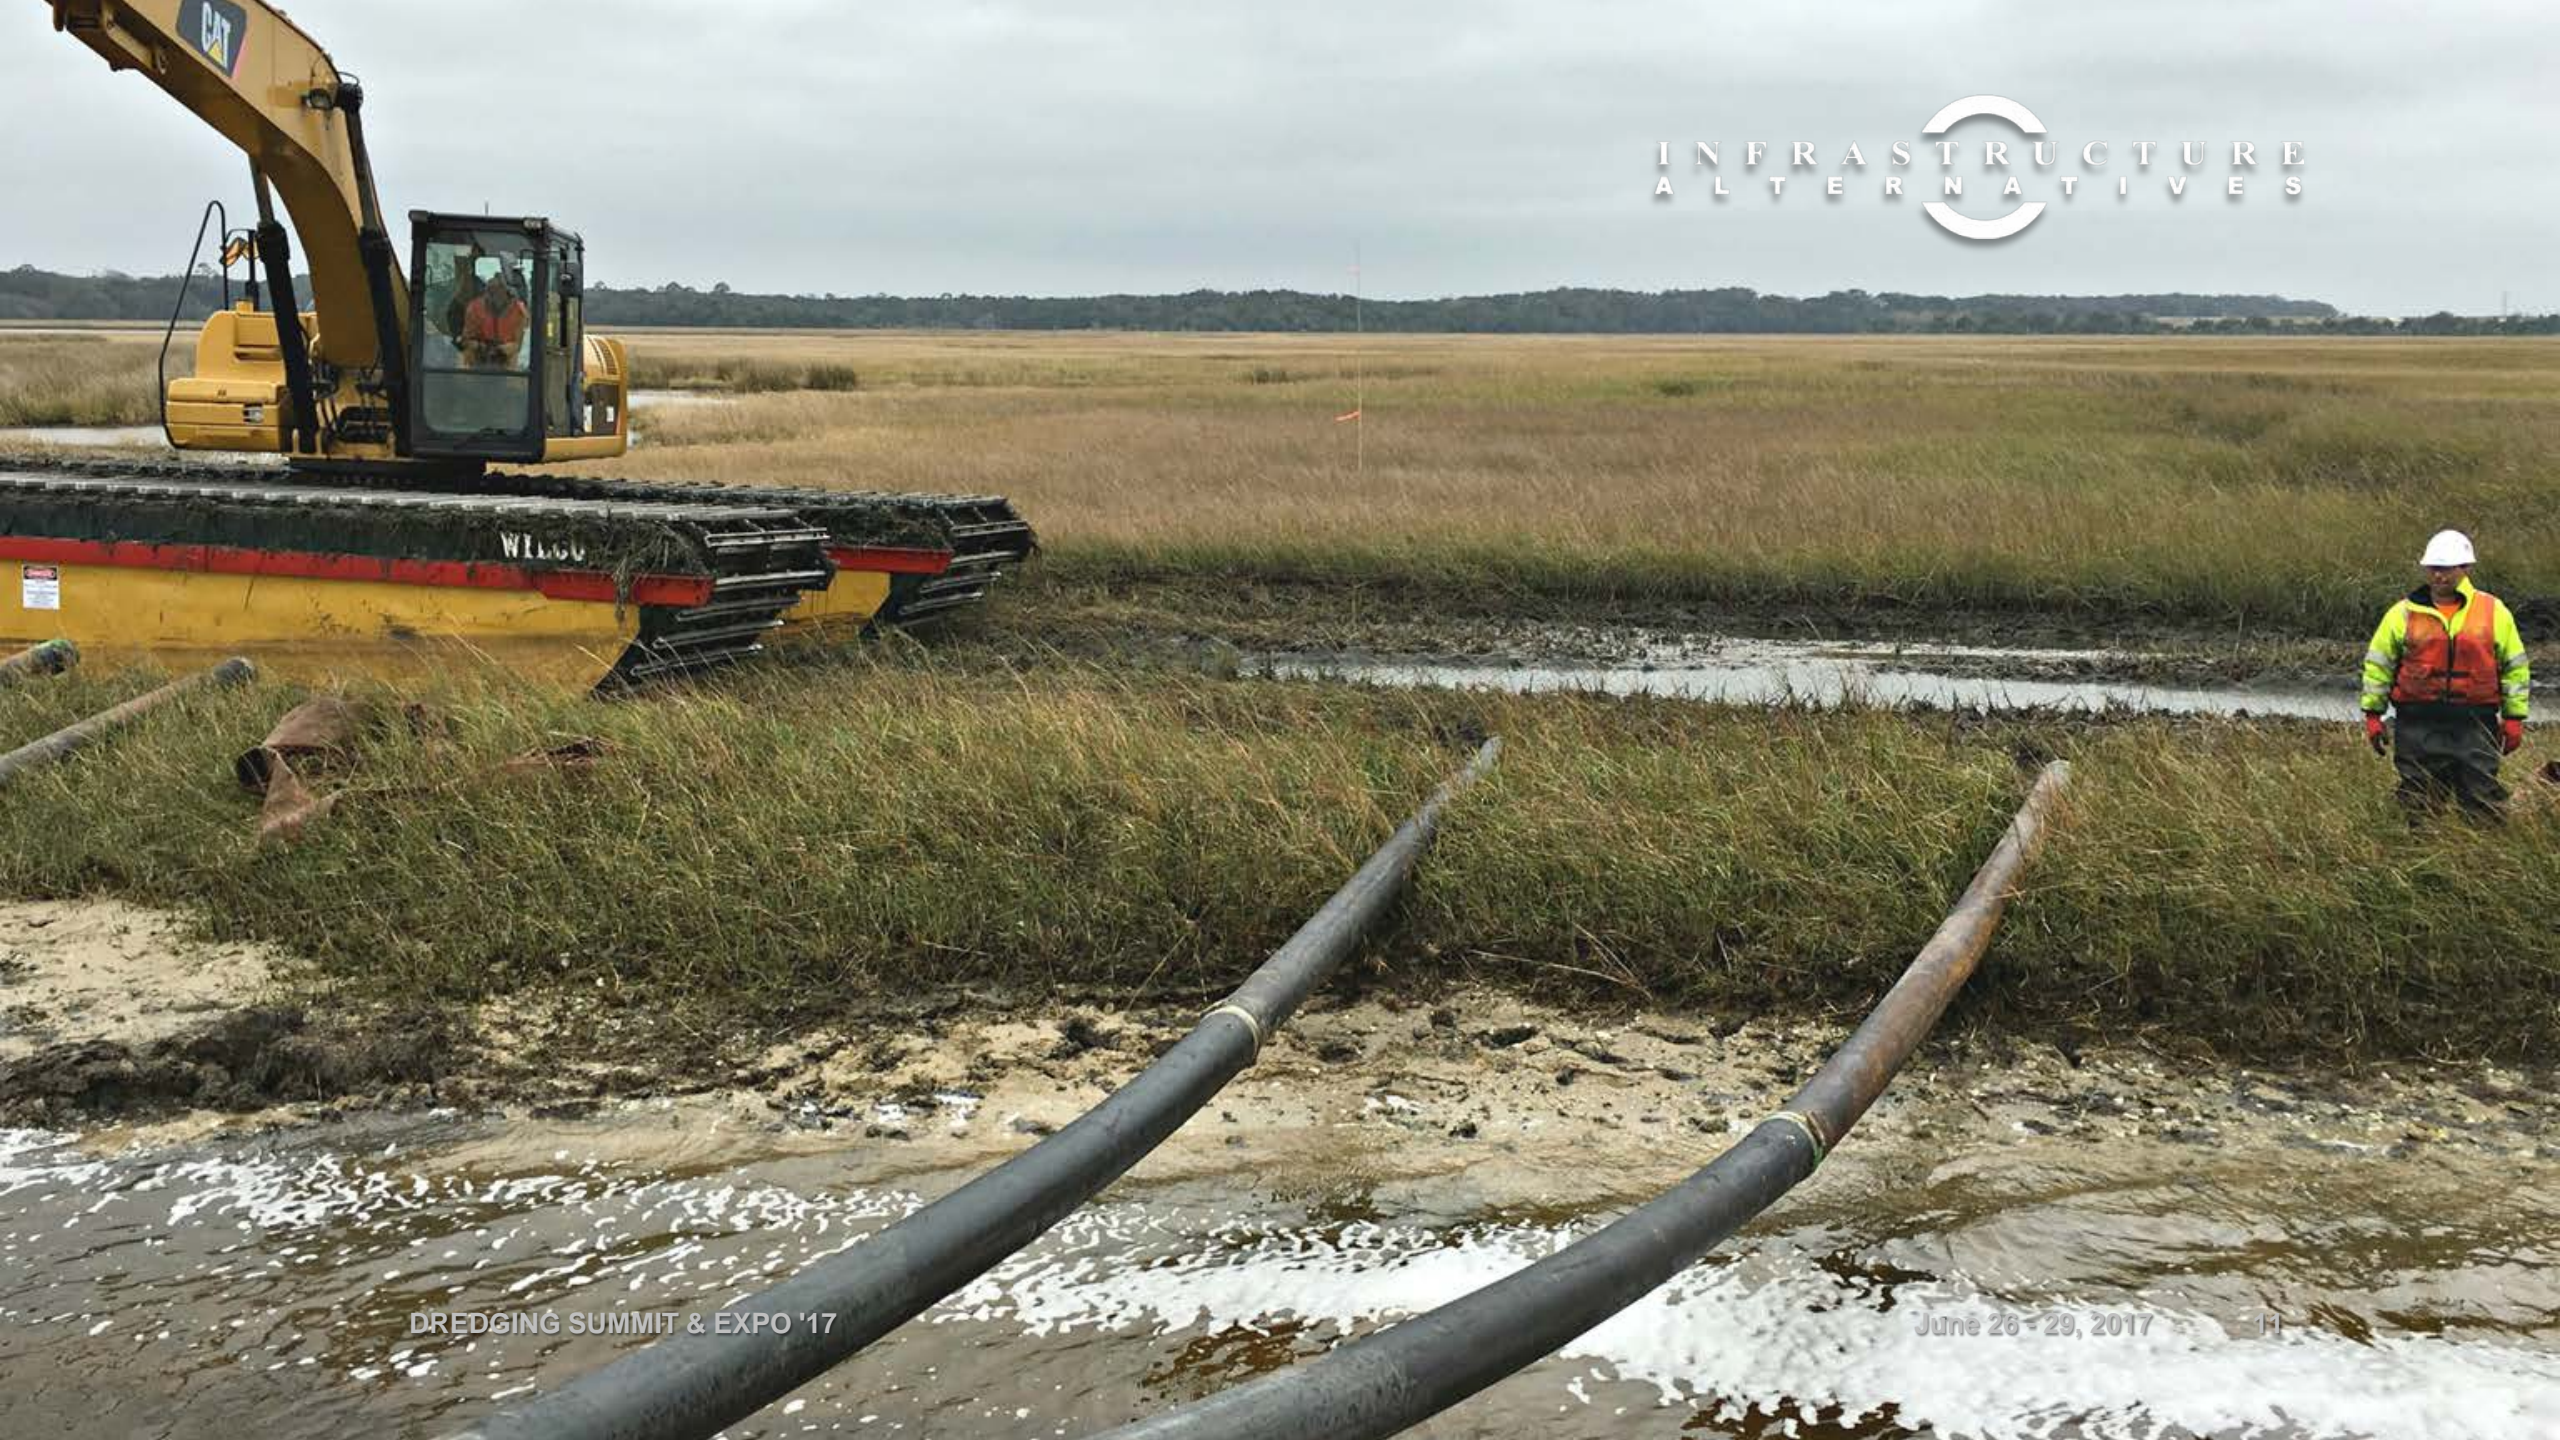
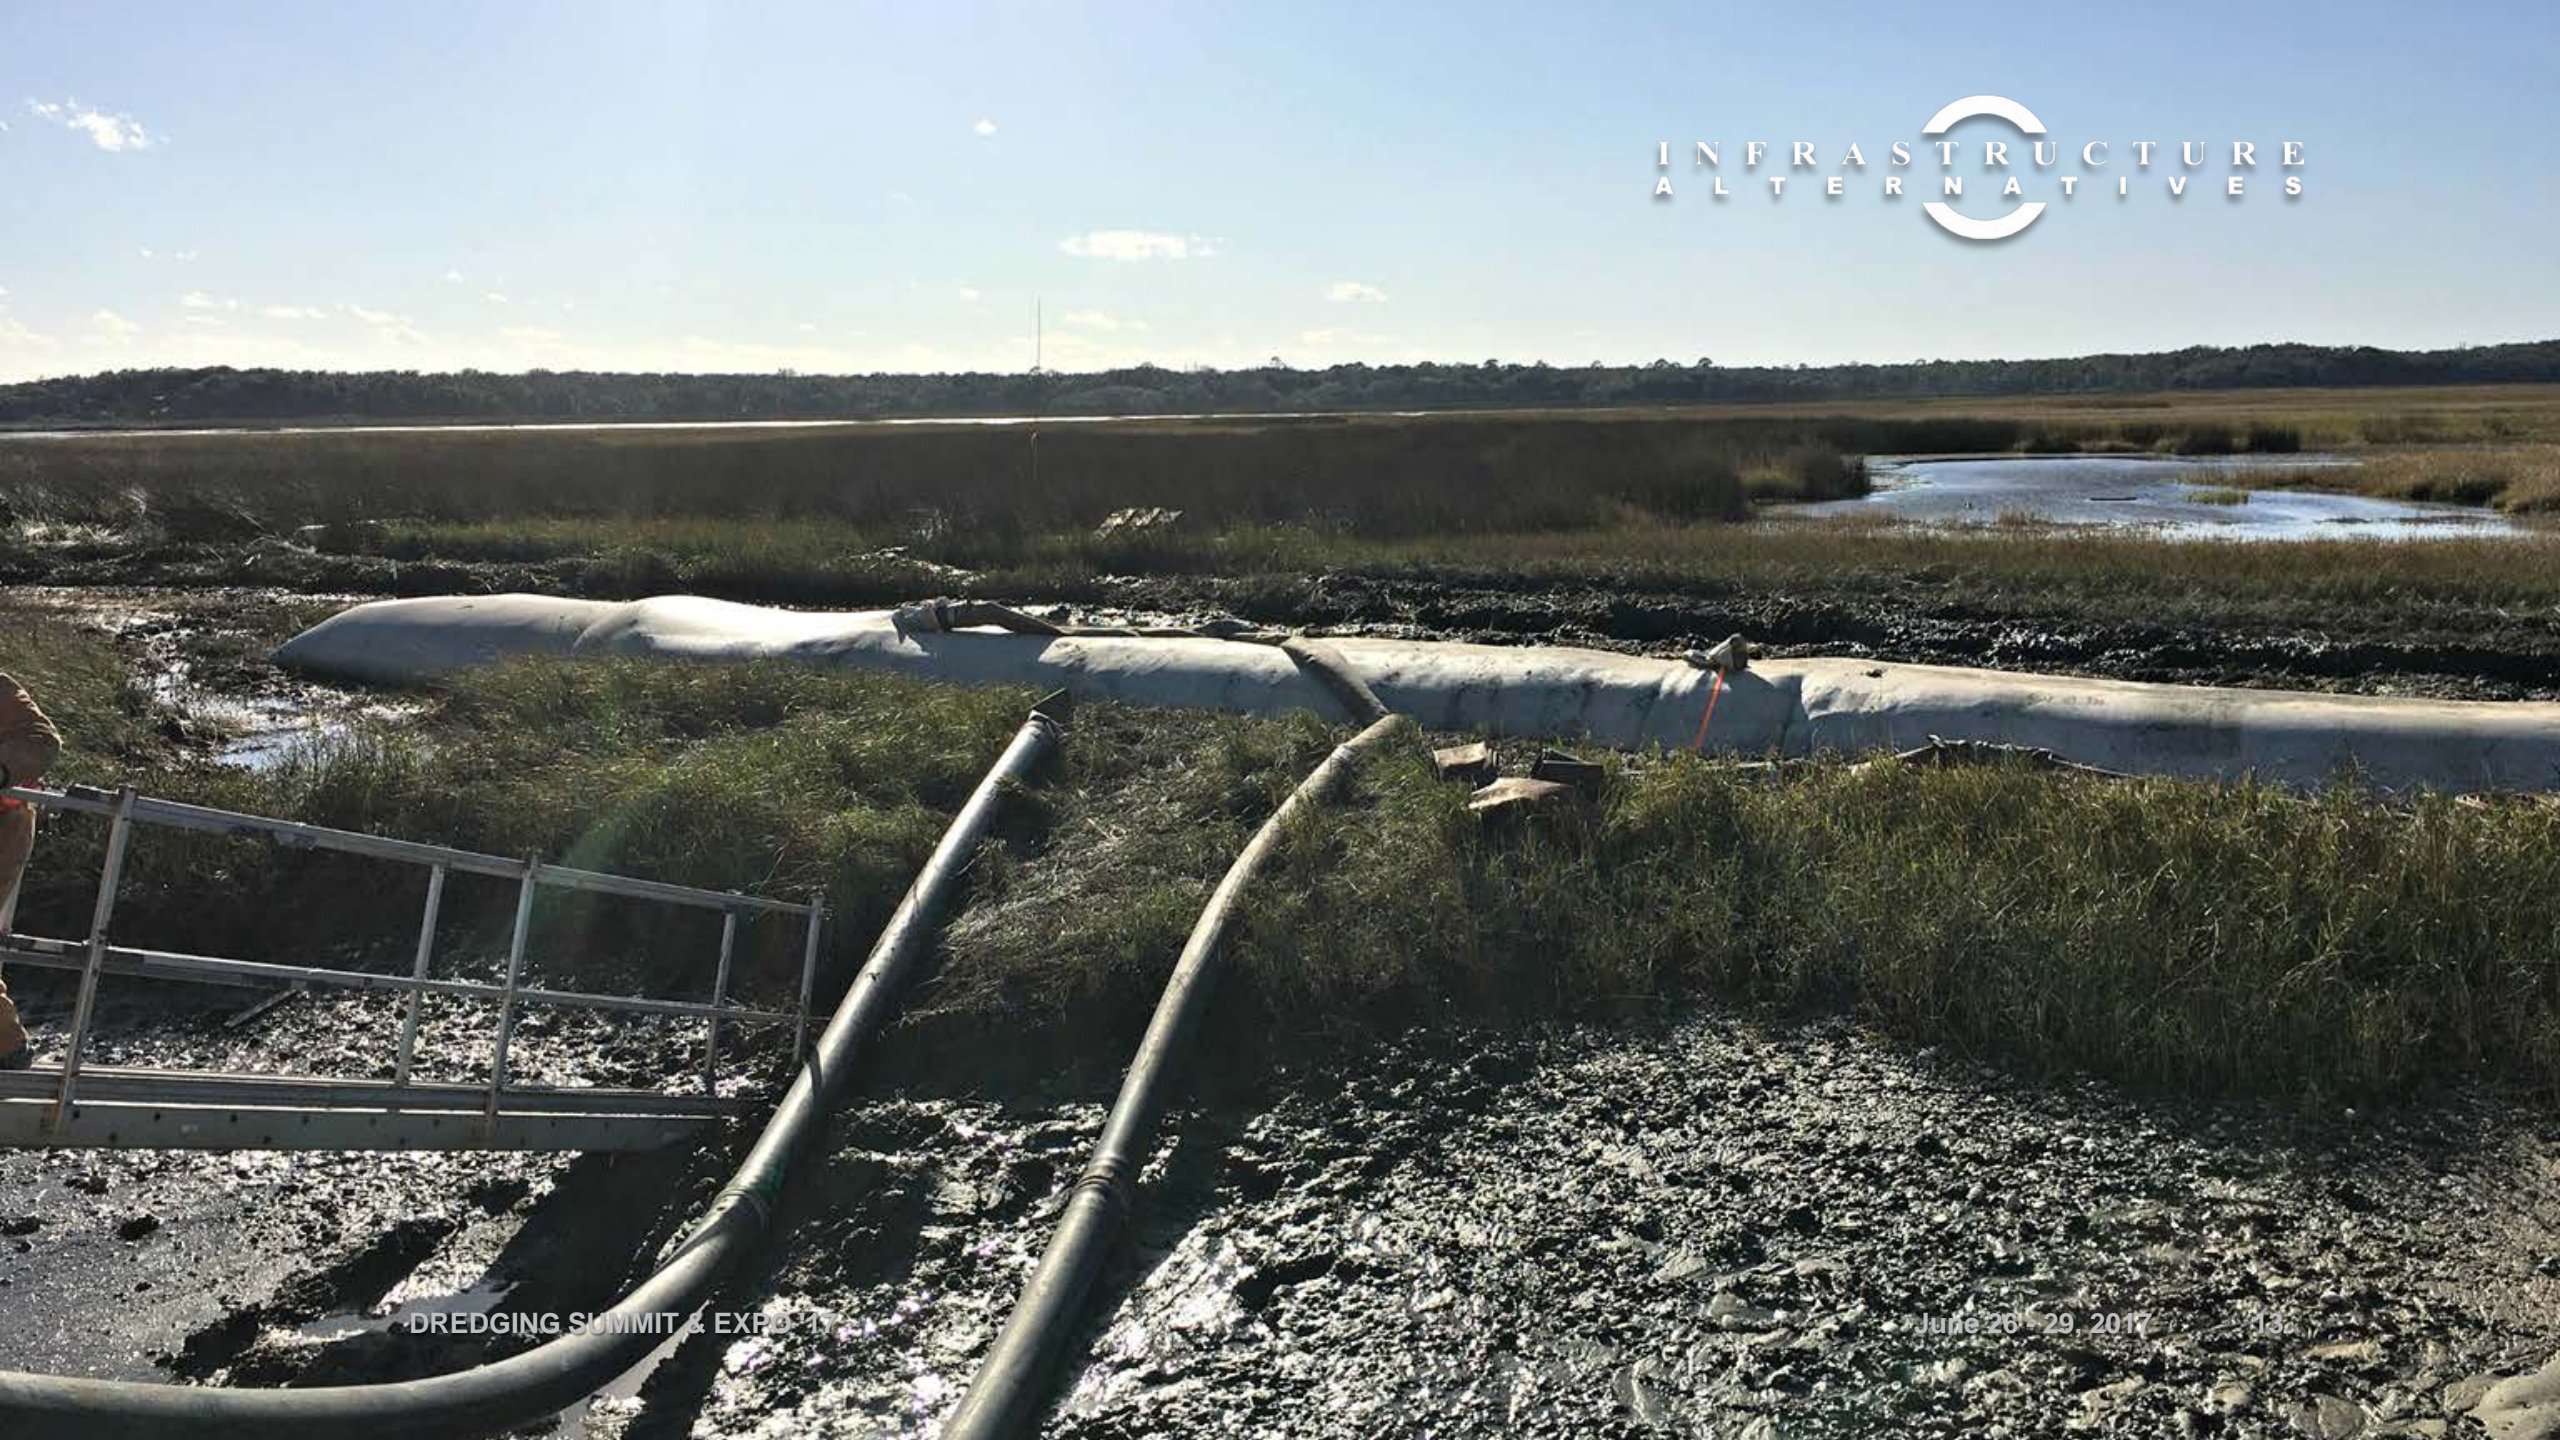
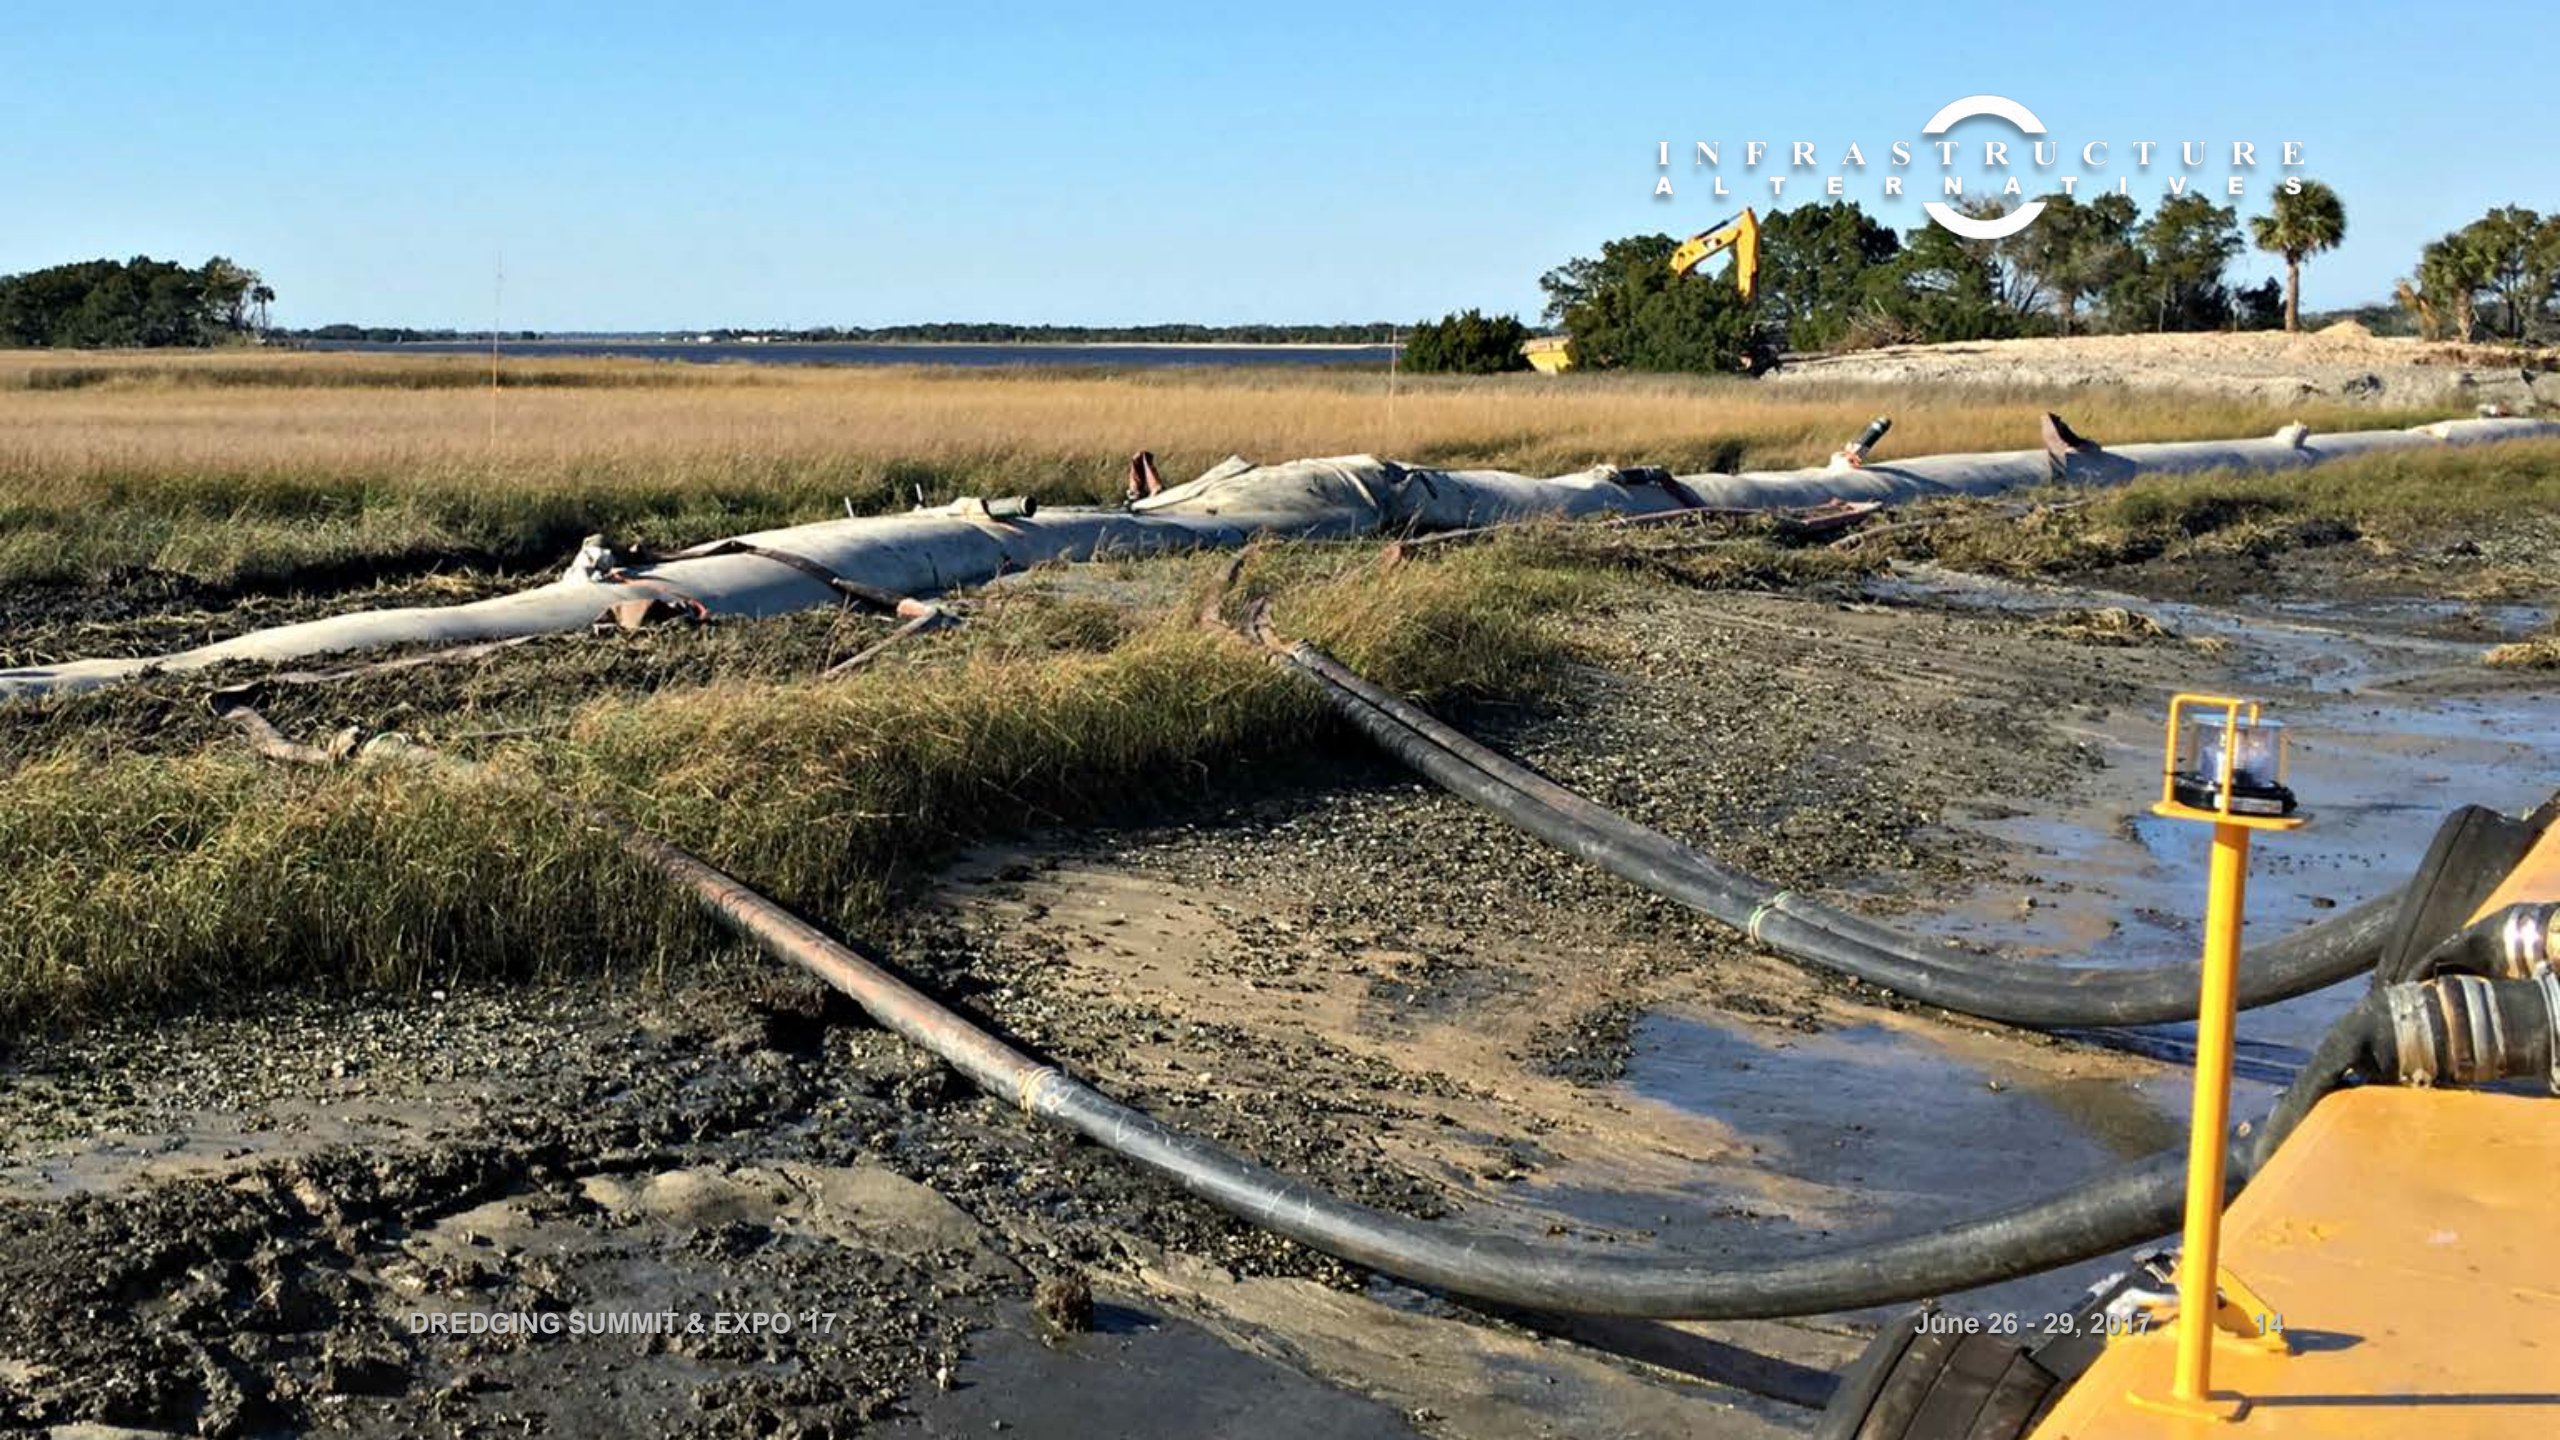
AREA 1 – STATIONS 0+00 TO 13+00

- 17-ft. circ. X 210-ft. long geotextile tubes
- Min. fill height: 5 ft. MLLW
- Deployed several from boats due to tides
- Tide swings, 5 – 7 feet
- Work could only be performed in daylight hrs.
- Placement of the header barge was critical; tides limited draft to move them
