INFRASTRUCTURE
ALTERNATIVES

MILE POINT TRAINING WALL
JACKSONVILLE, FL

Geotextile Tube Installation

MILE POINT TRAINING WALL RECONFIGURATION
JACKSONVILLE, FLORIDA
DREDGING SUMMIT & EXPO '17

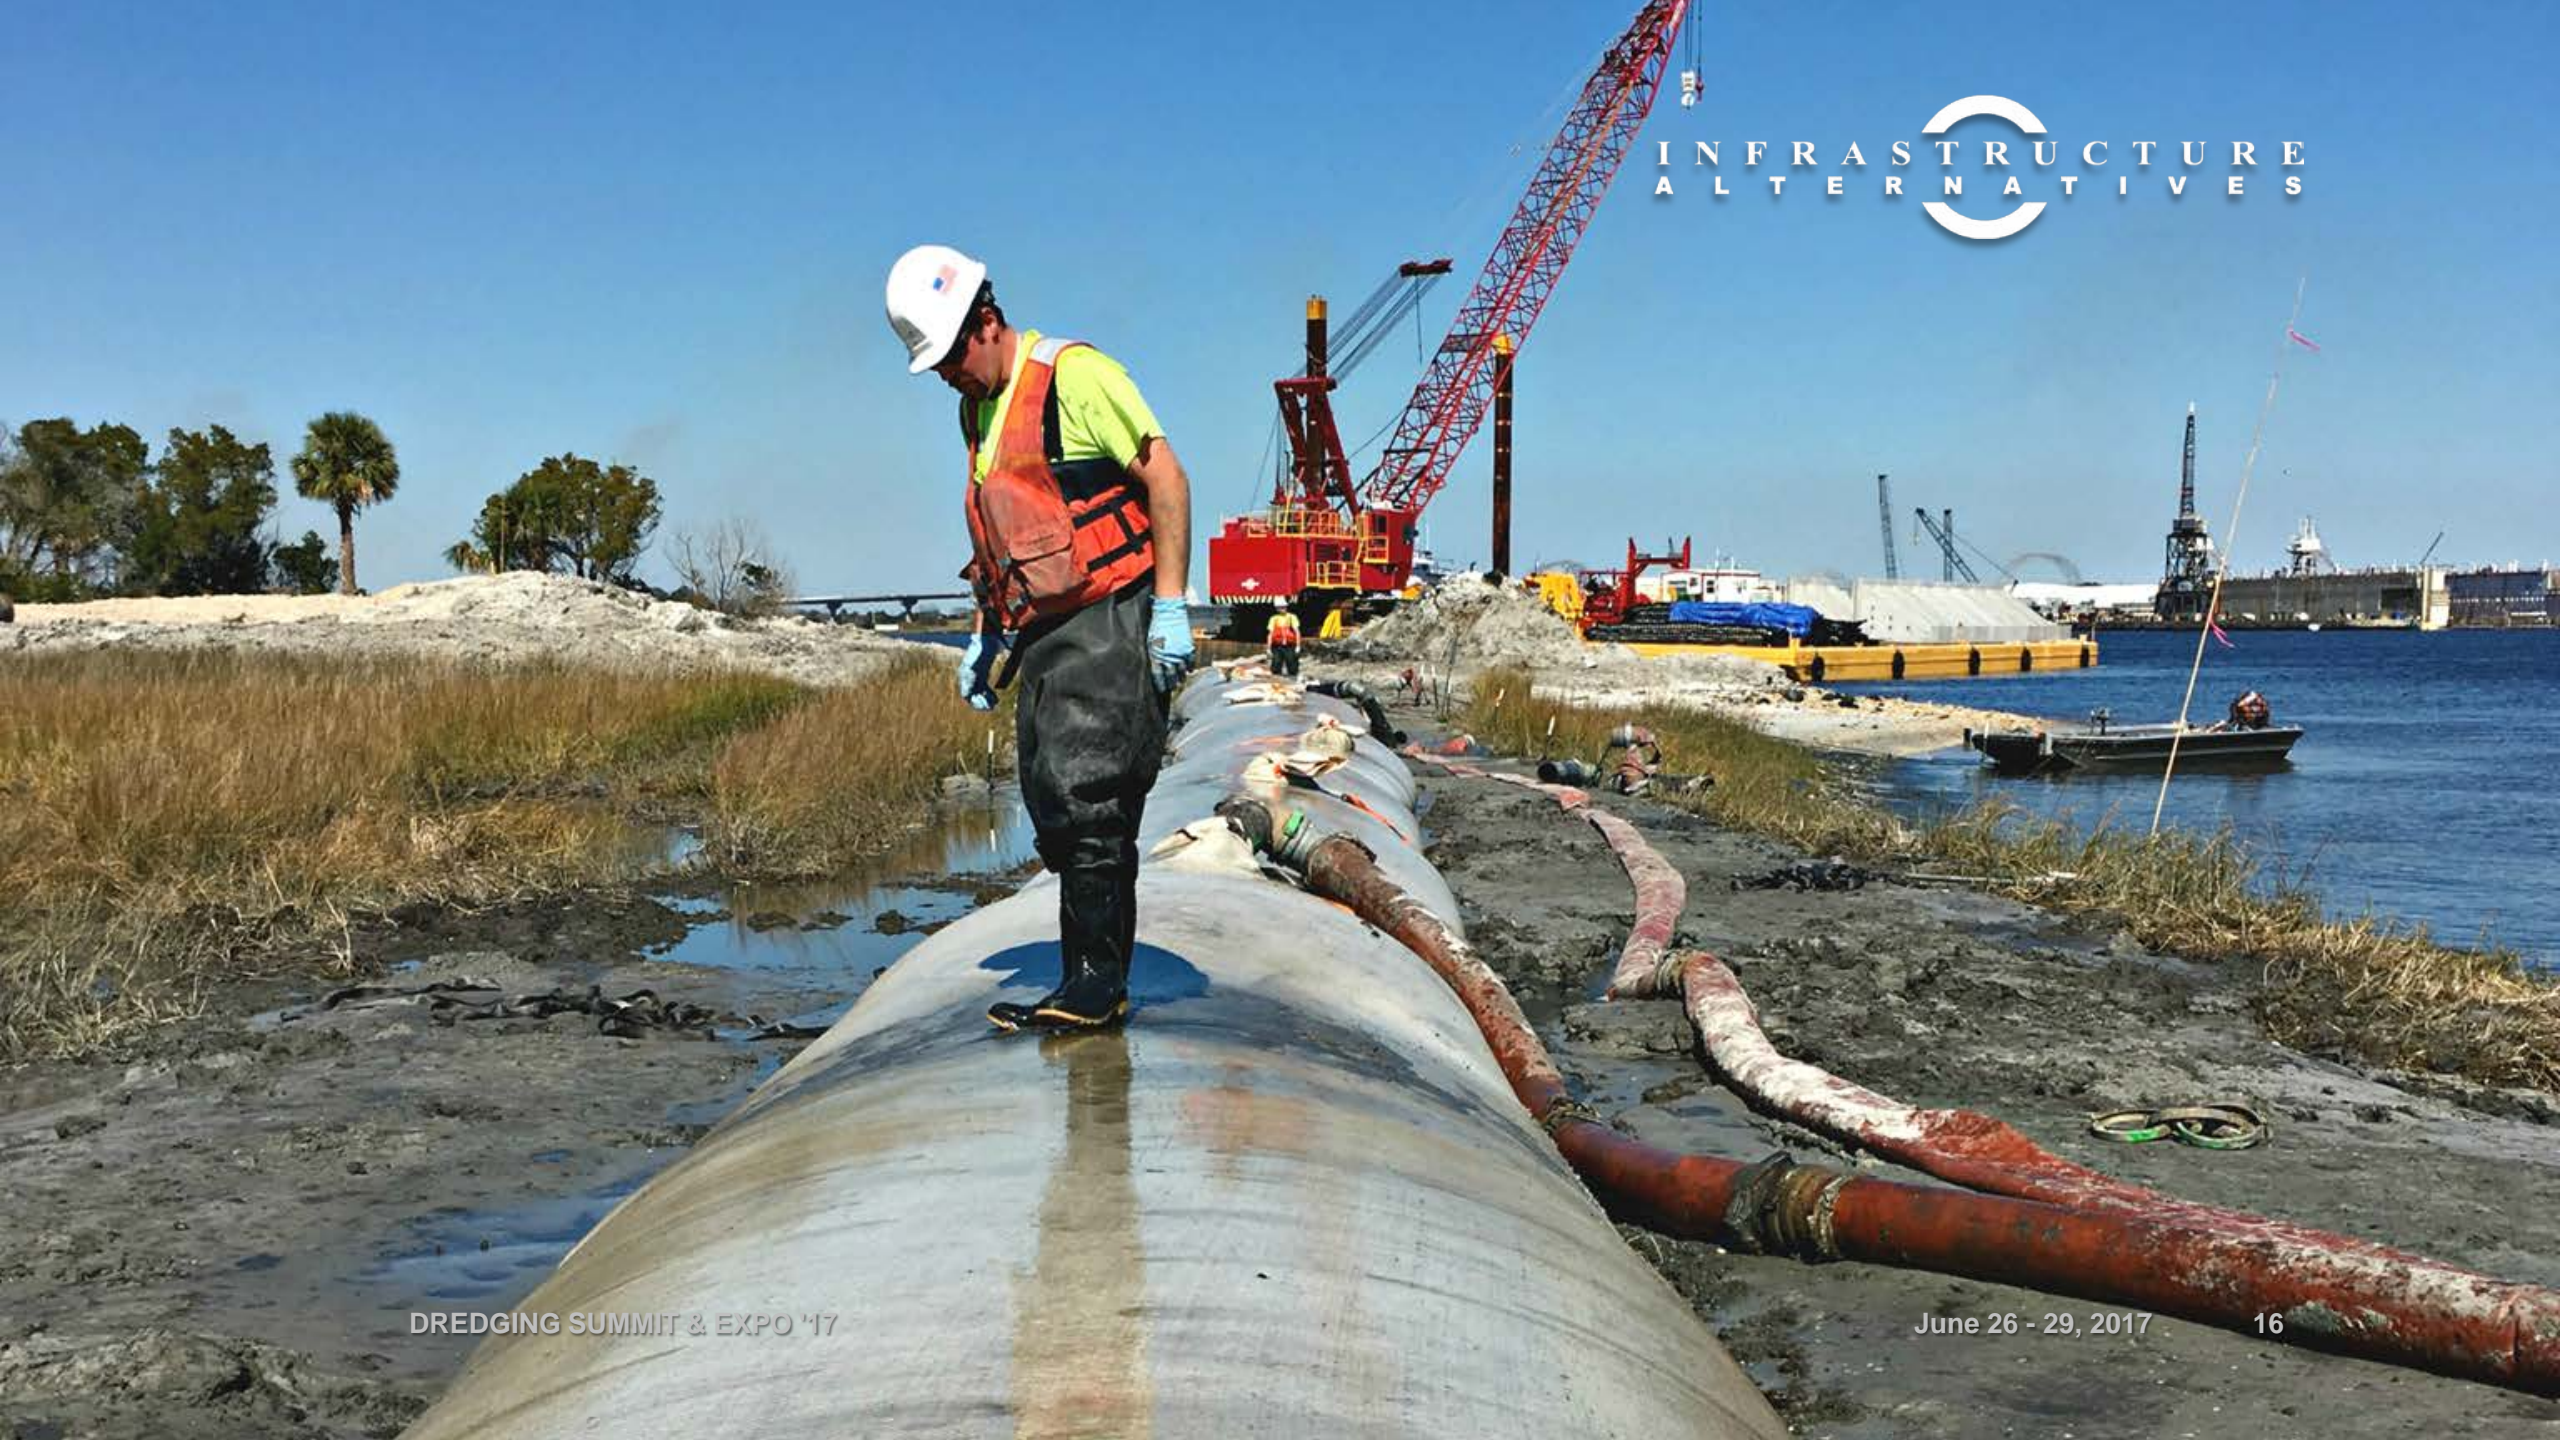
STATIONS 3+00 TO 5+00

- Challenging, unstable foundation
- First 400-ft. of tubes filled quickly and were level at 4-ft. height
- Next a.m., tubes had sunk into the foundation
- Conducted surveys
- Placed sand to stabilize foundation

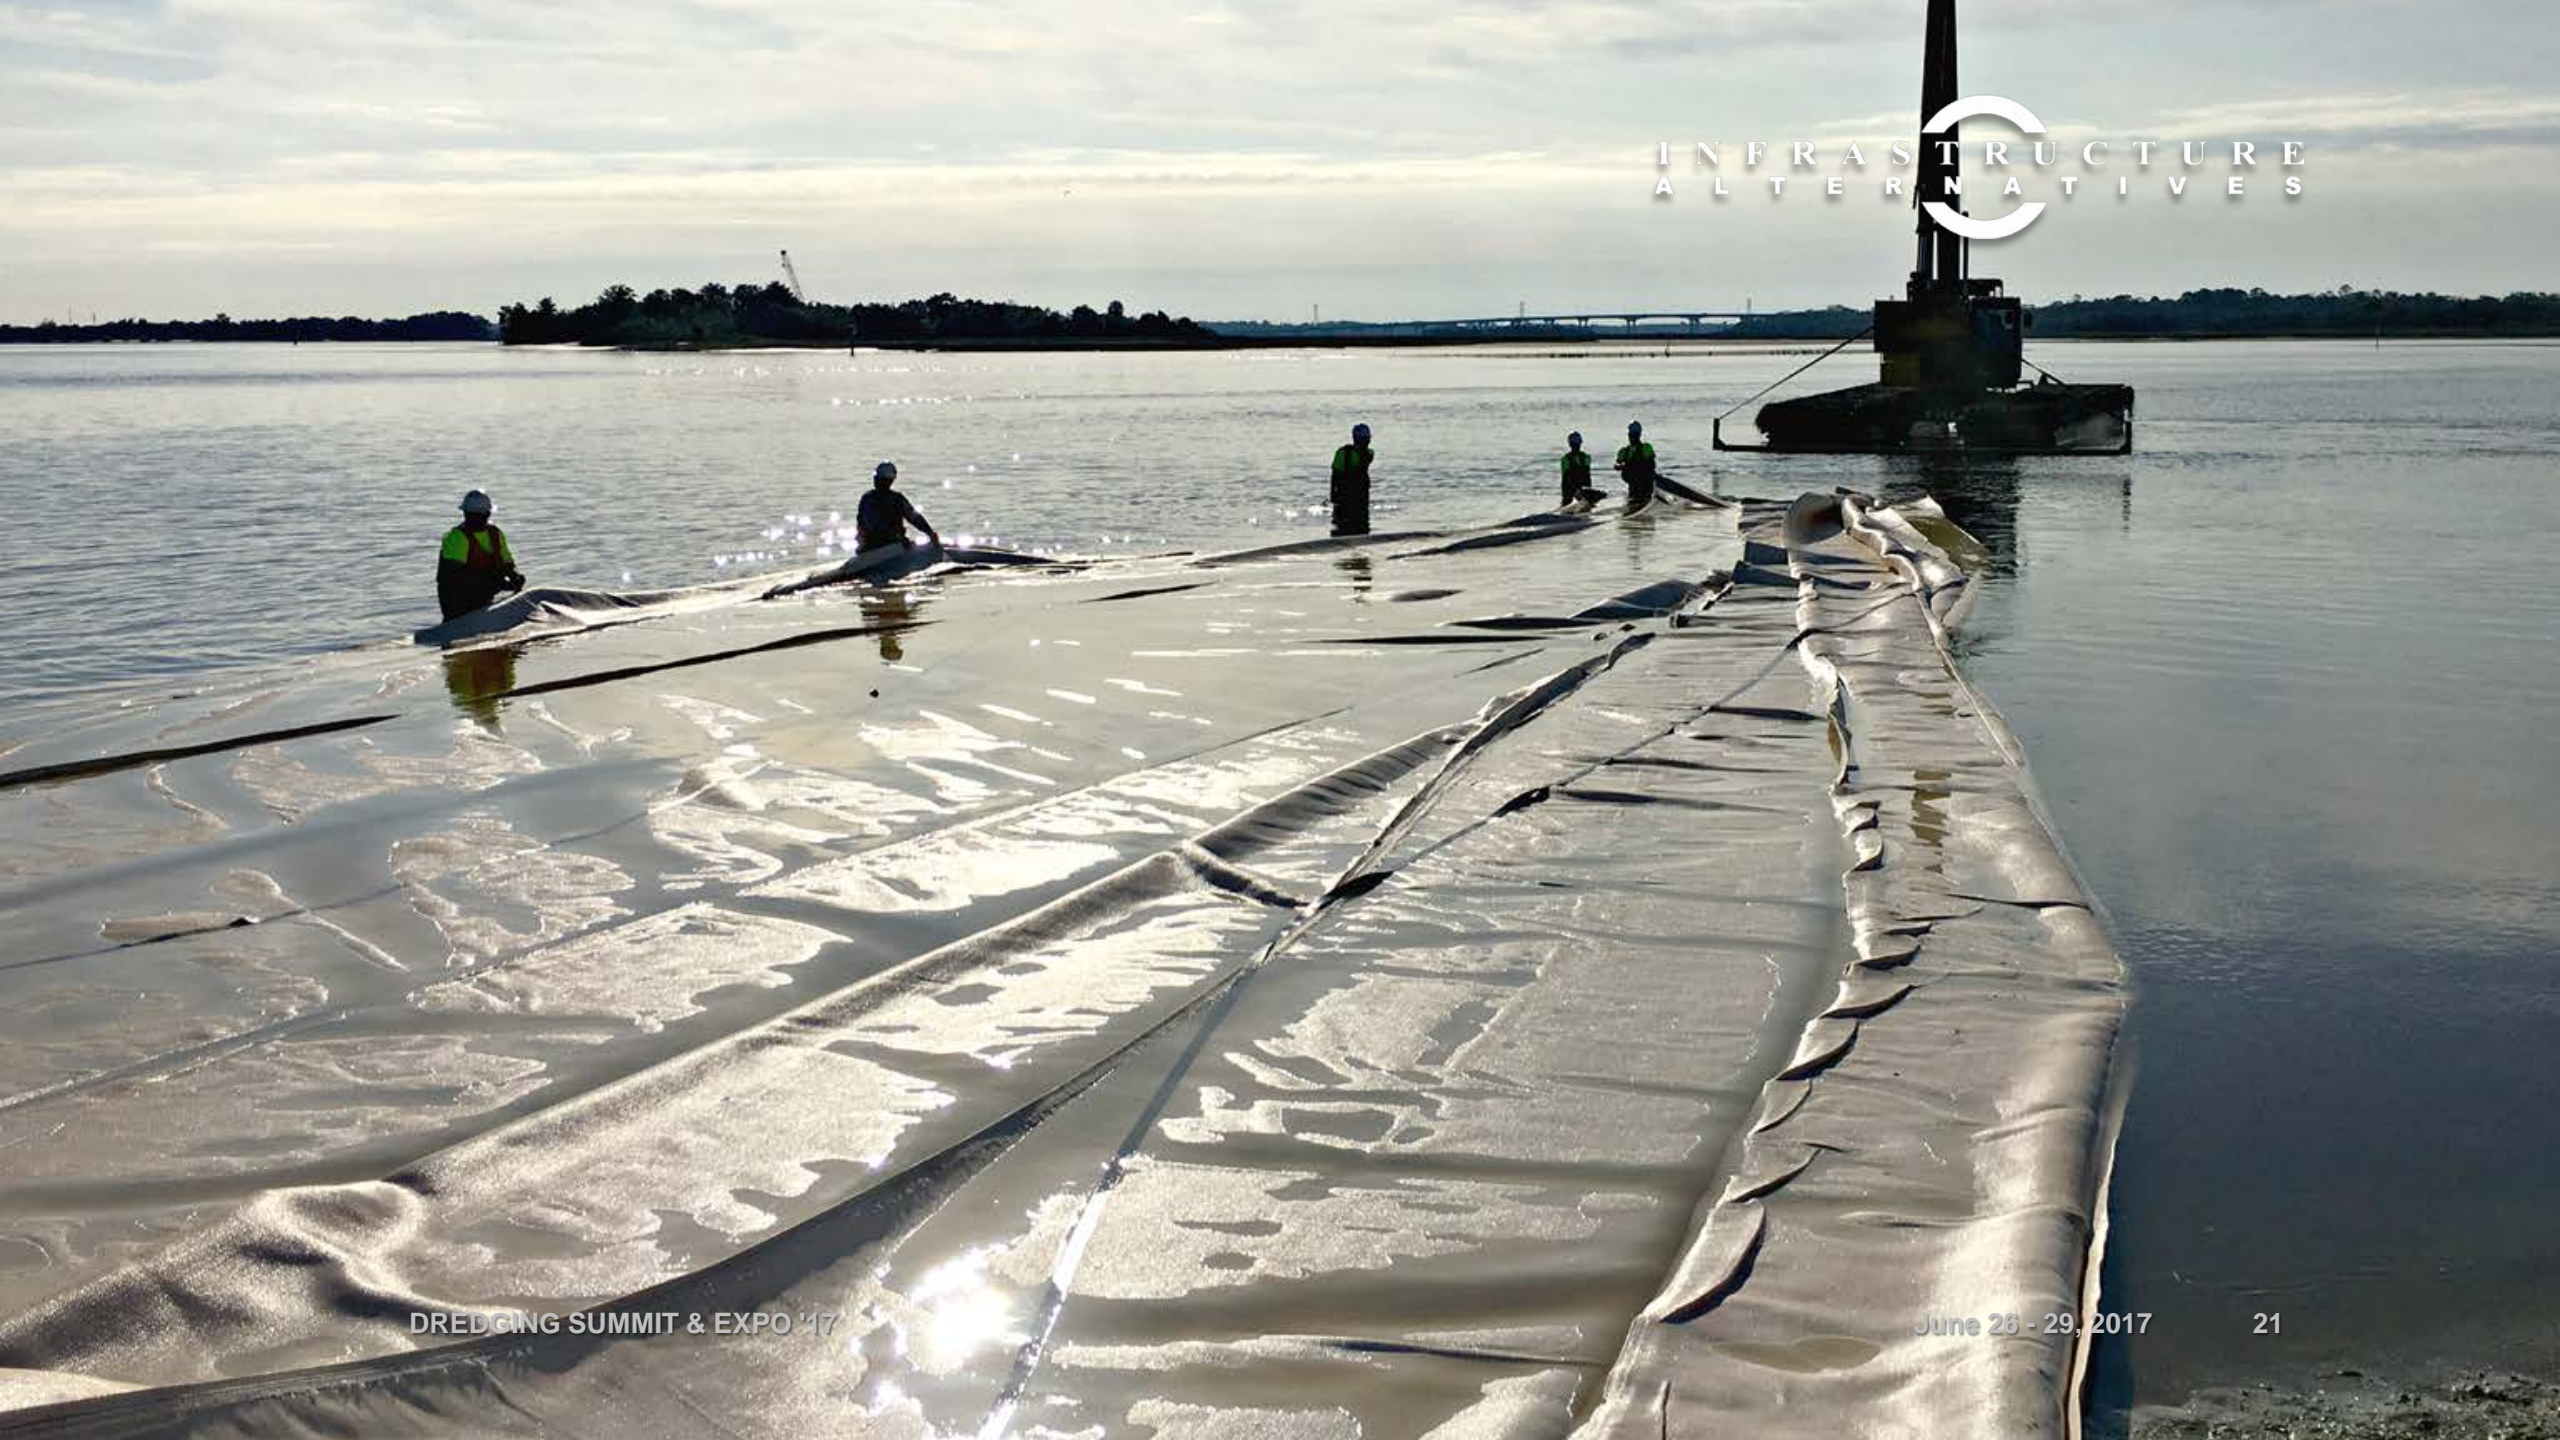
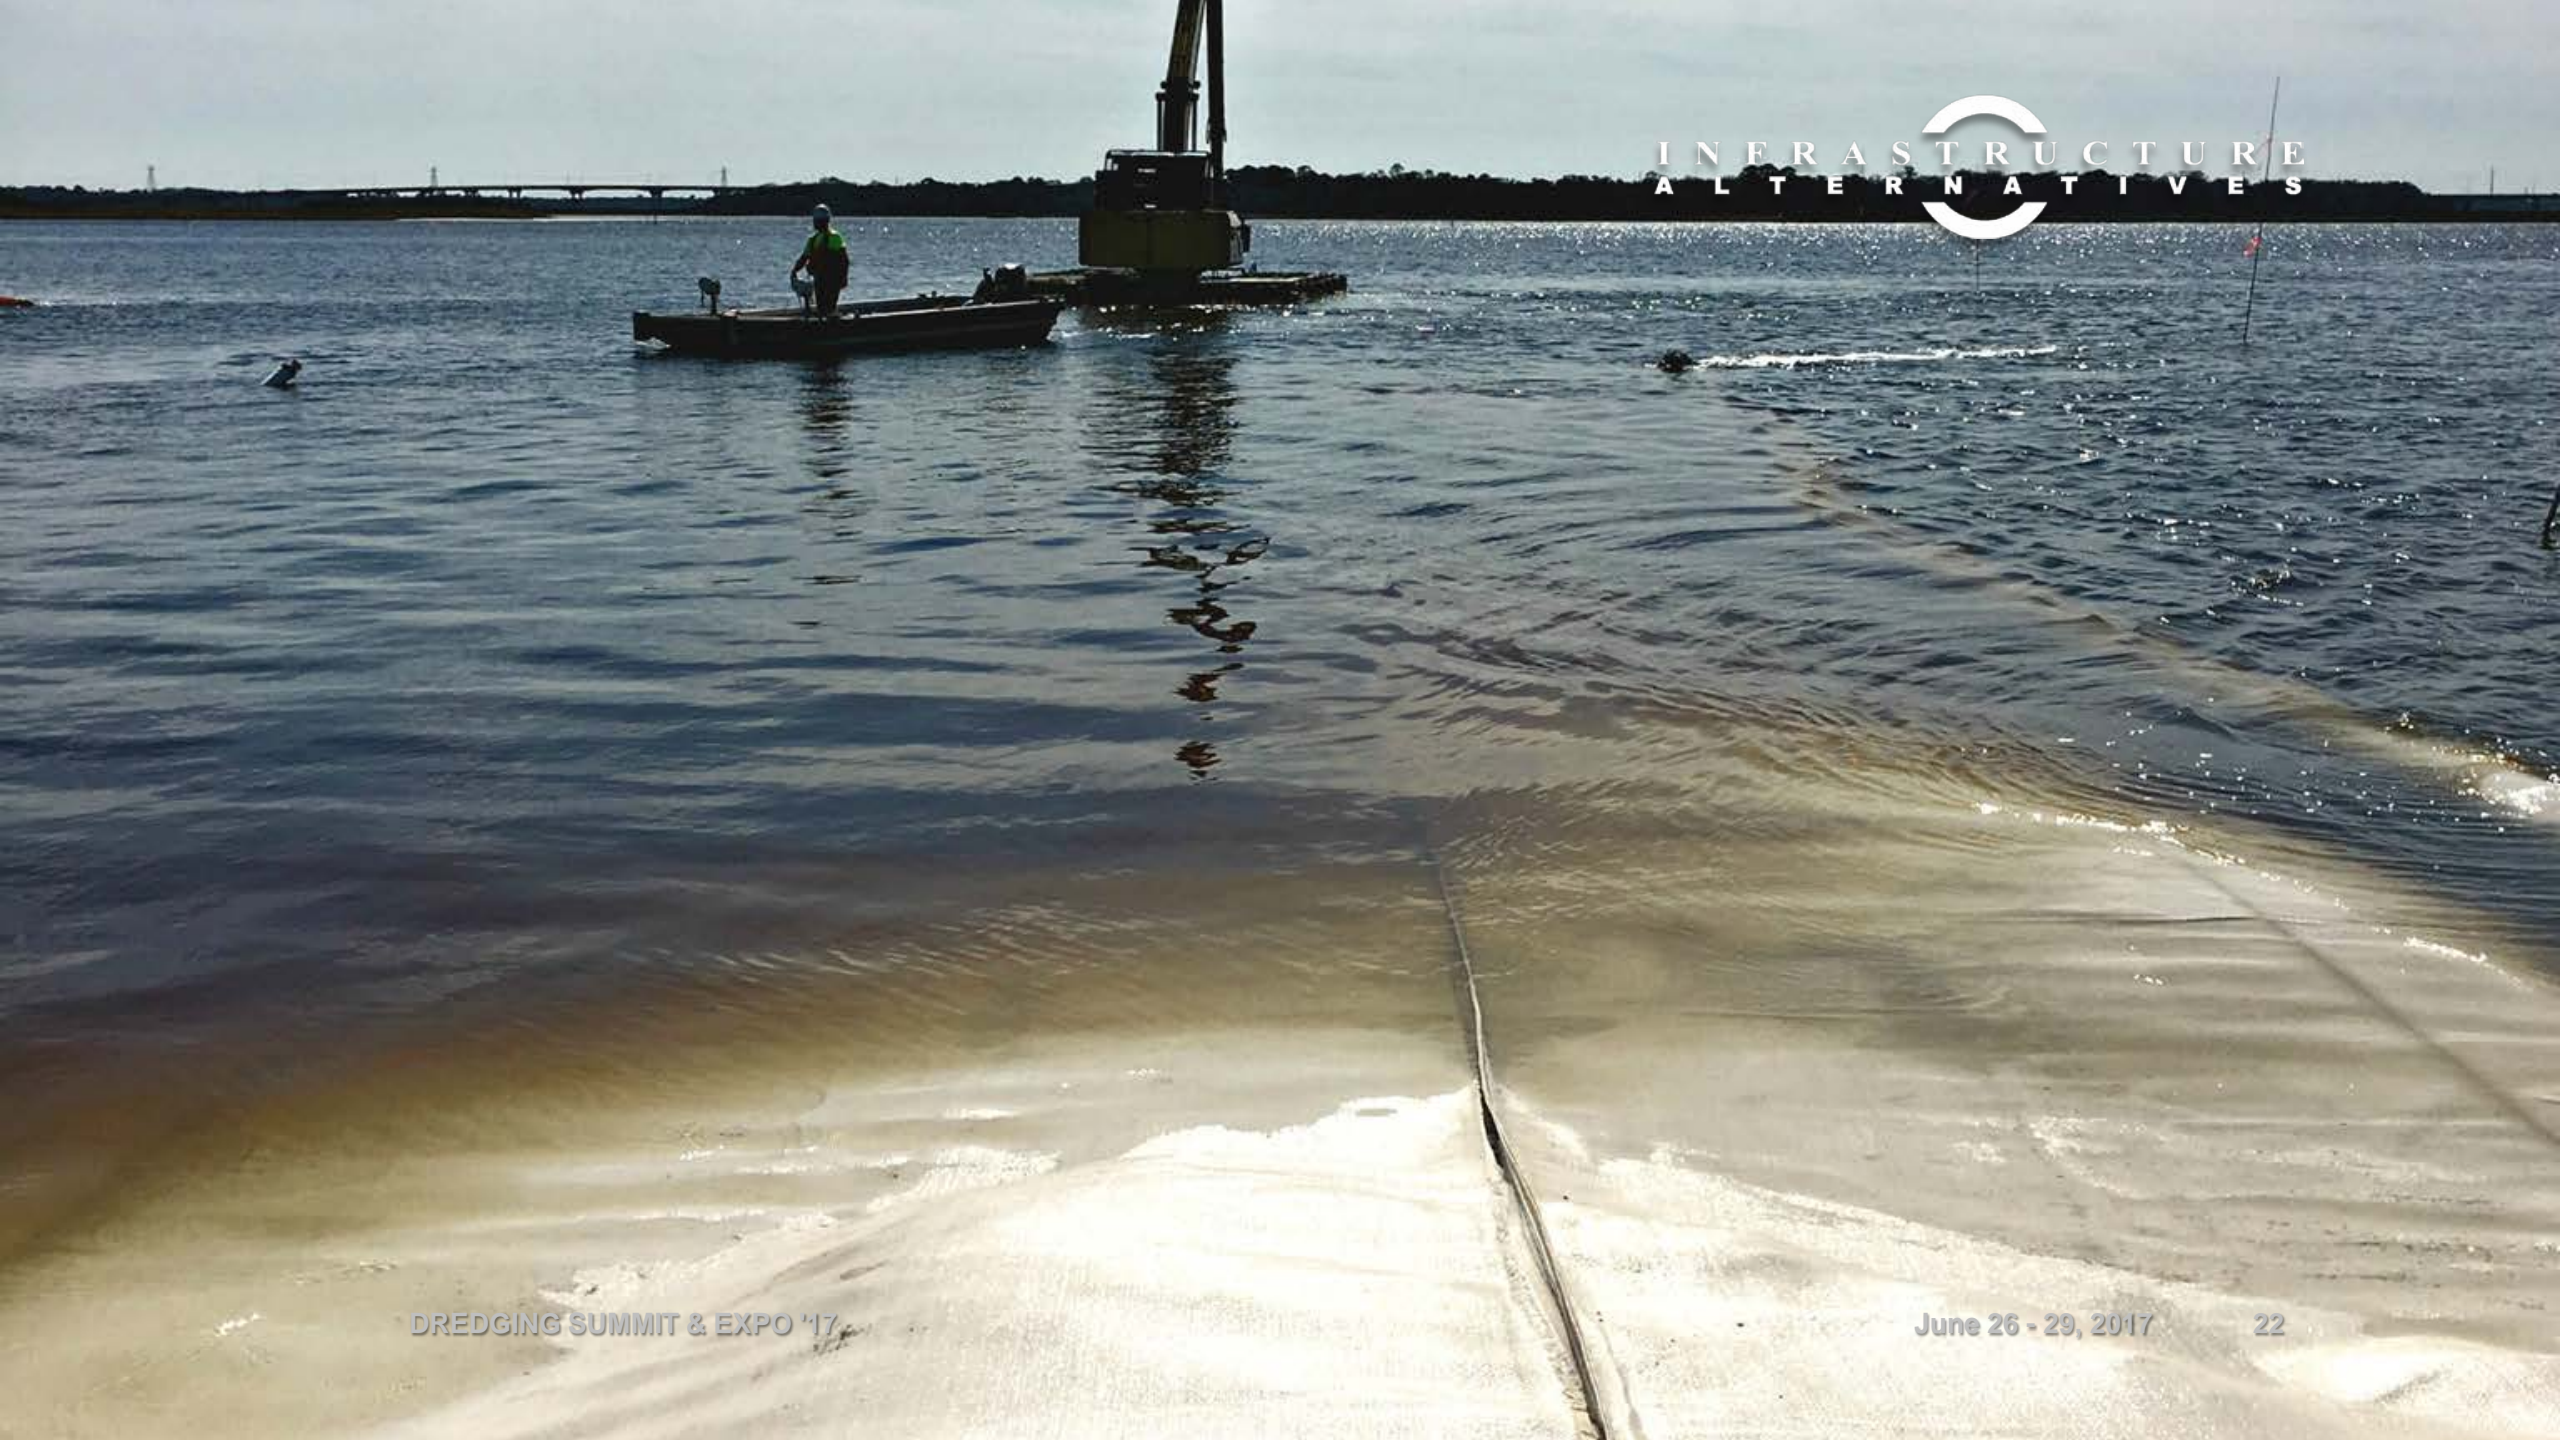
SCOUR APRONS

- 75-ft. wide by 210-ft. long
- Protect the foundation, where the tubes will be placed
- Prevent wash-out of the base beneath the geotextile tubes

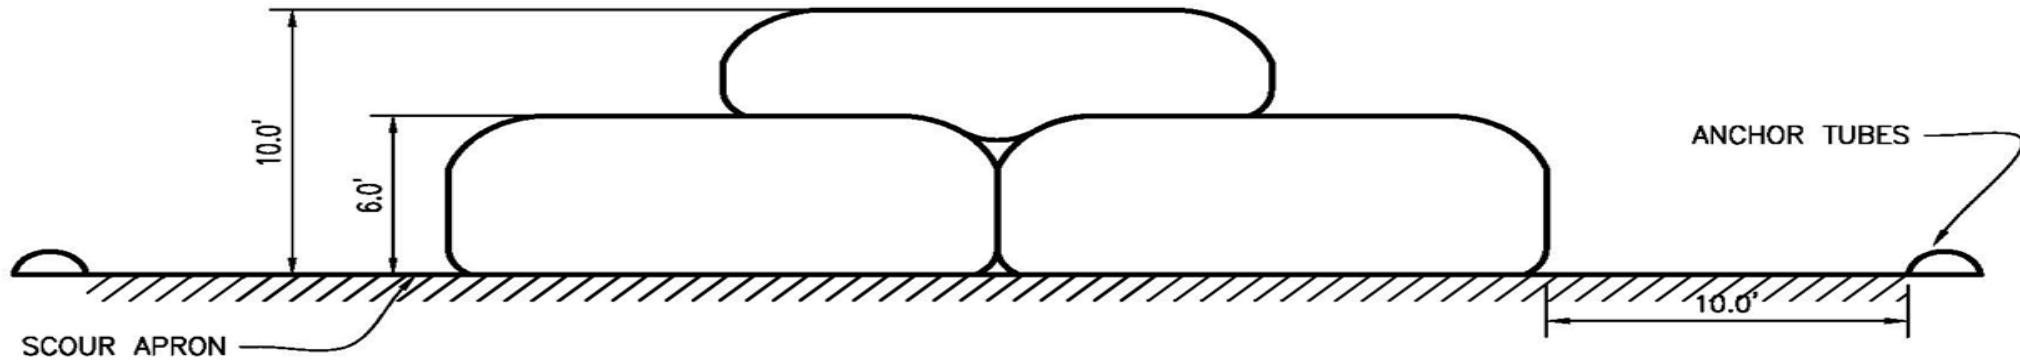
PROFILE DRAWING - AREA 3

- In some areas, we had to stack three layers of tubes to achieve the target elevation
- Tubes ranged from 34-ft. to 60-ft. in circumference depending on the depth of water to maintain the 6-ft. MLLW
- At high tide, the top level tubes are nearly under water
- In a storm event, during high tide, the entire stack of tubes is submerged

34-F.T. CIRCUMFERENCE

STACKED CROSS SECTION

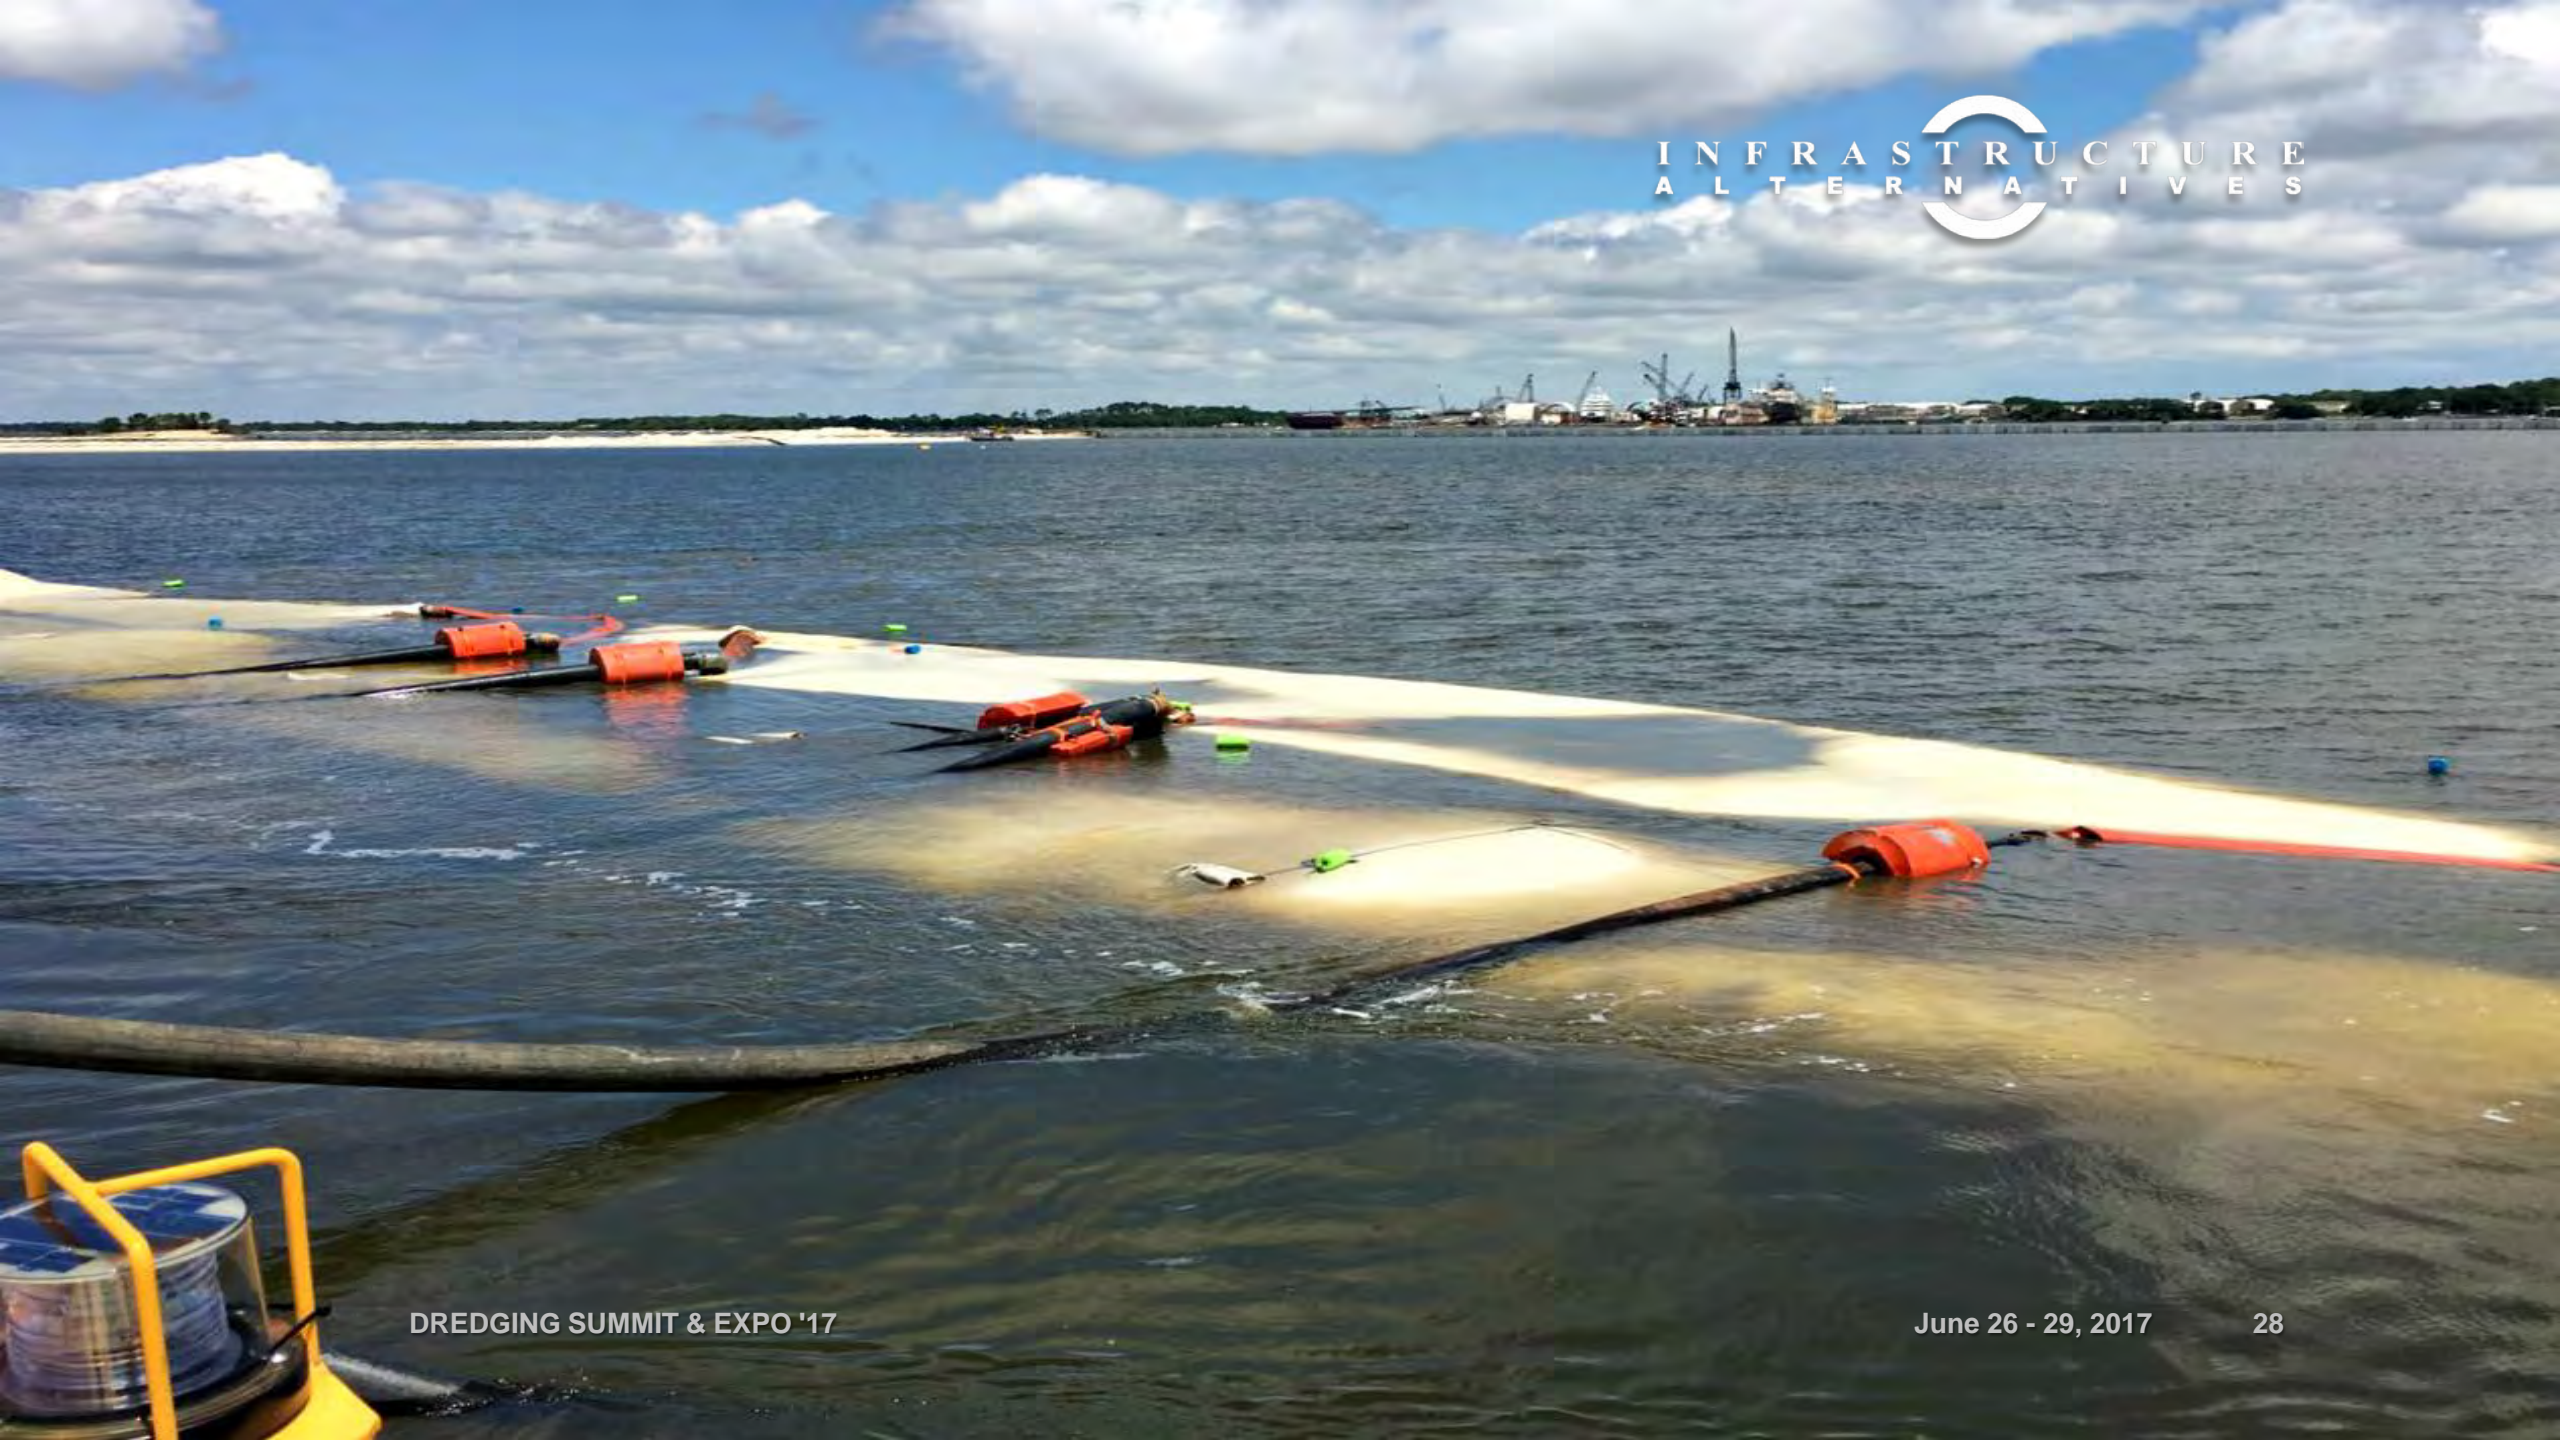
FLOATS

- Orange floats attached to header lines as the water was up to 11 feet deep in areas
- Blue and green floats attached to loops on the scour aprons or lower layer tubes to secure the upper layer tubes in place
