INFRASTRUCTURE
ALTERNATIVES

MILE POINT TRAINING WALL
JACKSONVILLE, FL

Geotextile Tube Installation

MILE POINT TRAINING WALL RECONFIGURATION
JACKSONVILLE, FLORIDA
DREDGING SUMMIT & EXPO '17

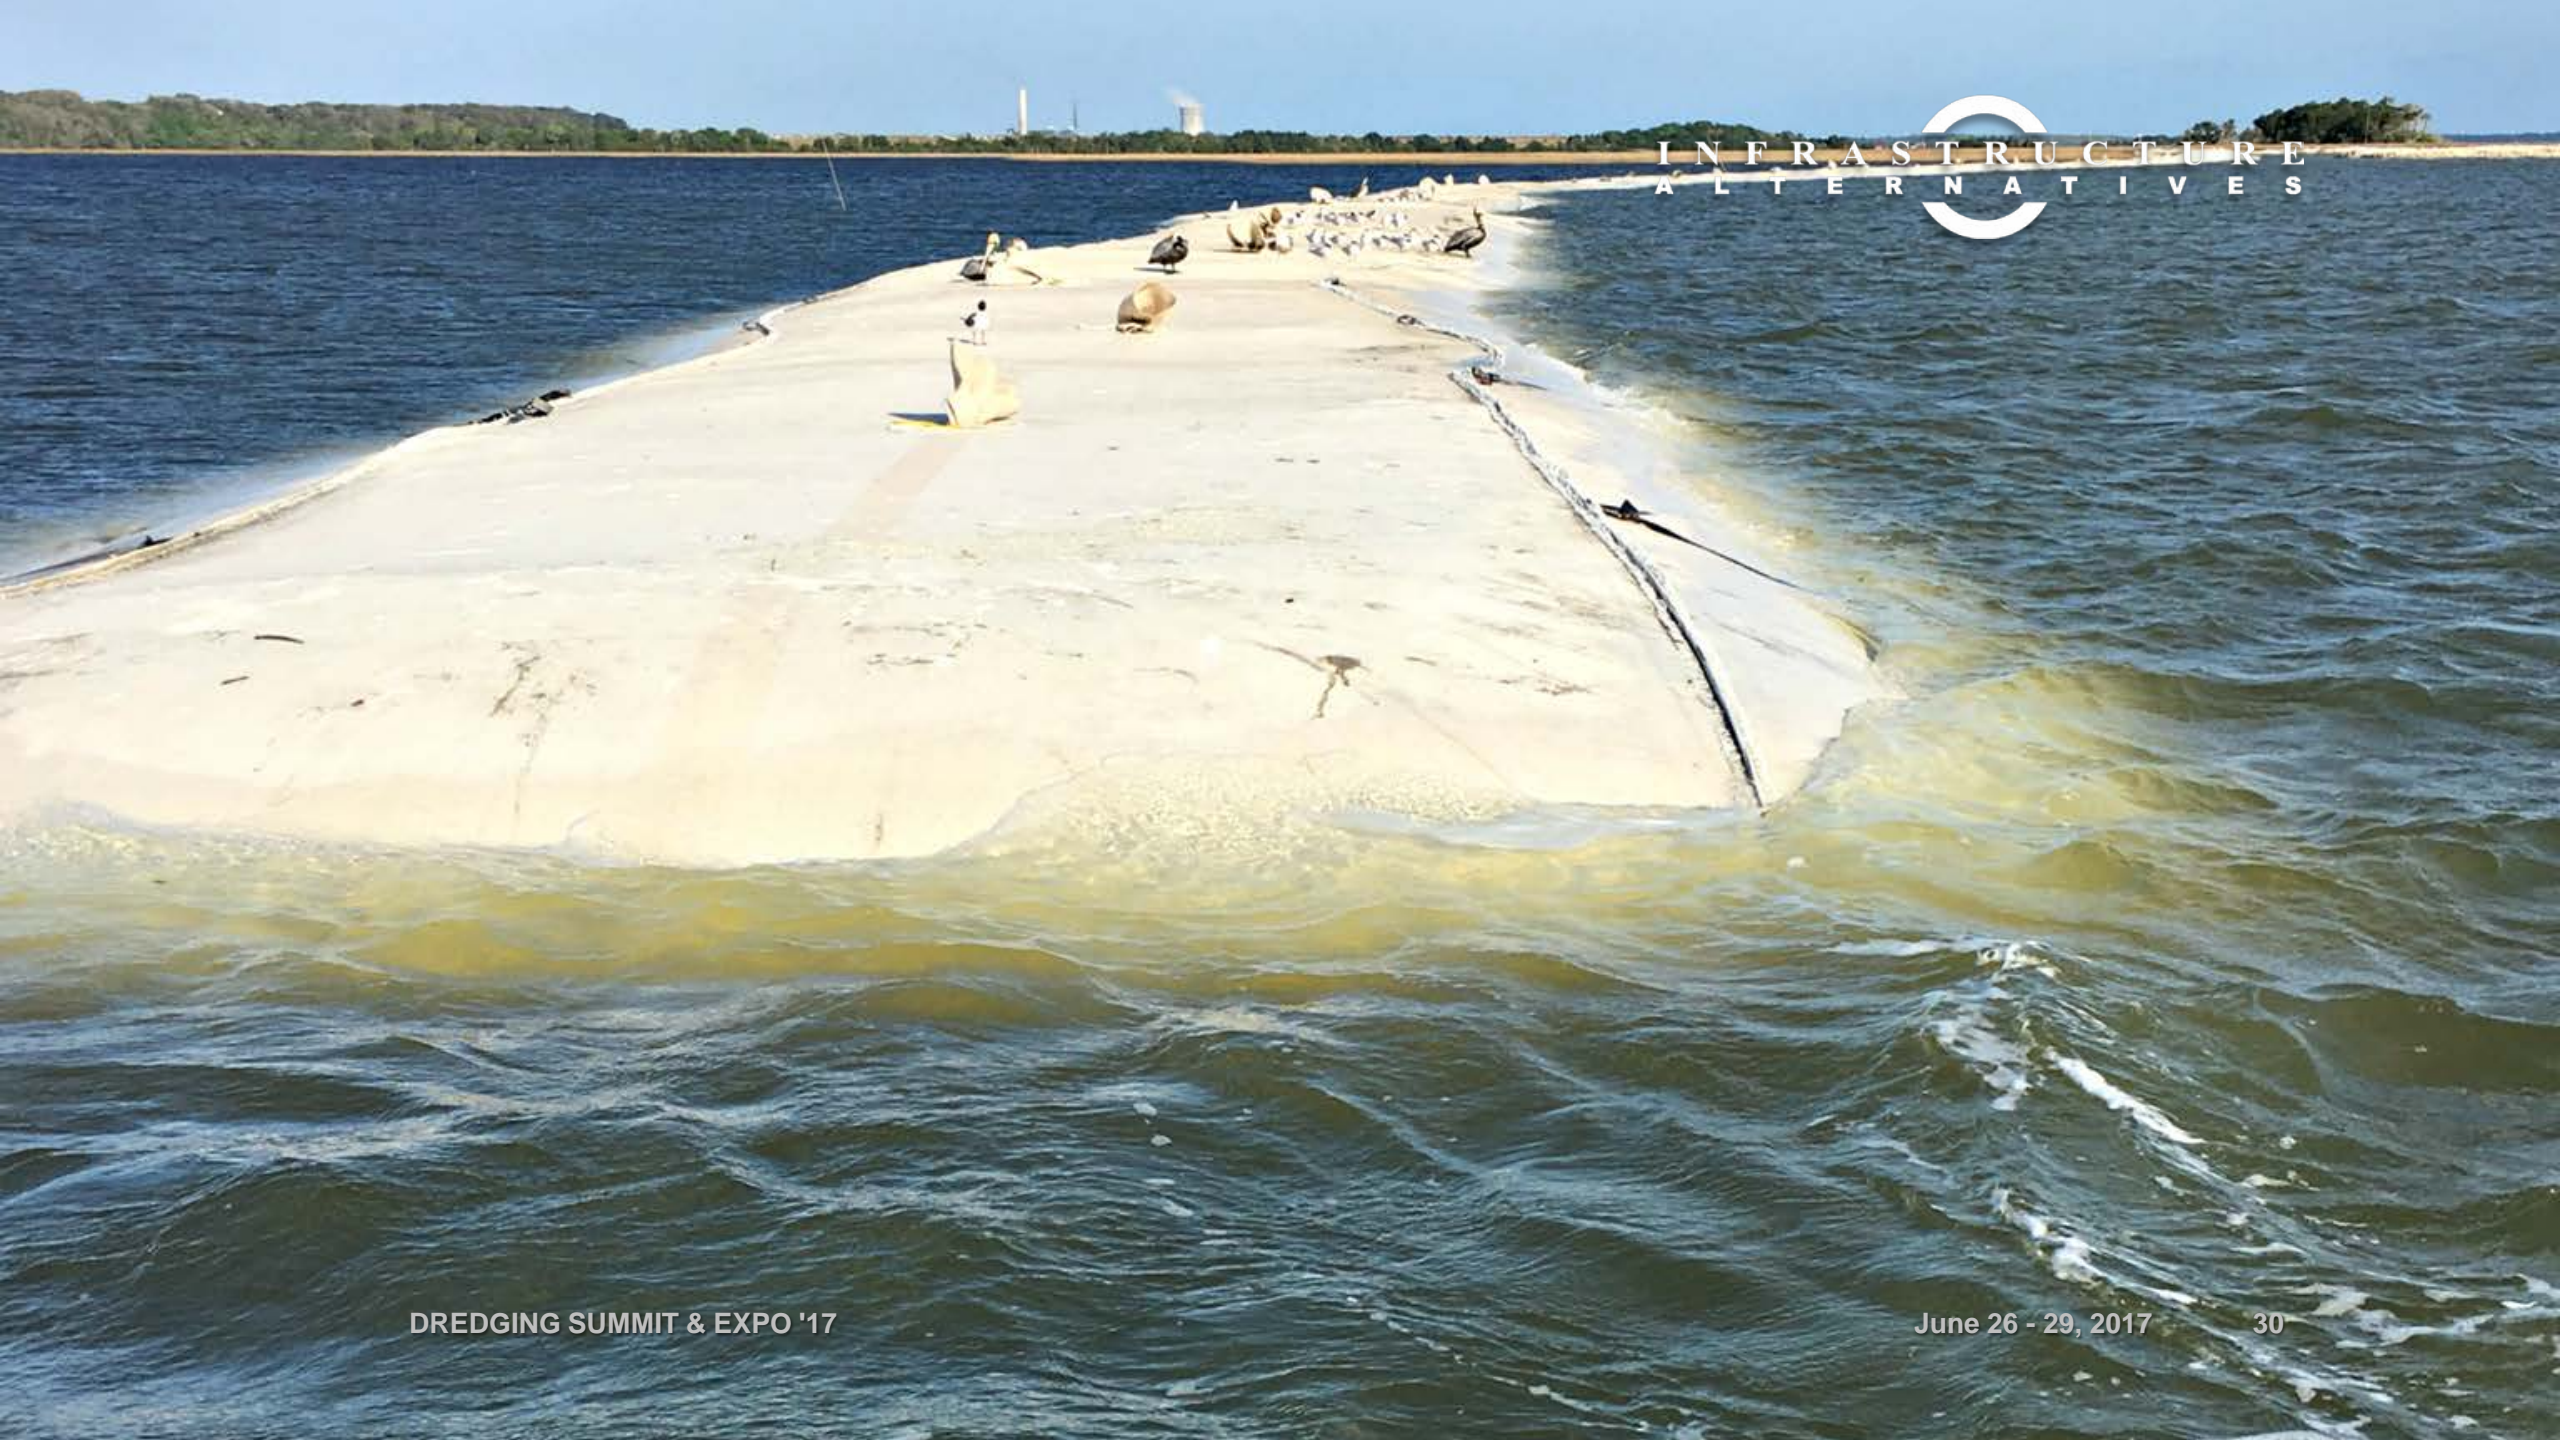
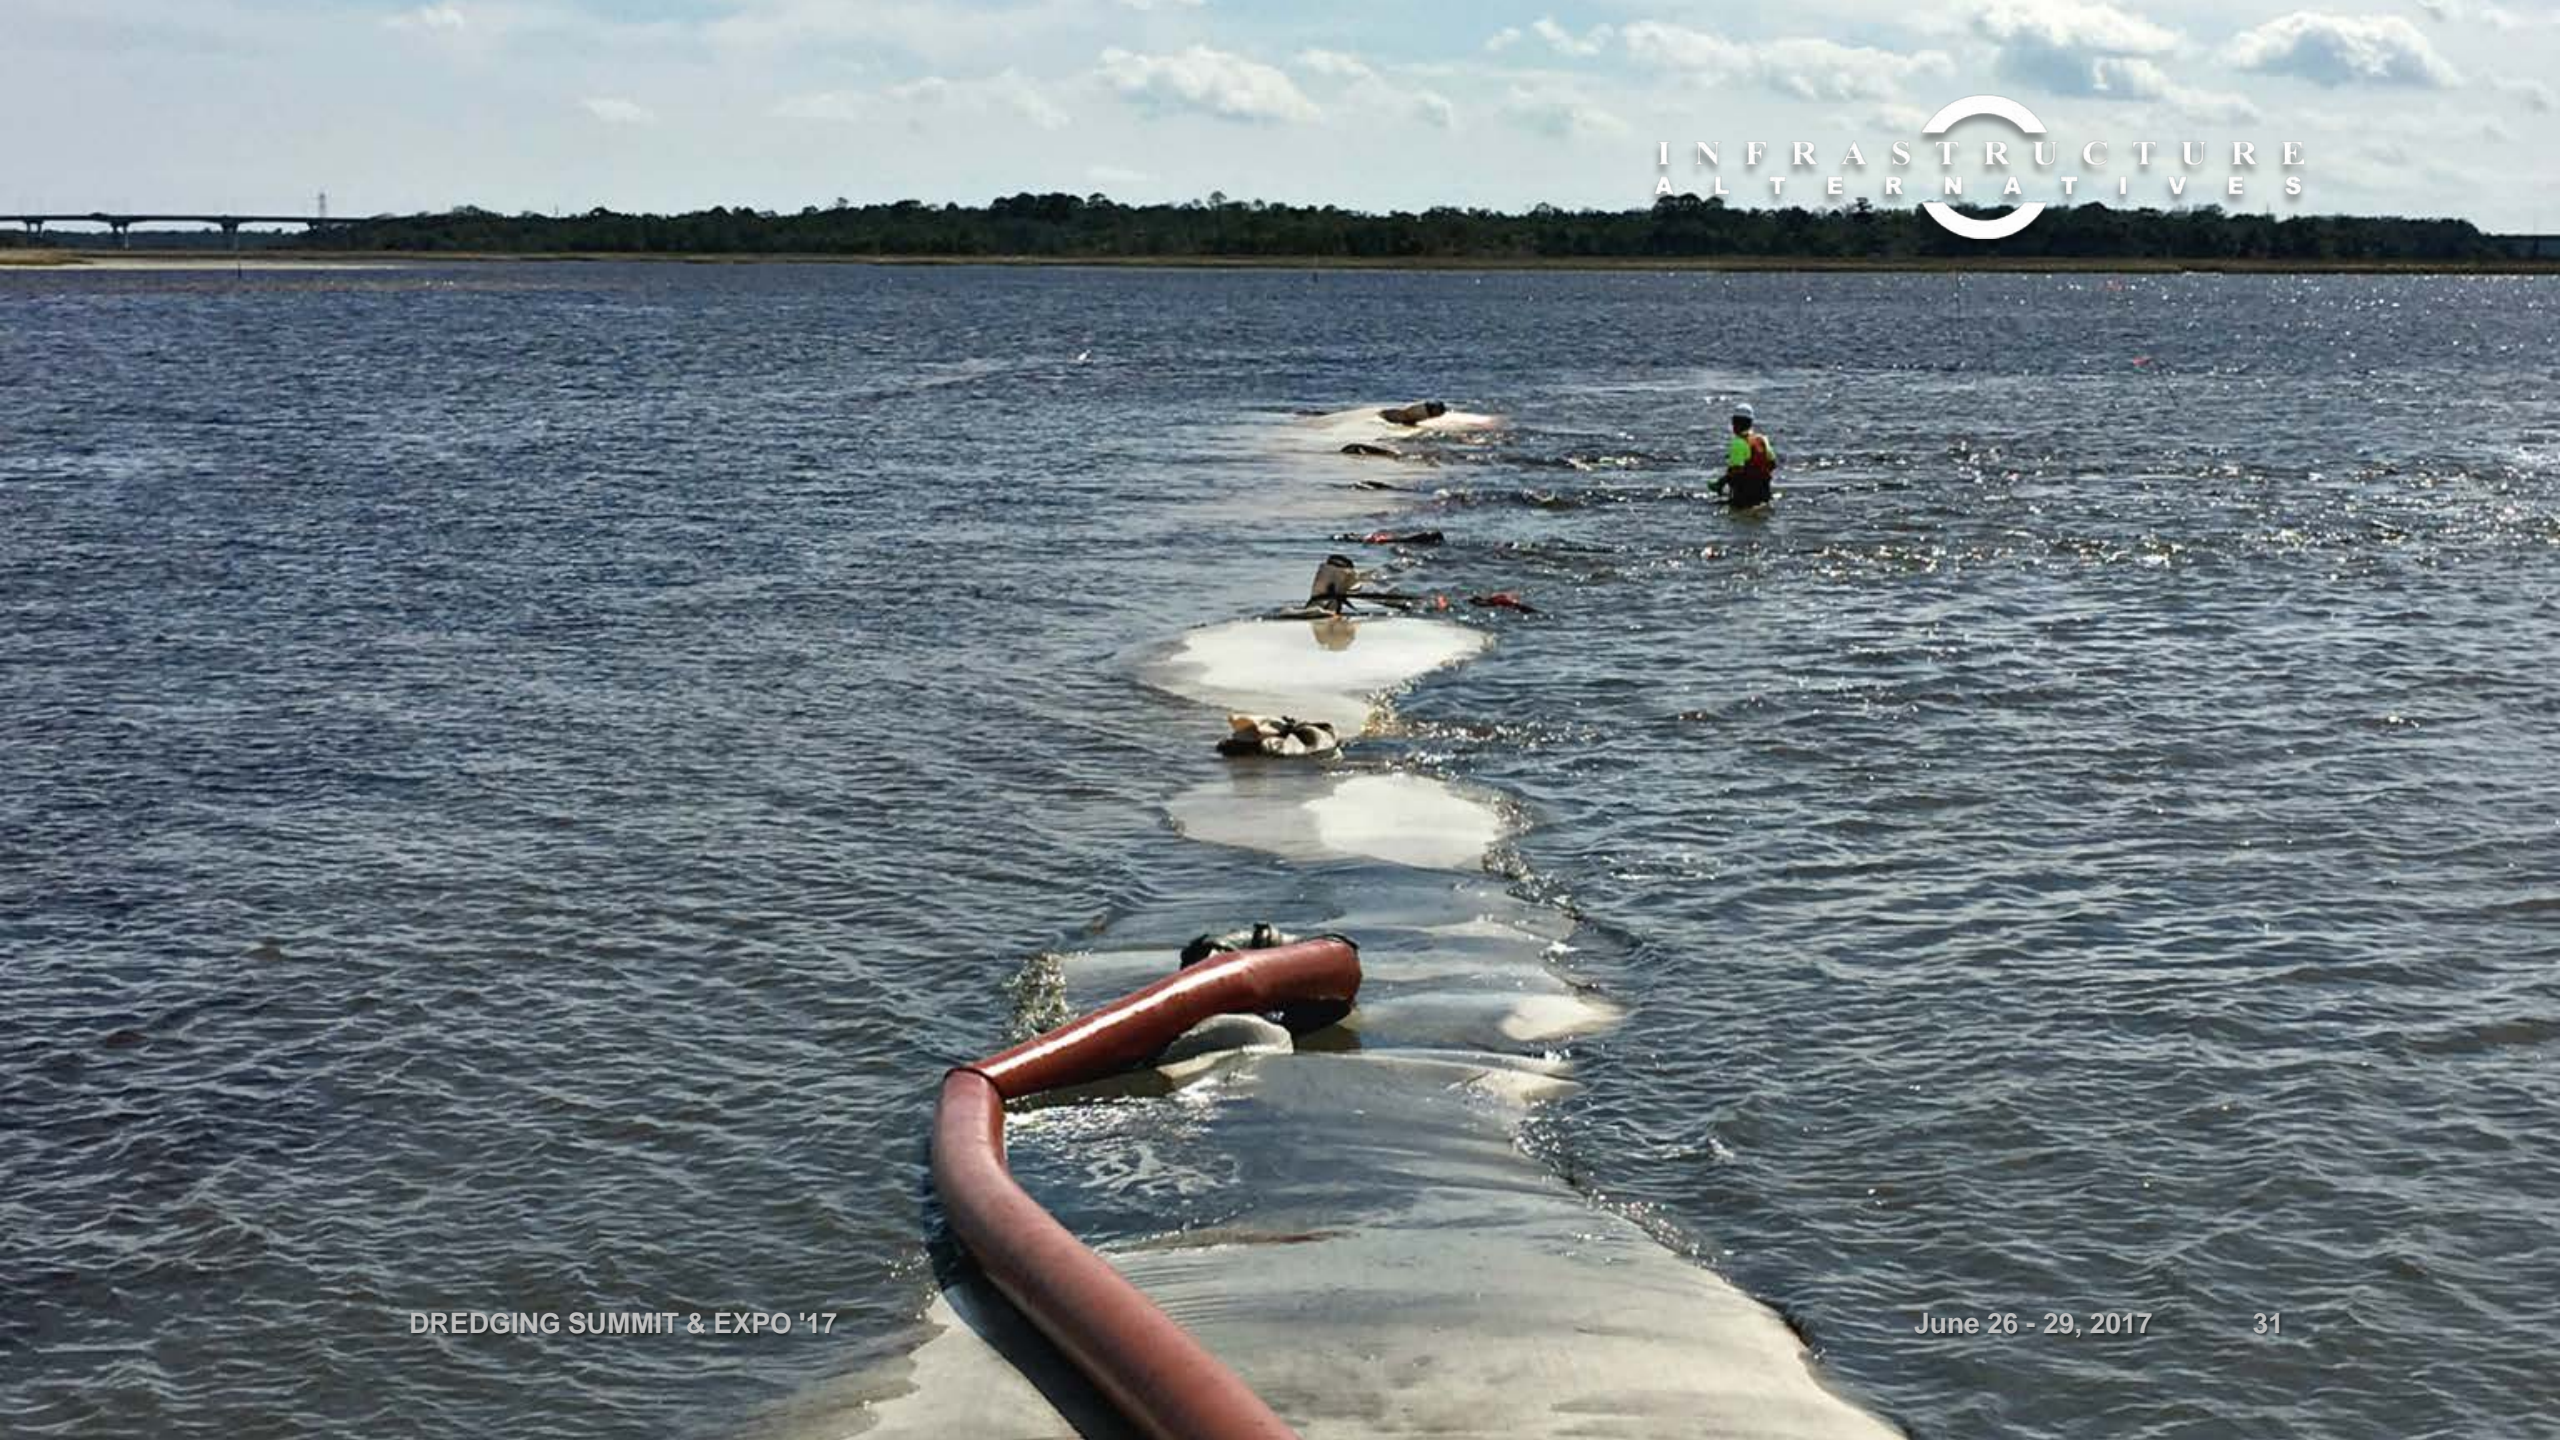
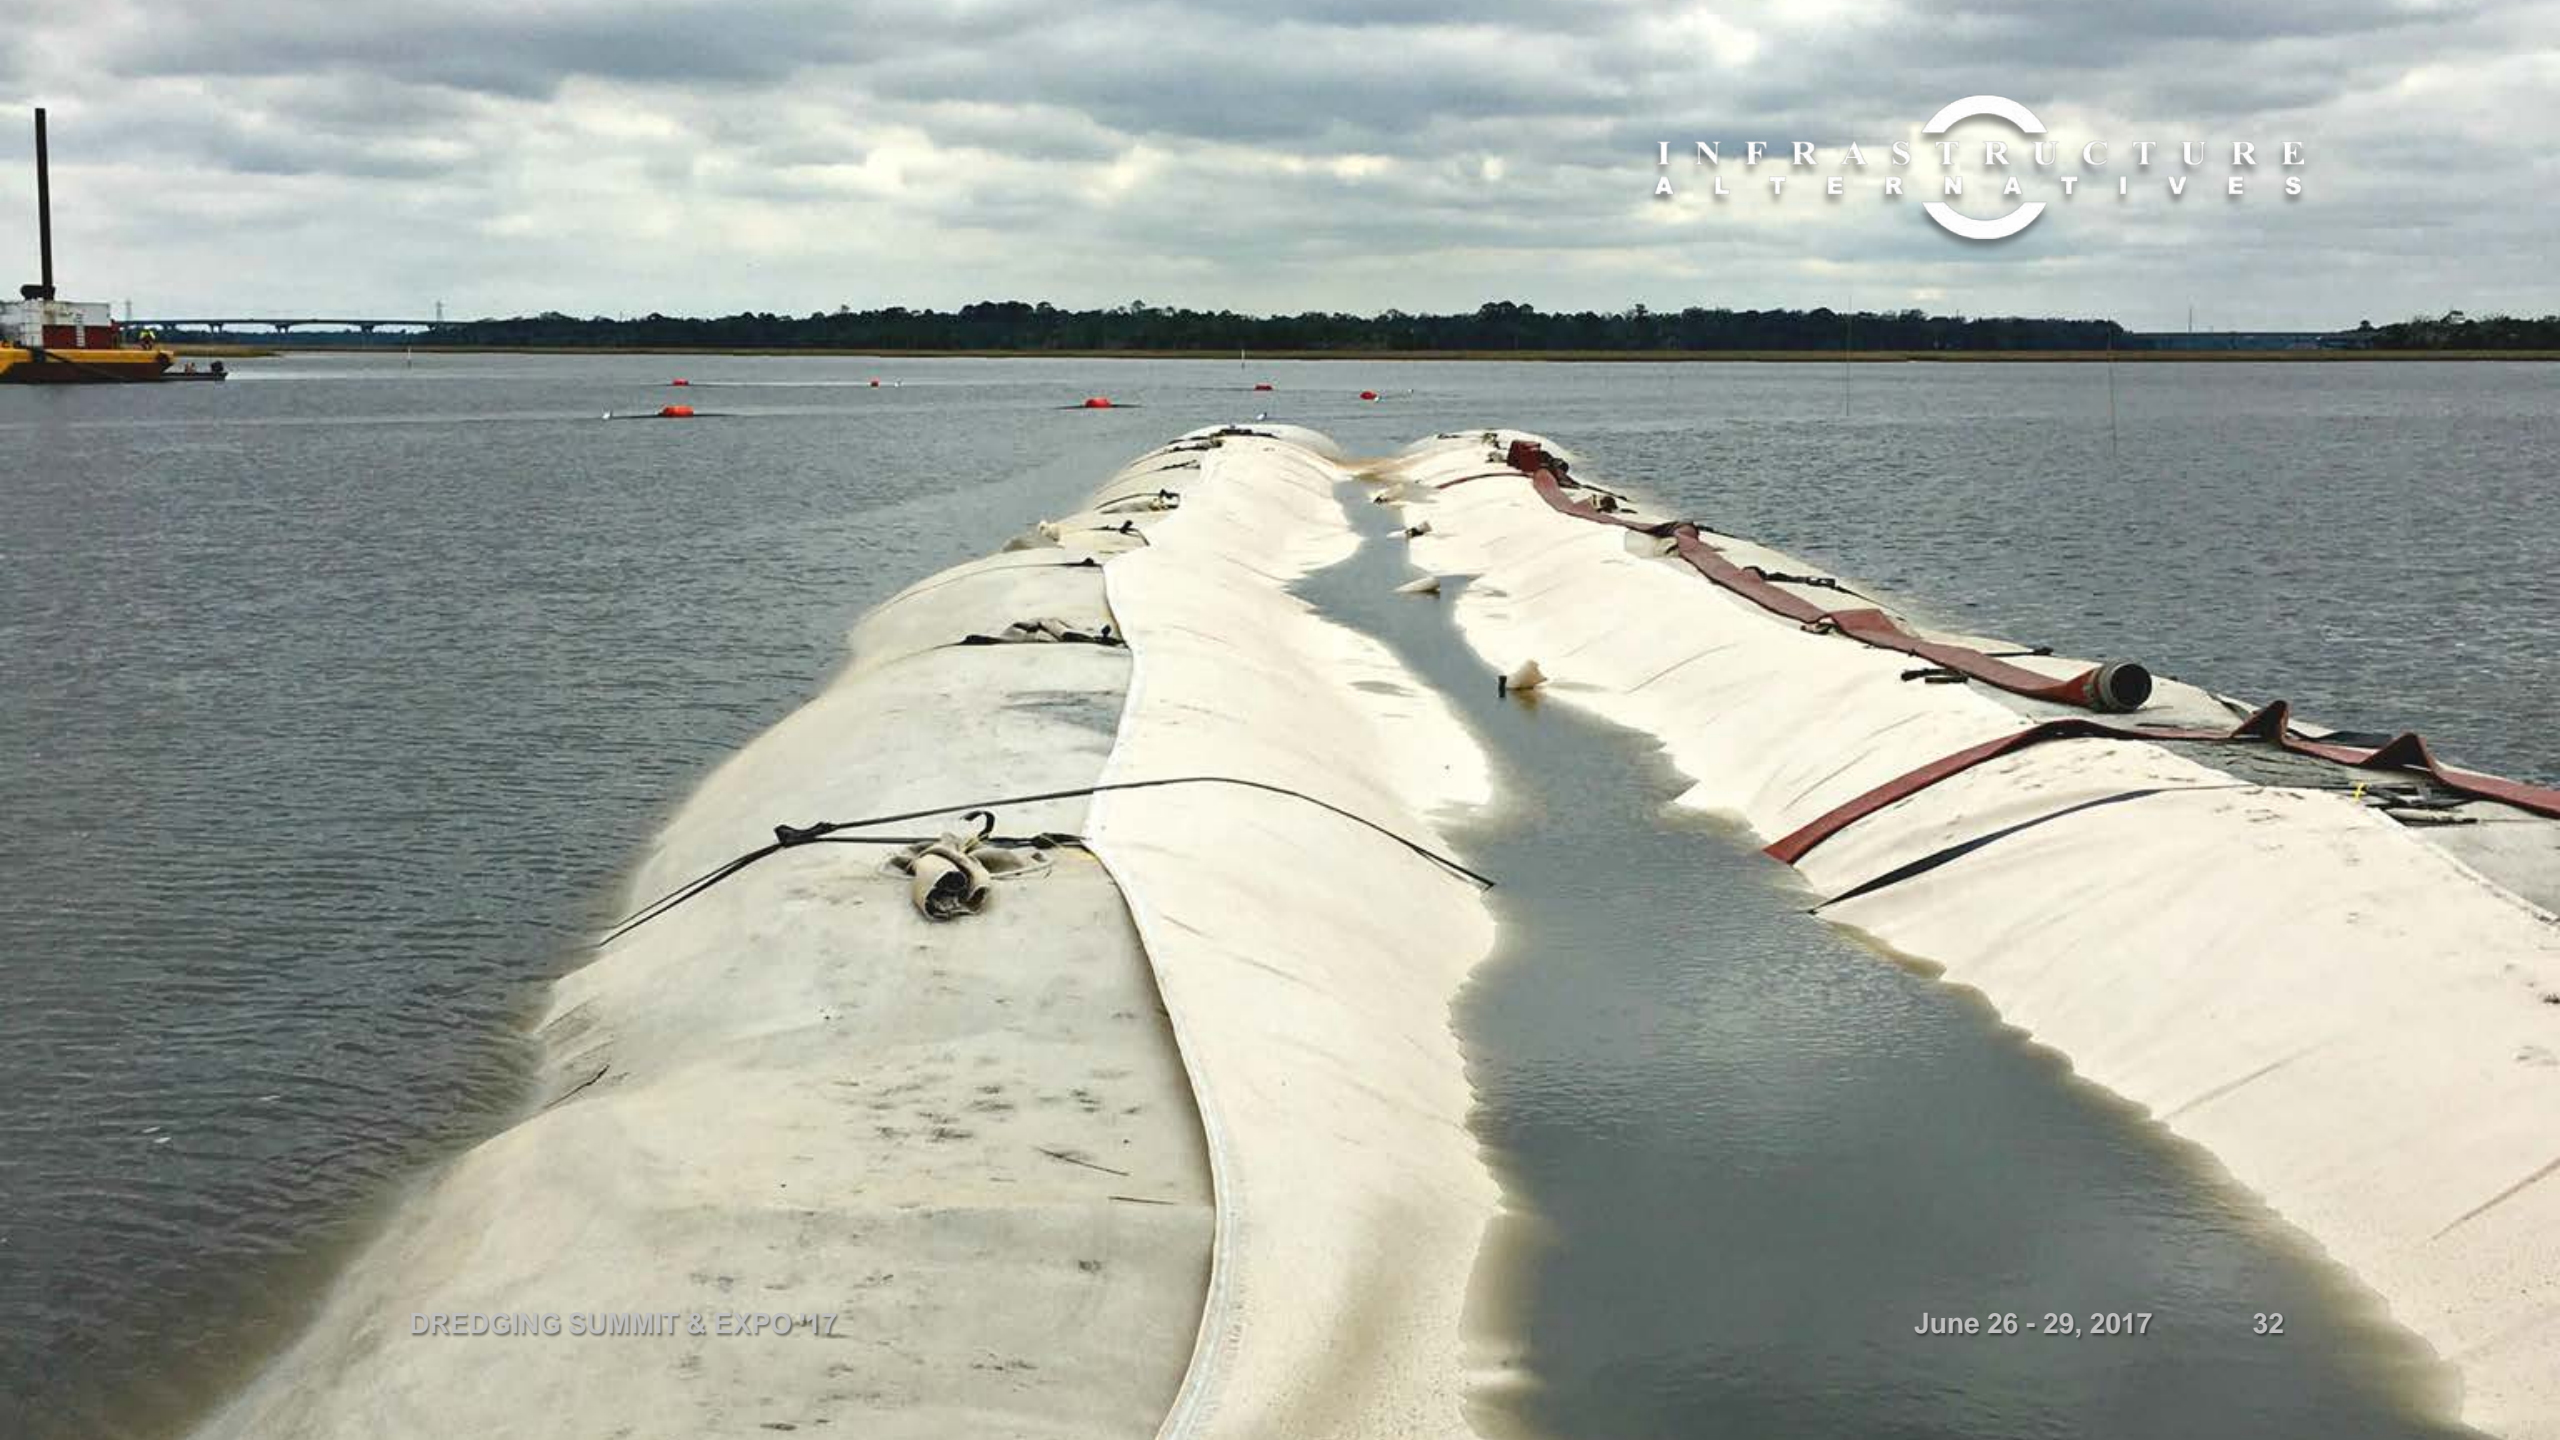
STATION 19+00 – 25+00

- Geotextile tube dimensions: 60-ft. circumference x 210-ft. long
- Min. fill height: 6-ft. MLLW.
- +/-1 ft. tolerance in this area
- Needed to maintain desired elevation at high tide

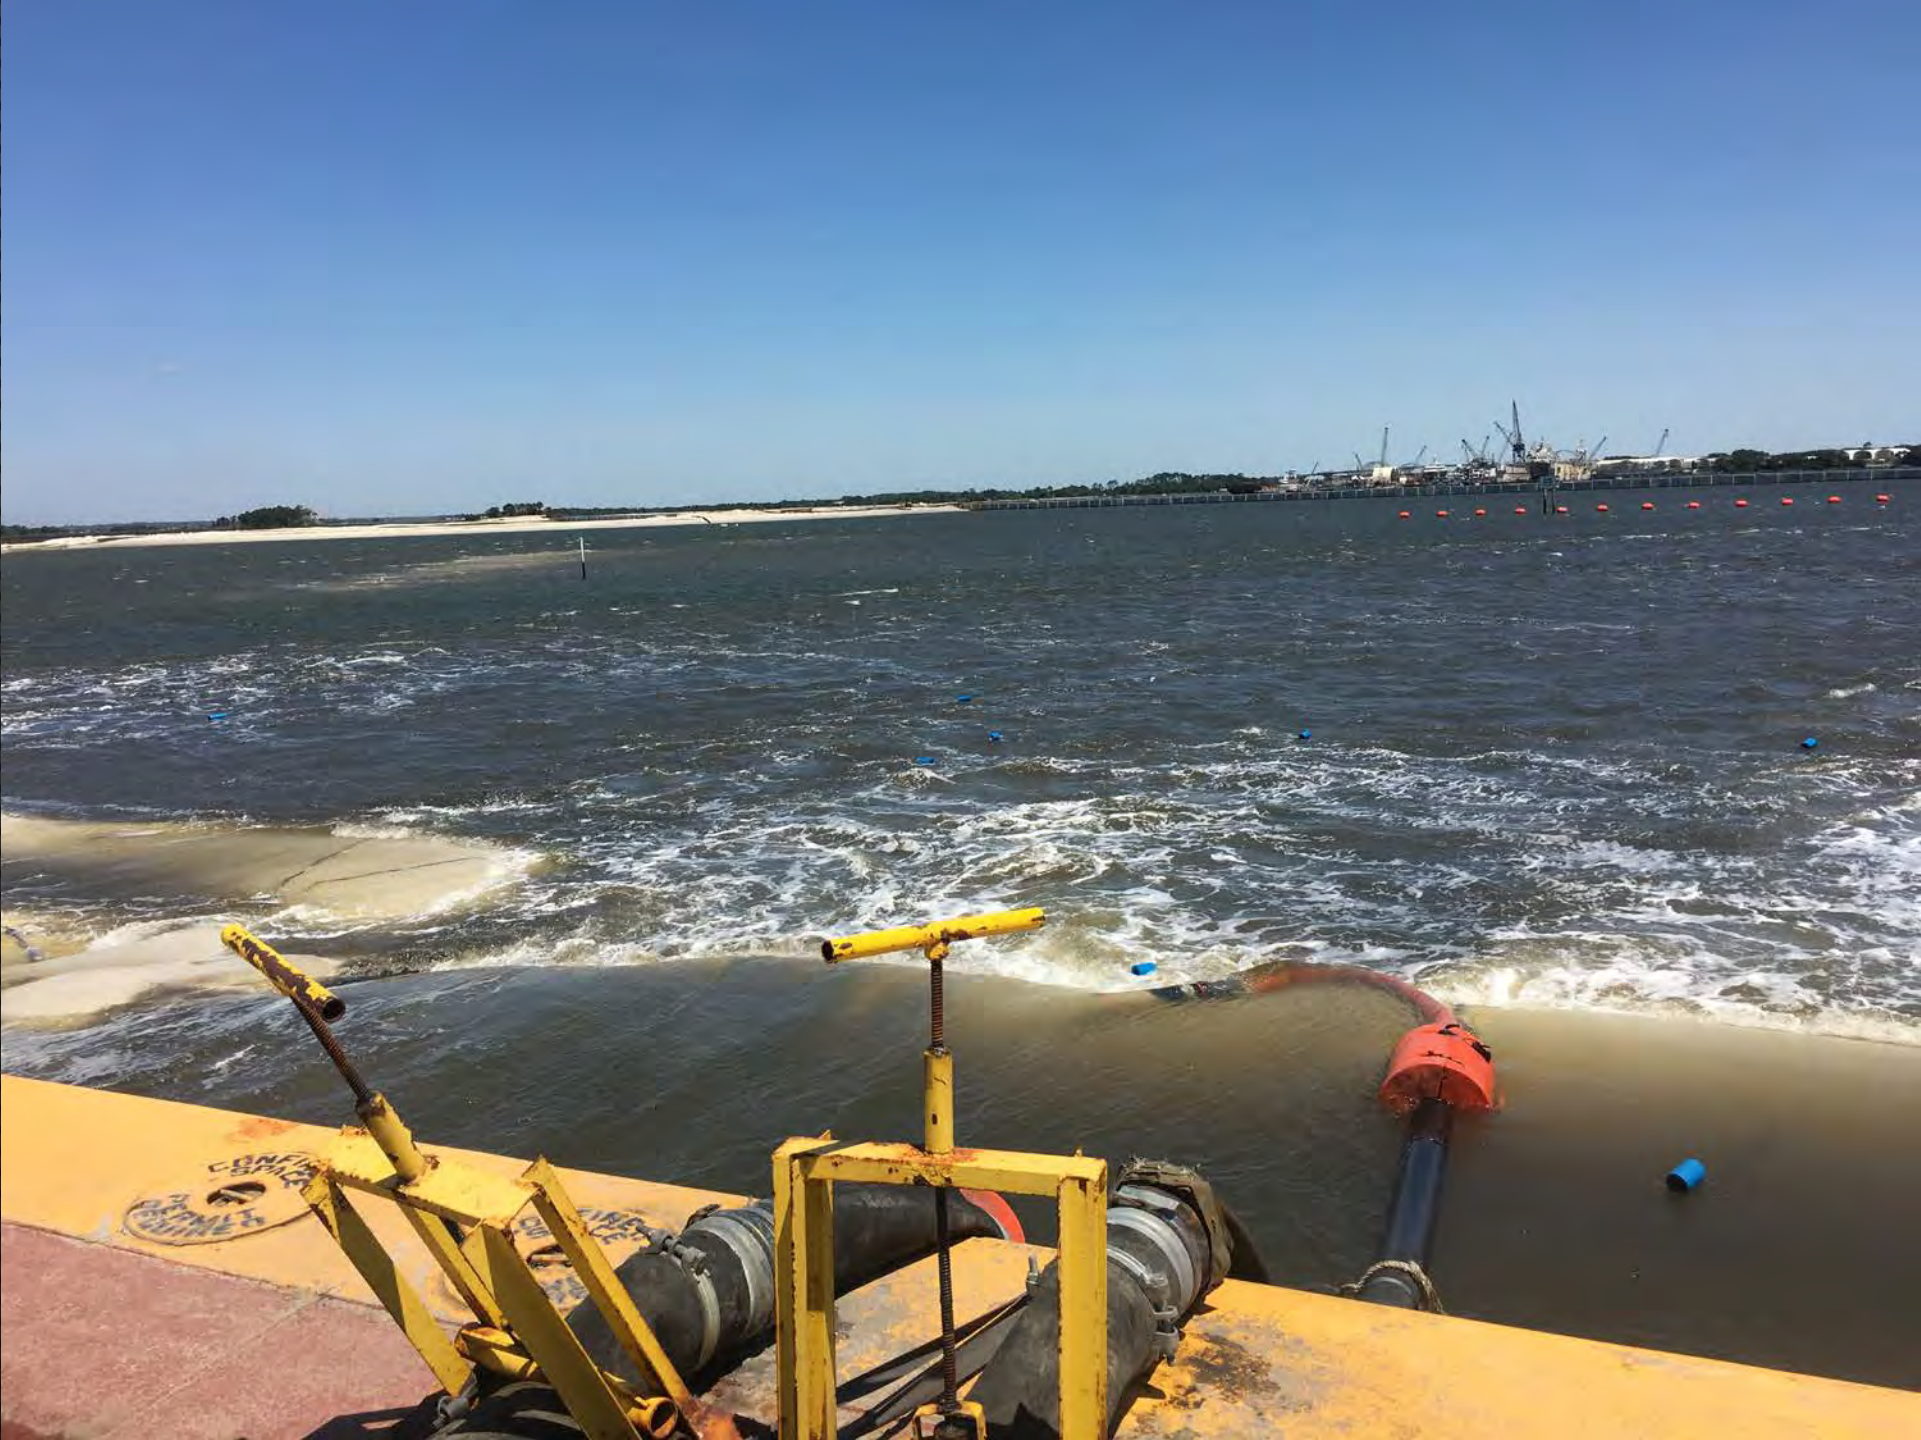
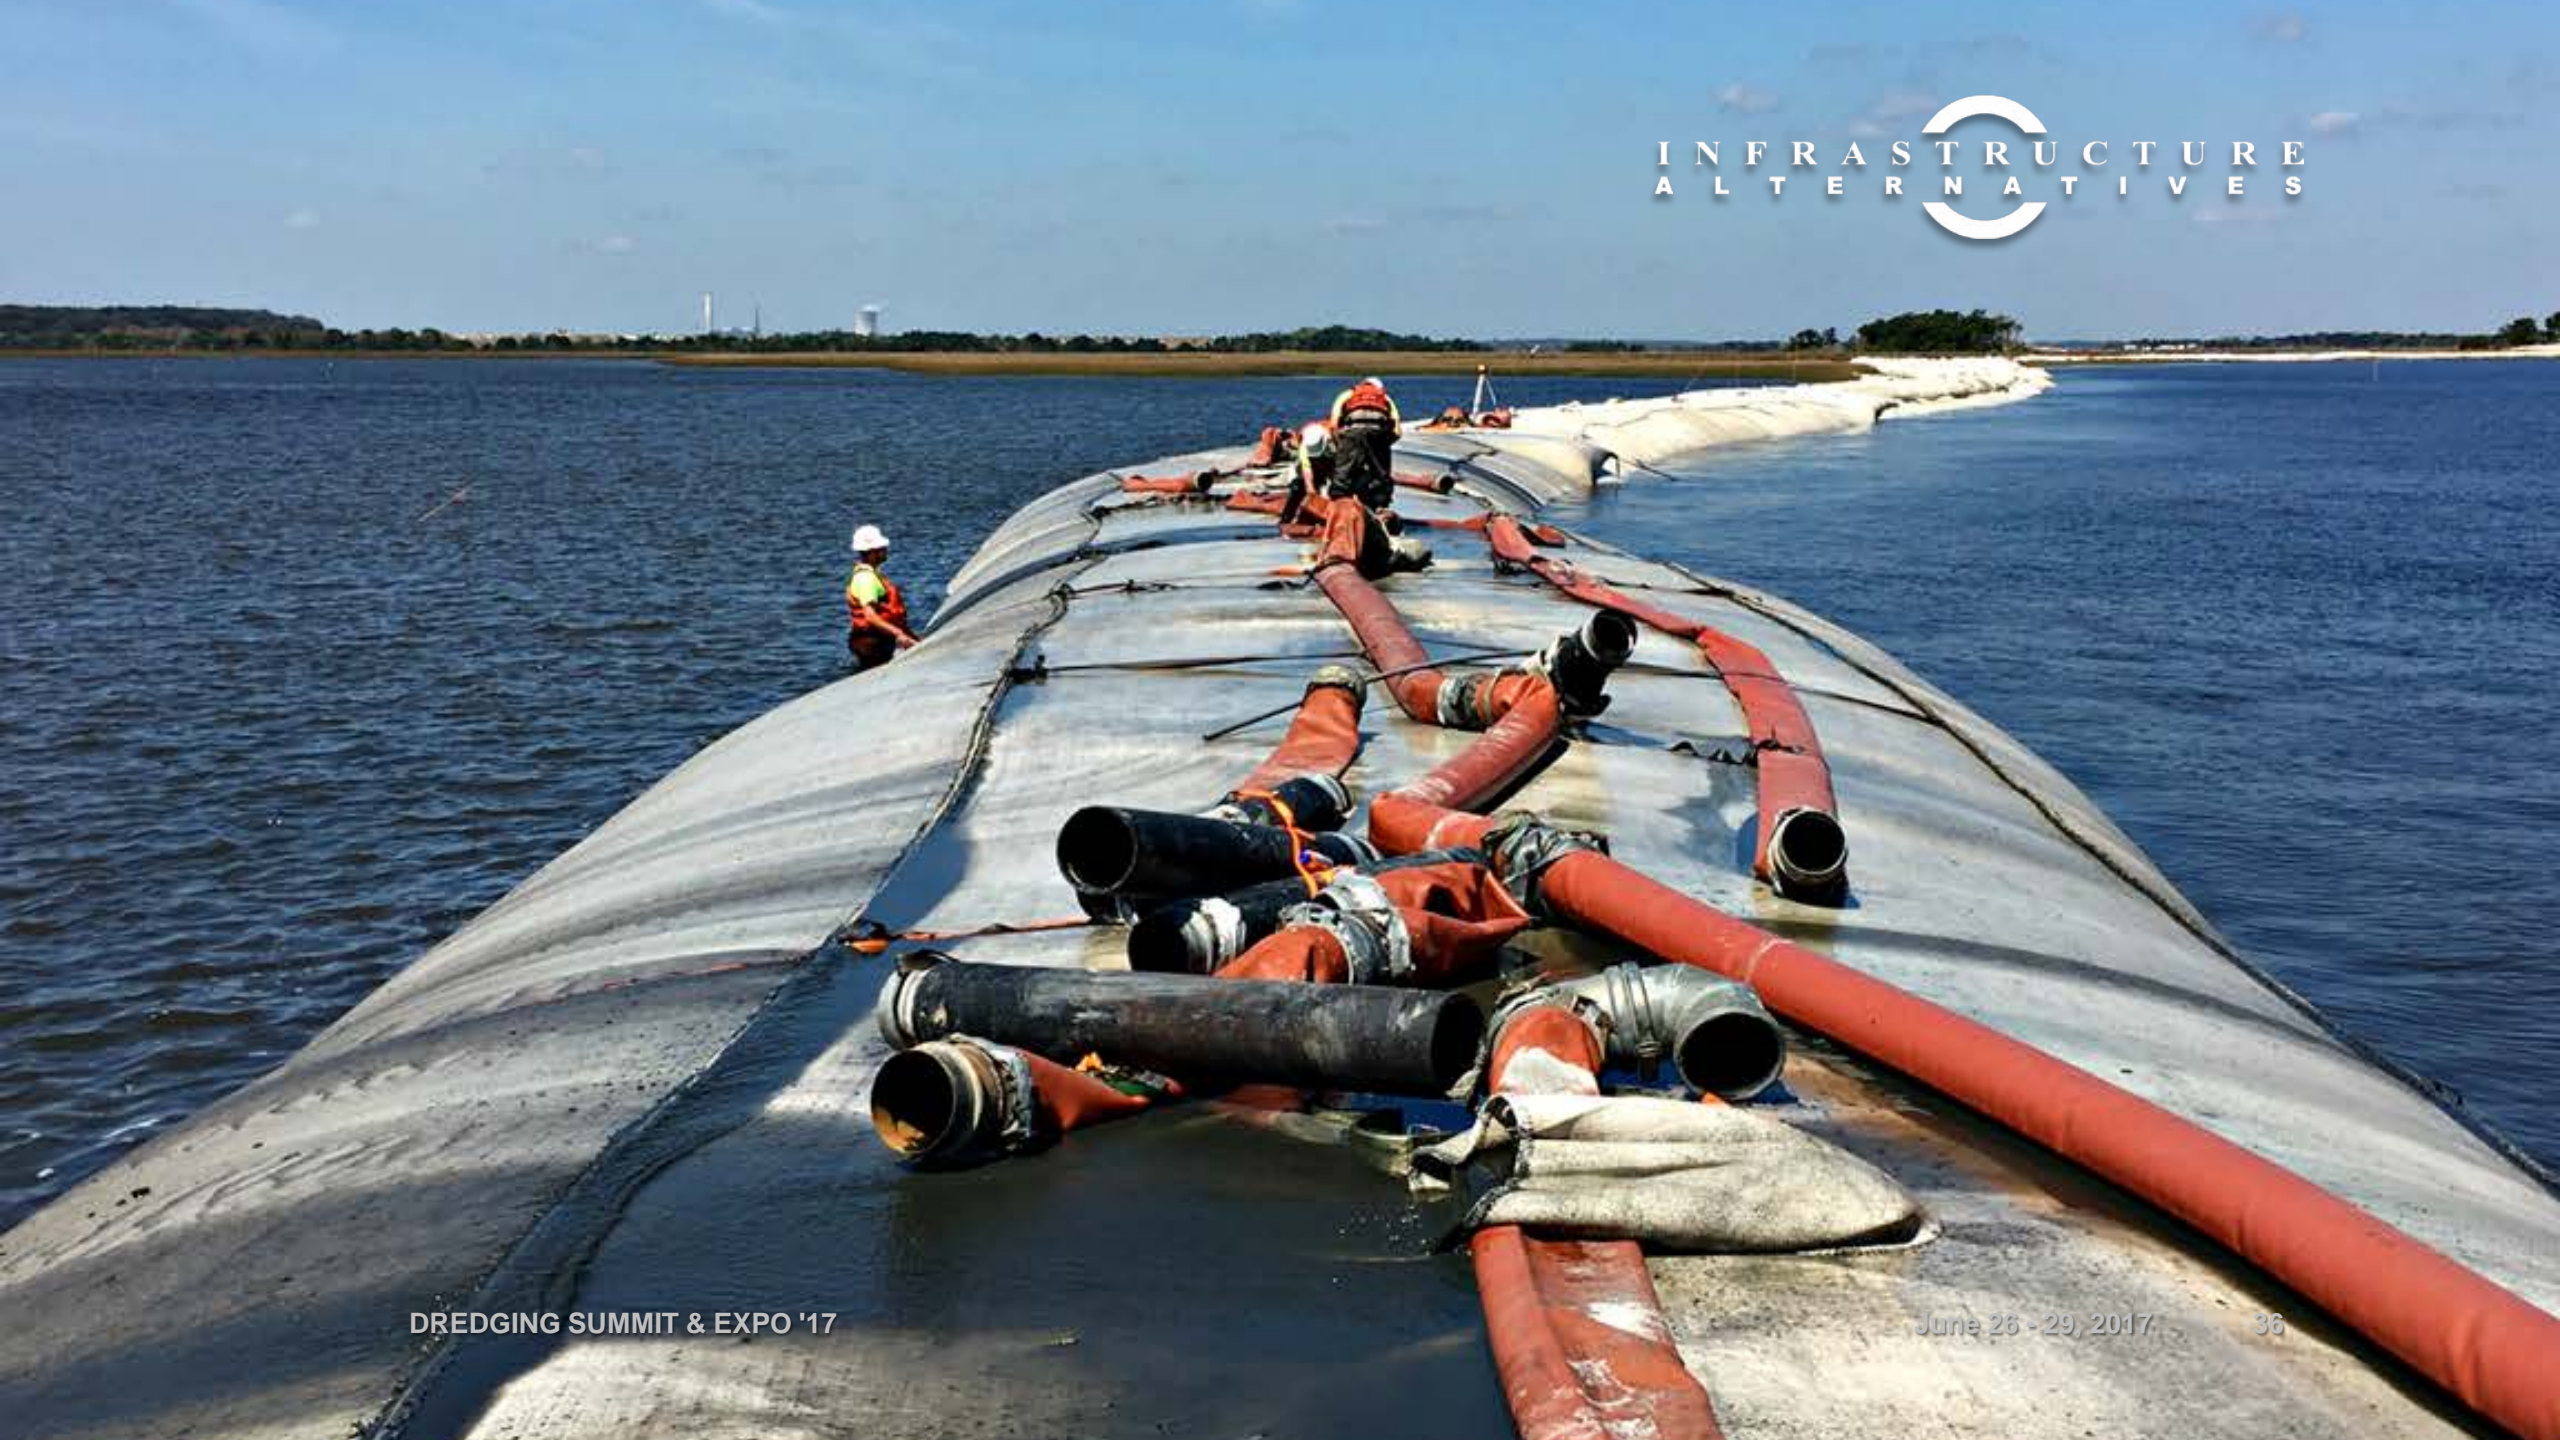
SEQUENCE OF OPERATIONS

- 400-ft. sections were filled at a time
- Header lines and hoses had to be flushed, rolled up & secured each night
- Frequent high winds
- Tidal cycles
- Center line of the design was followed with 1 - 2 feet.
