Monitoring Effectiveness of Pilot-Scale Sediment Caps in a Dynamic Sand Riverbed

WEDA 2019 Dredging
Summit and Expo
June 4-7, 2019
Chicago, Illinois

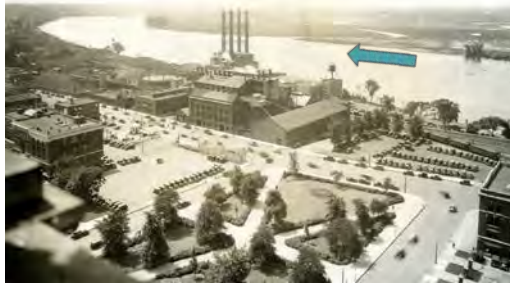
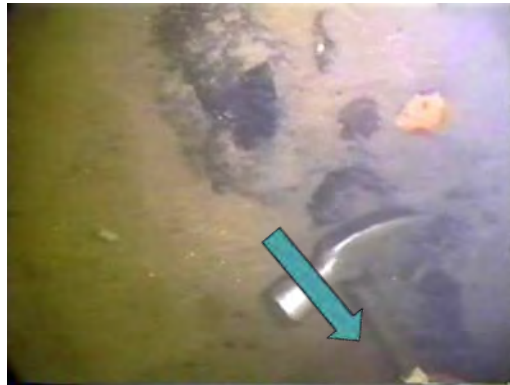
Site overview

- Tar-infused sandy sediment at surface:
 - Very weathered
 - Firm
 - Resists erosion
- Tar at depth is less weathered
- Sand constantly in motion
- Low PAHs in sand reflect background

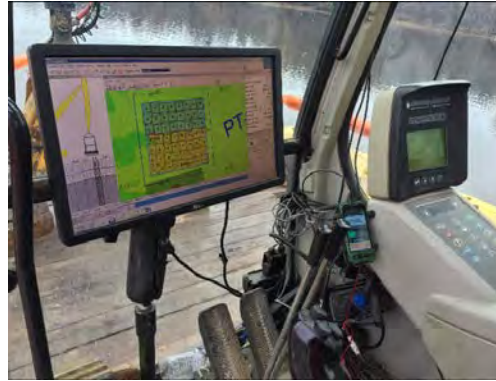
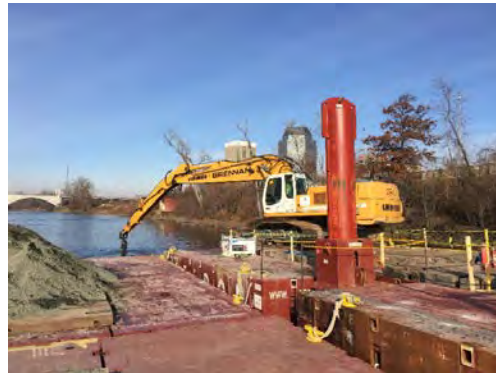
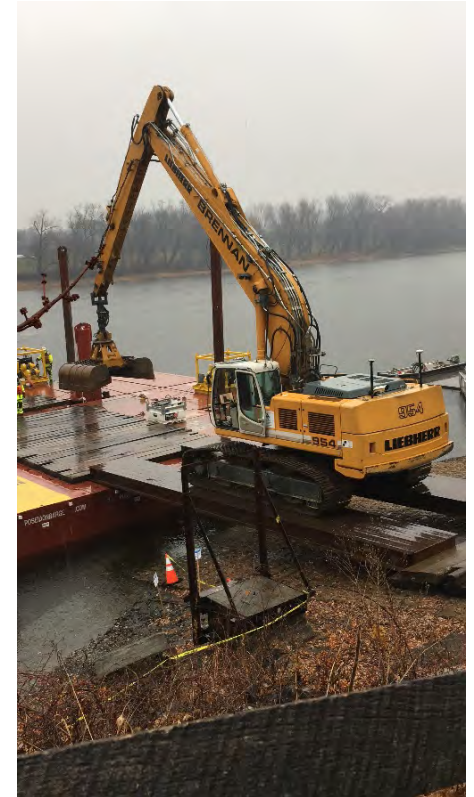
Staging Areas and Cap Placement

- Two staging areas obtained for loading and personnel movement
- Material placed via crane onto barges
- Hauled via barge up to 6 miles away to placement site
- Work conducted in late fall/early winter
- Work ceased when ice flows hinder material transport and diver surveys
- Material placed accurately using DredgePak software

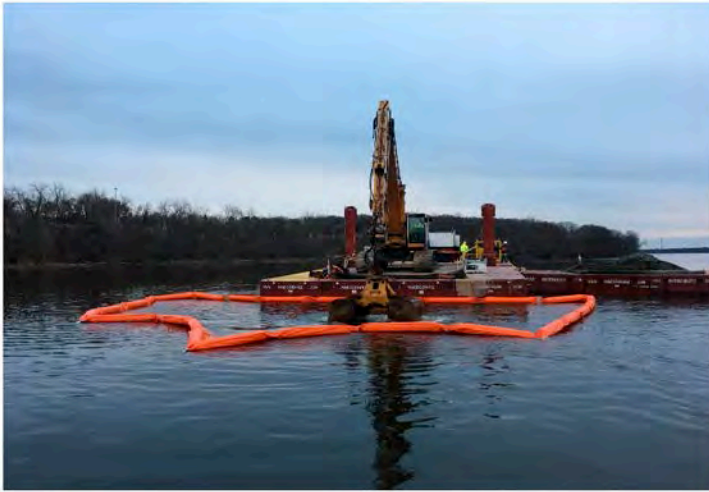
Fish Barrier

- Fish barrier required by CMP
- Ineffective and inefficient
- Not able to withstand river flows

- Stopped using the barrier after the TOY restriction ended in December with permission

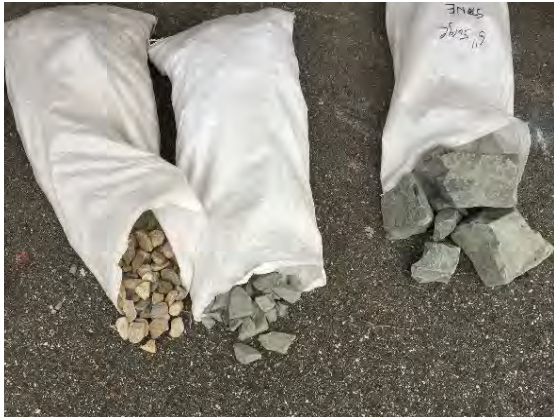
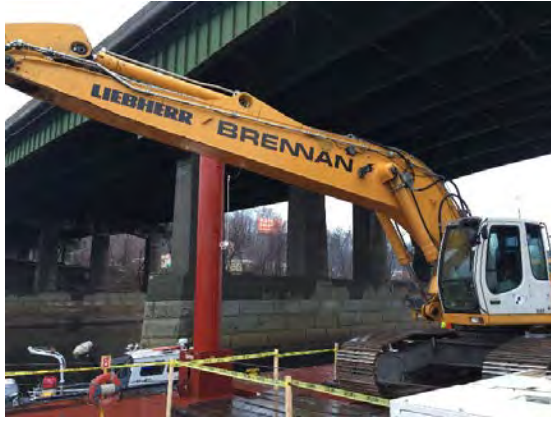
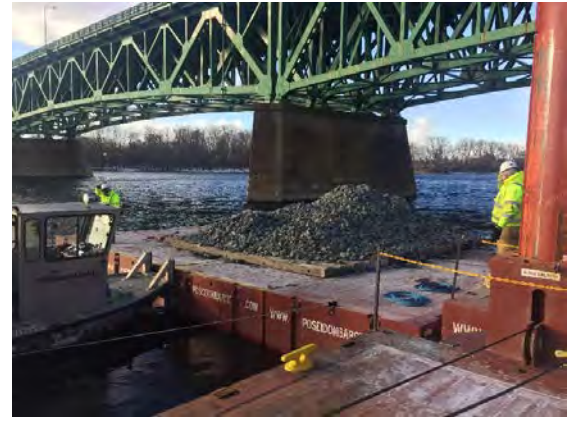
Armoring material

- Fine to medium gravel – filter layer
- Coarse gravel – armor layer
 - 4-inch minus
- Cobbles – armor layer between bridge piers
 - 8-inch minus
