The Restoration of the Cedar Bayou and Vinson Slough Inlet

Thomas Everett, PE

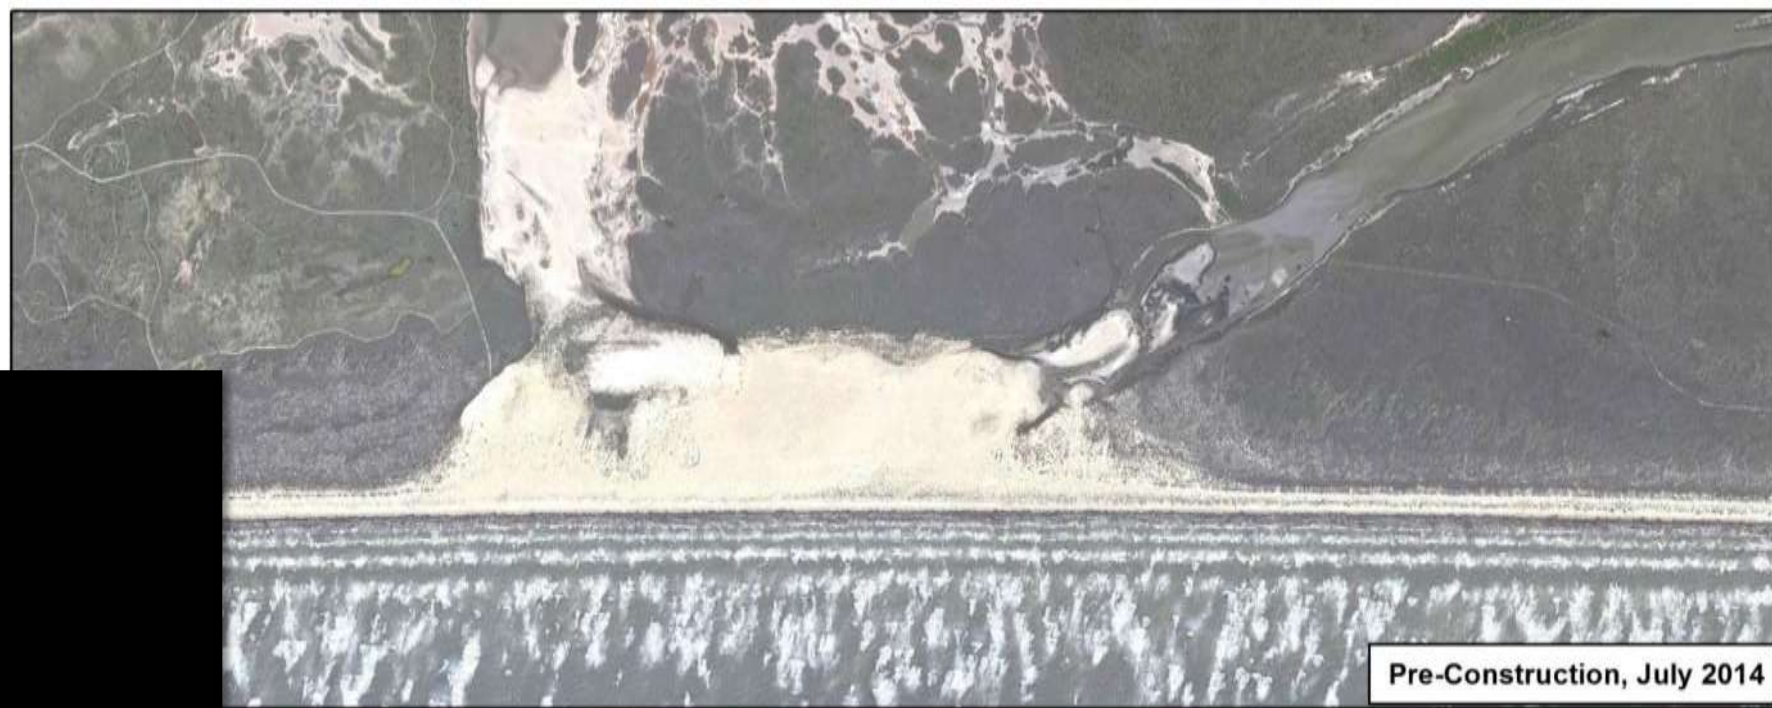
Pre-Construction, July 2014

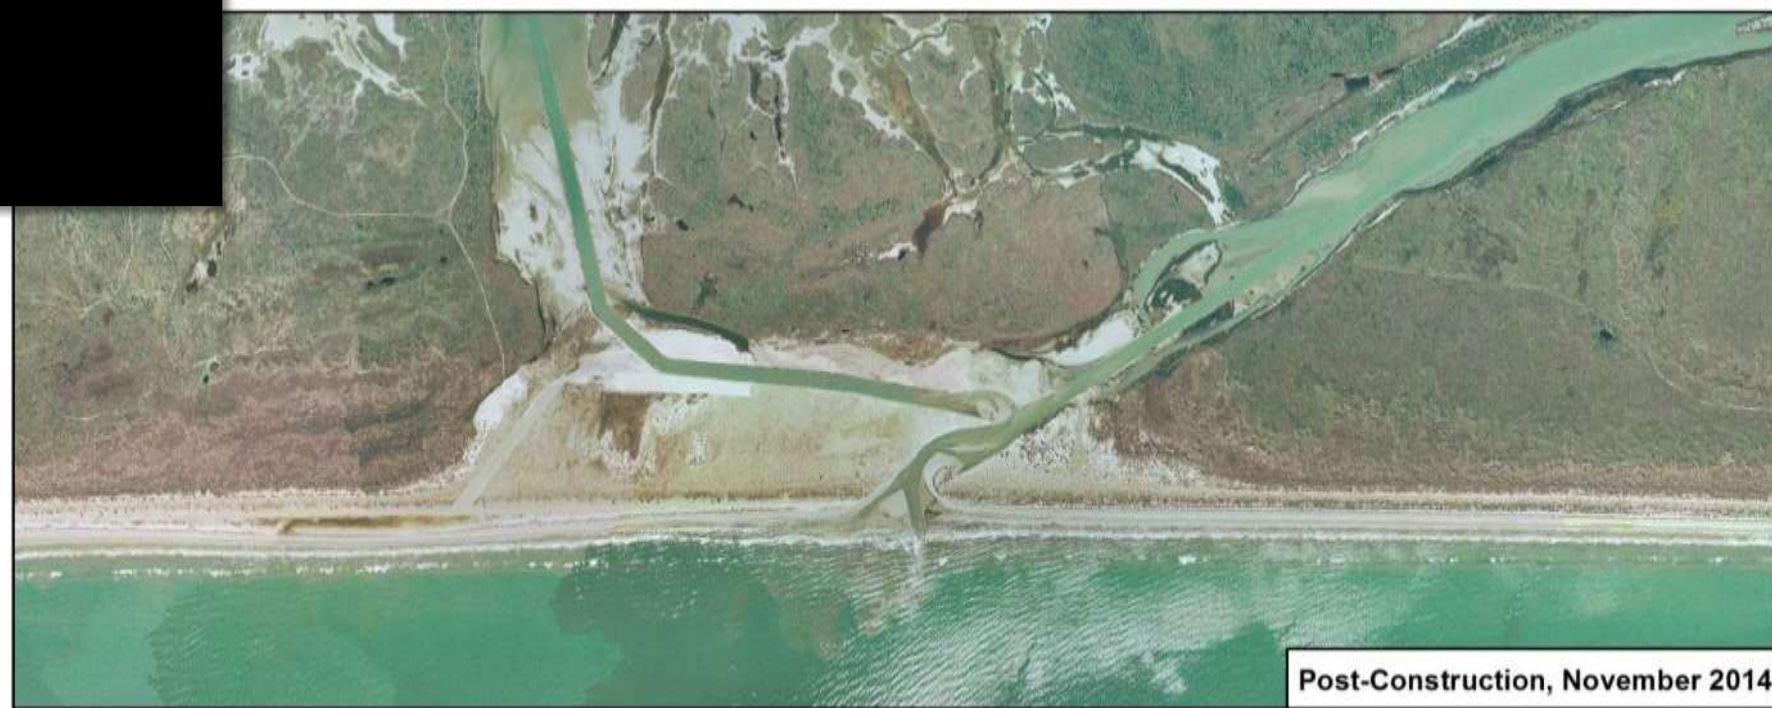
Post-Construction, November 2014

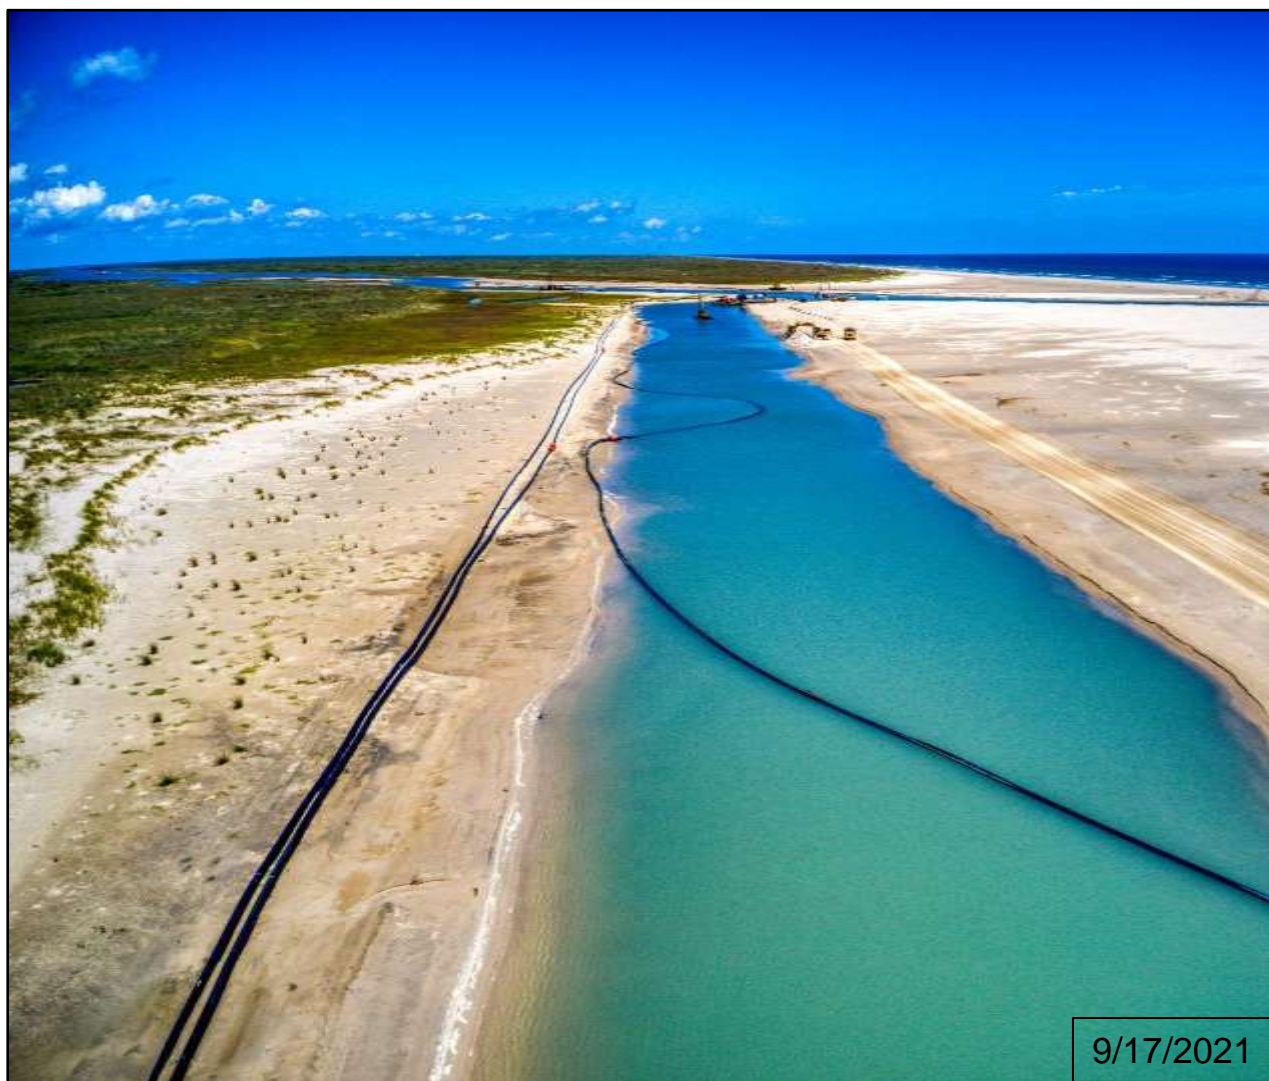
Pipeline transporting dredged material from cutter head dredges to disposal area.

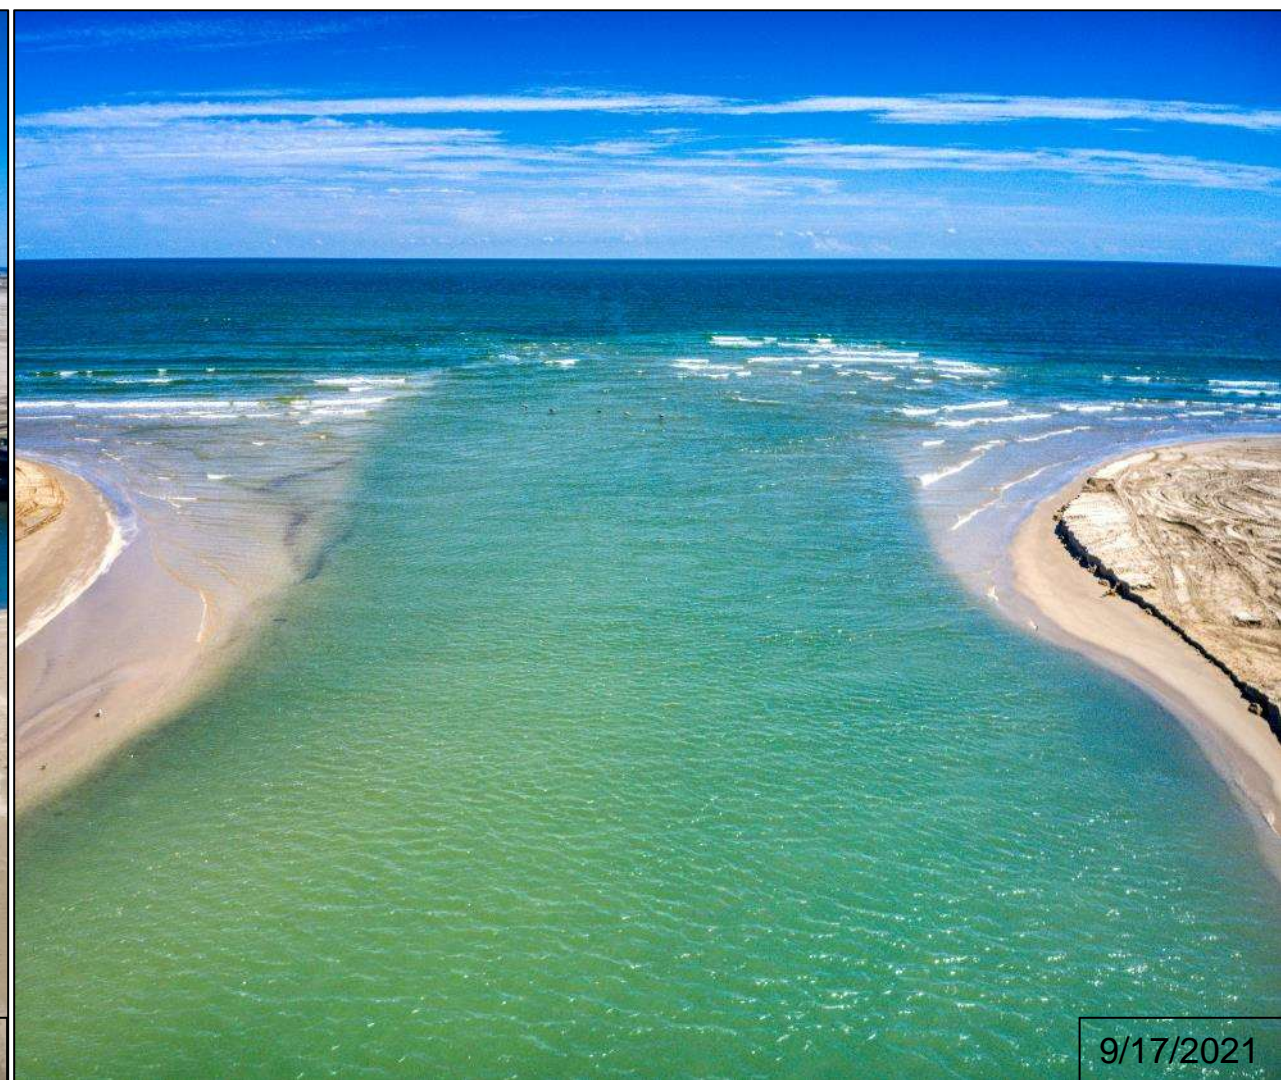
Inlet opening after hydraulic connection to the Gulf of Mexico prematurely re-established by the passing of Hurricane Nicholas.

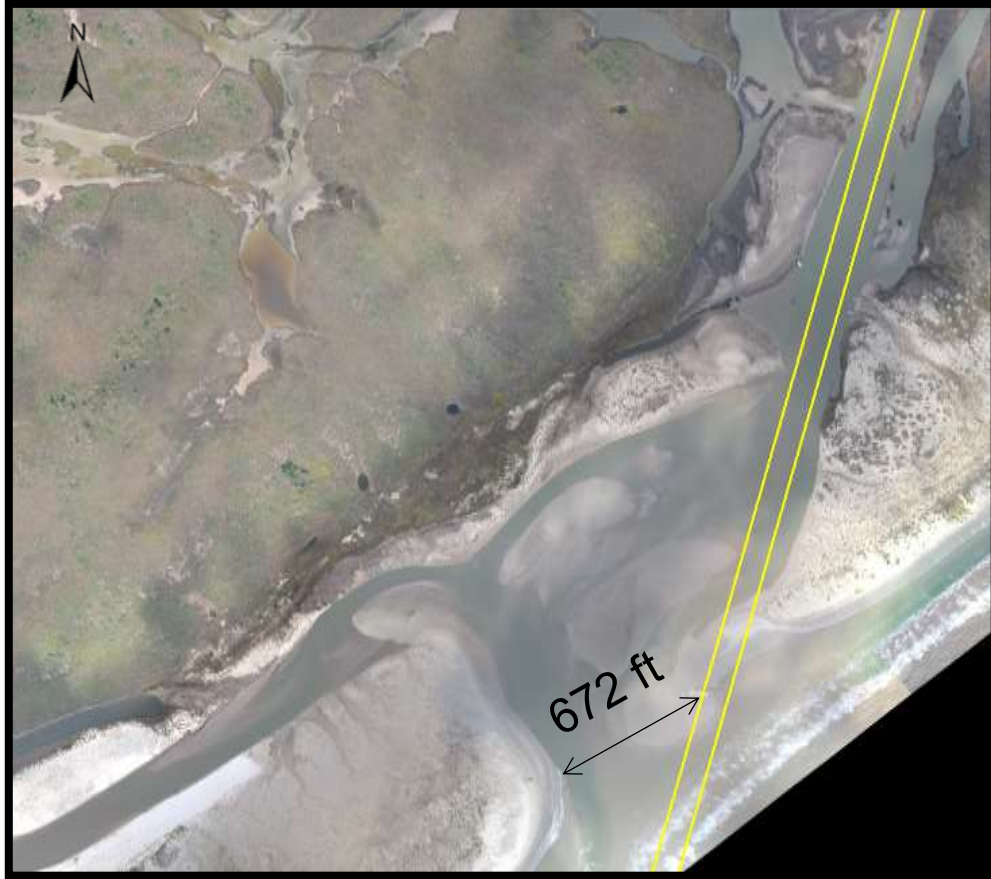
2015 (after opening)

- Historical Migration rate = ~266 ft/yr
- Migration typically stabilizes over time

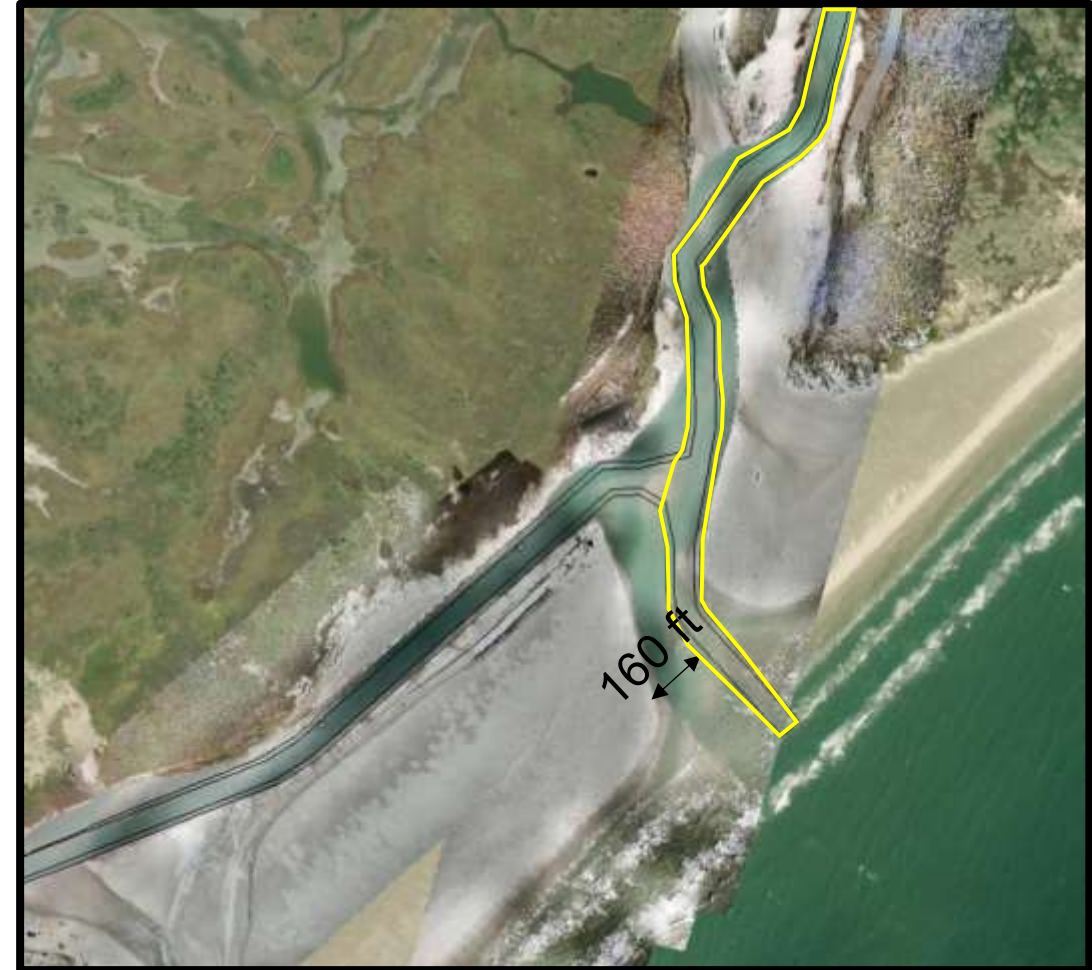
2022 (after opening)

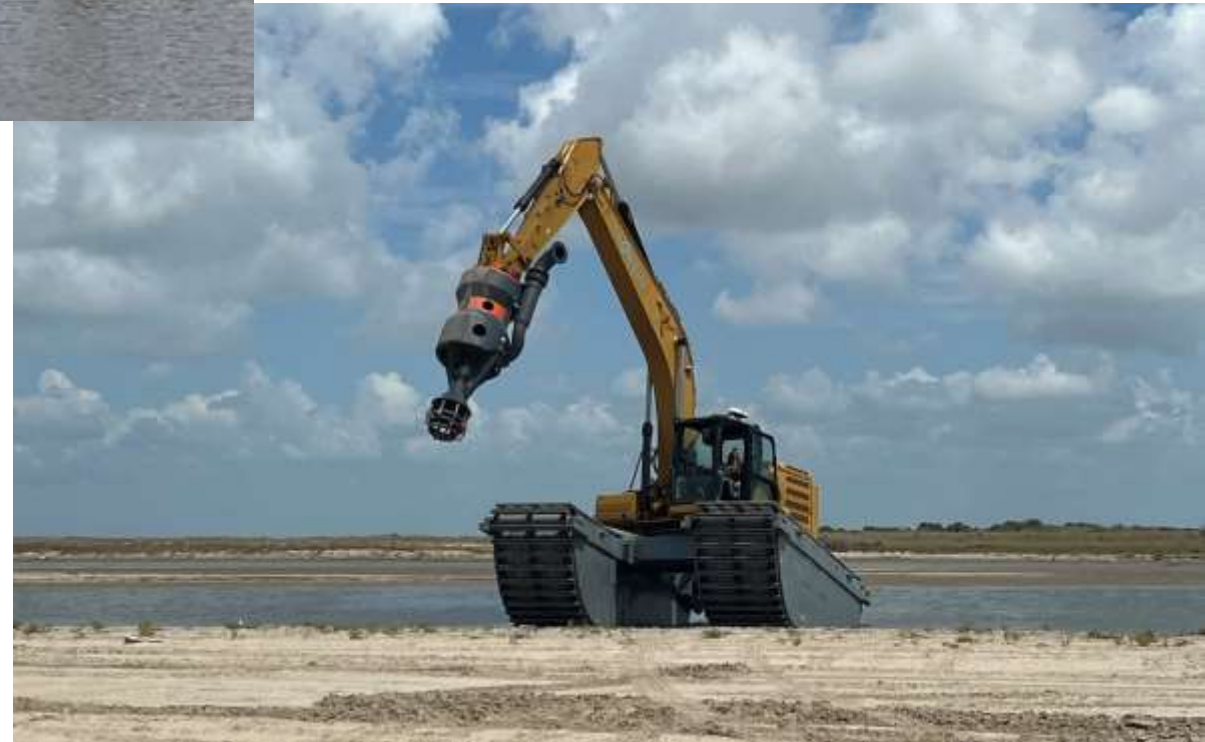
2022 Dredge Operations

- Bell 250 pump with Suction Head mounted on a CAT swamp buggy
- 12" pipeline from pump runs to placement area
- Equipment setup rated for ~2000 yd/day
