Natural Recolonization of a New England Salt Marsh: Build it and the Grasses Will Grow

Alan S. Fowler
Geosyntec Consultants, Inc.

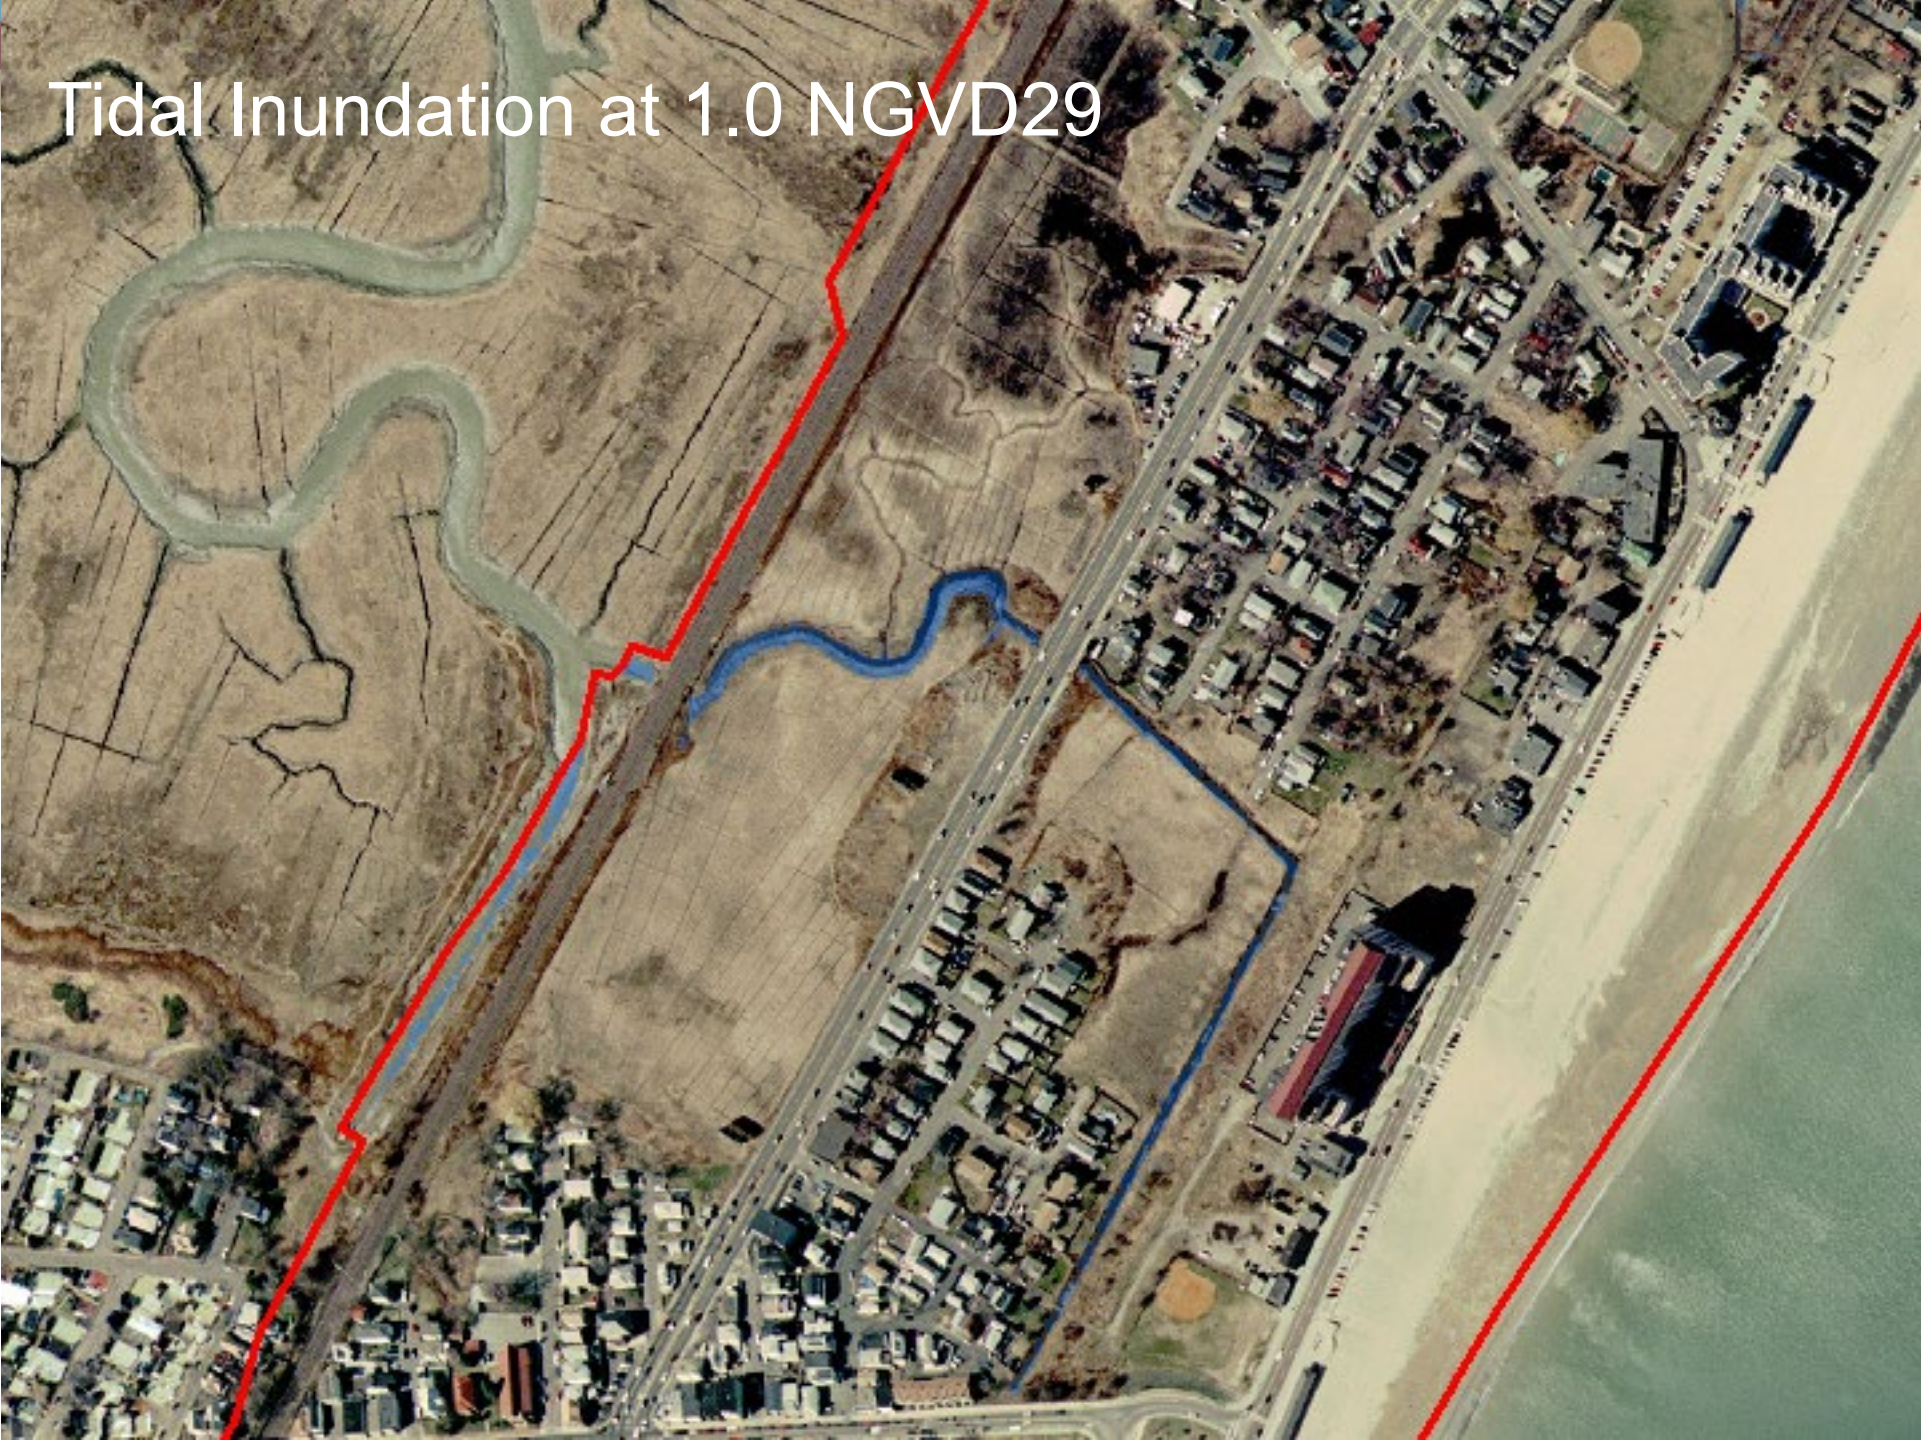
Tidal Inundation at 1.0 NGVD29

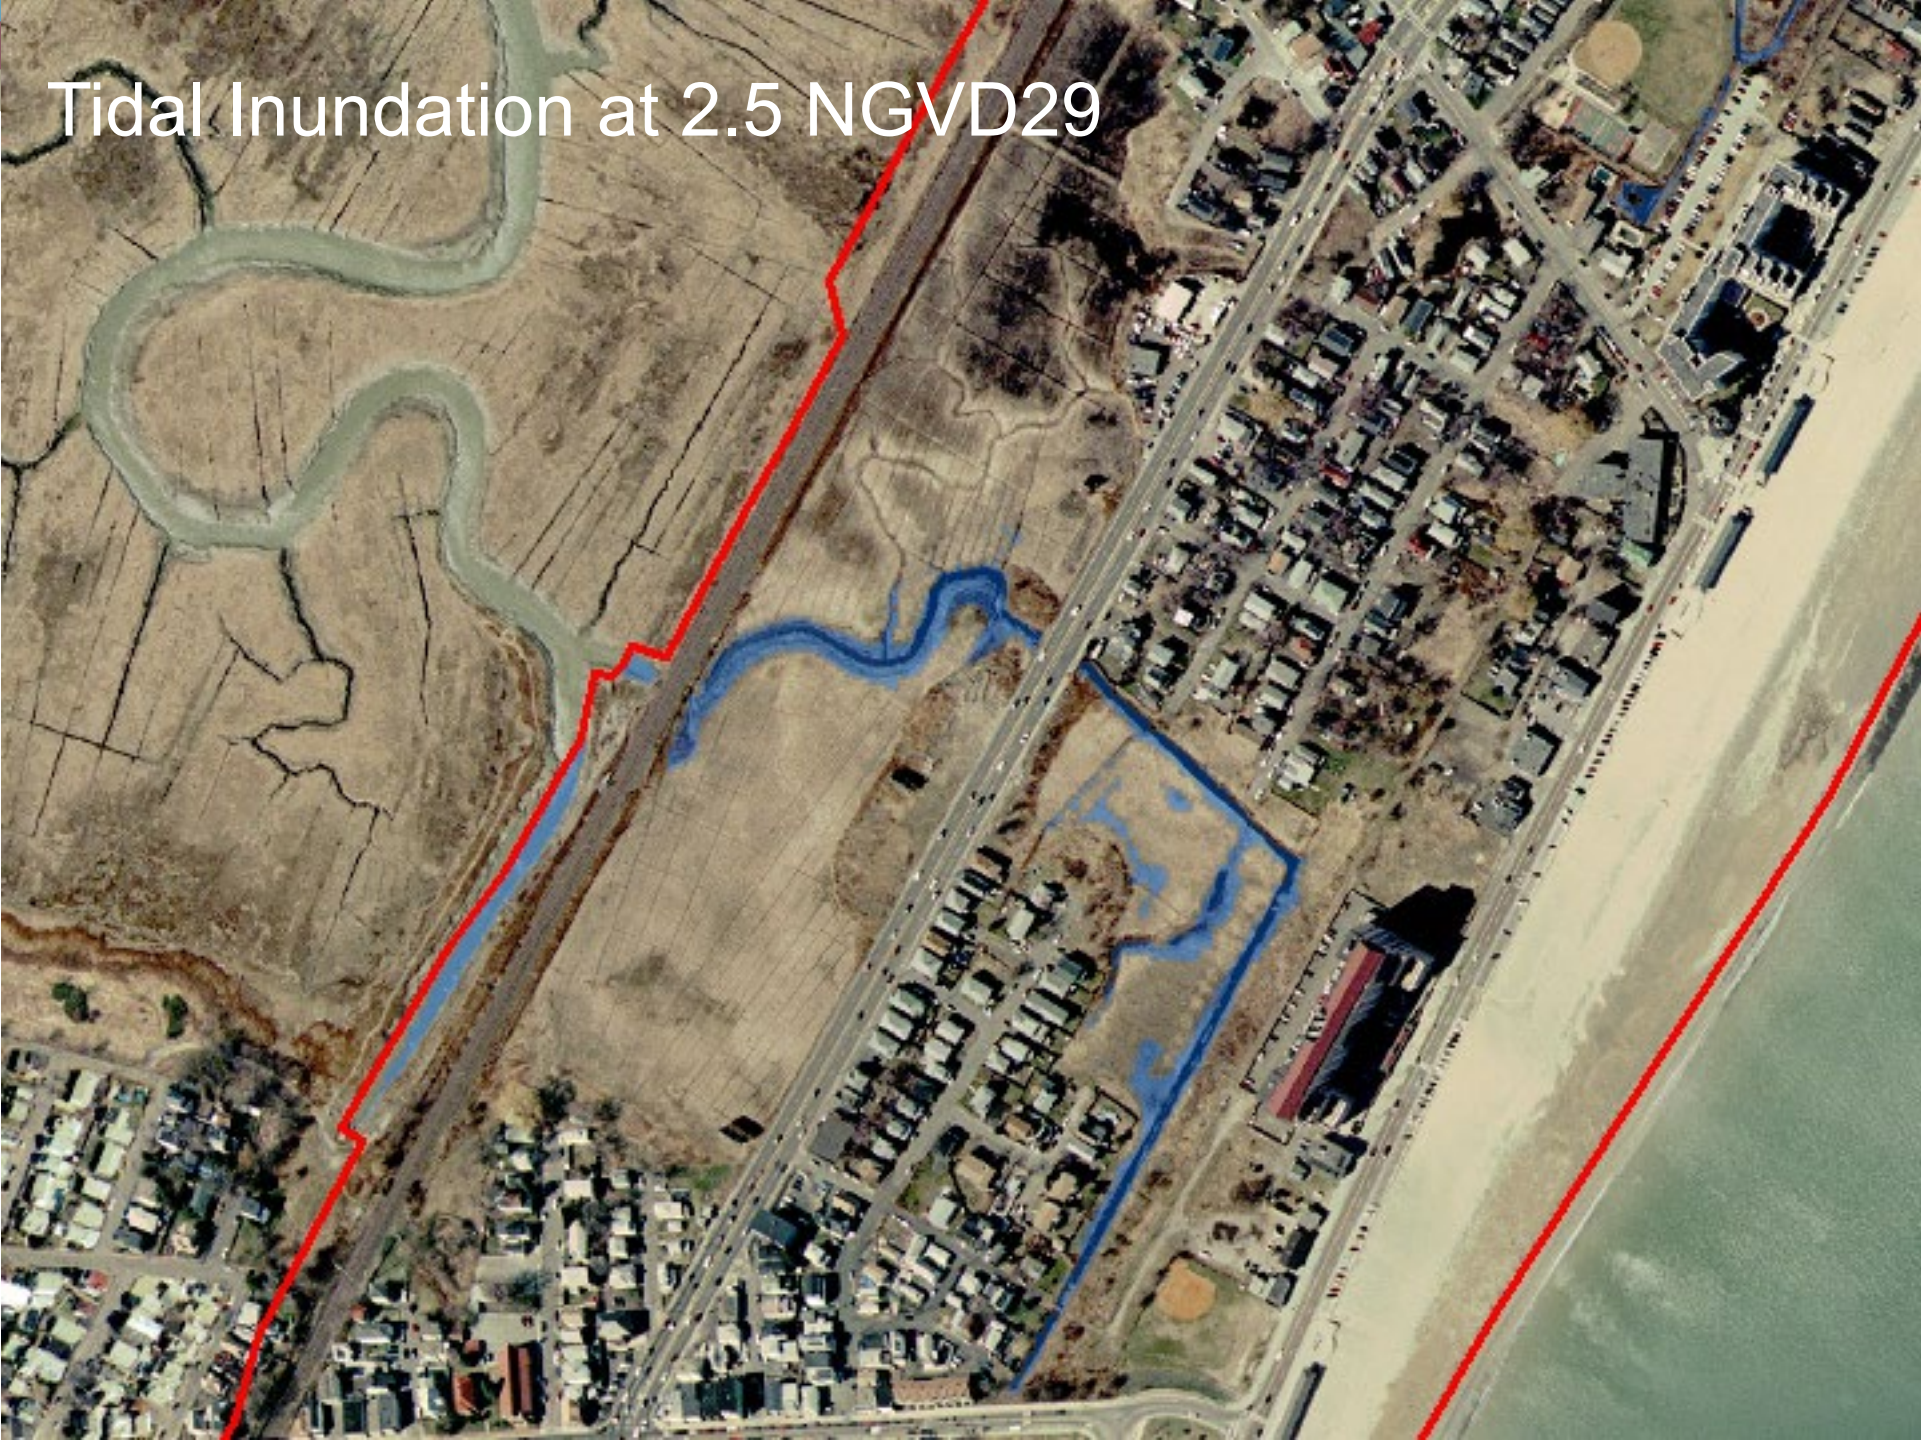
Tidal Inundation at 2.5 NGVD29

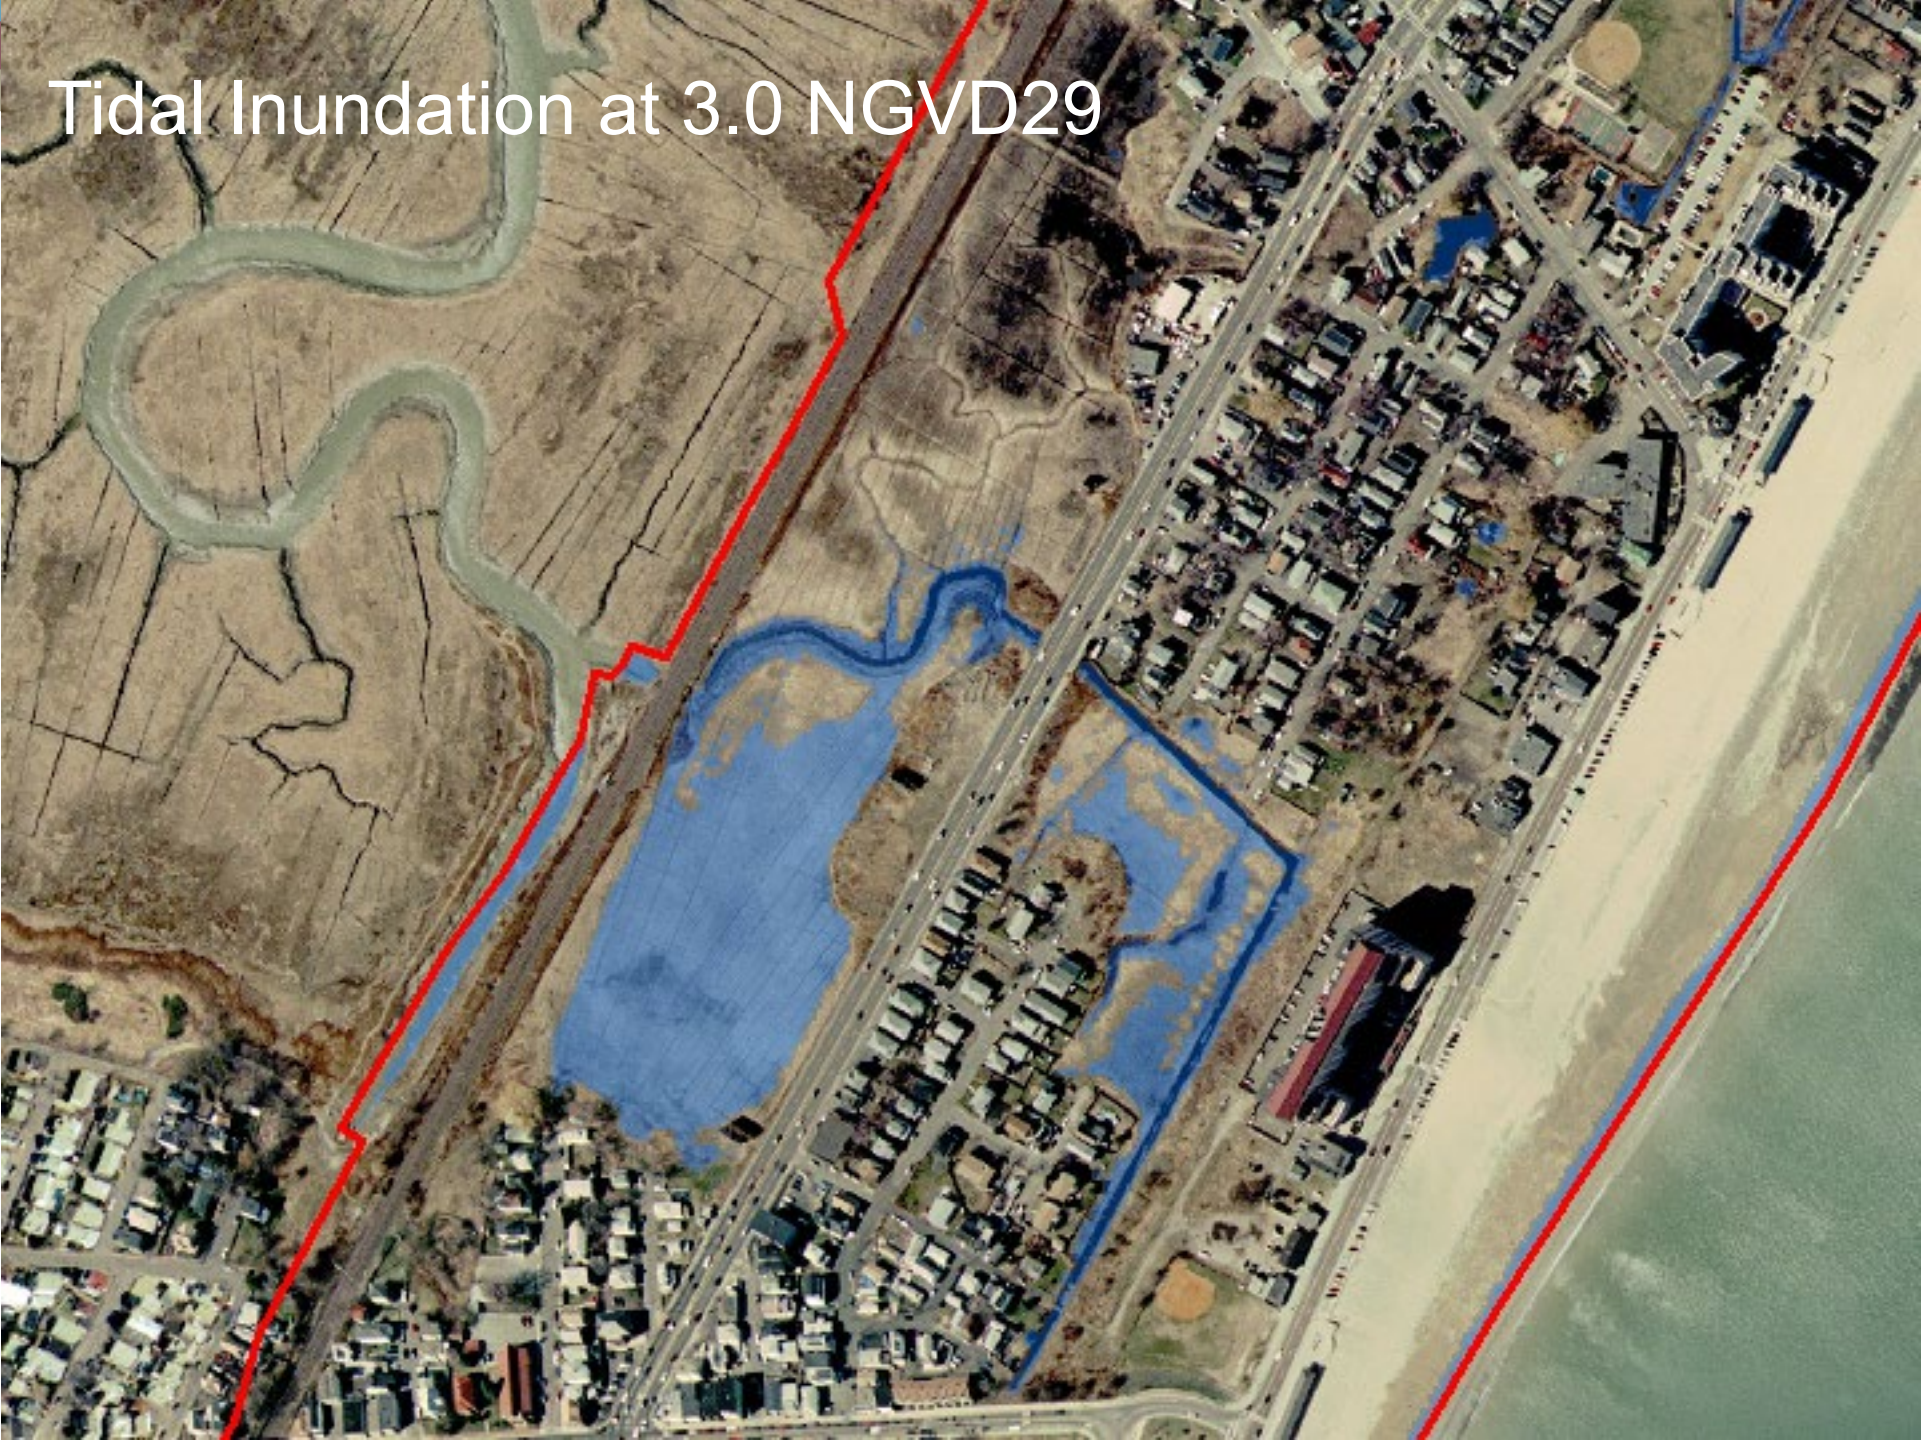
Tidal Inundation at 3.0 NGVD29

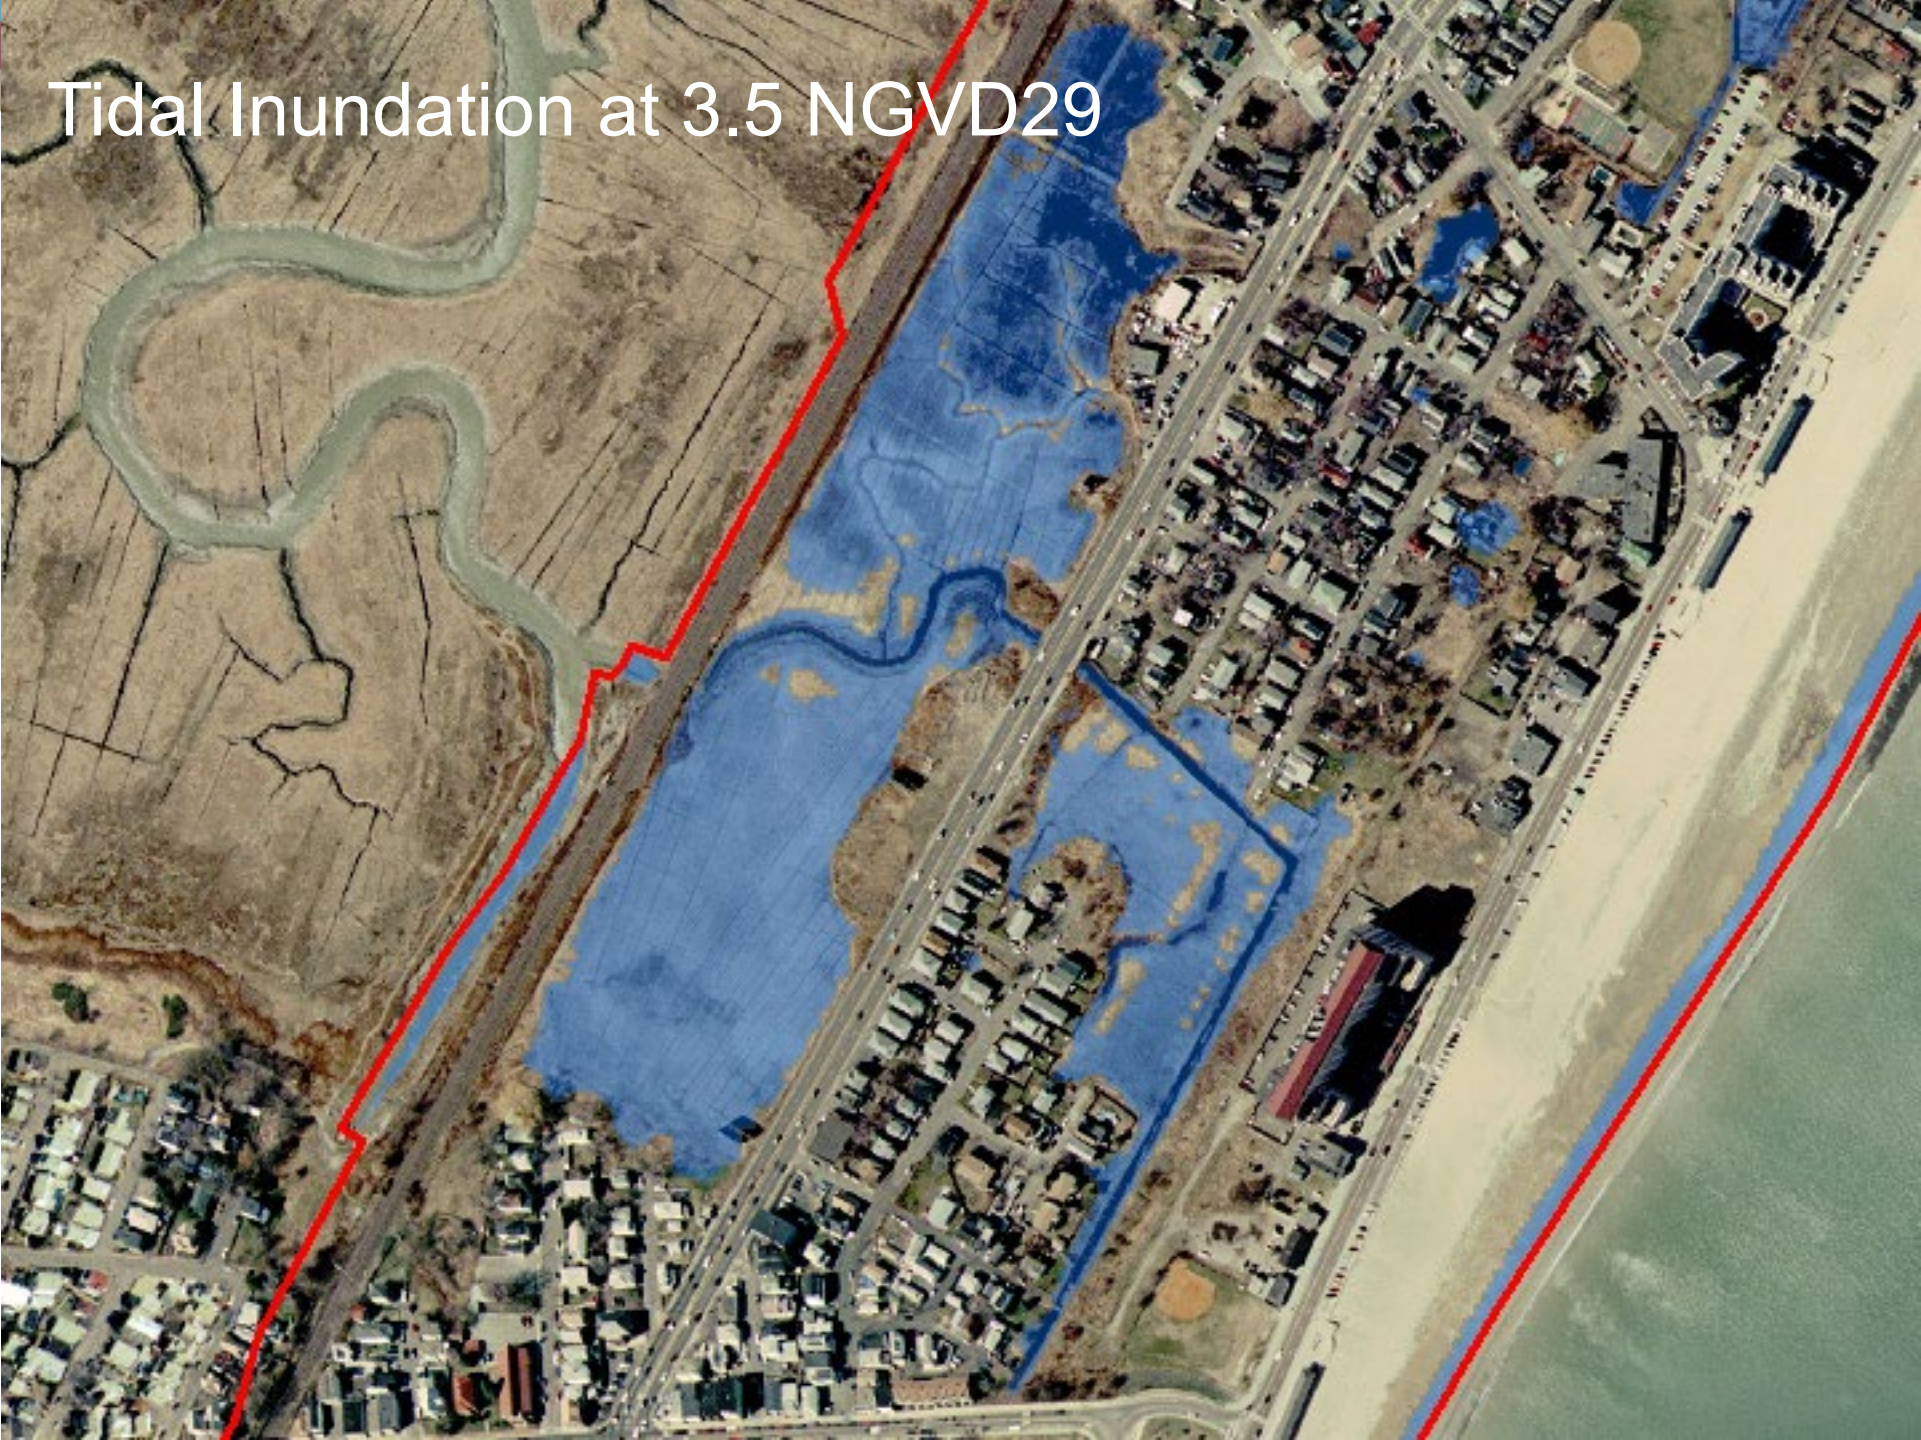
Tidal Inundation at 3.5 NGVD29

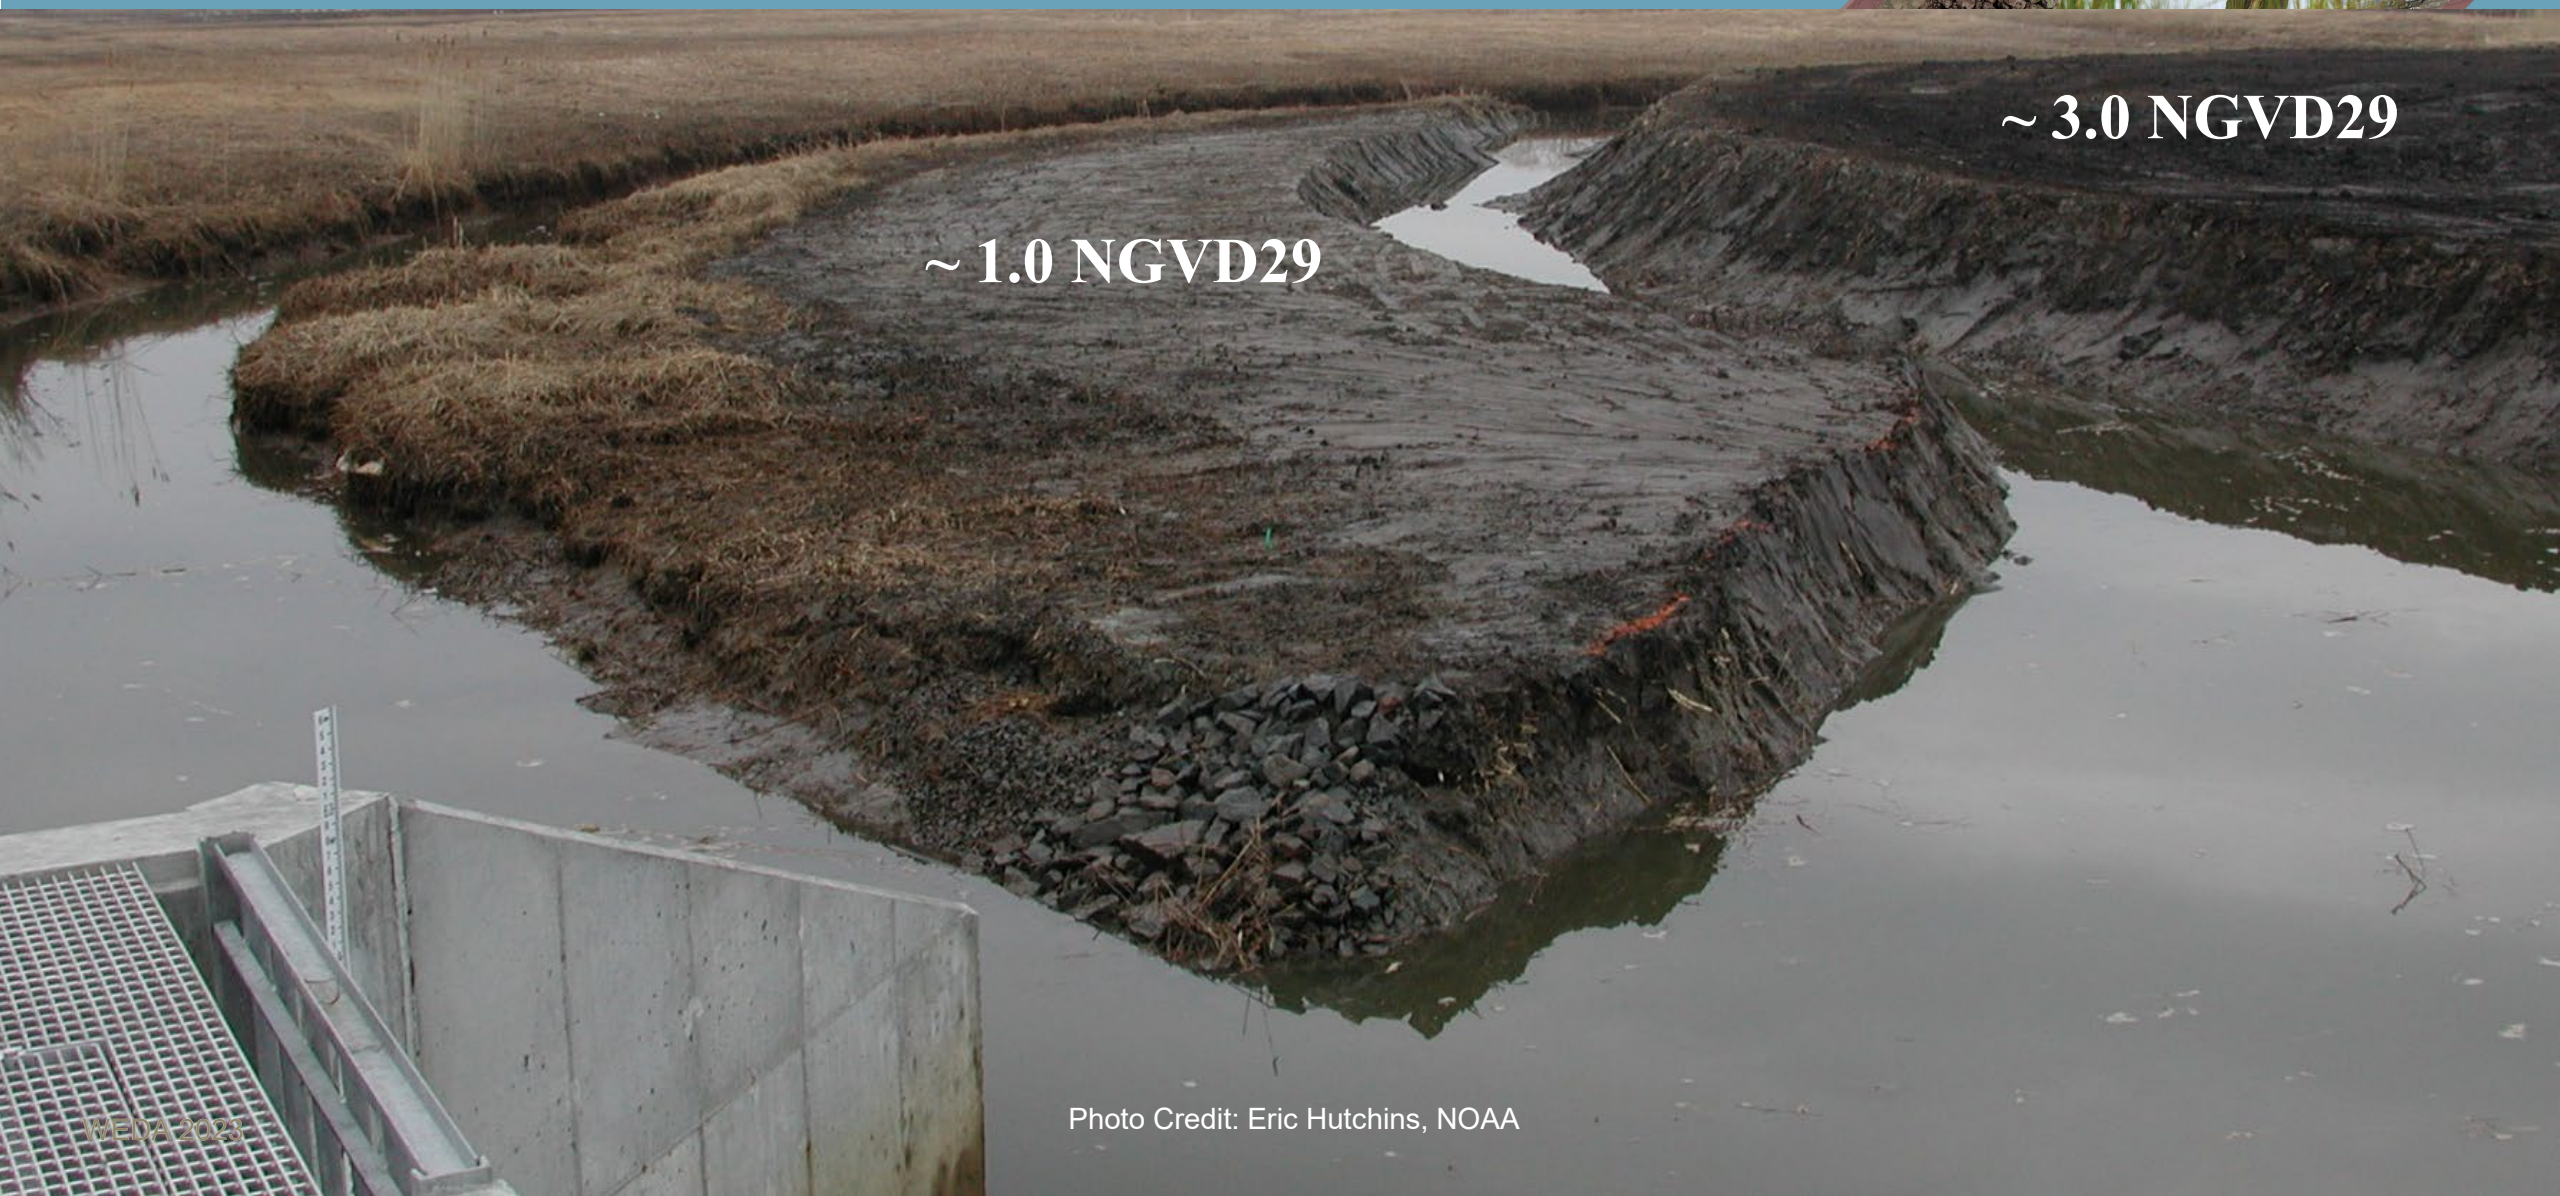
Self-Regulating Tide Gate, Channel and Island (2004)

~ 3.0 NGVD29

~ 1.0 NGVD29

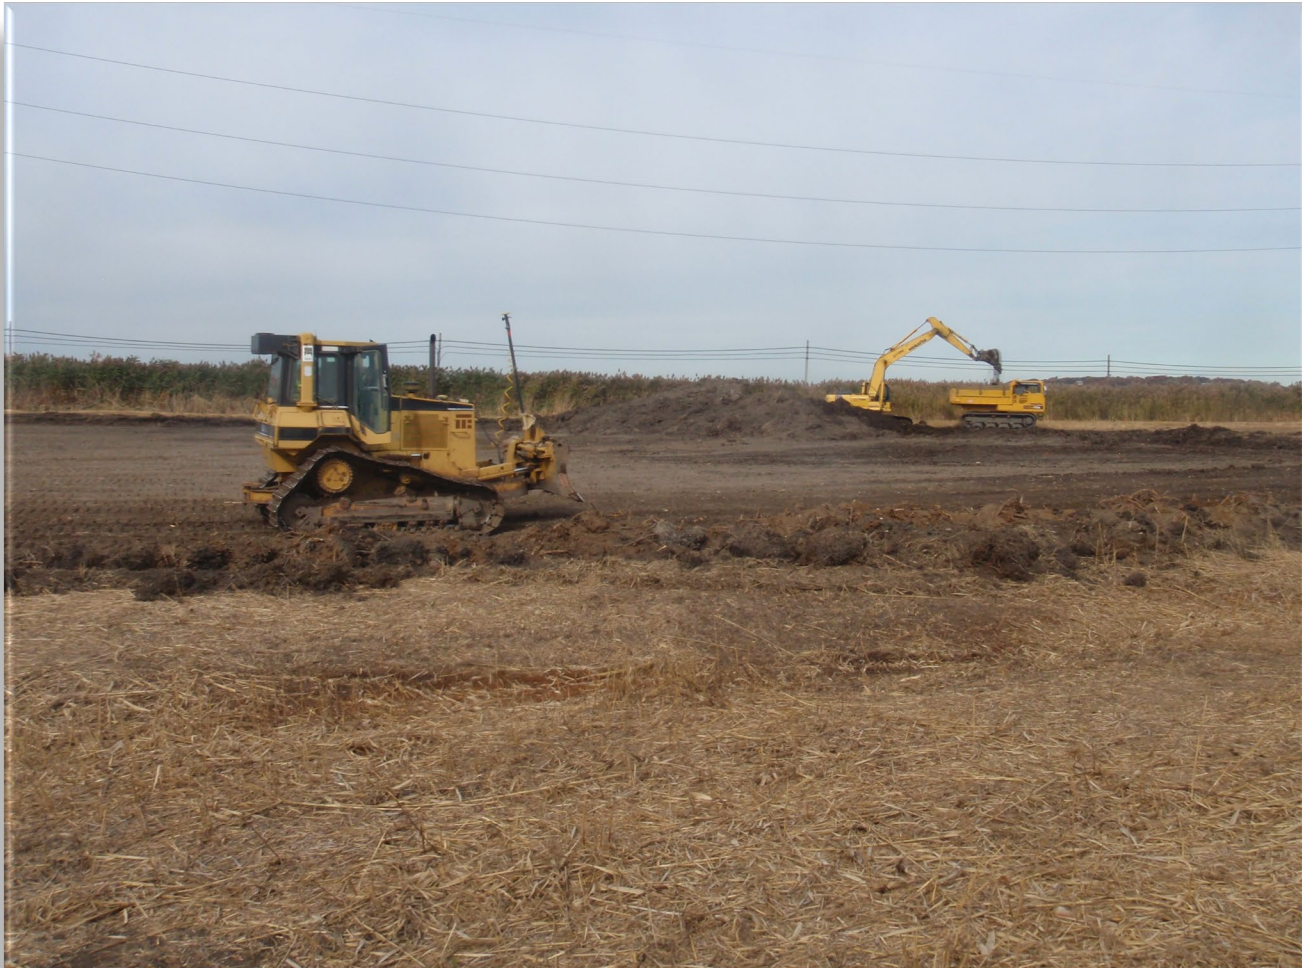
Establishing New Marsh-Bench Elevations in 2013

- Approximately 7,000 cubic yards of marsh soil removed
- Beneficial use of excavated marsh soil as cover material at a local landfill

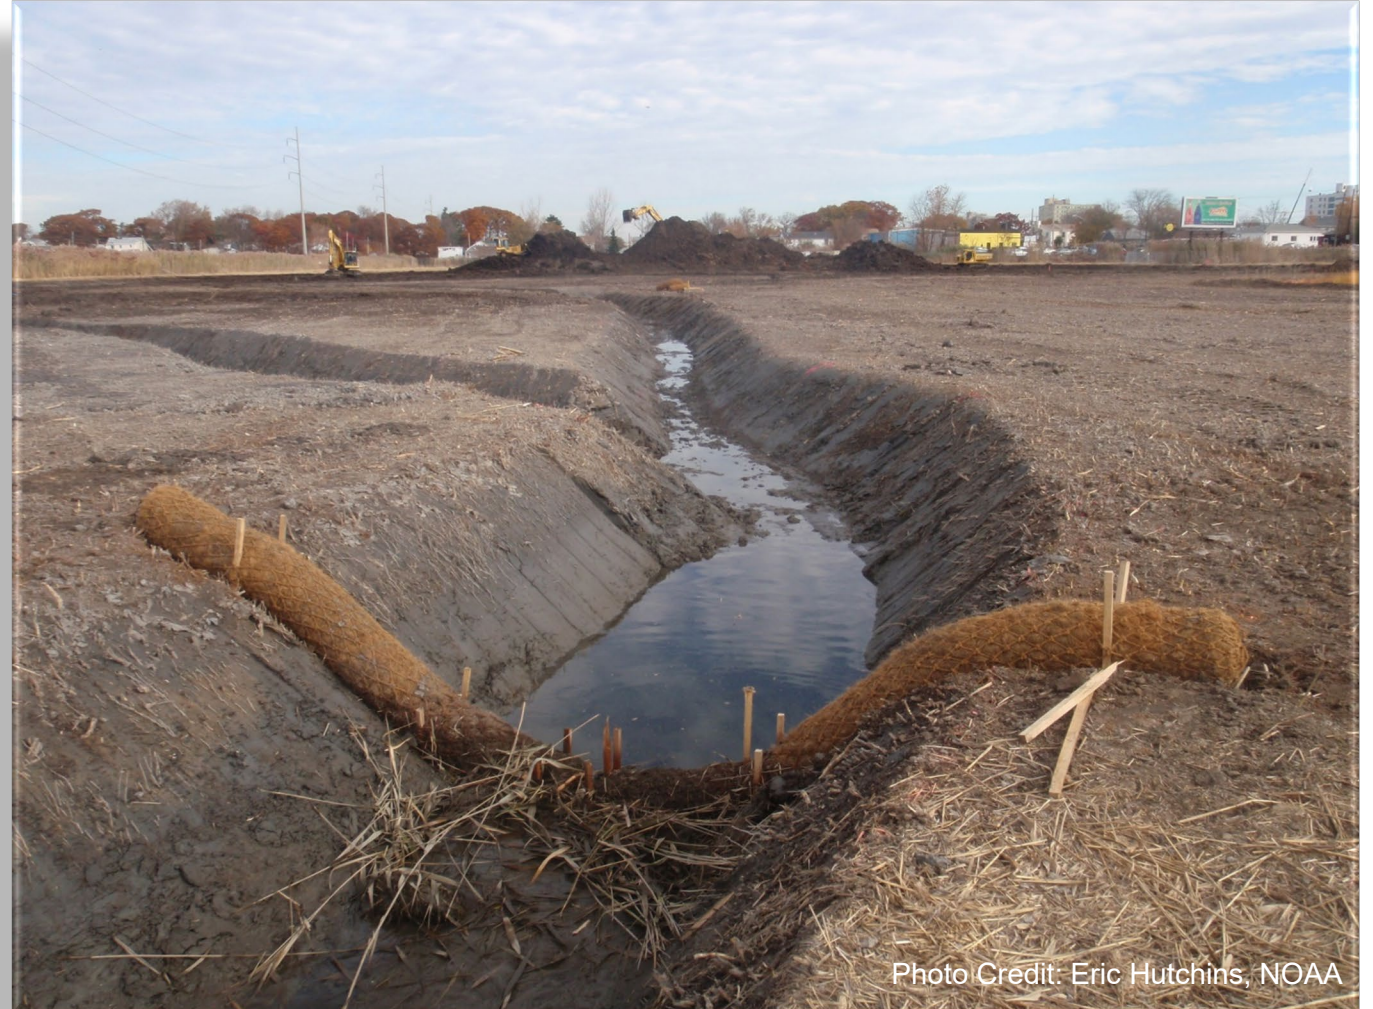
Flow Channels Design

- Quickly inundate marsh bench areas to maximize duration of saltwater intrusion
- Allow for the development of secondary flow channels
- Provide sufficient surface water velocities to minimize in-channel sediment deposition

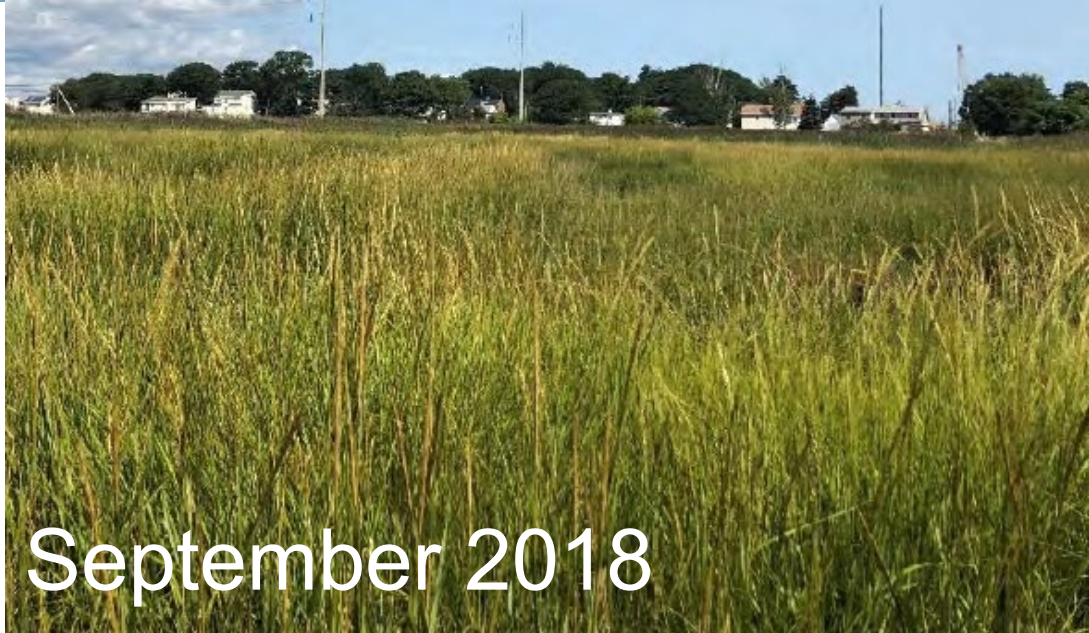
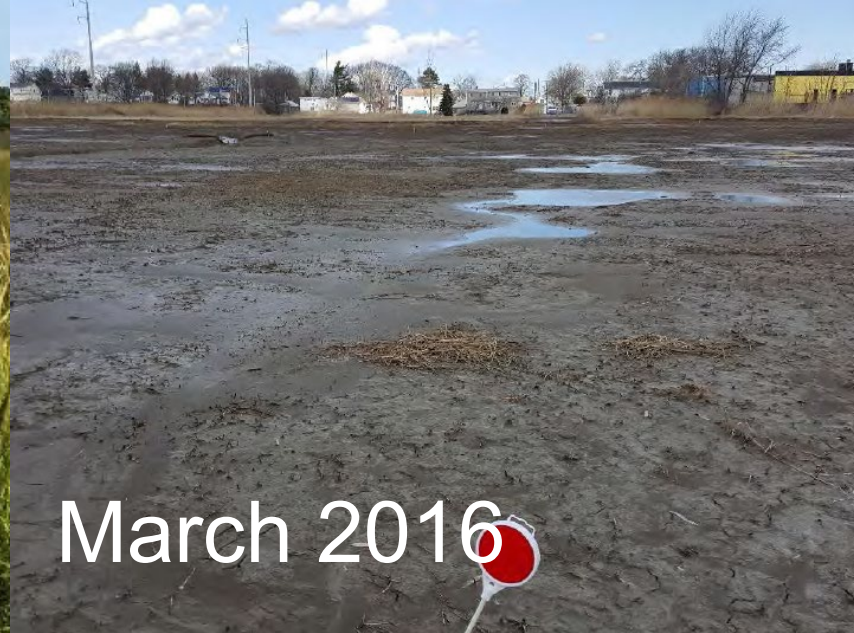
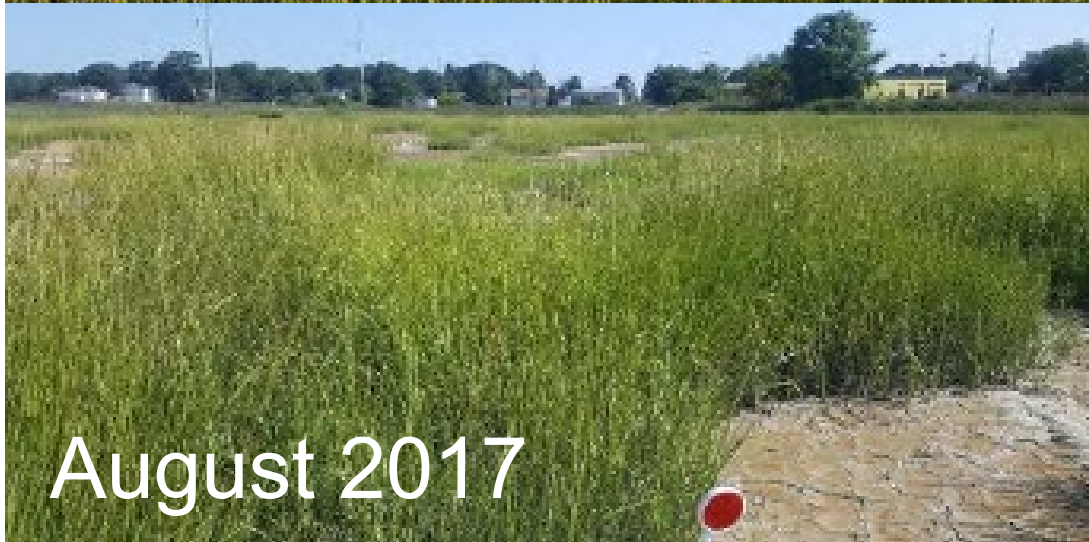
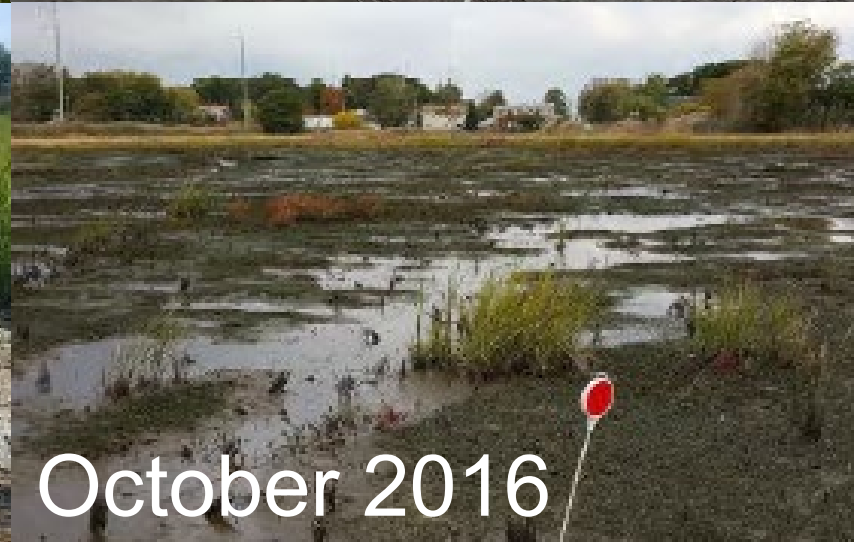
Station H-1 Looking Northeast

September 2018

March 2016

August 2017

October 2016
