## **High-Profile Site**

- Boathouse Row National Historic Landmark
  - Olympic rowing training facility
  - Last successfully dredged in 1999
  - Mud and land in front of boathouses

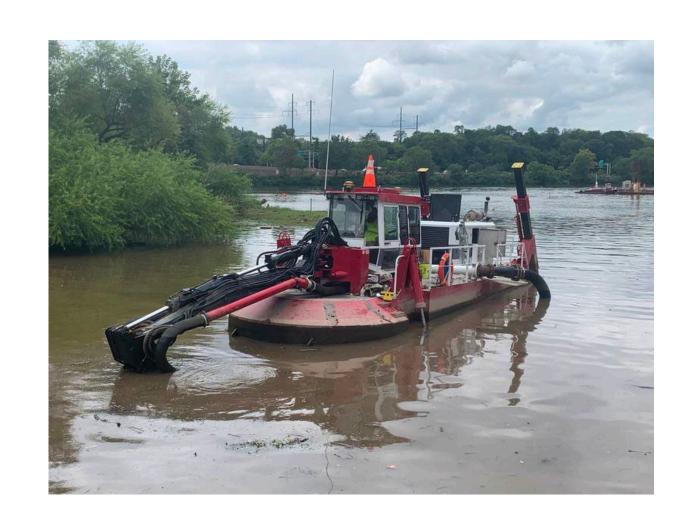
# **Specialized Equipment**

Submersible dredge pump
Barge-mounted excavator
2 spud barges

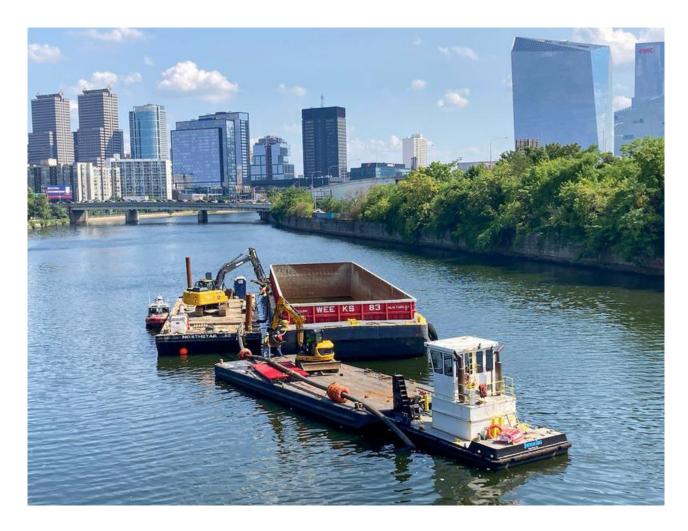
## **Challenging Dredging Conditions**

Hard clay, silt and mud Sand mixed with coal Anthracite coal lumps Debris (150 cubic yards)

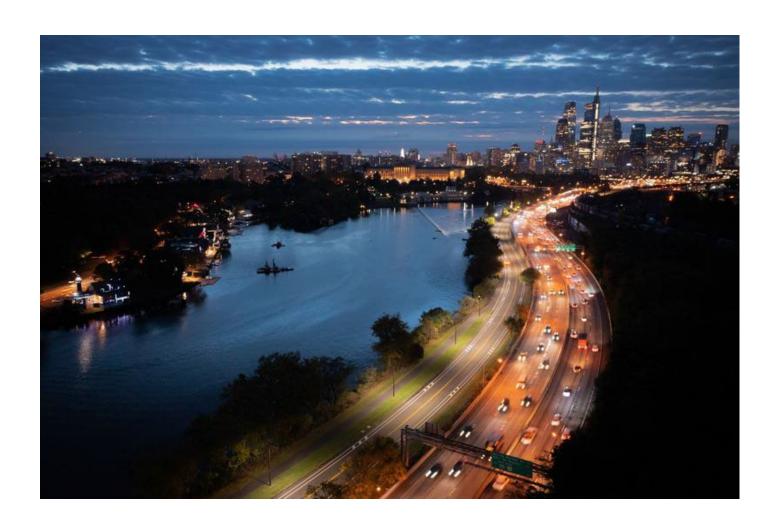
**Boathouse Row restored**
