**2015 WEDA ENVIRONMENTAL EXCELLENCE AWARD  
NOMINATION FOR CONSIDERATION FOR  
ENVIRONMENTAL DREDGING**

**Public Works and Government Services  
Canada Phase 1 Esquimalt Graving Dock  
Waterlot Remediation Project**

Nomination Submitted by WEDA Member Anchor QEA, LLC

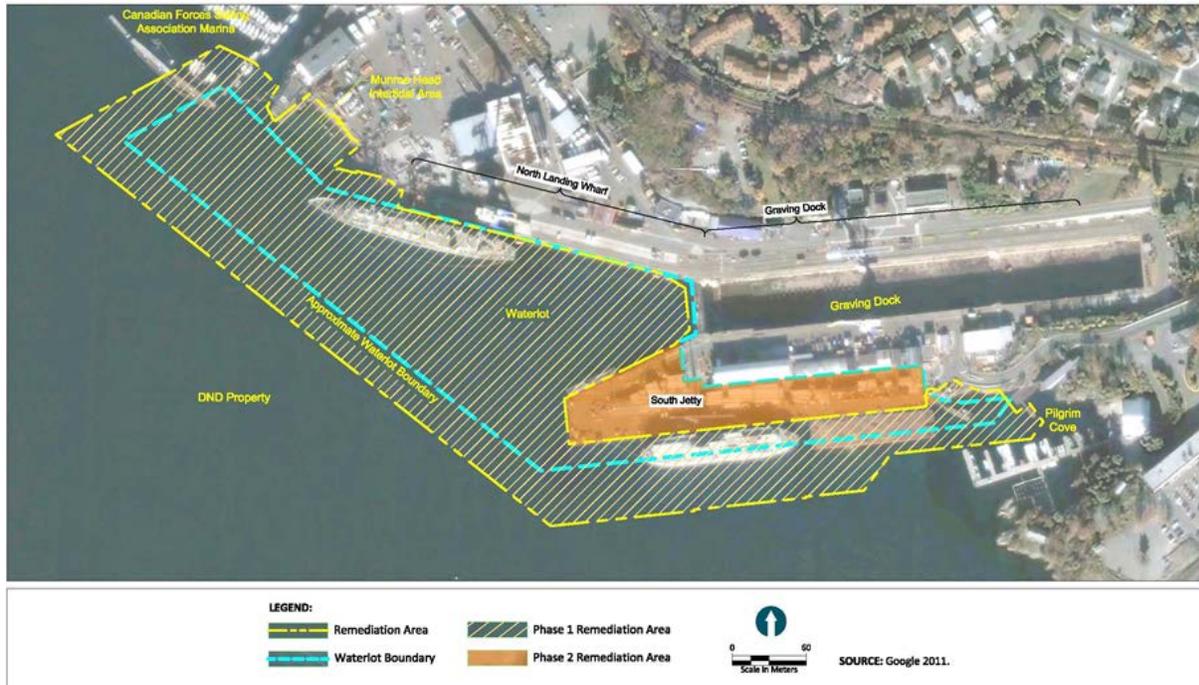
Figure 1. Project Area and Boundaries

In support of these goals and objectives, PWGSC developed a multi-phase remedial action plan and engineering design for cleaning up contaminated sediments within the Waterlot and in adjacent areas administered by the Department of National Defence (DND). Phase 1 consisted of remediation of open-

water sediments, excluding sediments beneath the South Jetty, which will be addressed in Phase 2 starting in 2015 (Figure 1). Phase 1 project work was completed between November 2012 and April 2014.

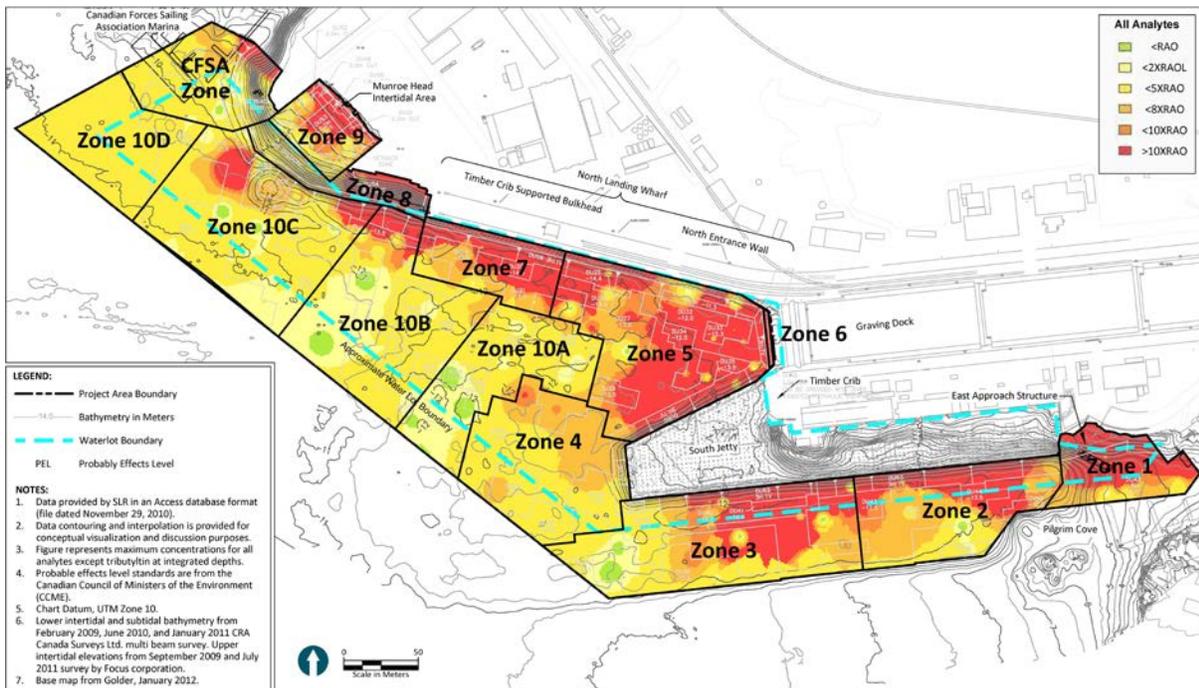
Figure 2. Remediation Zones and Contaminant Characterization

The EGD Waterlot Remediation Project is the largest sediment remediation project completed in Canada to date. EGD is located within Esquimalt Harbour, where elevated contaminant levels from years of industrial and commercial use have required fish consumption advisories. The EGD Waterlot contained some of the highest concentrations in the harbour prior to remediation, including very high levels of PCBs, PAHs, tributyl tin, and other metals up to 100 times cleanup criteria (Figure 2). This project incorporated conservative decisions to take the first key step in

Construction duration was limited to 10 months, and nearly all staging was conducted on marine vessels due to the limited upland staging areas available at EGD, further challenging scheduling and logistics for construction. A specific construction sequence was required to provide certainty for EGD operations in the Waterlot and to minimize the potential for recontamination from vessel propwash, with dredging conducted in the Zones with the highest concentration sediments first (Figure 2). However, the vessel booking schedule and arrivals/departures of

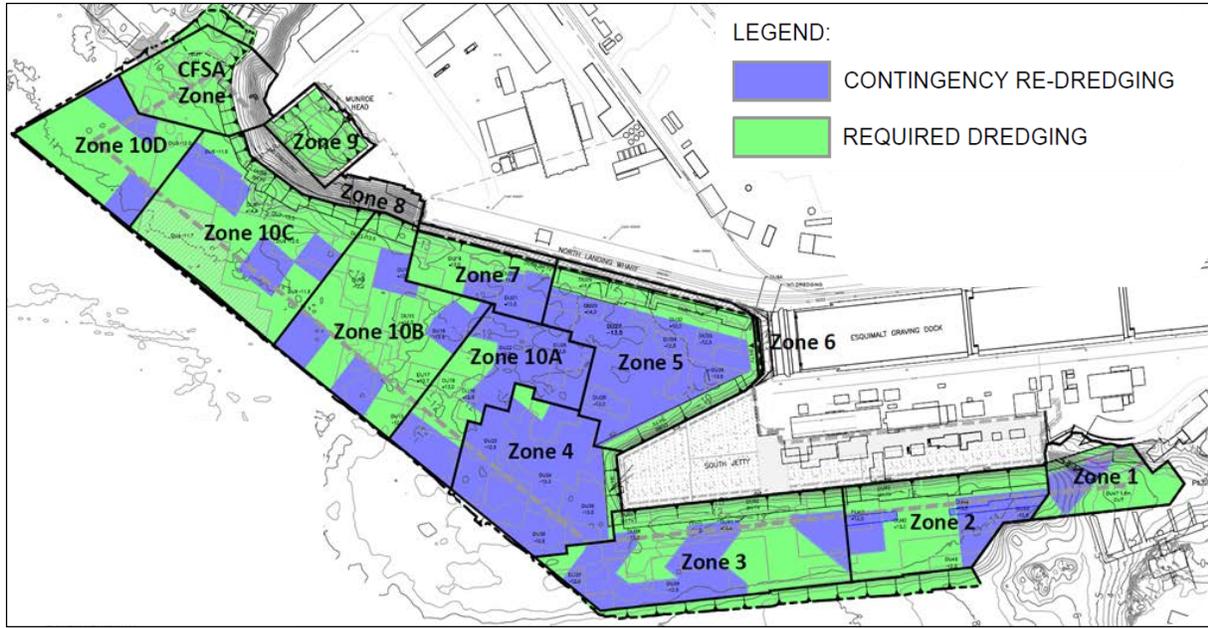
Figure 3. Phase 1B Required and Contingency Dredging

For the Phase 1B open water area, to remove the maximum contamination practicable, the remediation design was based on the extent of contaminated sediments that exceeded the most stringent of applicable federal and provincial generic numeric criteria. These criteria were also used as part of an intensive contingency re-dredging program to remove missed inventory and generated residuals following the completion of required dredging. The post-dredge confirmatory sampling program used an intensive sampling program, with surface and subsurface sediment samples collected every 25 metres, to ensure maximum removal and confidence in final site conditions. Approximately 41% of the project area was subject to contingency dredging, resulting in a final contingency re-dredging volume of 23,581 m<sup>3</sup>, or 16% of the entire dredge volume (Figure 3).

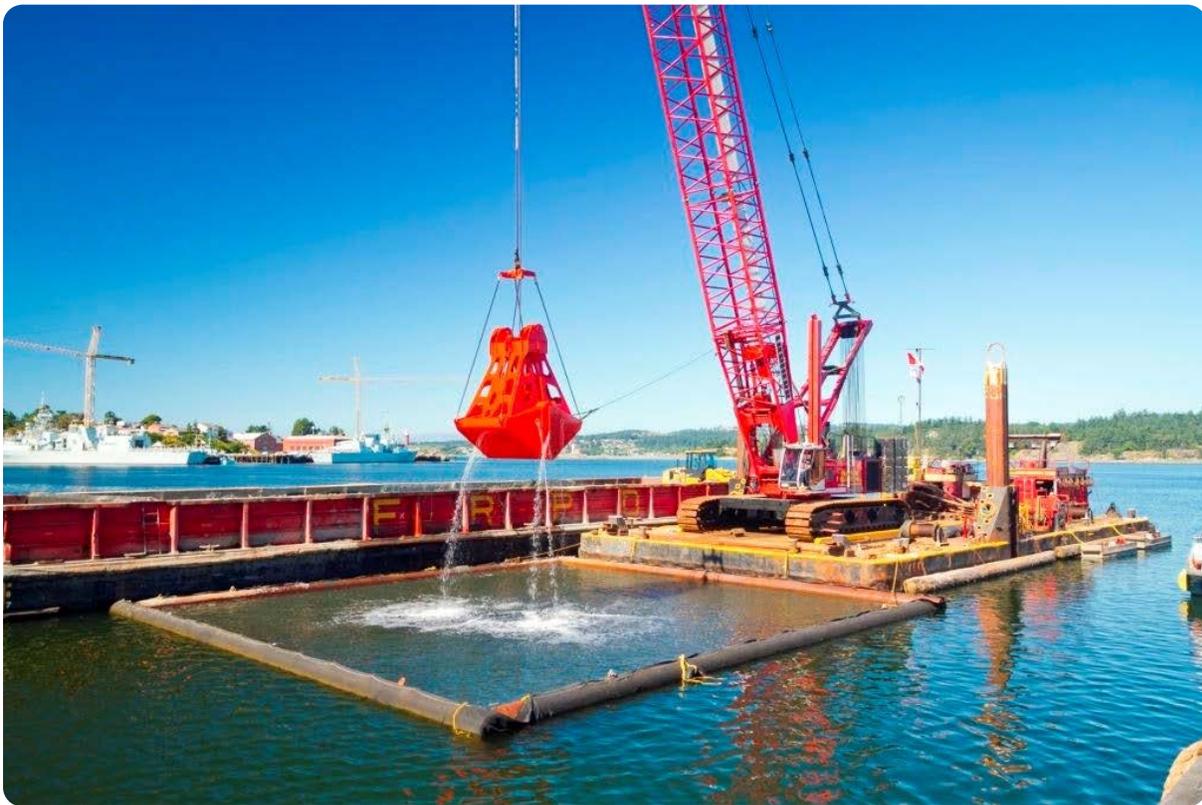
Photo 1. Phase 1B Dredging with Silt Curtain Frame

Very minimal water quality impacts were generated as a result of the 10-month project. A fixed 50-foot by 50-foot frame was used to support a 6-m long silt curtain around the mechanical dredging operation,

which assisted in minimizing water quality impacts. Water quality compliance monitoring was conducted at monitoring locations 25 and 100 m from the work activity and consisted of turbidity, total suspended solids, and chemical monitoring throughout the water column to ensure compliance with stringent water quality criteria developed for the project. Passive dewatering was not completed on material barges in Phase 1B due to concerns about meeting water quality criteria. Instead, an advanced water treatment system was used for on-site treatment of dredge water, which was sited on a barge due to constrained access in the on-site upland areas. Treatment involved physical separation of solids and water in order to meet TSS and turbidity requirements for discharge. Sediment dewatering and water treatment was completed at night, so the treatment/dewatering barge was ready for the next day's dredging activities.

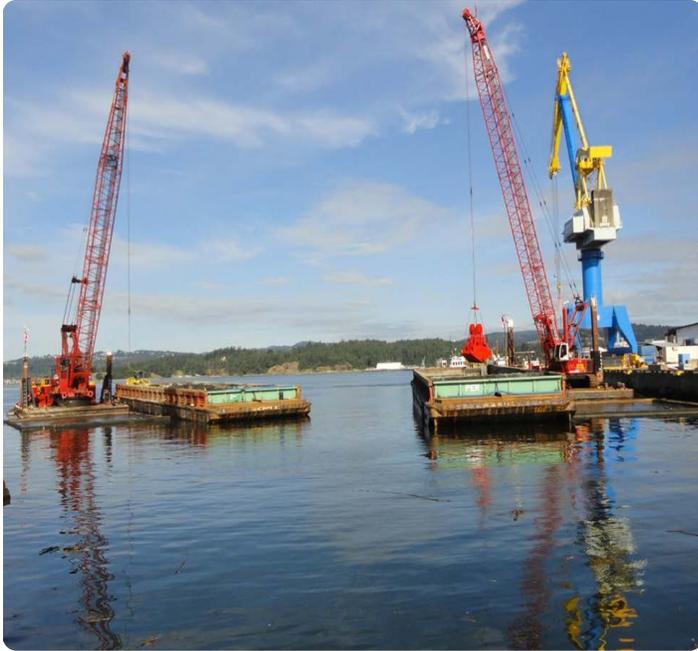
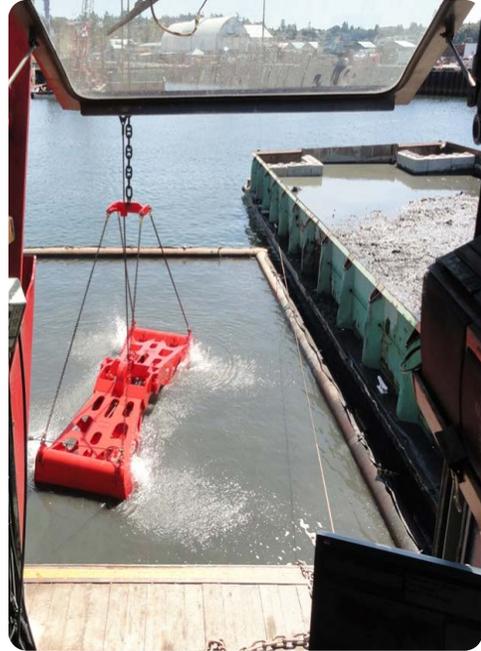
Photos 2 and 3. Concurrent Phase 1B Dredge Plants

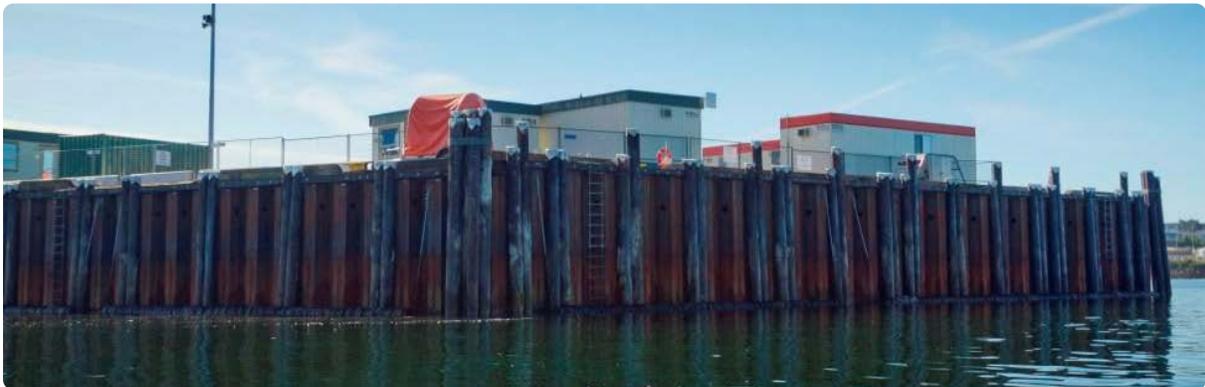
Photo 4. Completed Phase 1A Sheetpile Perimeter Wall around South Jetty

Phase 1A consisted of the installation of a temporary underpier erosion protection system (sheetpile wall) around the South Jetty structure to prevent resuspension and transport of contaminated, under-jetty sediment into the open-water area that was remediated as part of Phase 1B of the project. The sheetpile wall provided a barrier against waves and propwash from vessels operating adjacent to the South Jetty. The sheetpile wall was designed to be protective for selected design vessel operational conditions, with appropriate seabed embedment depths and attachment to the deck of the South Jetty to provide structural integrity. The construction was implemented in three segments to minimize the disruption for EGD operations and to accommodate fishery windows.

When initially installed, the sheetpile wall was pinned to the seaward edge of the deck of the timber jetty structure. This design of the sheetpile wall also considered requirements to contain suspended sediment generated during Phase 2 remediation. Prior to the initiation of Phase 2 remedial activities, the timber jetty structure will be removed and the wall will be driven deeper to an approximate top elevation of 0 m Chart Datum, in order to maintain its stability while still isolating the Phase 2 contaminated sediments from the newly remediated Phase 1 sediments.

When unpinned and driven deeper, the sheetpile wall design will change from a propped cantilever system to a free cantilever system. To understand the stability of the wall after the re-drive, the design for the original

sheetpile length/type and embedment requirements was based on an analysis of propwash forces on the sheetpile wall both following Phase 1 installation and during Phase 2 remediation using a Computation Fluid Dynamics (CFD) model. Additionally, the dynamic pressure acting on the sheetpile wall due to waves and suction forces was estimated to support the structural and geotechnical design. The re-driven sheetpile wall along with an integrated floating silt curtain will form a resuspension barrier to prevent recontamination of the Phase 1 area during Phase 2 remediation.

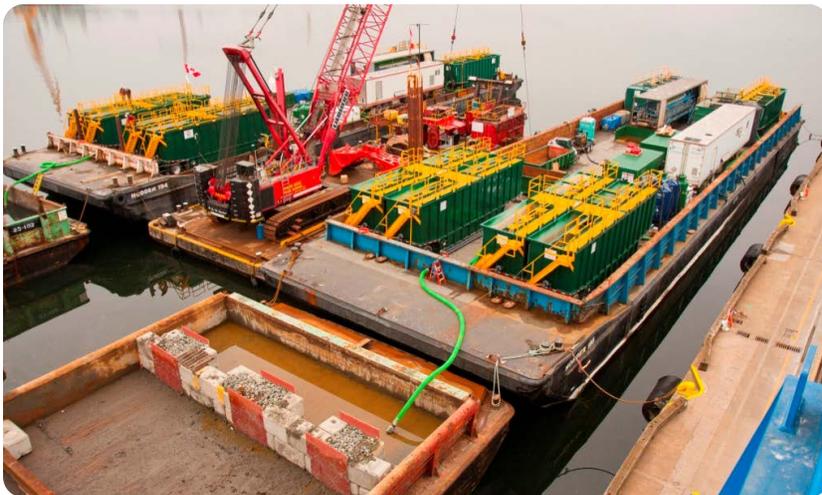
Photo 5. Phase 1B Barge Water Treatment System
