Lincoln Park / Milwaukee River Phase I Project – Sediment Remediation to Habitat Restoration

*Western Dredging Association (WEDA)
Midwest Chapter Annual Meeting – March 2015*

Huck Raddemann & Corey Wilcox– CH2M HILL

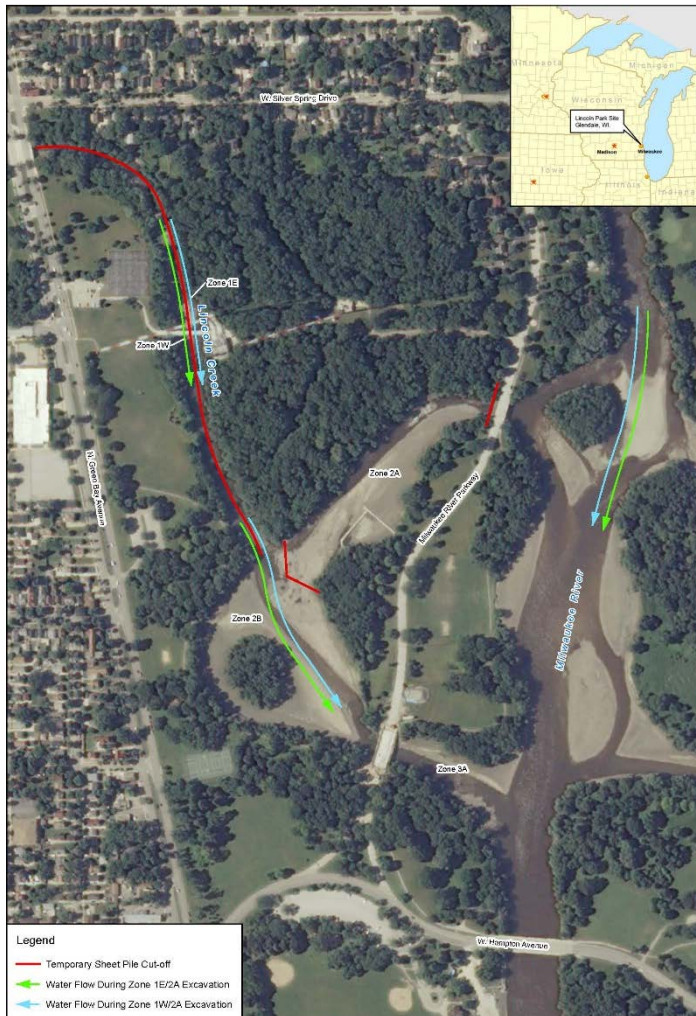
Stage 1

RA Summary – Water Flow / Sheet Pile Isolation

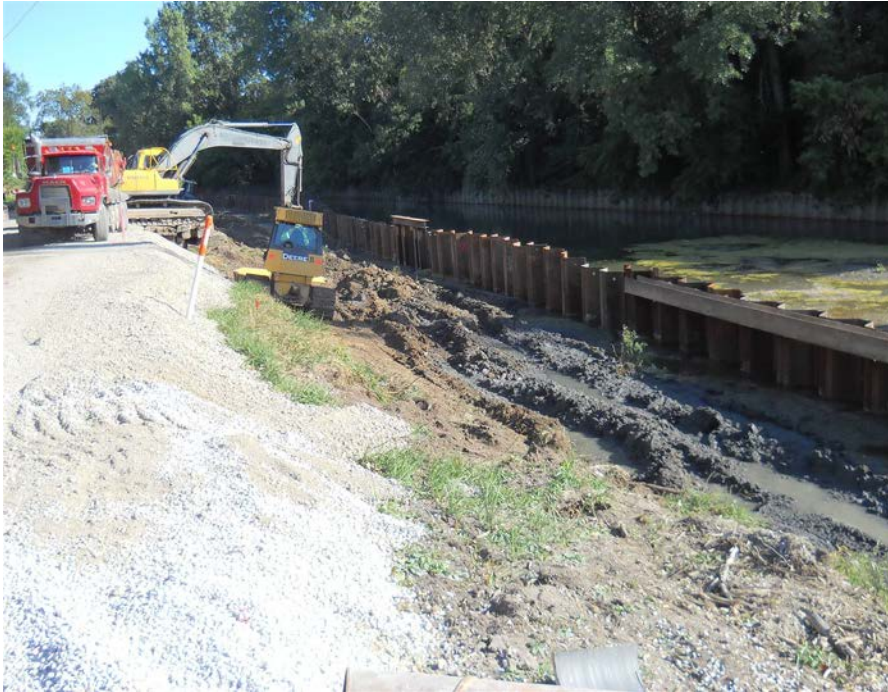
Zone 1 East / West Excavation and Dewatering

Excavation work in the west side of Zone 1

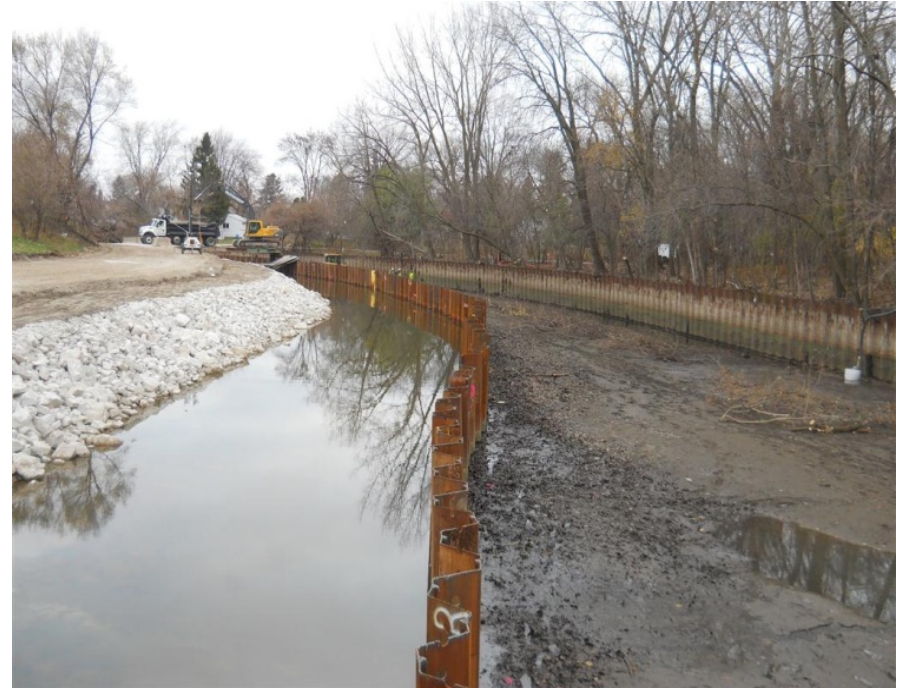
Zone 1 east dewatering and excavation (11/21/2011)

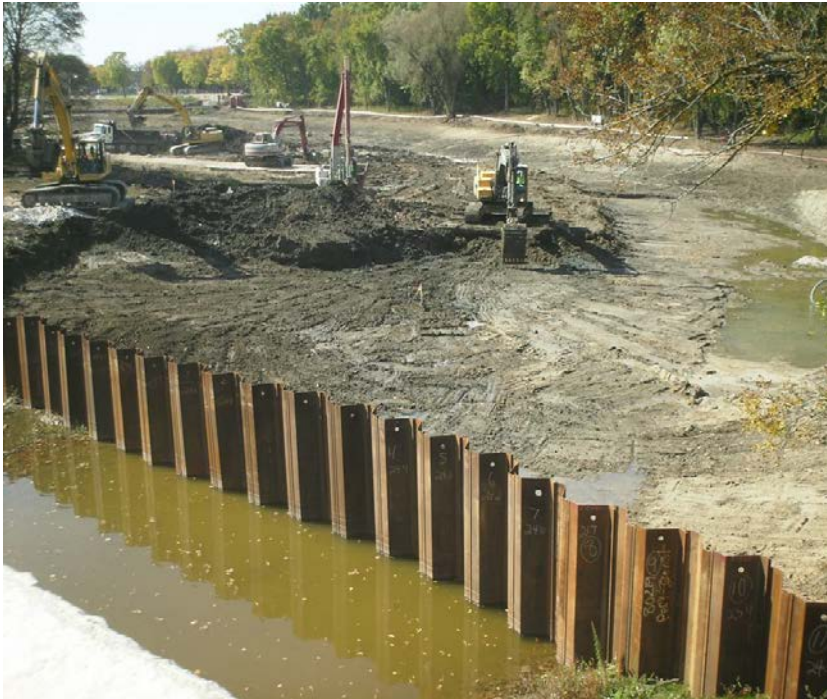
Excavation of northern end of Zone 2a (10/8/11)

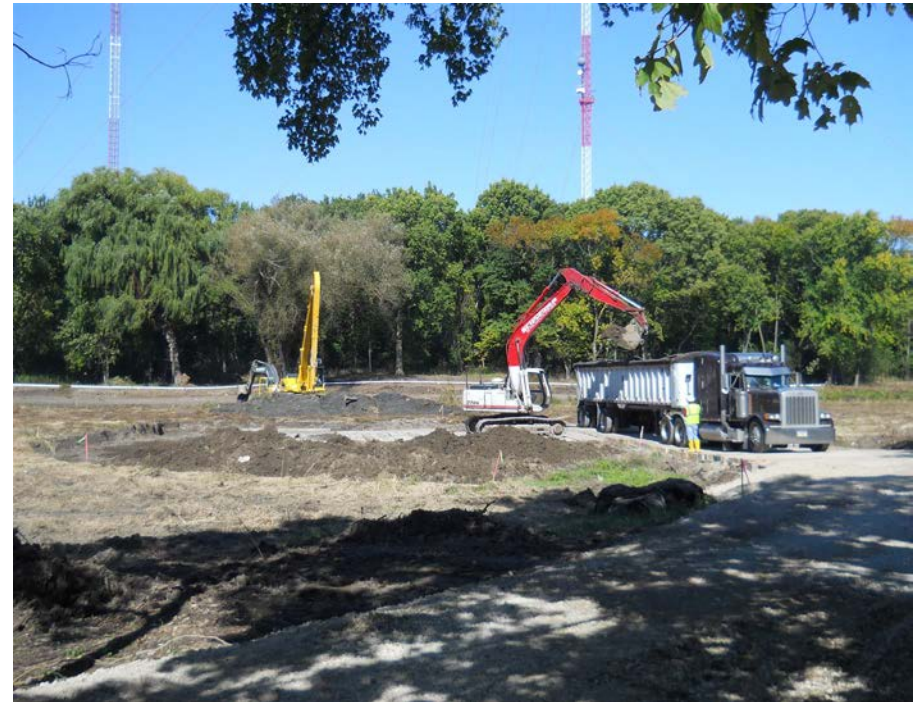
Excavation and hauling of TSCA material in Zone 2A

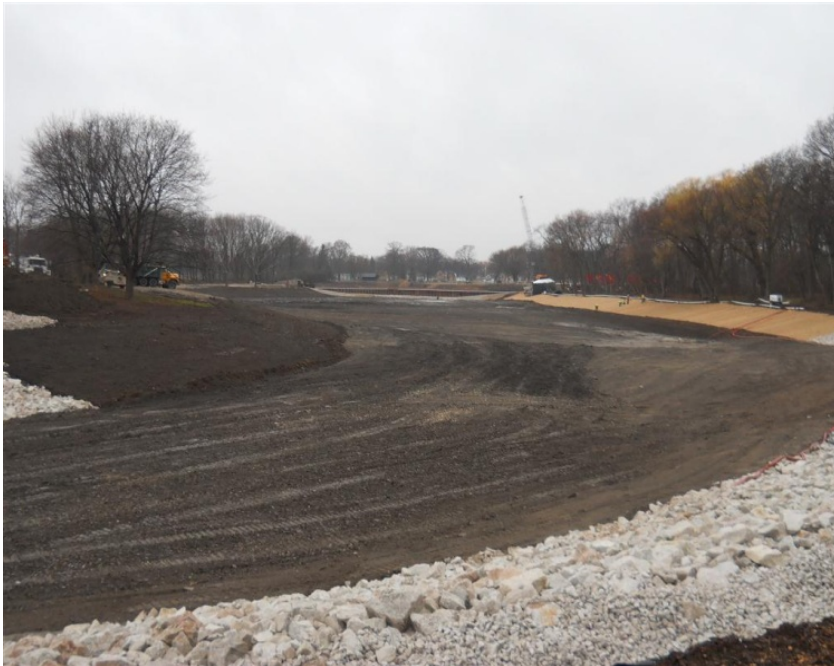
Zone 2A after completion of excavation and bank stabilization activities (11/26/2011)

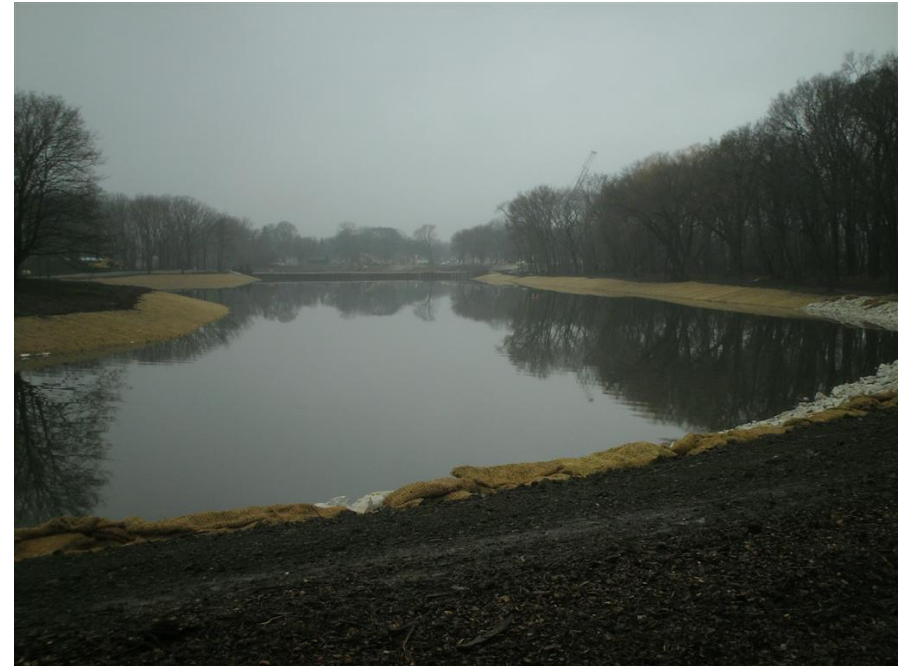
Water flow from Lincoln Creek was redirected through Zone 2A from Zone 2B

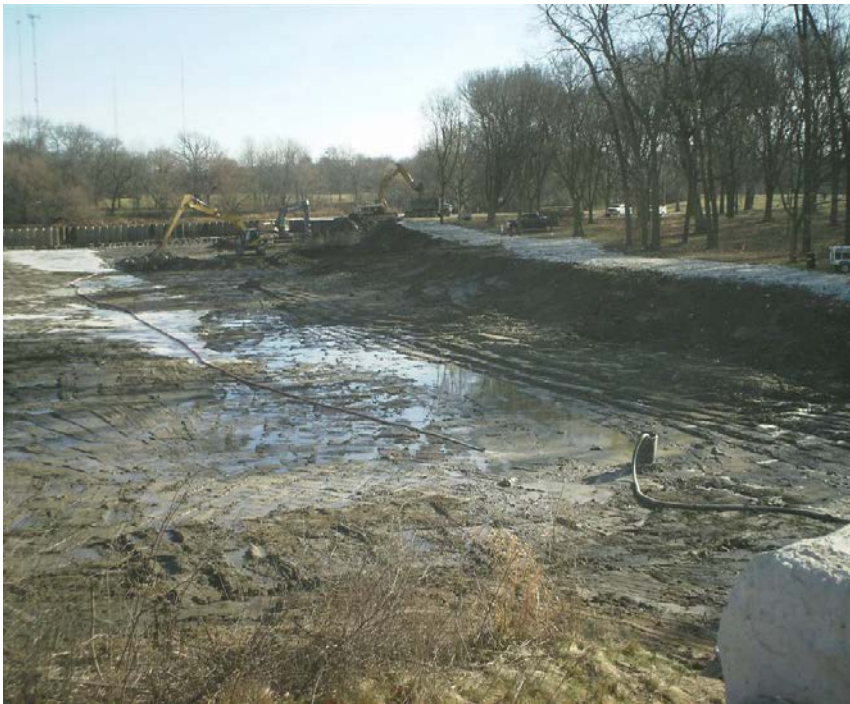
Excavation of sediments and dewatering activities in Zone 3A (1/5/2012)

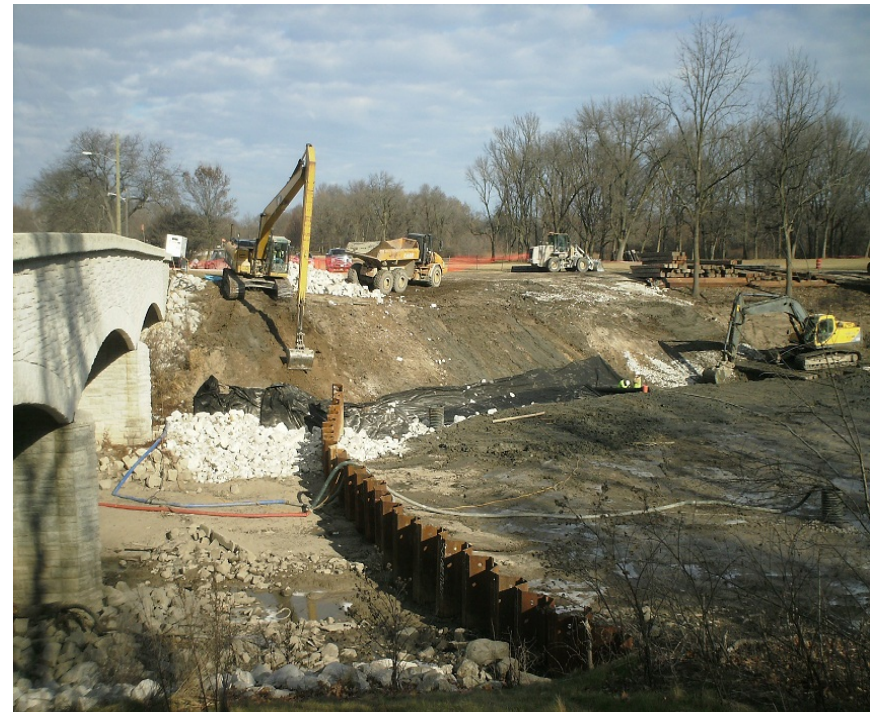
Restoration begins on the north bank on Zone 3A, trenching keyways, placing fabric and riprap (1/9/2012)
