NEW YORK & NEW JERSEY HARBOR NAVIGATION CHANNEL DEEPENING

A Project Manager's Perspective

Bryce Wisemiller
Project Manager
U.S. Army Corps of Engineers
New York District

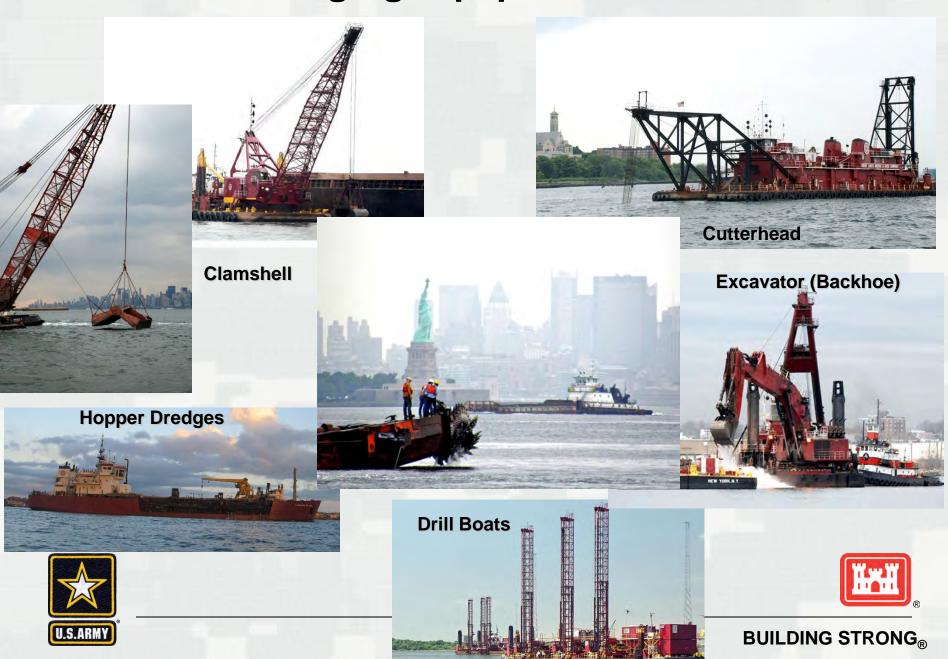
Dredging Equipment Used

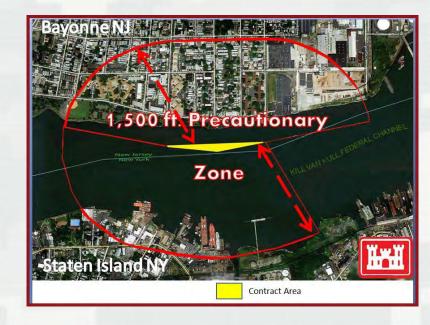
- Vibration from Blasting may not exceed these limits:
 - Historically Designated Structures 0.5 in/sec (Standard Used)
 - Residential Structures 1.0 in/sec
 - ► All Other Structures 2.0 in/sec

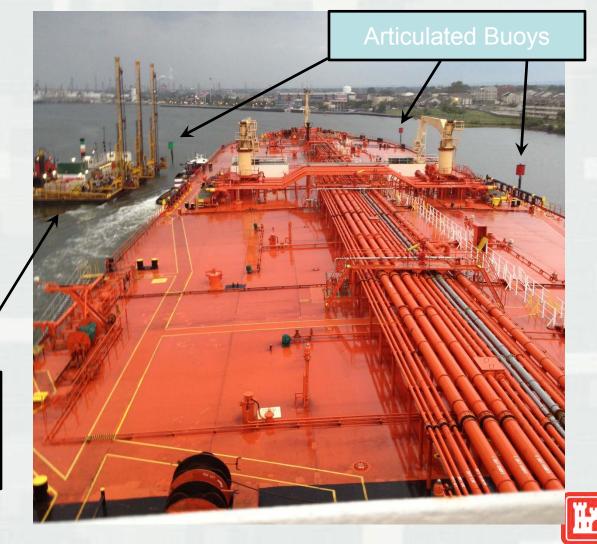
Drill Boat "Kraken"

Required Closure of
Over Half the
Channel Width —
Which Necessitated
Acquiring / Deploying
Articulated Buoys to
Maintain Navigation
in Arthur Kill Channel
due to Narrower
Channel Width

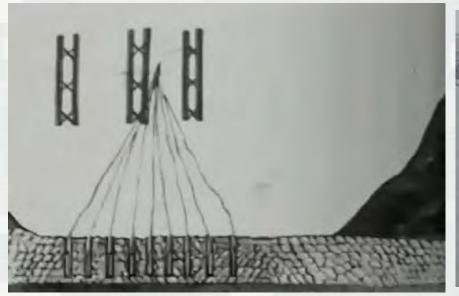
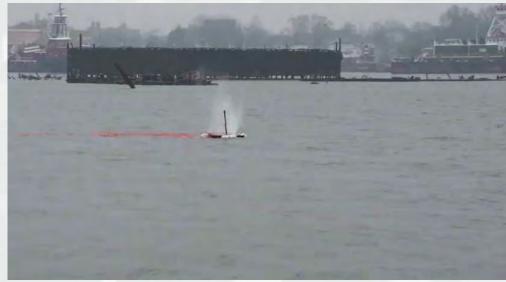
1920 2012

Drilling & Blasting in the Arthur Kill, Then & Now

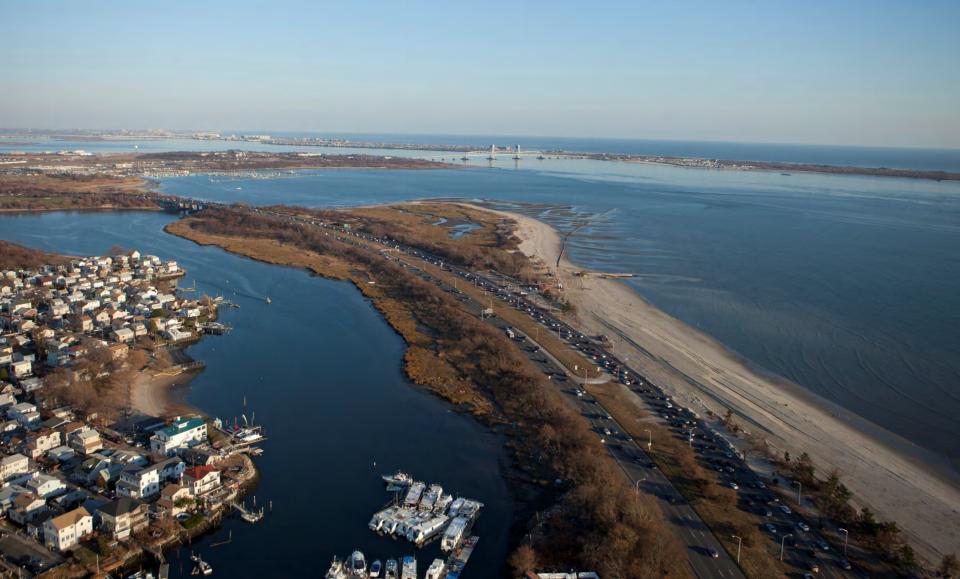
Plumb Beach Shoreline Stabilization: 133,000 CY Ambrose Sand Placed in 2012 Prior to Hurricane Sandy

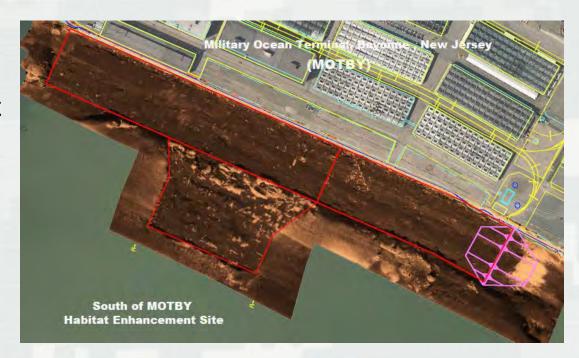
Habitat Enhancement Site

- Funded by New Jersey (\$5M) to Offset loss of 12 acres of sublittoral habitat in Port Jersey Channel Construction
- Involved placement of 935,000 CY of glacial till (dike) and sand from the Port Jersey Channel Deepening to enhance

approximately 43 acres of sub-littoral habitat within an unused former military terminal channel by returning it to shallower depth consistent with the surrounding flats area

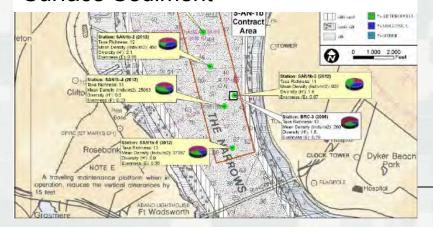
2005 and 2012 Benthic Taxa & Surface Sediment

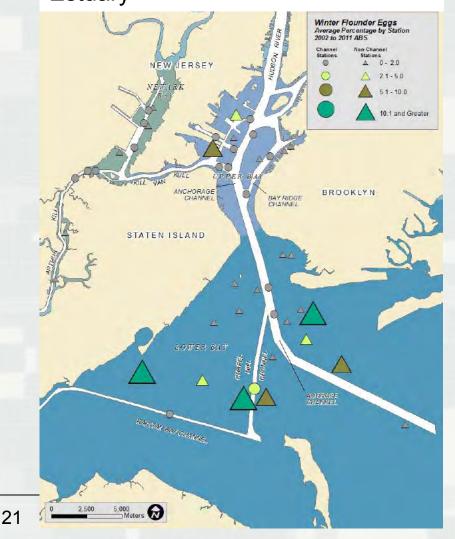
Winter Flounder Egg Distribution in Estuary

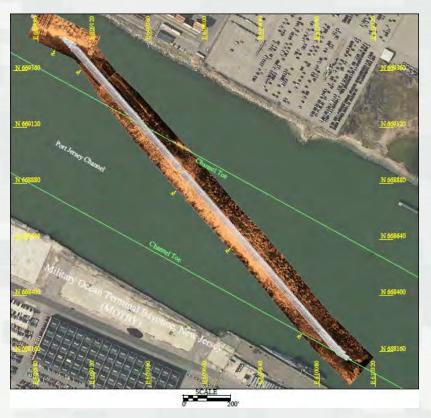
- Protection-in-Place Measures Required During Channel & Berth Deepening to Ensure Utility Tunnel Safety
- Utility Tunnel Nearly One Hundred Year Old, Hand Dug 12 ft. Inside Diameter Treated Effluent Outfall Tunnel Owned by the Passaic Valley Sewerage Commission (New Jersey State Agency)
- Protection-in-Place Measures Involved:
 - ▶ Overdigging Channel by Approximately 1 ft. to allow 6 inch thick ¾ inch bedding stone topped with 430 separate 5 inch thick, 30 ft. long by 4 ft. wide steel plates

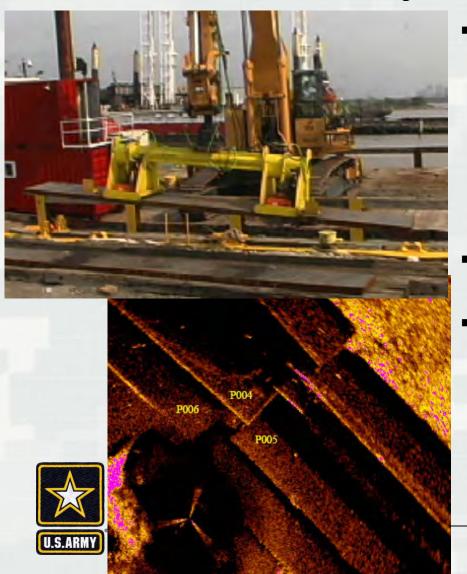
- Protection-in-Place Measures Involved:
 - ► Each 4 ft. by 30 ft. by 5 inch thick steel plate weighed approx. 13 tons
 - ▶ The cost of steel alone was over \$10M
 - ▶ Plates were required to be 1% of flat, centered within 1 ft. perpendicular of the PVSC tunnel center line, and no more than 4 inches apart from each other
- Initial Placements Impacted by Plates Sliding Unexpectedly Down Side Slope
- Schist Rock Outcrop in Center of Channel Required Protection-in-Place Modifications During Construction

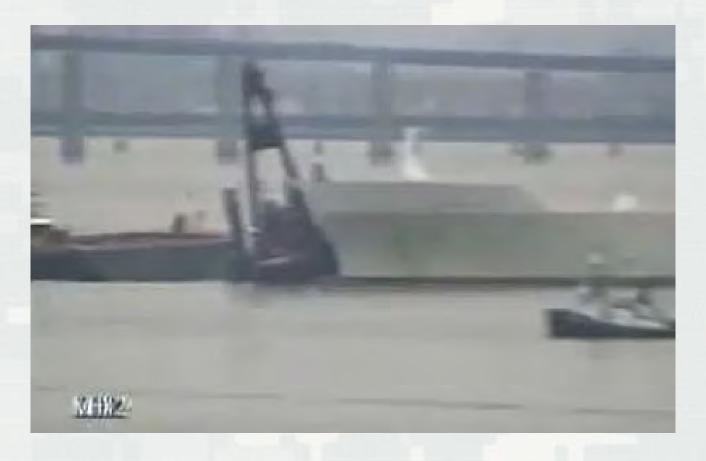
Multiple Ollisions with Excavators, boom breaks/collapses
