# Controlling Recontamination During Phase 2 Sediment Remediation Dredging at the Esquimalt Graving Dock

Dan Berlin, Matt Woltman, P.E., and Tom Wang, P.E., Anchor QEA  
N. Healey and R. Hill, Azimuth Consulting Group Partnership  
D. McKeown, SLR  
C. Major, A. Mylly, and D. Osguthorpe, Public Services and Procurement Canada  
D. Kettlewell, SNC Lavalin

WEDA Dredging Summit and Expo 2017  
June 26 – 29, 2017

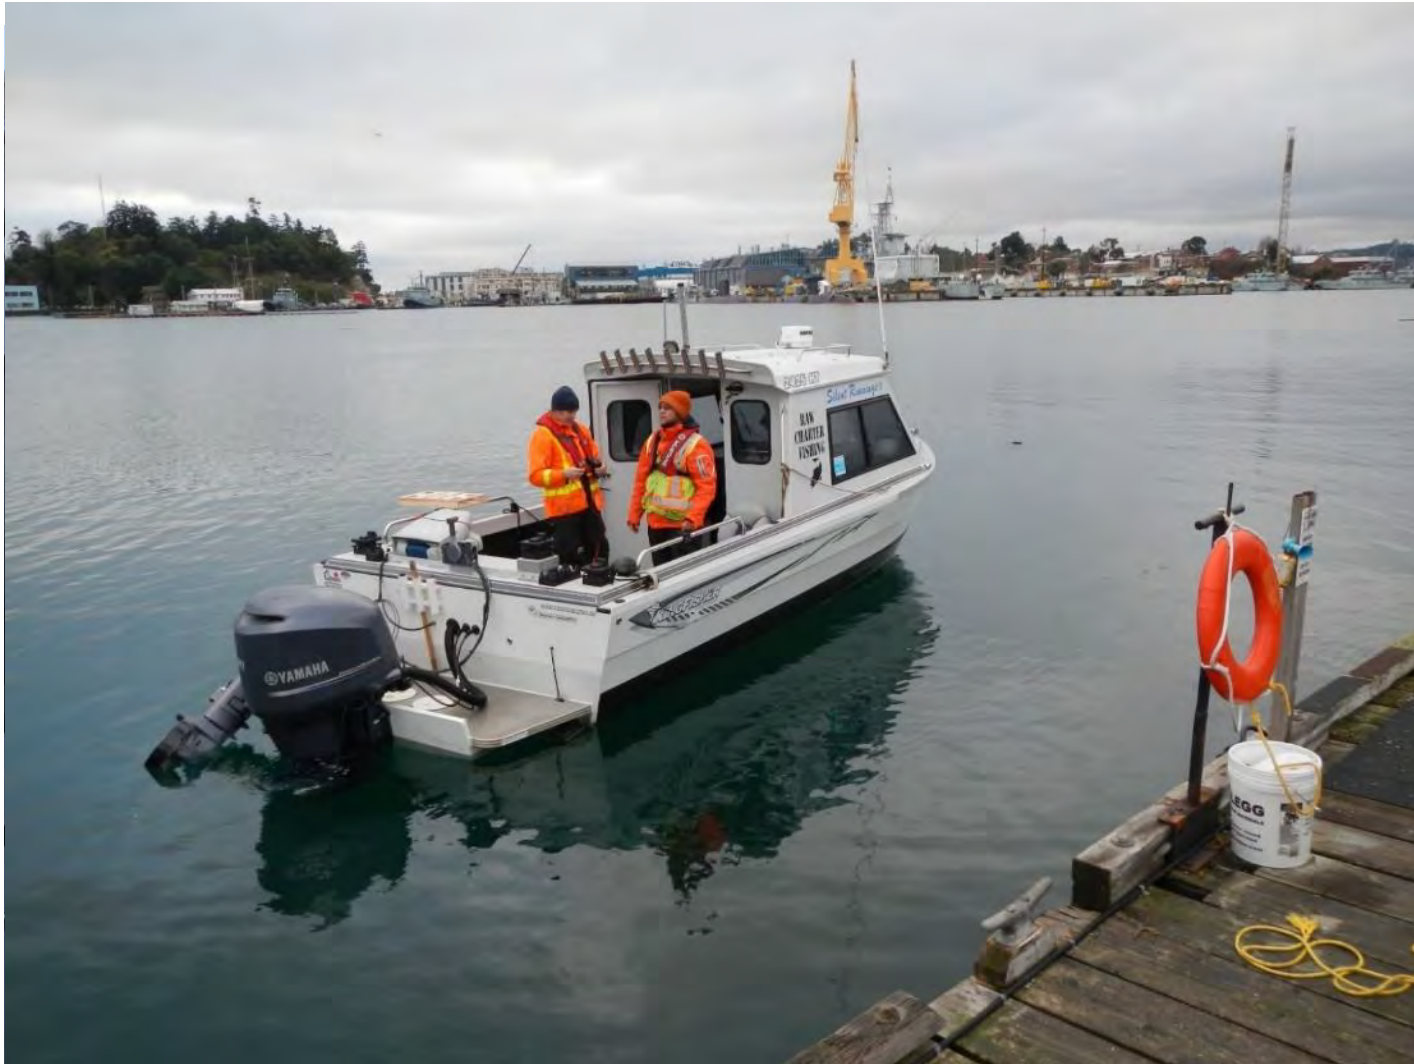
# Water Quality Monitoring

Parameter	Exceedances	Maximum	Criterion
21,934 <i>In Situ</i> Measurements of Water Quality			
Turbidity	93 (0.4%)	24 NTUs	2.5 NTUs
583 Laboratory Measurements of Water Quality			
TSS	13 (2%)	16 mg/L	5 mg/L
CU	3 (0.5%)	4.3 µg/L	3 µg/L

- Relatively low Project Water Quality Performance Criteria
- Intensive spatial and temporal monitoring
- Overall
  - Low frequency and magnitude of exceedances of water quality criteria
- Zones 2 and 3
  - More frequent and greater magnitude exceedances of water quality criteria
  - More frequent visual evidence of particulate release

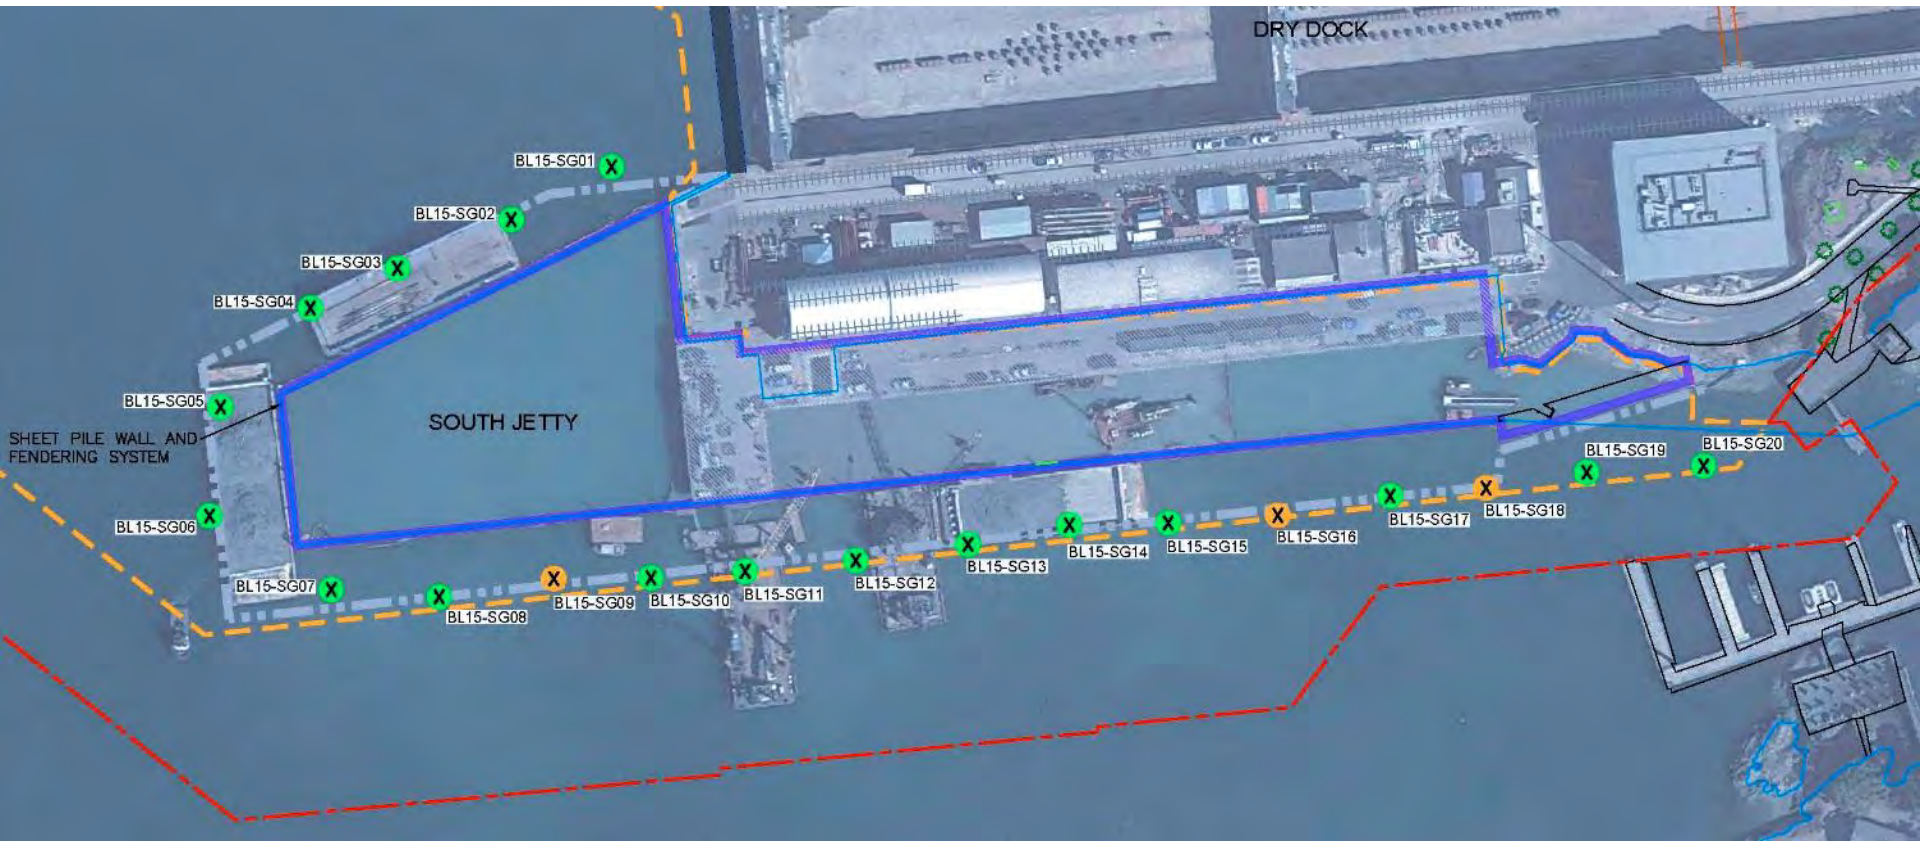
# Baseline Sediment Sample Results

- Baseline, interim, and at post-completion
- Surface sediment samples collected around perimeter of Phase 2 area
- Results compared to Numeric Remedial Action Objectives (NRAOs)
- Diver inspections of areas outside of TRB

- Baseline results below NRAOs, with three exceptions
- Interim resampling indicated elevated levels of select parameters (metals, PAH, PCB) in some locations
  - Prompted additional step-out samples for delineation purposes
- Final post-construction sampling confirmed elevated levels of select parameters in localized area at east end of project
- Source uncertain, but evidence suggests release of suspended sediment from eastern Phase 2 area (corroborated water quality data and lighter material deposits)
- Post-construction diver inspections identified localized sediments brought to surface at perimeter of Zone 5 during SPW extraction

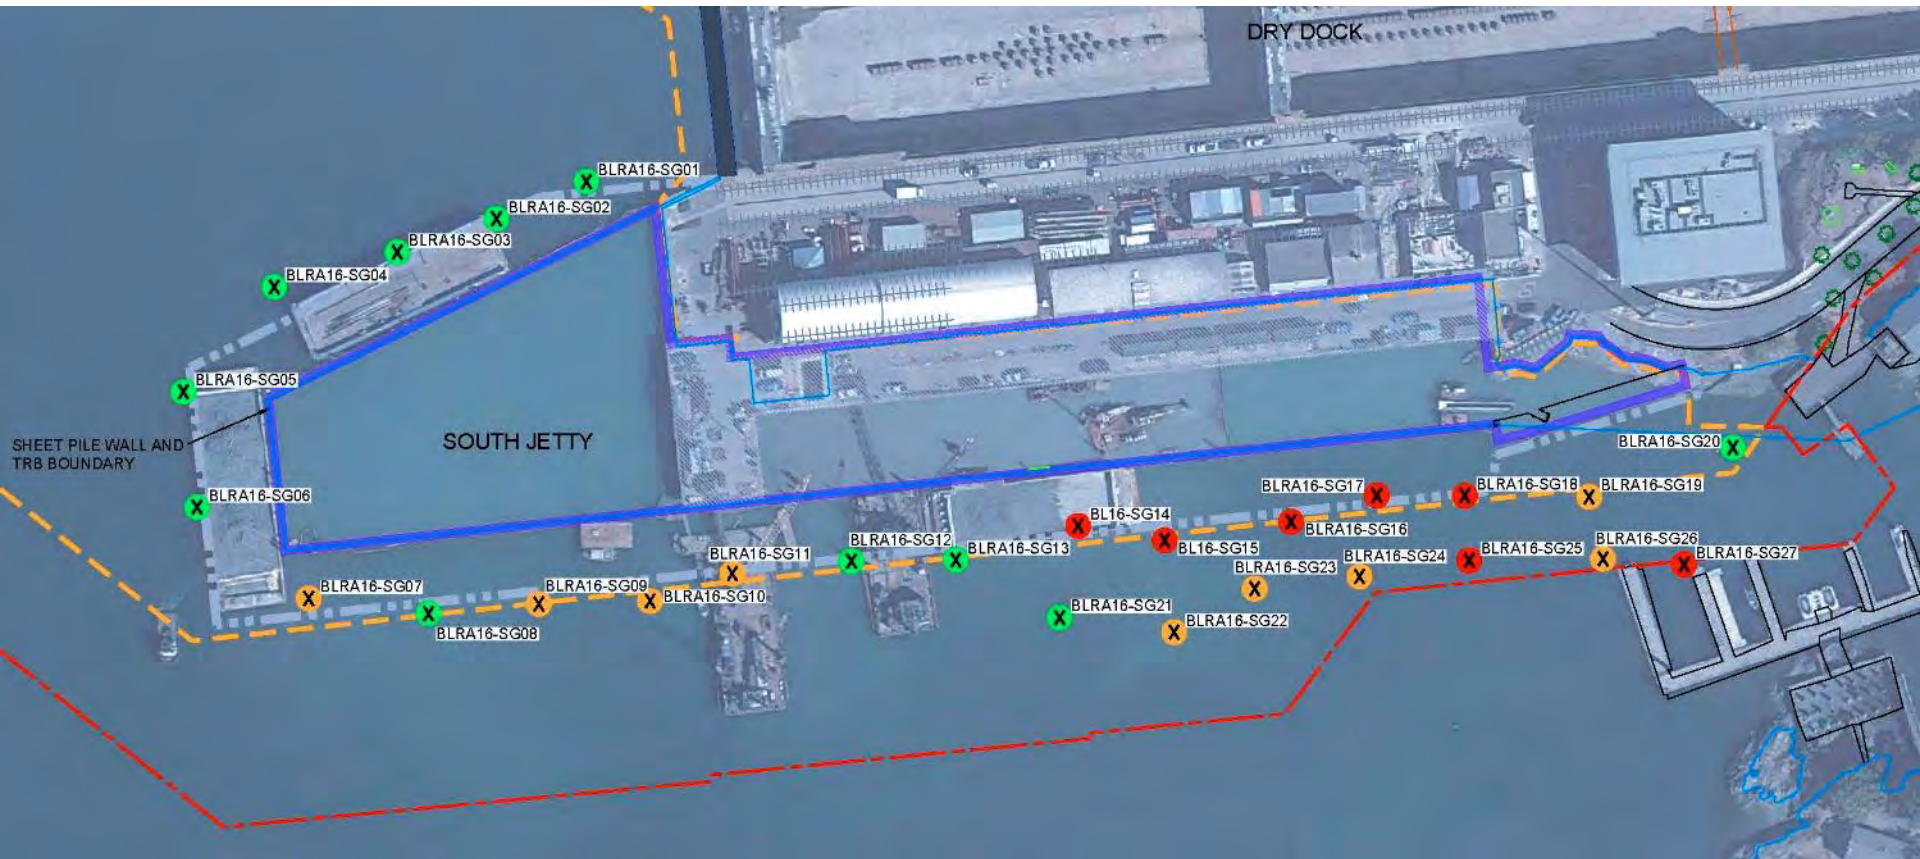
# Sediment Re-Assessment Results

- Re-sampling conducted at all baseline locations and seven step-out locations following substantial completion (November 2016)
- Results compared to NRAOs and baseline results to determine changes in sediment chemistry during Phase 2 works
- Diver inspections also completed

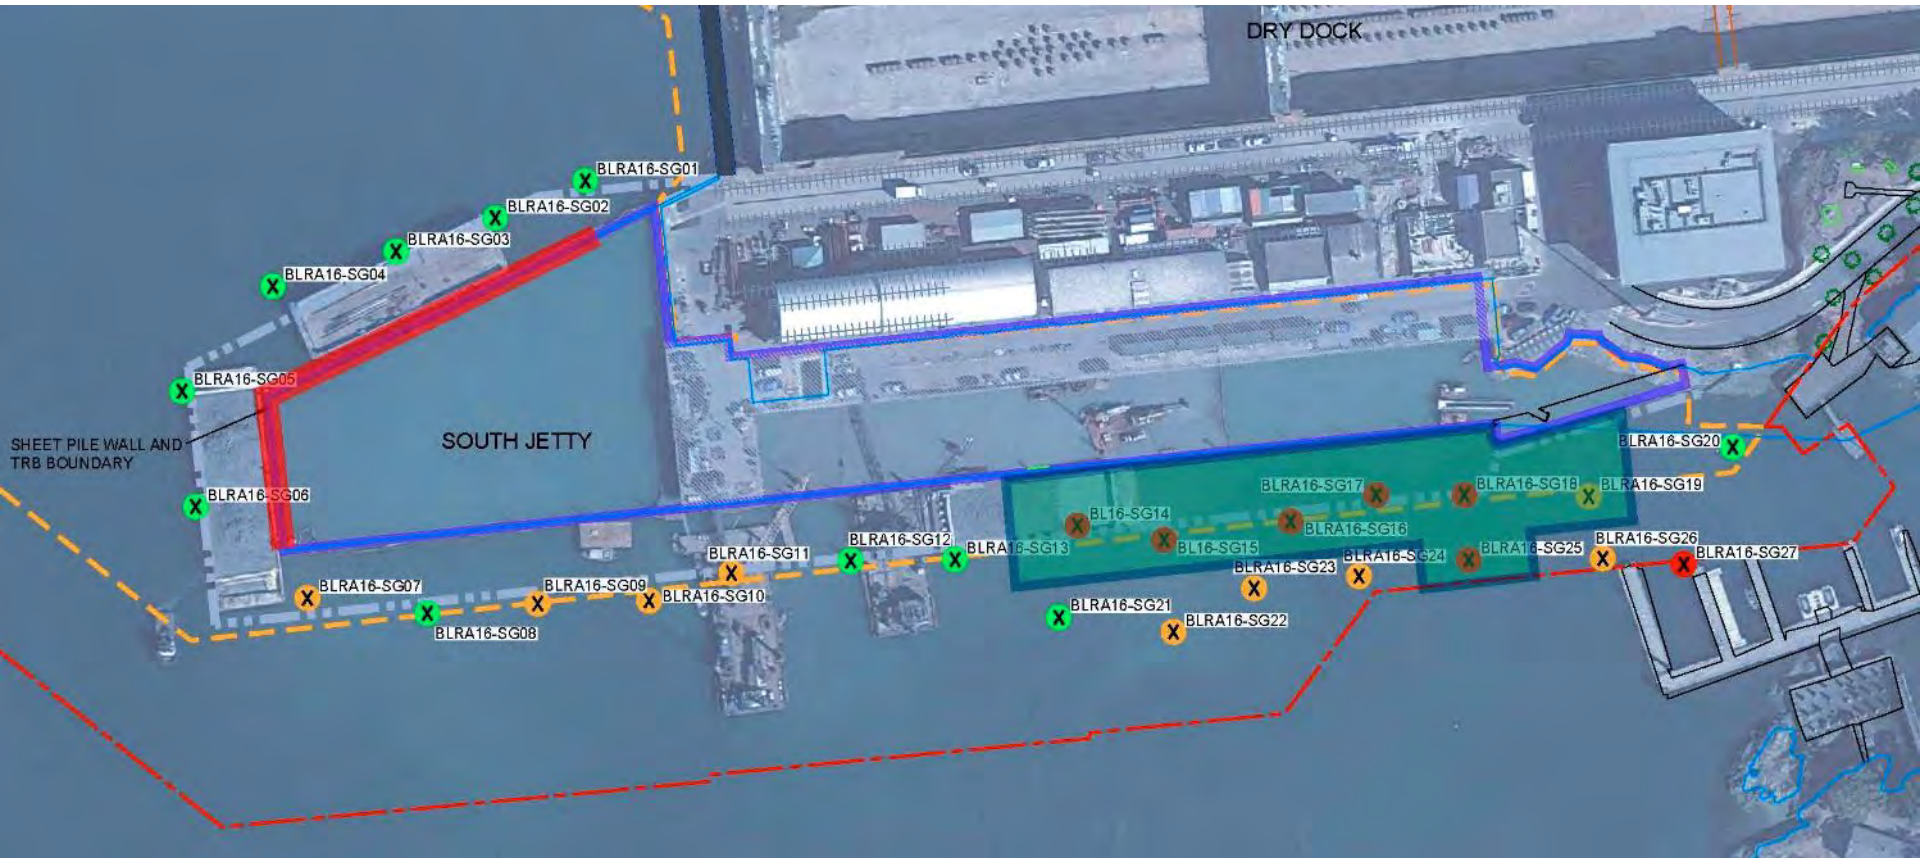
# Corrective Actions (cont.)

RMC Placement (0.3-m thickness)
-

Additional Armour Rock Placement

- Residuals management cover (RMC) placement
  - 0.3-meter-thick RMC layer placed in localized area where elevated surface concentrations noted
  - Based on exceedance of four times the NRAO
  - Provides clean surface at end of construction
  - Anticipated to mix with underlying sediments over time to achieve remedial targets
  - Long-term monitoring of sediment quality planned
- Sheet pile wall extraction
  - Extraction of SPW created exposed sediment noted during final diver inspections
  - Additional armour rock placed to isolate sediments and provide seamless transition between Phase 1B and Phase 2 armour covering
