#### Exercising Record of Decision Flexibility with a Contaminated Sediment Dredging Pilot Project at the Ashland/NSP Superfund Site

Steve Laszewski, Denis Roznowski, *Ken Potrykus*, Steve Garbaciak and Ken Aukerman (Foth), Alan Buell (Envirocon), Greg Smith and Tyler Lee (JF Brennan)

#### Ashland/NSP Lakefront Superfund Site

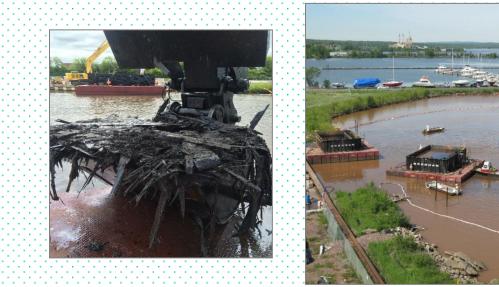
40,000-square foot Pilot Study Dredge Area

- 8,000-cubic yards removed
- ✤ 520-truckloads to Sub-Title D Landfill
- 12,000-tons of Woody/Concrete Debris and Sediments
  4-million gallons of Water Treated

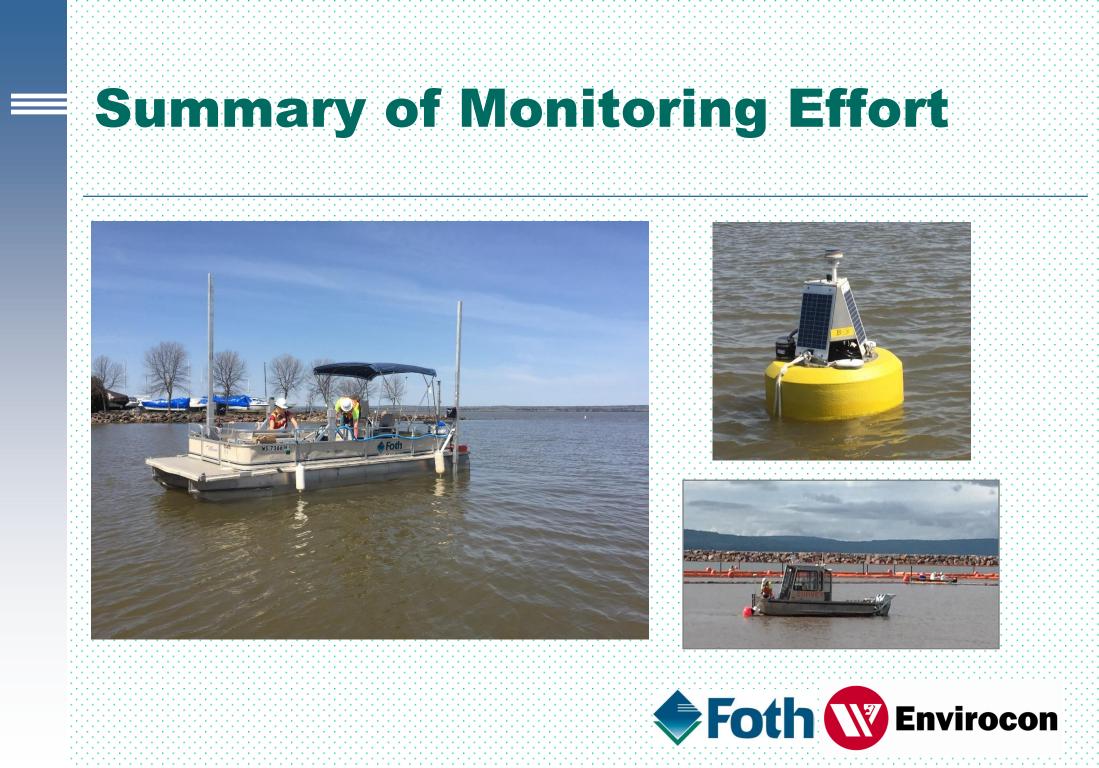
## Pilot Project Overview - Summary of Monitoring Effort

- Extensive Monitoring Plan
  - Surface Water
  - Sediments
  - Water Treatment
    Air Monitoring
  - Noise Monitoring

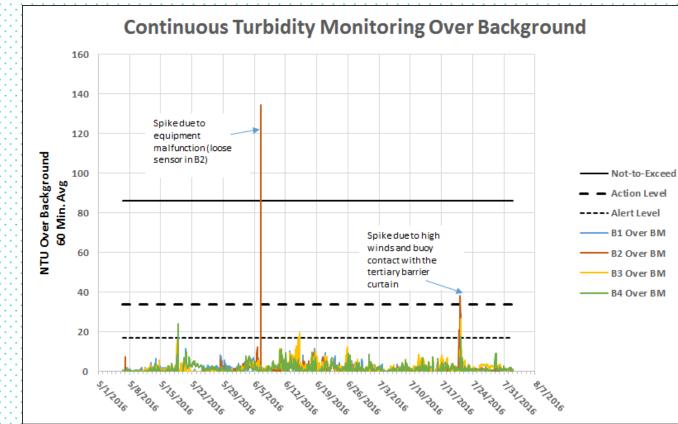
#### **Turbidity Results**

#### No Results over Action Levels

#### Thousands of water samples measured

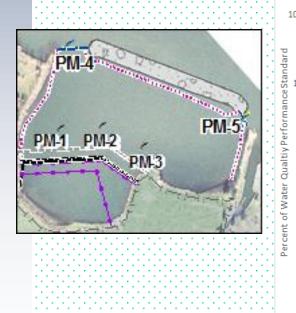
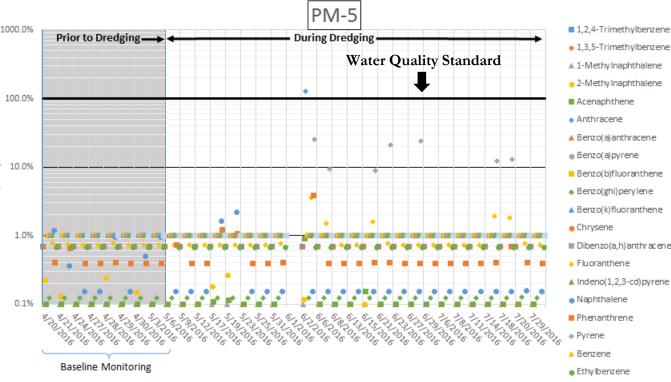
### Monitoring Results - Surface Water COCs

#### Over 1,300 monitoring analyses at PM-4 and PM-5, one result for one constituent above compliance value - within range of baseline conditions:

21 Analyses are illustrated for Each Sampling Event Day

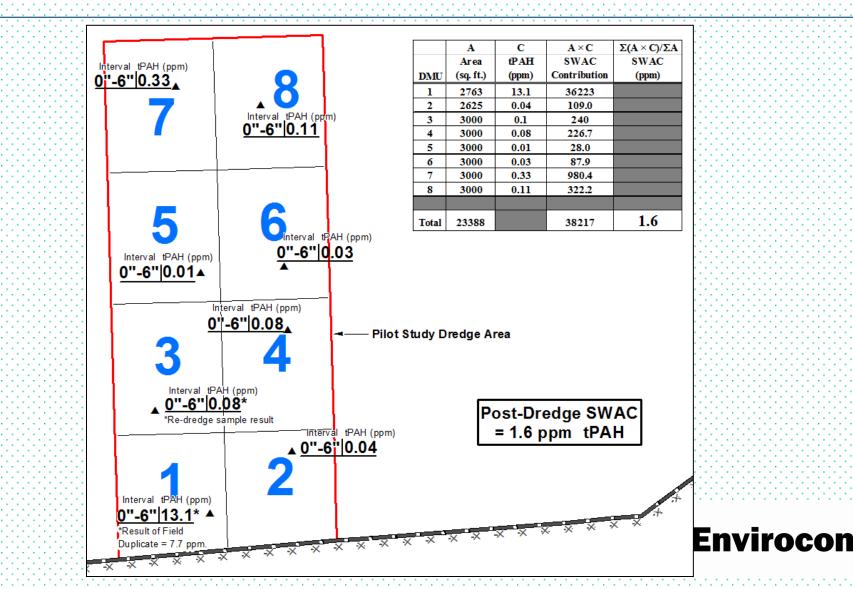
### Monitoring Results - Sediment SWAC 1.6 ppm

### Post-dredge Targets

### 9.5 ppm SWAC tPAH 22 ppm Not-to-Exceed tPAH
