Beach Stabilization and Dune Restoration in Progreso, Yucatan, Mexico

SAMARCEL BEACH STABILIZATION TREATMENT PROCESS

Project Site in Progreso, Yucatan, Mexico

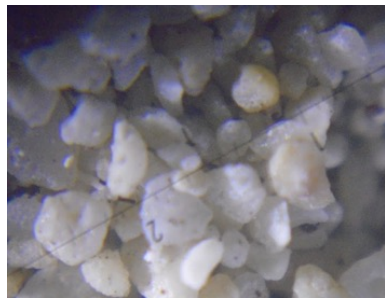
without SandFirst

- Natural biodegradable proprietary polysaccharide protein biopolymers, PPBs.
- PPB formulation, SandFirst (SF) designed through laboratory testing with sand from the site.
- When the PPB SF product is applied, the natural color and texture of the sand are not altered.

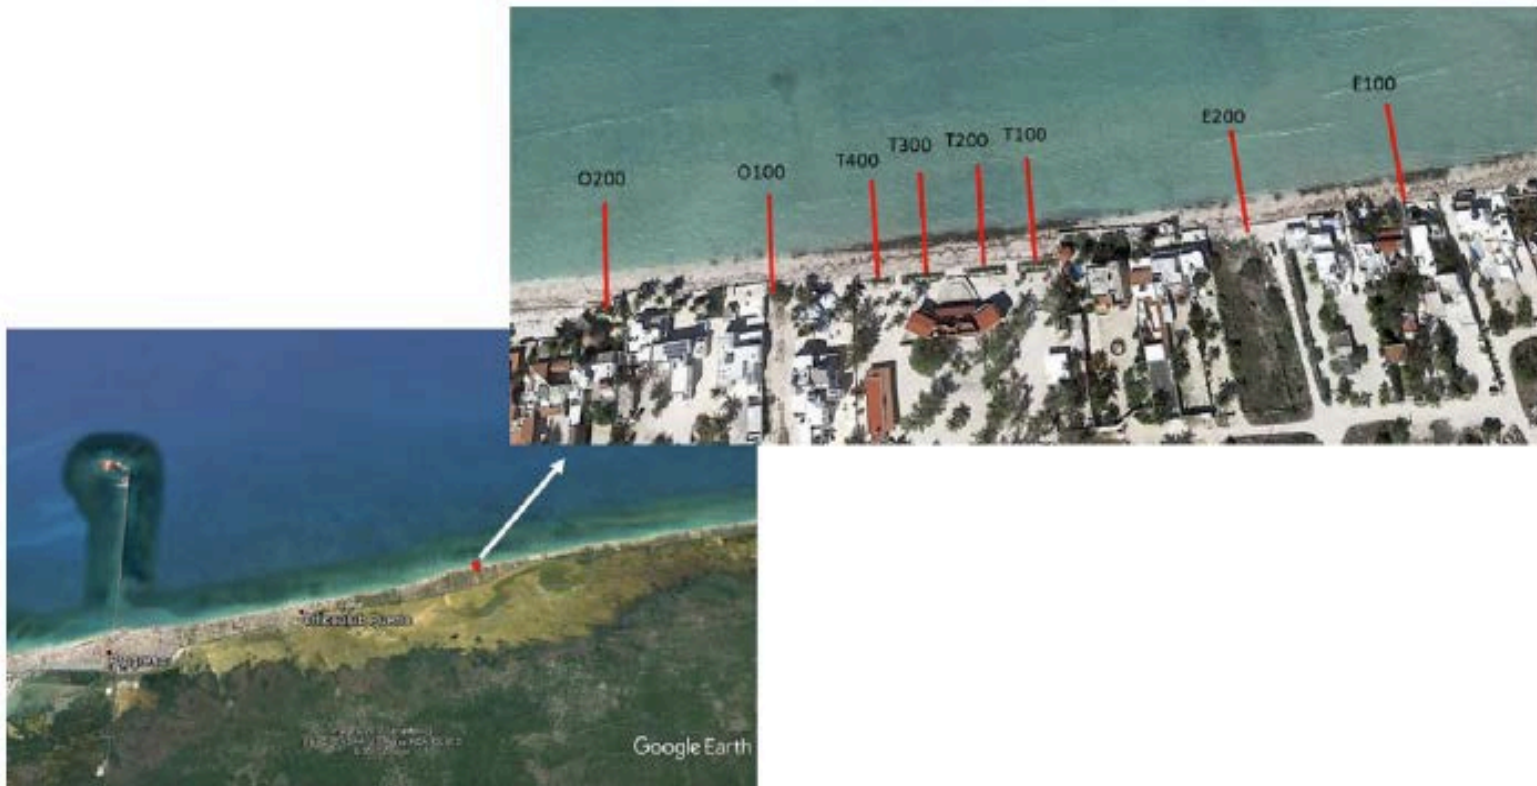
Figure 1. Location of the study area. T100-T400 represent the profiles measured in the Treatment zone and profiles O100-O200 and E100-E200 correspond to the West and East Control zones, respectively.

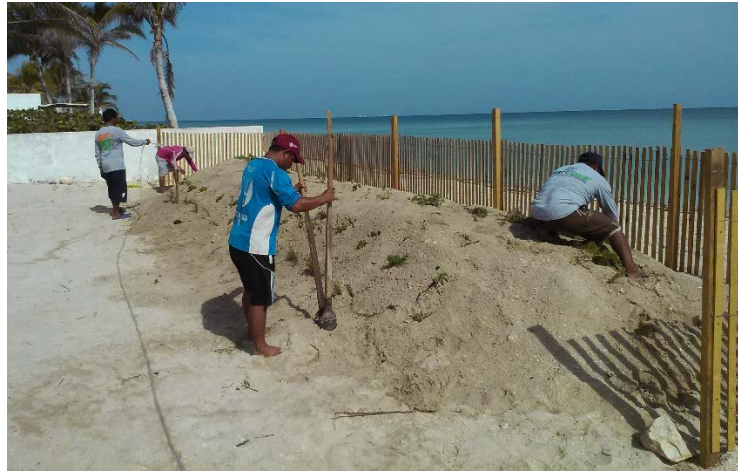
Reclaimed windblown sand

Native plant species placement, sand fence installation and application of the PPB SandFirst for dune stabilization

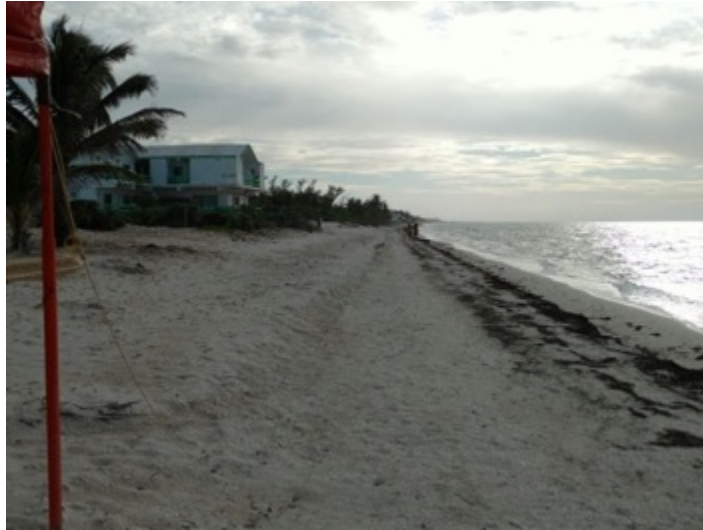
August 5, 2016

Profile Evolution

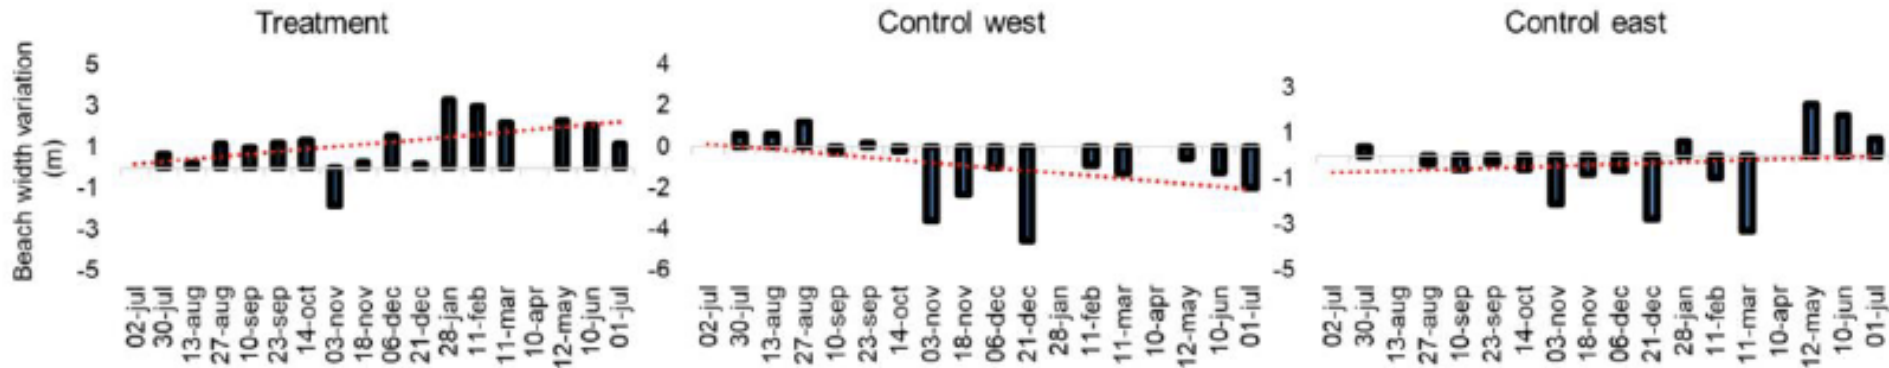
Figure 5. Time series of the coastline in the Treatment zone and the Control zones

- In the Treatment zone, the sediment balance (erosion/accretion rate) was stable between the supralittoral and sublittoral areas ($0.06 \text{ m}^3/\text{m}$), while in the Control zones it had an average negative balance of $-4.04 \text{ m}^3/\text{m}$.
- The coastline in the Treatment zone shows a tendency to expand seaward. The Controls regressed.
- Our findings suggests that the treatment is a suitable method for increasing beach resilience and may be used to complement beach renourishment projects.
- The sand dune restoration was successful. Dune vegetation was enhanced by the PPB treatment.

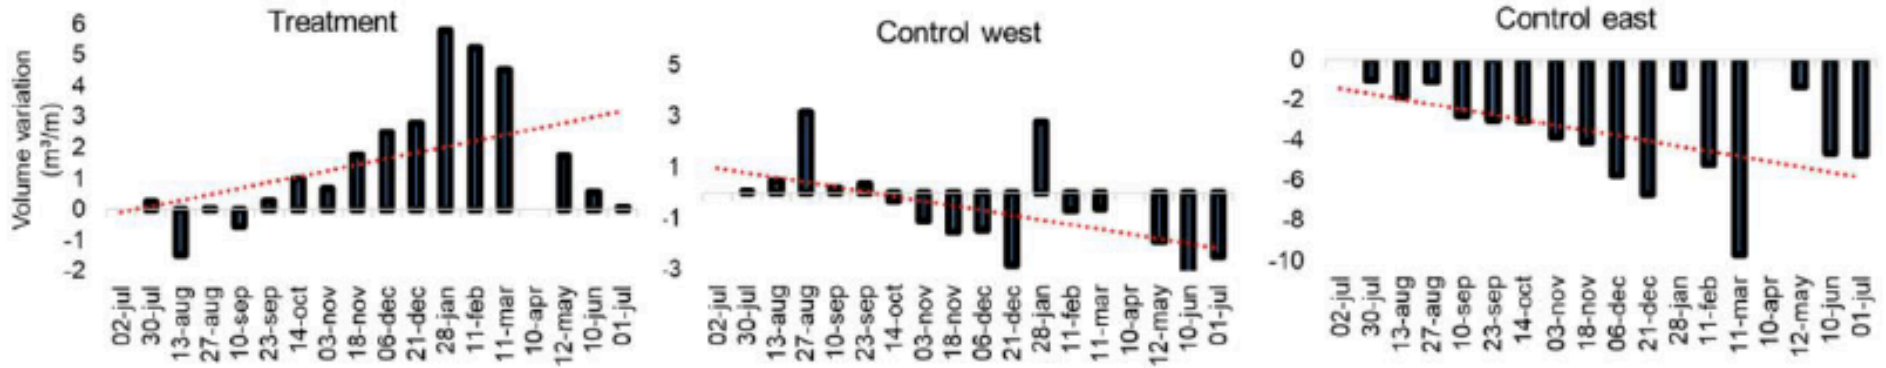
Figure 7. Average variation of the sand volume, and tendency (red line) in the Treatment zone and in the Control zones

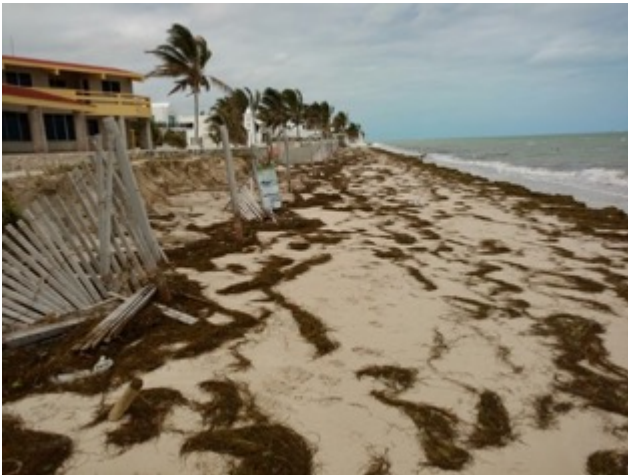
Major Storm: May 4, 2017

A severe storm affected the Yucatan coast on May 4th, 2017. The dune demonstrated its importance by preventing an inundation of the premises.
