Innovative Approaches for Assessing Post-Dredge Sediment Data and Residuals Management Decision Making on the Grasse River

Remediation Project Overview

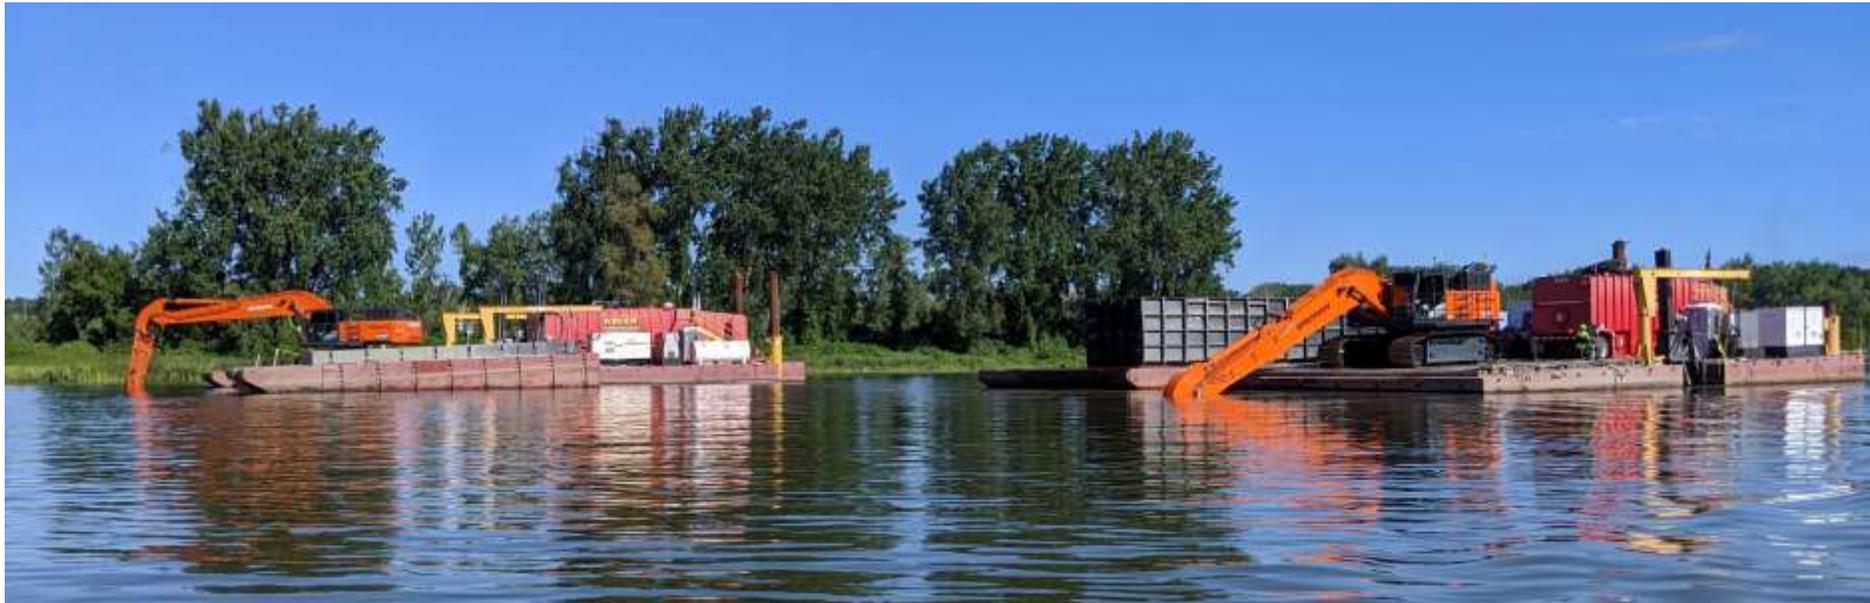
Project Challenges

- Demanding Construction Schedule
- Sediment Cleanup Objectives
- Quality Control
- Need for Expedited Agency Stakeholder Review

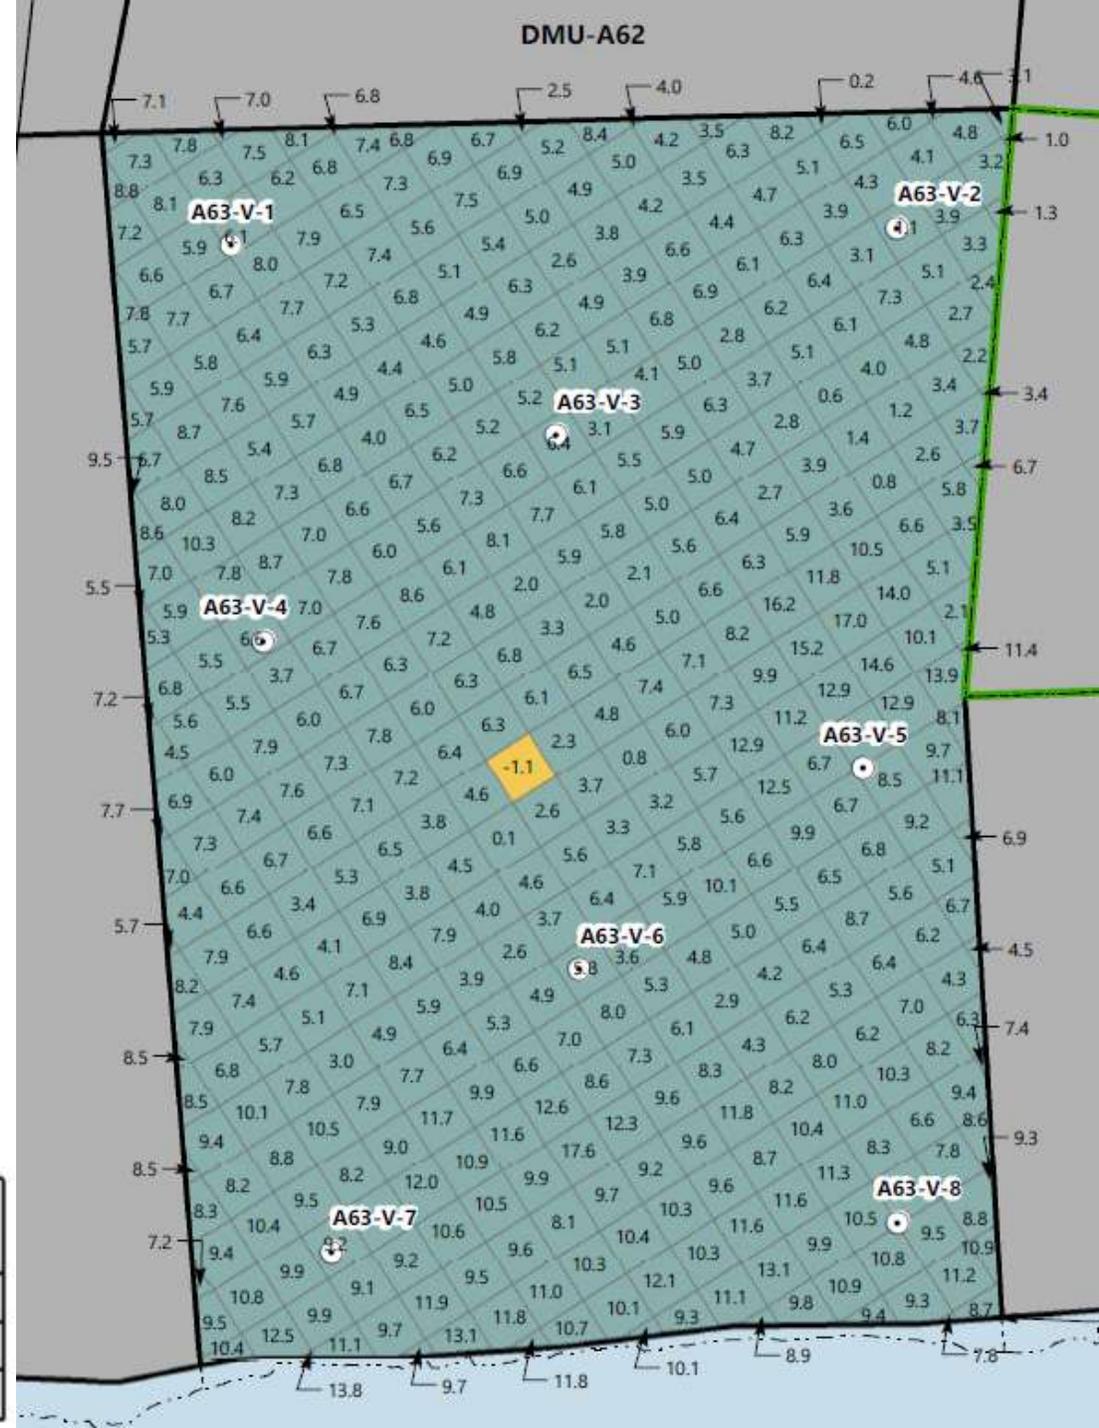
Example Survey Verification Figure

Post Dredge Target Locations

⊙ Post-Dredge Verification (V)

Average Elevation Difference Relative to Target Cutline (10x10 Grid - inches)

■ > 3" Above Target Elevation

■ > 0 to 3" Above Target Elevation

■ At or Below Target Elevation

■ Excluded Cells (see Note 4)

Summary Statistics: DMU-A63

Post Dredge Elevation Relative to Target Cutline	Percent of Area (rounded)	Specification Requirement
> 3" Above Target Elevation	0 %	0 %
> 0 to 3" Above Target Elevation	0.3 %	<= 5 %
At or Below Target Elevation	99.7%	>= 95 %

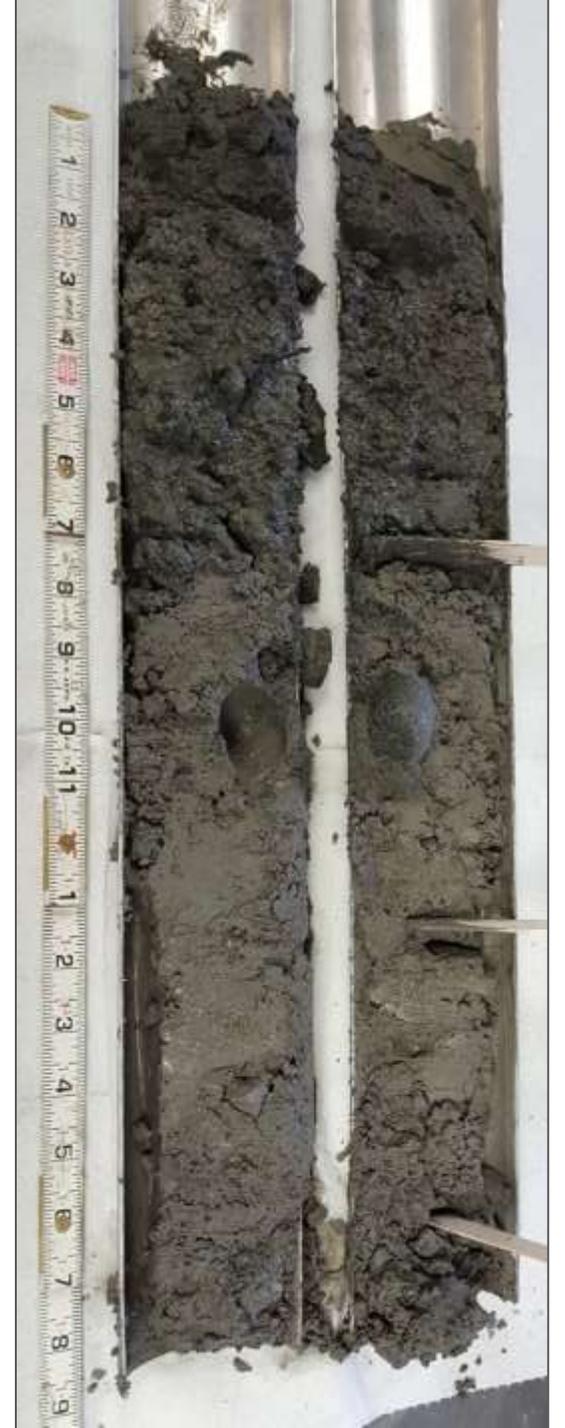
Post-Dredge PCB Sampling Verification

- Sampling density: 8 cores/acre
- Re-dredging was required if the DMU average for a 6-inch interval exceeded the project cleanup criteria
 - Re-dredge prisms targeted the sampling locations causing the exceedance
 - Delineated using Thiessen polygons
 - Not required where the previous dredge pass encountered high subgrade (e.g., hard clay or rock)
- Once PCB levels were met, dredging for a given DMU was complete and backfill was placed

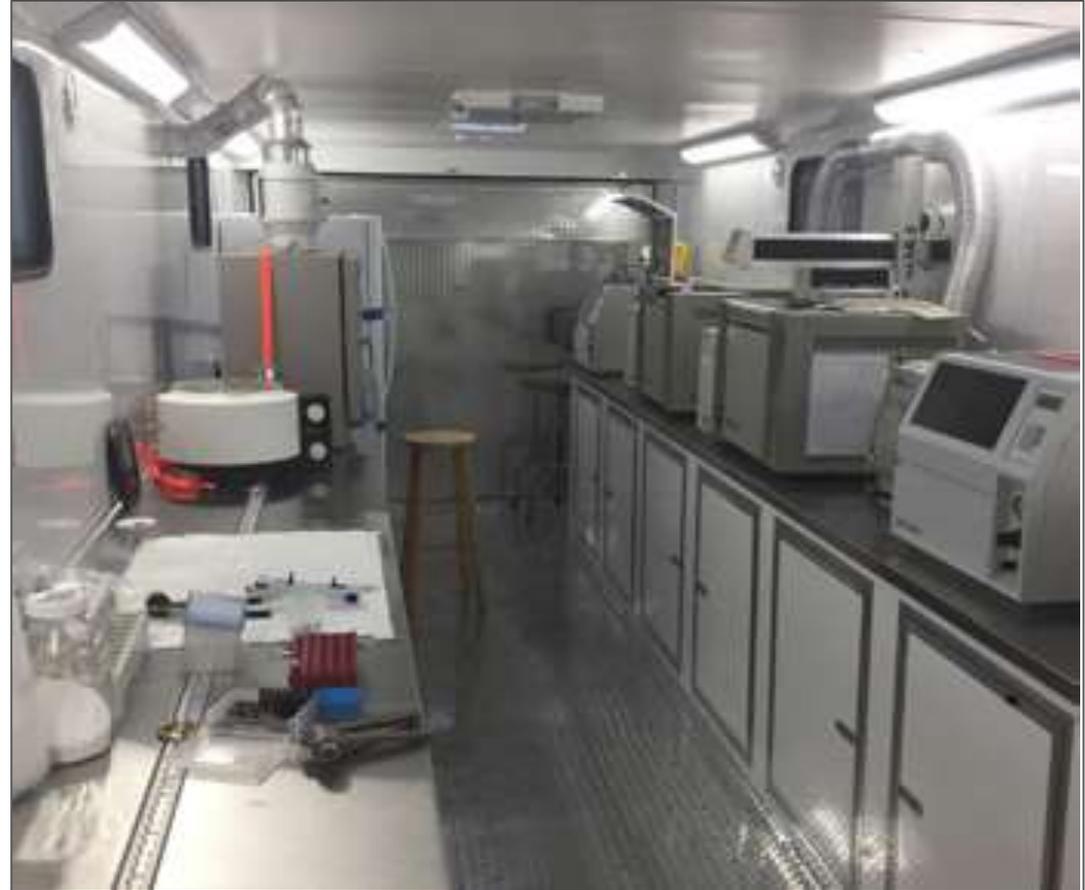
On-Site Laboratory

- Pace Analytical Services, LLC
- Dedicated staff
- Quality controls
- Results reported within 24 to 48 hours
- 2019 to 2021:
 - ~2,000 sediment samples
 - >500 locations

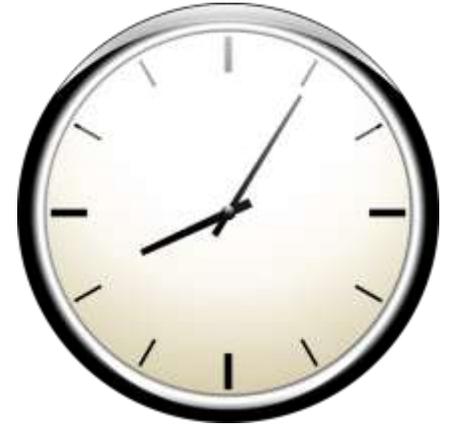
Innovations in Data Management

- Anchor QEA developed customized applications to enable automated data loading, quality review, and reporting
 - Field data: sample IDs, COCs, and field measurements
 - Lab data: analytical results, data validation, and data reporting
 - Significantly reduced data processing time and critical to ensuring high-quality data

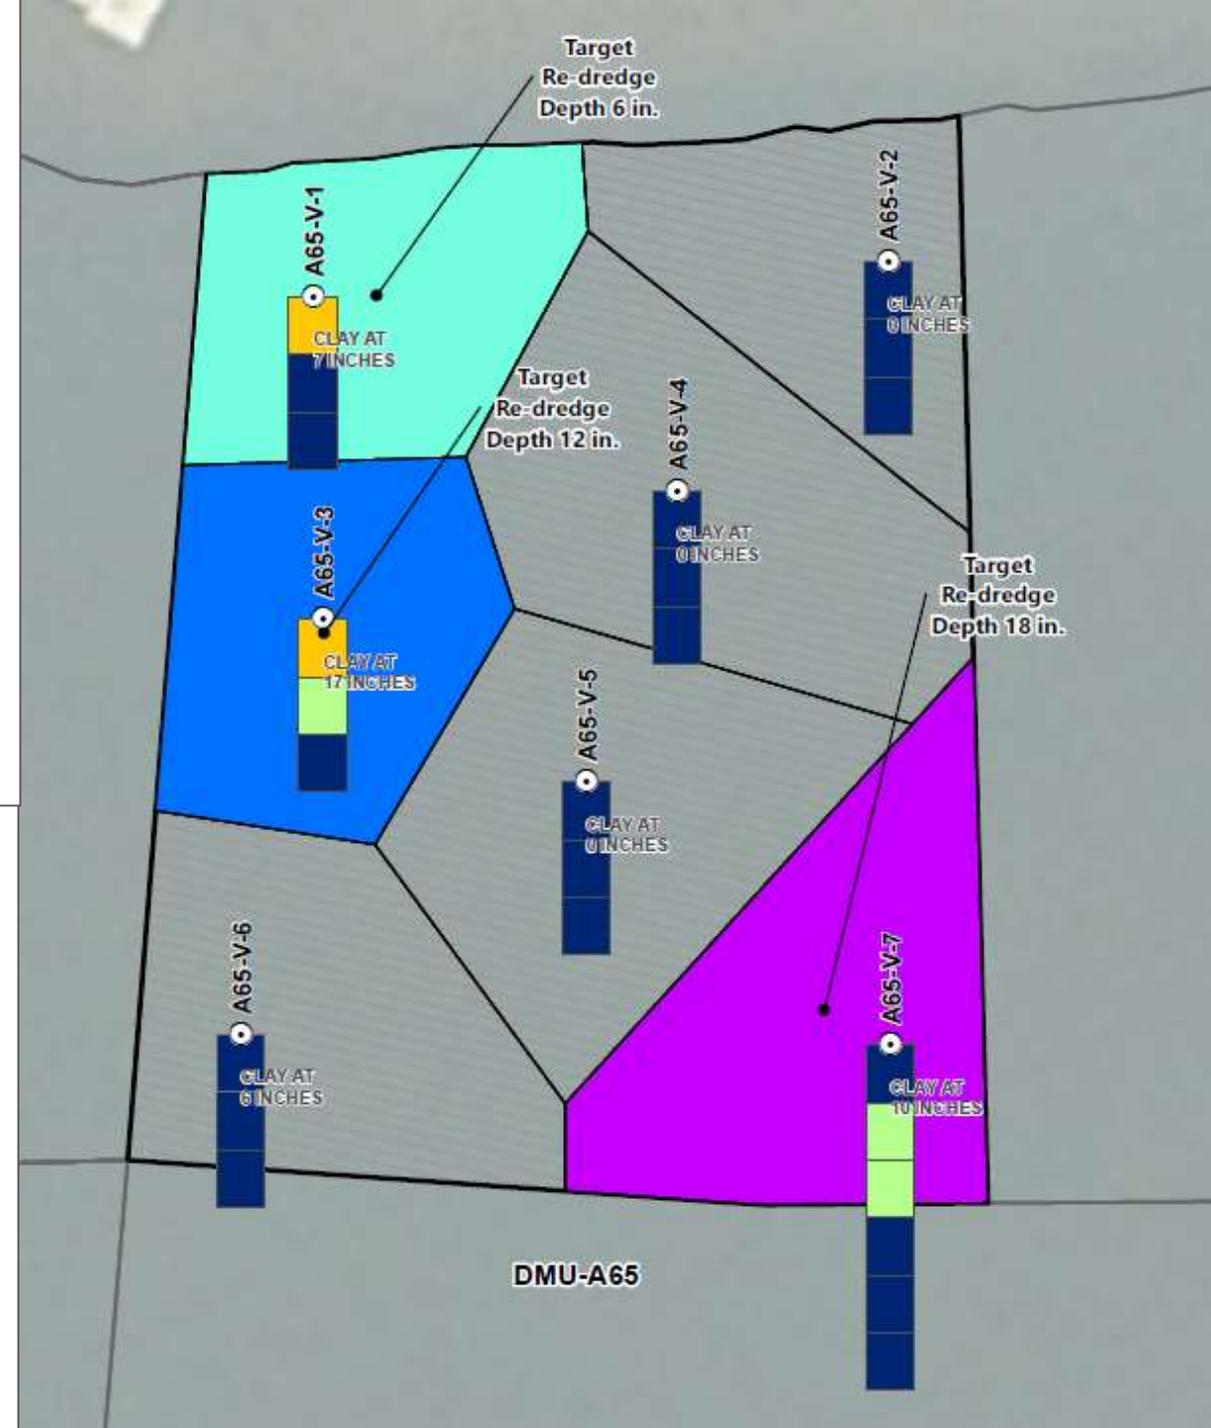
Example PCB Verification Figure

Verification Location Counts	
Sampled Locations	7
Abandoned Locations	0
Locations in Clay/Bedrock	0
Locations > 10 mg/kg at any depth	2
Total Compliant Locations	4
Backfill Locations	NA
Re-Dredge Locations	3

DMU Average Total PCB (mg/kg)	
0 - 6"	7.10
6 - 12"	1.99
12 - 18"	1.42
18 - 24"	ND
24 - 30"	ND
30 - 36"	ND
36 - 42"	NA
42 - 48"	NA

Example PCB Verification Summary Table

Core ID	Depth	TPCB (mg/kg)	Area (sqft)	TPCB x Area
A65-V-1	0-6"	22	4521	99455
A65-V-2		0.7	4016	2811
A65-V-3		32	4687	149990
A65-V-4		0.04	6167	259
A65-V-5		0.04	5858	240
A65-V-6		0.8	5161	4128
A65-V-7		0.07	5809	378
Total			36,218	257261
DMU Average (0-6") (mg/kg)				7.10

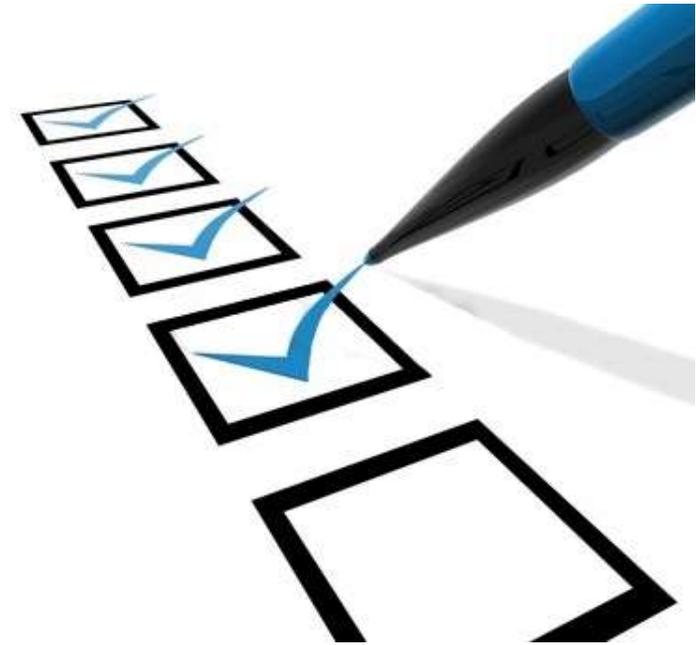
Certification Packages

- Developed for each DMU
- Summarized survey and PCB verification data for each dredge pass
- Documented compliance with project requirements
- Standardize packages supported efficient reviews
- Similar tools, automated processing, and certification packages developed for cap and backfill verification

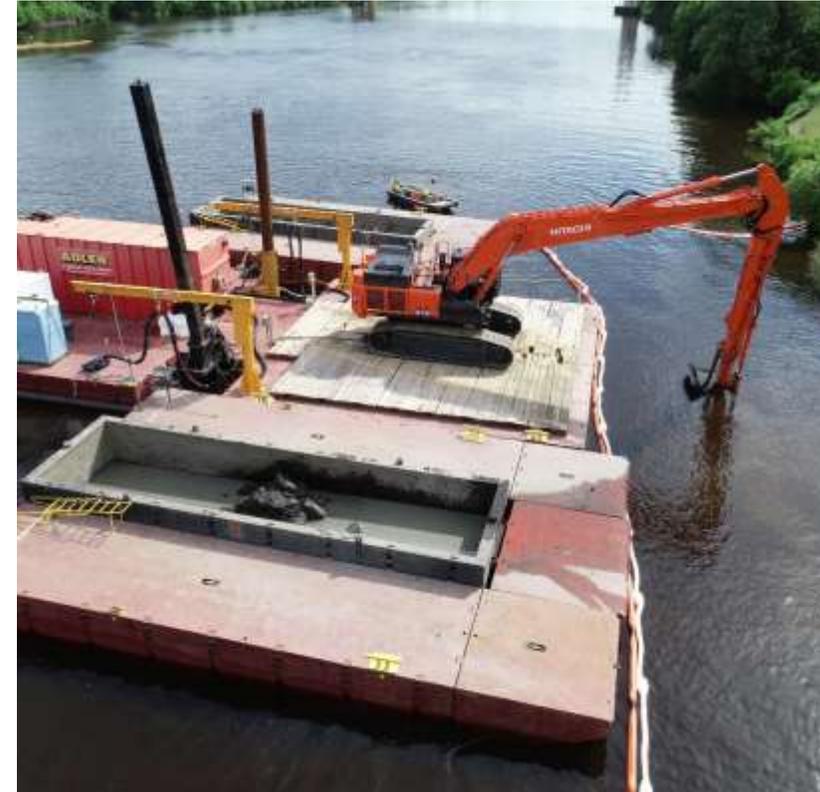
Dredging Completion

- DMUs approved after:
 - First dredge pass: 26 (11.7 acres)
 - Two dredge passes: 40 (26.7 acres)
 - Three dredge passes: 11 (9.6 acres)
- 139 individual rounds of PCB verification evaluations
 - GIS/Python processing: ~5 minutes or less
 - Automated tools also developed for survey processing
 - Significant reduction in processing time
 - Consistent and high-quality verification packages
