Addressing Dredging Challenges Through the
Use of Barrier and Treatment Designs:
Shorelines and Control of Contaminant Migration

July 17, 2023

John A. Collins, COO

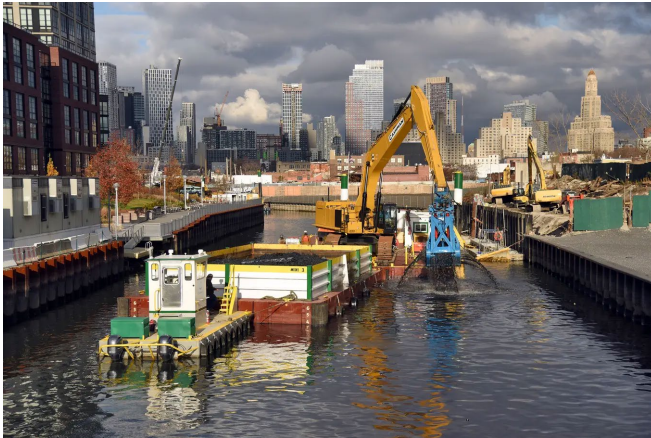
Dredging Along a Bulkhead

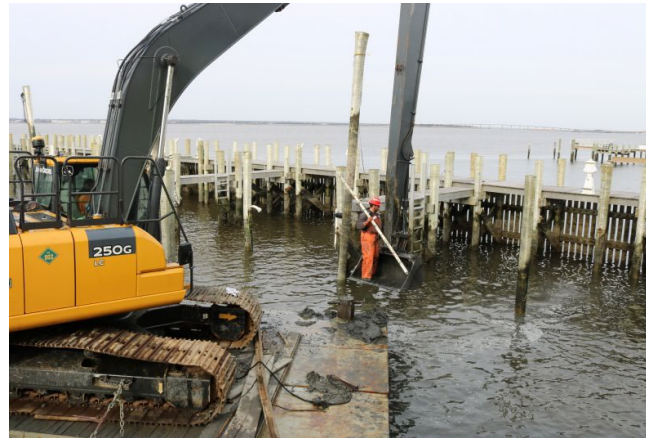
Piers and Obstructions

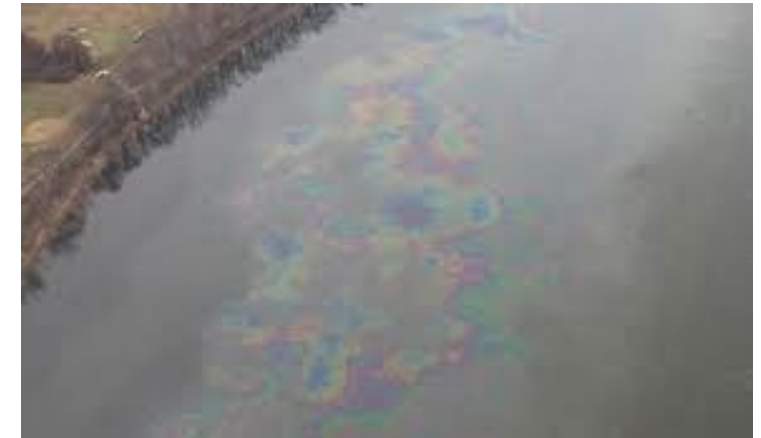
Upland Seepage & Ebullition

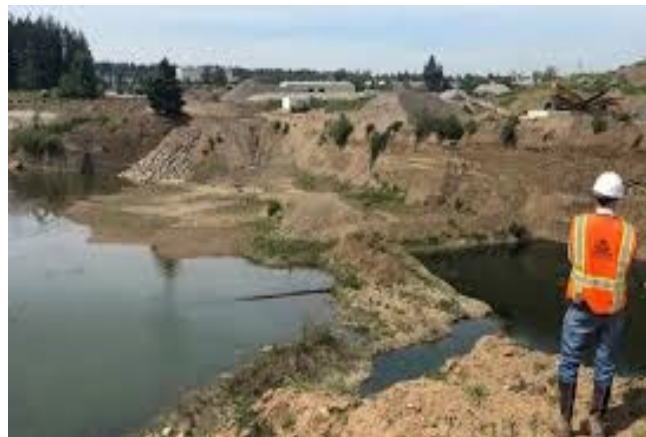
Shoreline Slope Stability

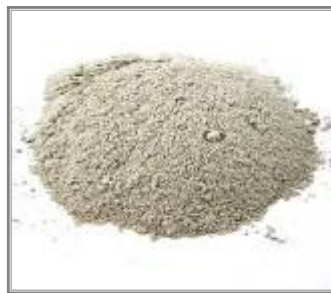
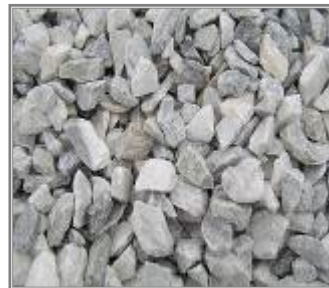
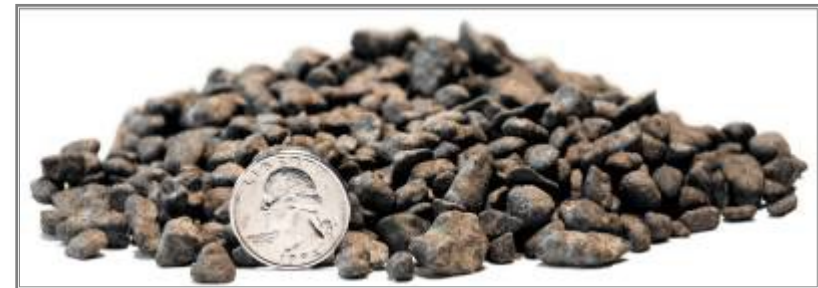
Powder Coated Aggregate Particles Provide Uniform Delivery of High-Value/Low-Volume Materials to Address Sediment Contamination & Upland Seep Zones

Powder coating

Aggregate core

AquaBlok/AquaGate “Composite Particle”

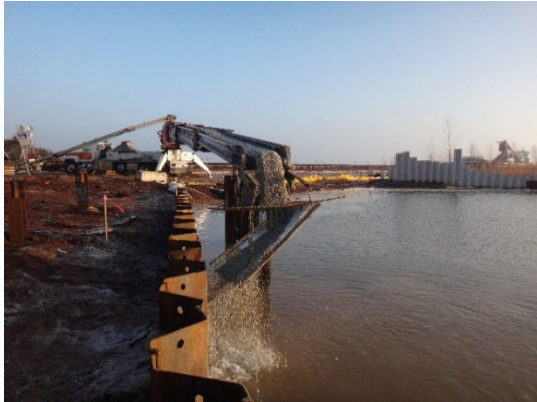
AquaBlok® For Contaminant Sequestration/Isolation

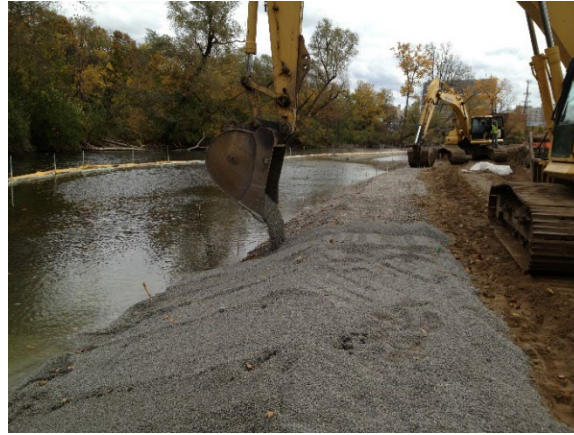
Sealing Bulkhead Wall to Limit Upland Residual Contaminant Migration

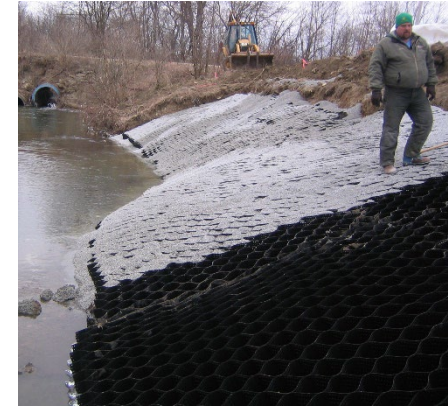
Limiting Residual Upland NAPL

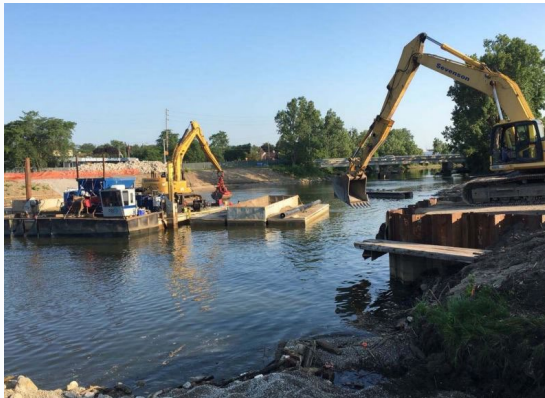
Bank Stabilization

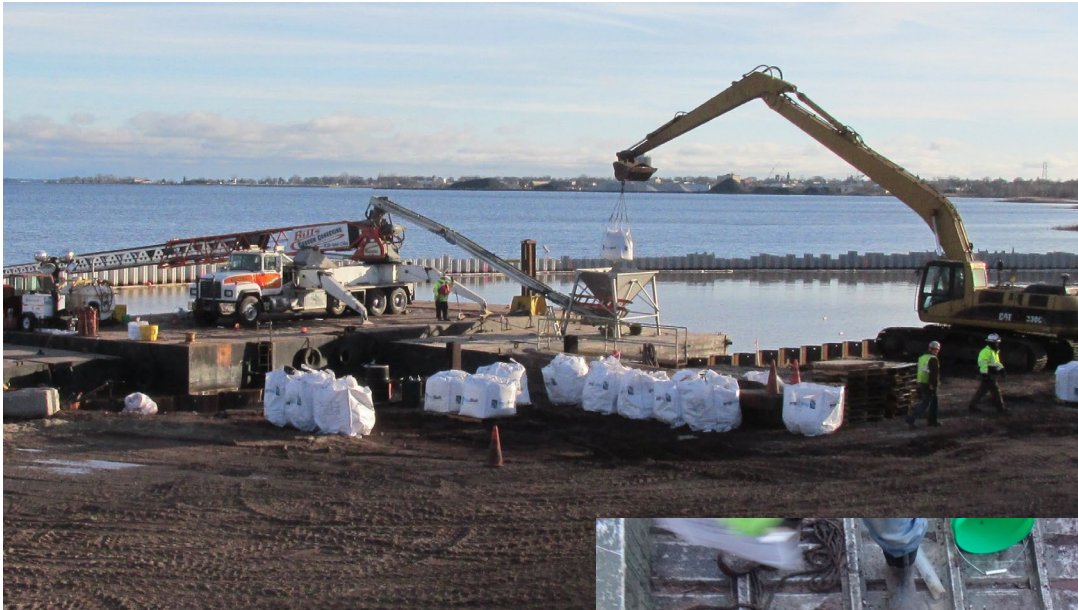
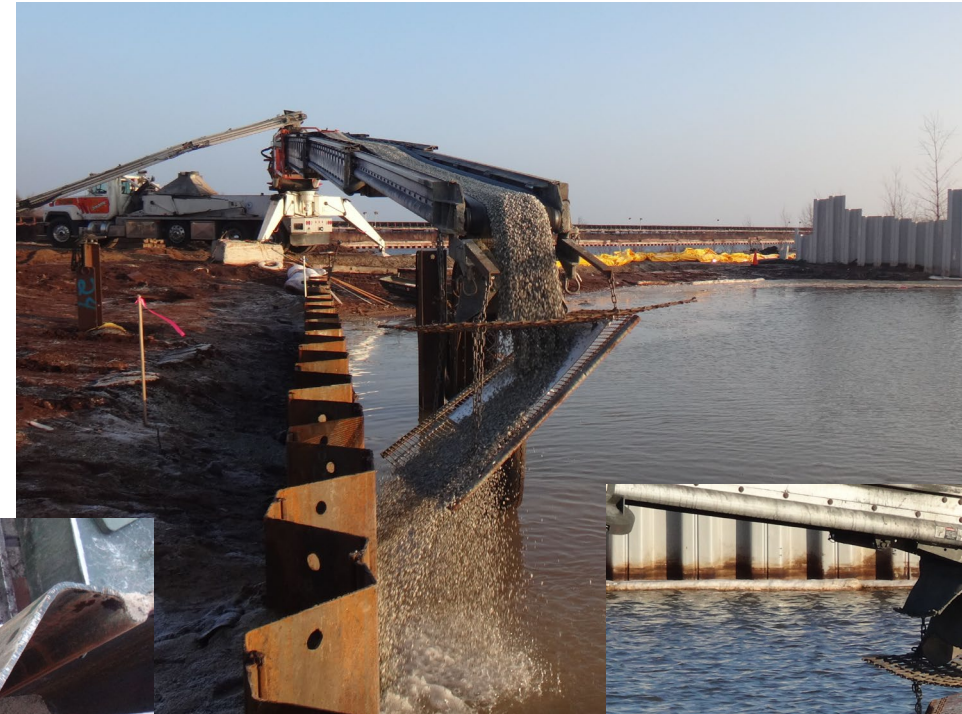
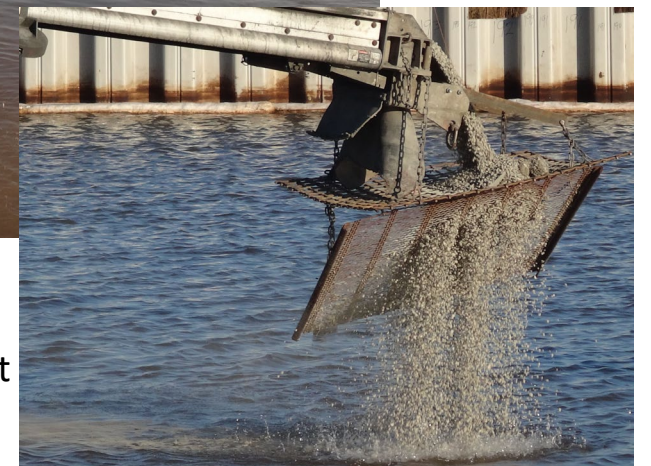
Upland Seep at Sheet Pile Wall: Low- Permeability Capping at Bulkhead Limits Residual Contamination Impacts

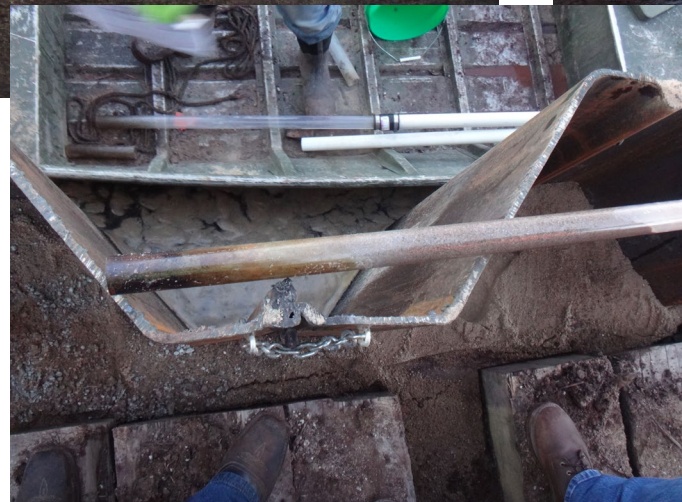
Historic Rail Yard Along
Lake Shore:
Limited Ability to Remove
Upland Contaminants Due to
Current Site Operations

AquaBlok Placed to
Address Seepage along
Bulkhead and In Sediment

Left: Cores taken to
confirm layer thickness

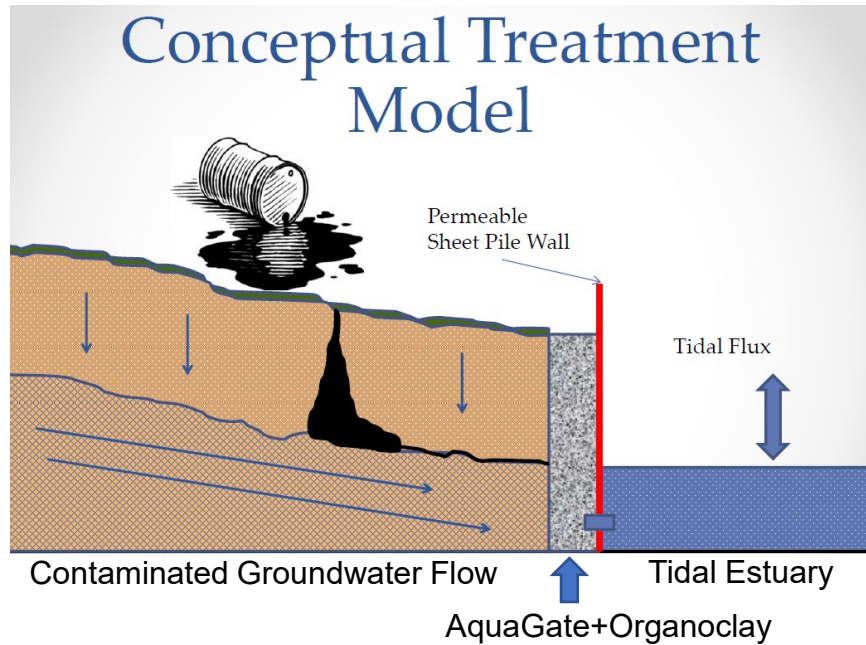
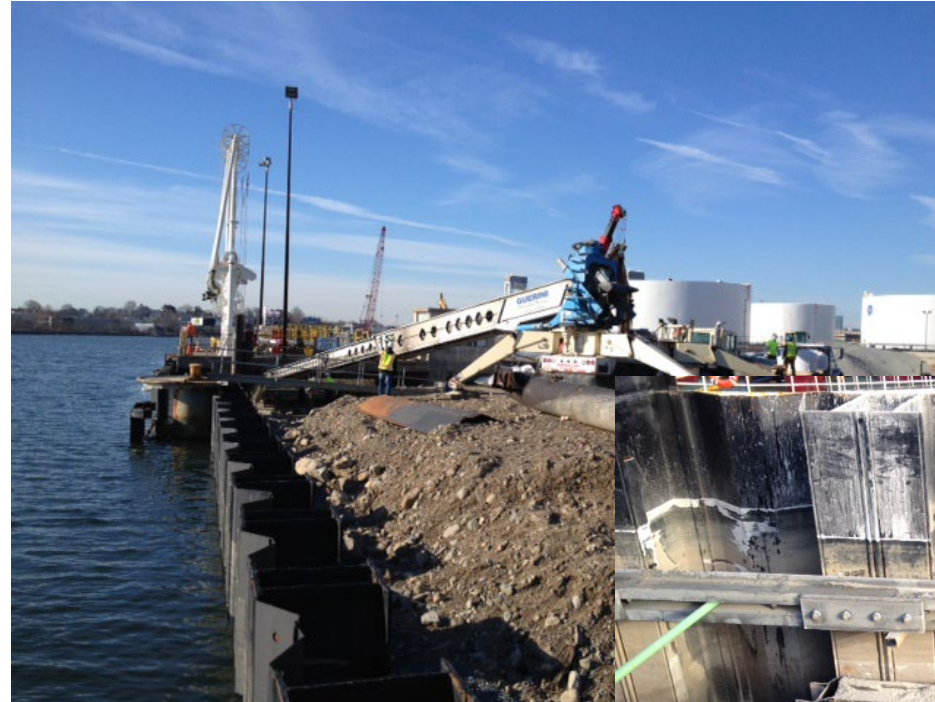
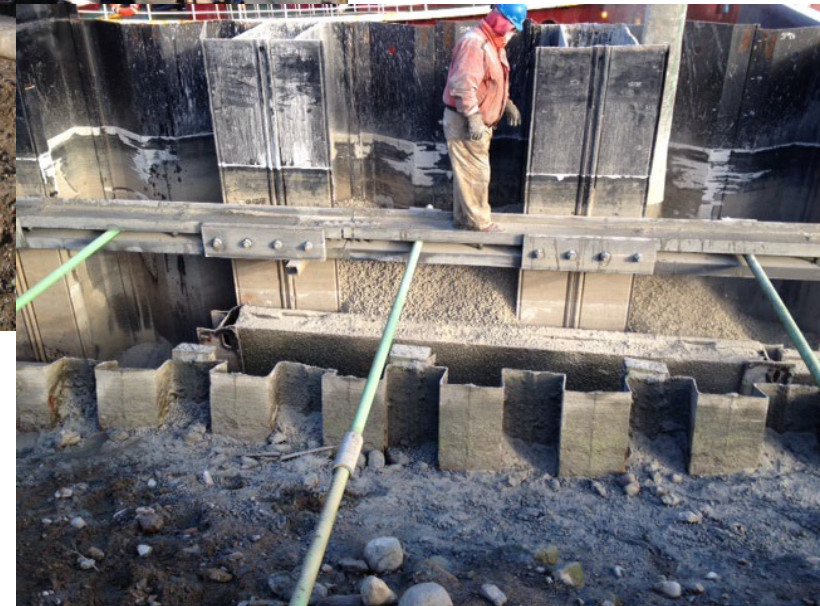
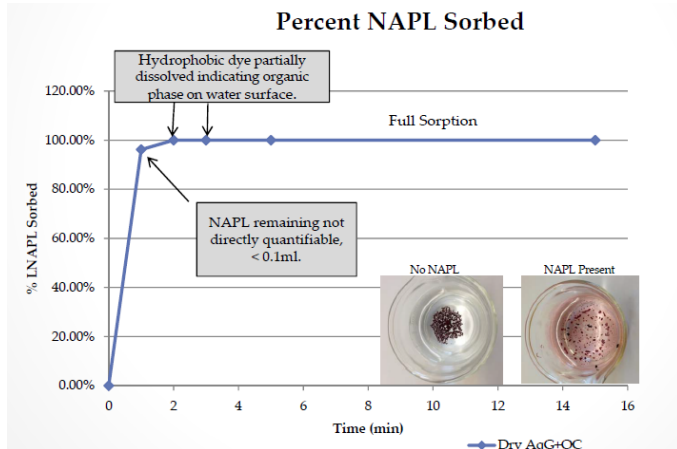
Upland Seep at Sheet Pile Wall: Permeable Reactive Barrier (PRB) Material at Bulkhead Limits Residual Contamination Impacts

- Site Overview:
1. New Bulkhead Installed Outside of Existing Wall
 2. Material Installed Between Walls to Establish PRB

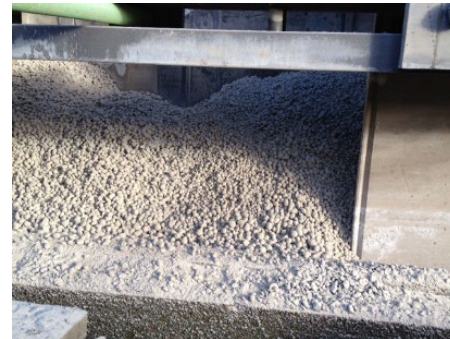
Lab Testing Performed to Confirm Permeability at Fully Saturated State (University of New Hampshire)

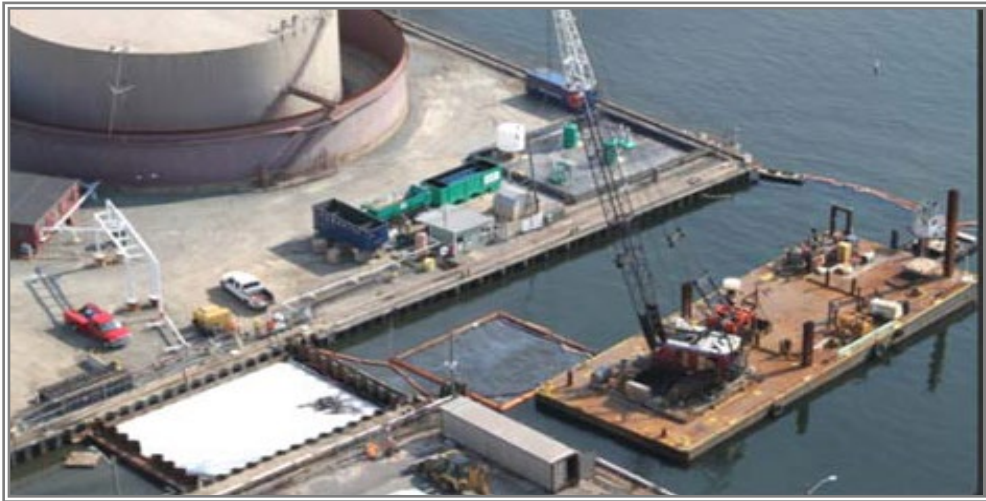
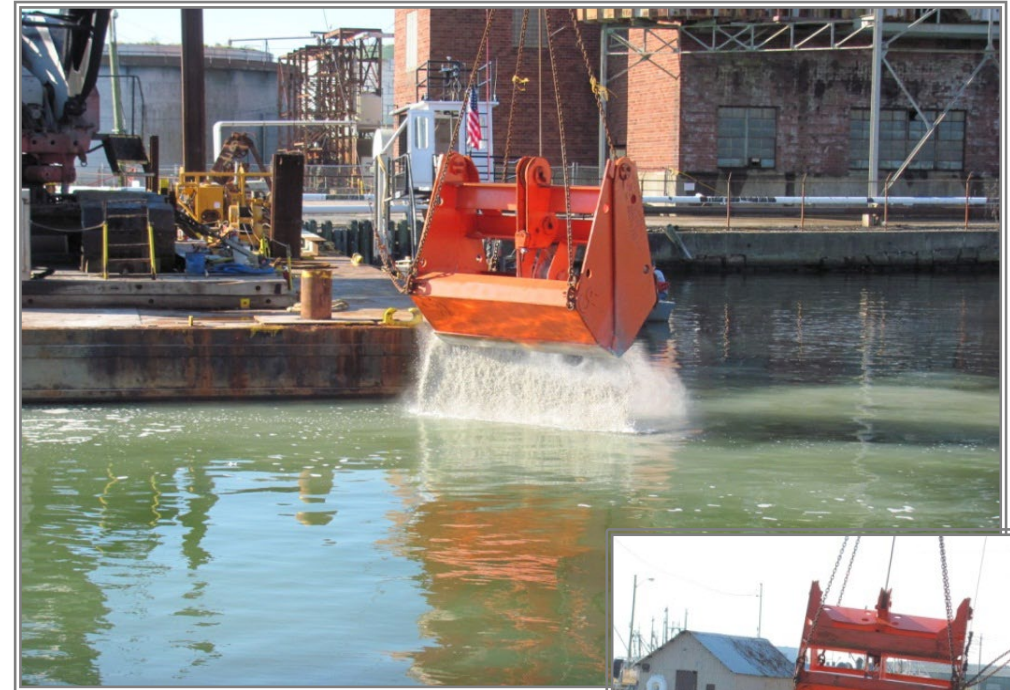
Addressing Residual at a Shoreline: Low- Permeability Capping Limits Residual Contamination Impacts

- **Setting/Purpose:** MPG Site Waterfront Slip - provide cap after partial removal from sediments.
- **Contaminant(s) of Concern:** Coal Tar associated with historic MGP site.
- **AquaBlok Cap Design/Site Area:** Multi-layer comprising six-inch layer of AquaBlok 3070SW#8 saltwater formulation followed a graded aggregate for armoring protection.

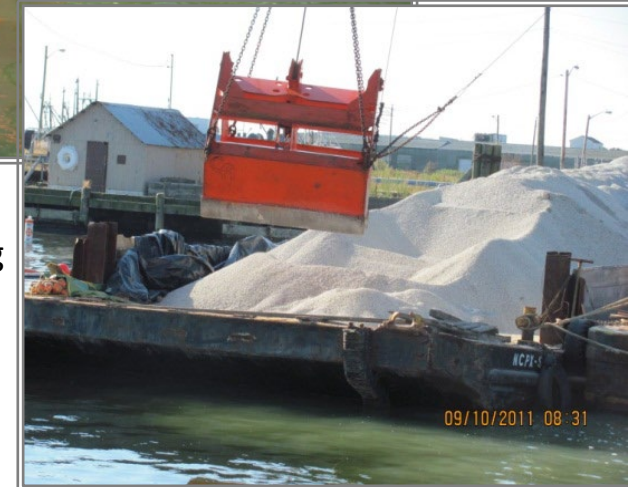
Material Placed with Level Cut
Environmental Clamshell Lab Testing
Performed to Confirm Permeability
at Fully Saturated State (University
of New Hampshire)

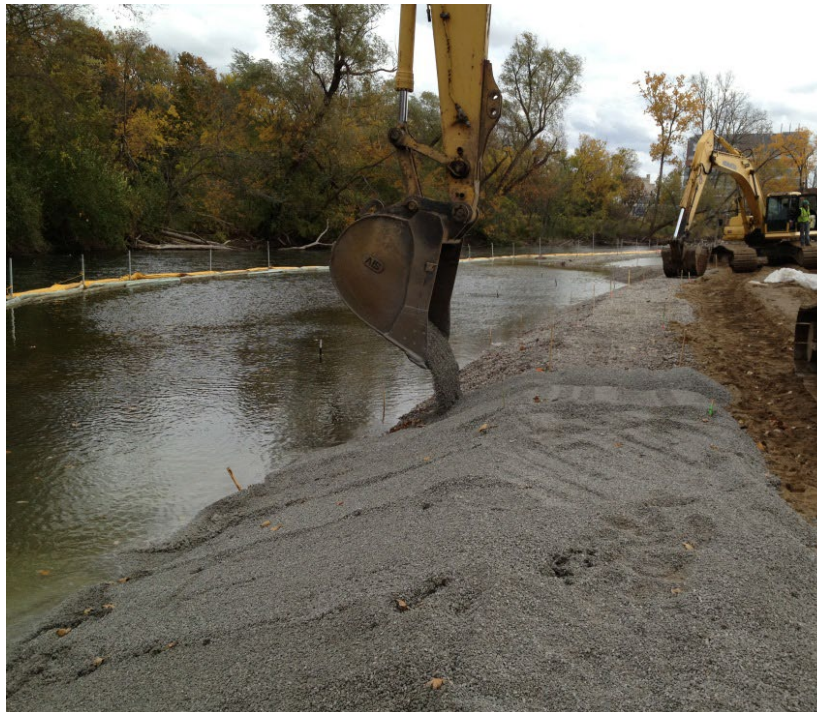
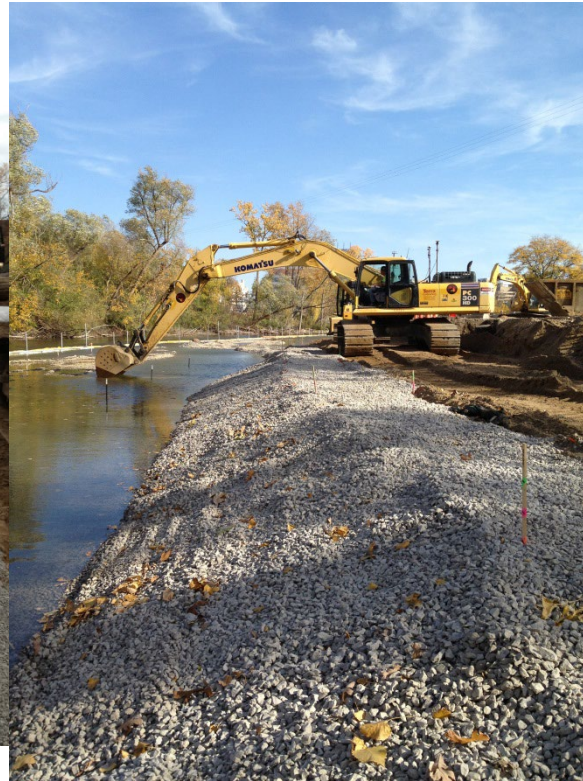
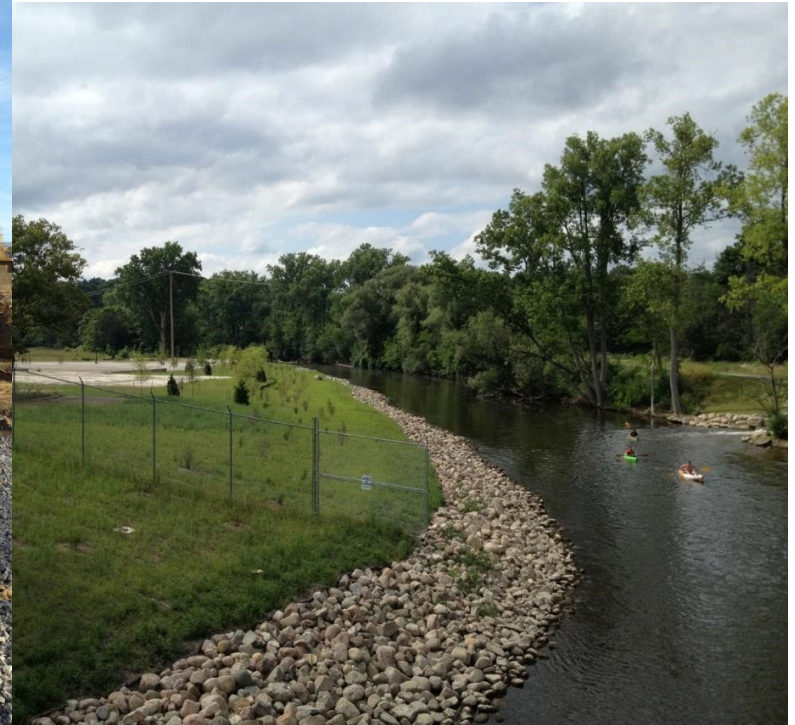
NAPL Trapping Cap* Design for Control of Seep & Ebullition

* NAPL Trapping Cap is Patented and was designed by RMT/TRC

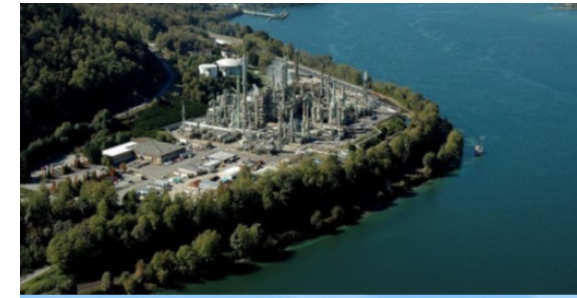
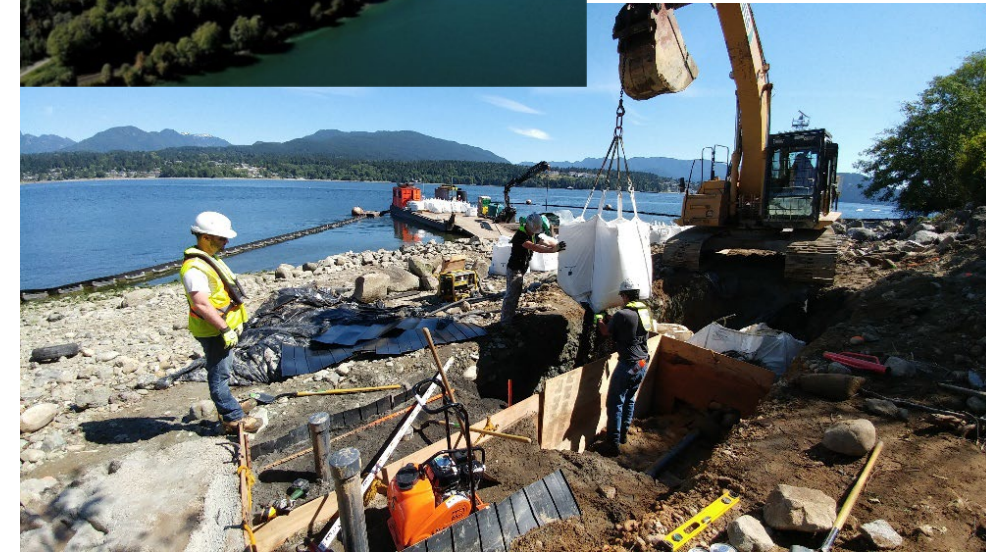
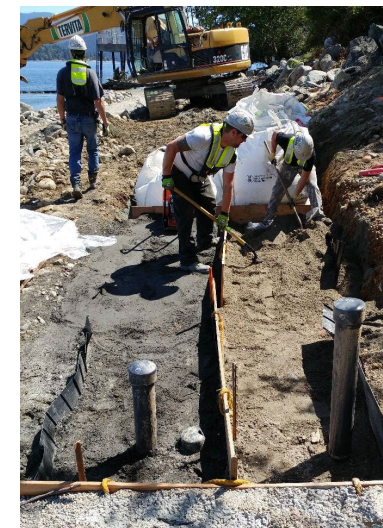
Passive Shoreline PRB to Address NAPL & Dissolved-Phase PAHs in Groundwater

- AquaGate+Organoclay
- AquaGate+PAC
- AquaBlok 2080FW

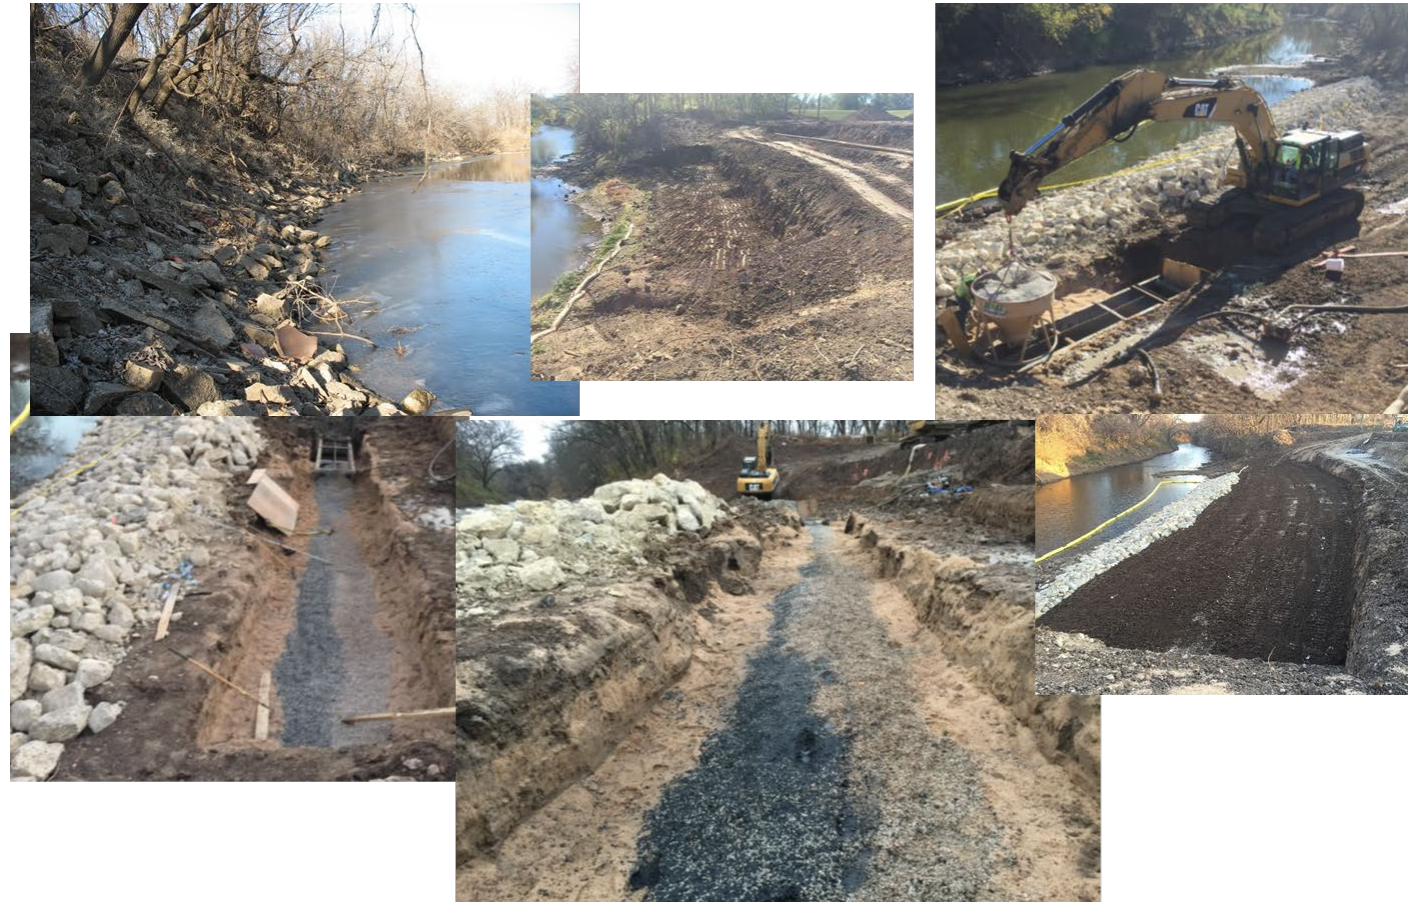
Materials Addressed Metals & Dissolved Phase PAHs in Groundwater Entering Stream

- AquaGate+Organoclay
- AquaGate+Provect-IRM
- AquaBlok 2080FW
