DESIGN OF THE CAMPBELL SHIPYARD SEDIMENT REMEDIATION PROJECT, SAN DIEGO, CALIFORNIA

T. S. Wang P.E.¹, M. Whelan P.E.², D. Keith R.G.³, J. Verduin P.E.⁴ and P. Brown⁵

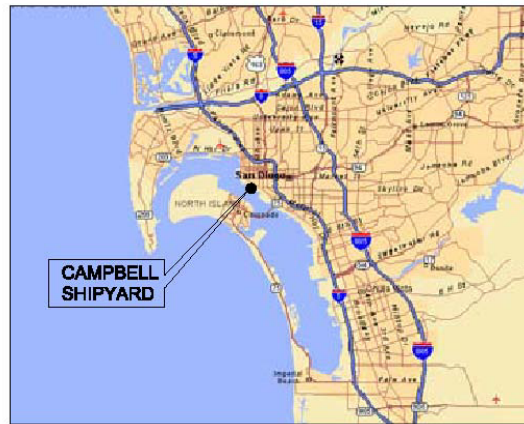
Figure 1. Site location in San Diego Bay.

The former Campbell Shipyard site is located on the northeastern shore of San Diego Bay between the San Diego Convention Center and the Tenth Avenue Marine Terminal (TAMT), at Eighth Avenue and Harbor Drive (Figure 1). This facility is owned by the Port of San Diego (Port) and was first used for industrial operations in 1926 with the Campbell Industries Marine Construction and Design Company. Site operations focused initially on the construction of commercial fishing vessels, and later (in the 1980's) on naval ship repair.

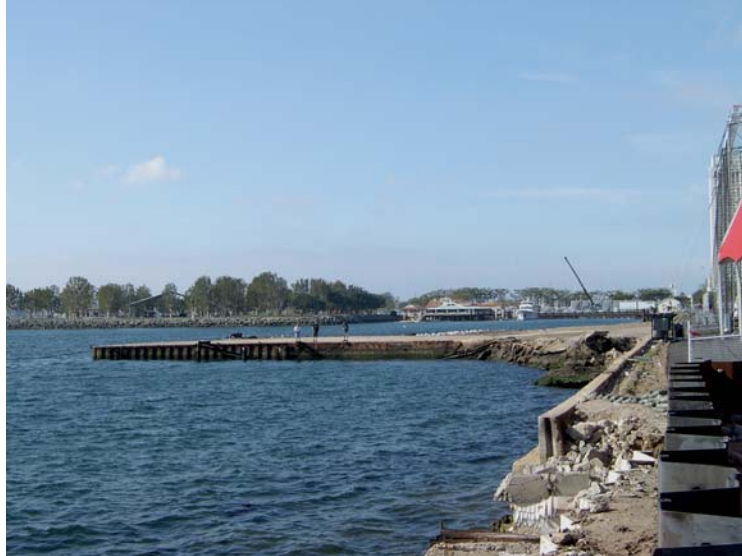
Figure 3. Campbell Shipyard project site before construction – seawall (right foreground) and south mole pier (center).

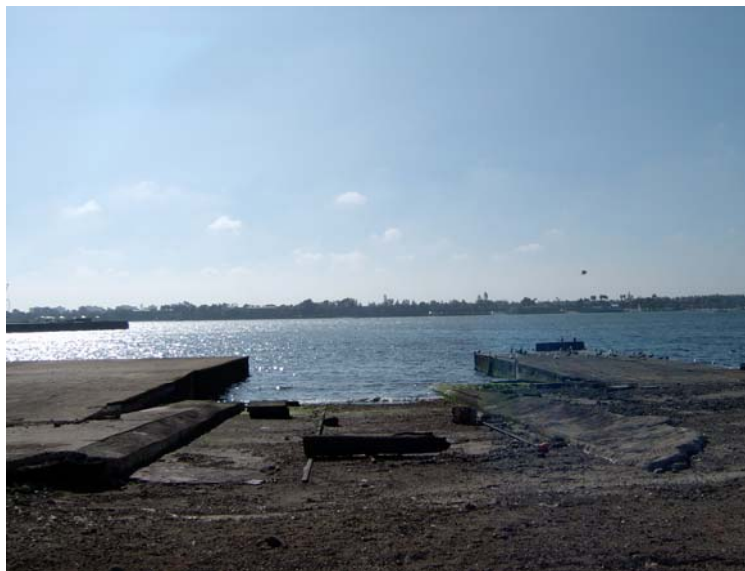
Figure 4. Abandoned shipways area, showing mole pier (left) and marine railway (center).

Site operations were discontinued in the 1990's, and most of the shipyard facilities were demolished in 2000, except for a set of abandoned shipway ramps and marine railways extending bayward from shore near the middle of the site (Figure 2). The features that remained at the start of design – a shoreline seawall (Figure 3) and a set of abandoned shipways (Figure 4) – dated back to the earlier part of the 20th century.

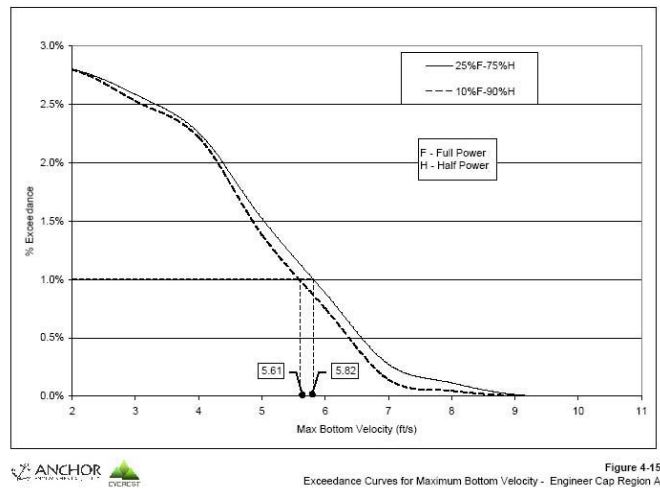
Figure 7. Probability distribution of propeller-wash velocity incidence on cap area.

These data were used to construct a probability of occurrence of maximum bottom velocity on an annual basis (Figure 7). The most commonly occurring maximum bottom velocity was on the order of 1.2 to 1.5 meters per second (4 to 5 feet-per-second (fps)), and the maximum overall bottom velocity (no projected chance of exceedance) was 2.8 m/s (9.2 fps).

Given this probability distribution, a design-level velocity needed to be defined and an appropriate armor rock size selected. An important factor in this decision process was the fact that erosive events would have a very short duration, during which some rearrangement of surface armoring material could be expected. In other words, erosion-induced “damage” to the armor layer would not amount to an actual breaching of the cap, but rather would consist of a modest repositioning or shifting. For this reason, a one percent chance of velocity exceedance was selected as a reasonable criterion for armoring design. This translated into a maximum design velocity of 1.77 m/s (5.82 fps).

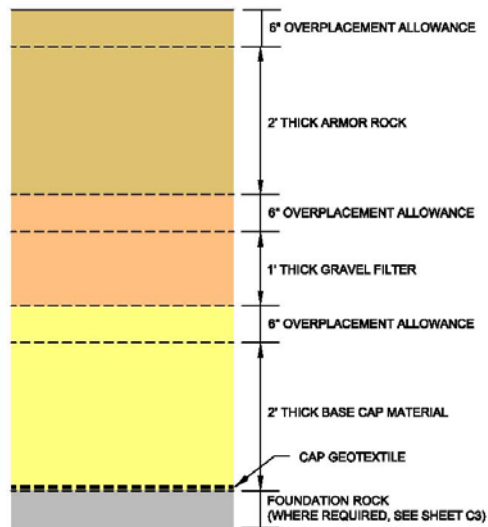
Figure 8. Summary cap design for sediment isolation cap.

Using this design velocity, armor layer thickness and rock size was determined based on guidance from EPA (1998) and USACE (1998). The result was a uniform 0.61 meter (2-foot) thick layer of armor rock with a median diameter of 0.3 meter (1 foot), throughout the capping area. The armor rock would be placed over a filter layer of gravel material.

Figure 8 summarizes the final selected cap design for the overall site.

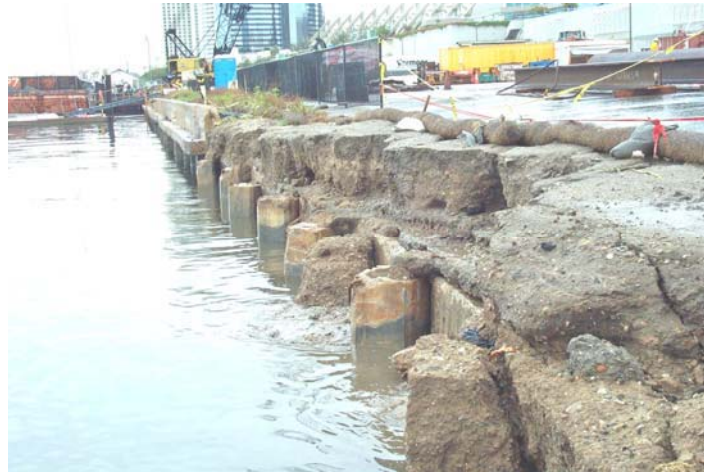
Figure 10. Typical portion of existing seawall in need of repair.

A concrete and timber seawall constructed in the mid-1920s is located along the property. Along most of its length, its pre-existing condition was poor (Figure 10). Geotechnical and seismic studies indicated that the wall is seismically unstable, and that it would likely fail under a design-level earthquake (10 percent chance of exceedance in 50 years). Since this would damage portions of the sediment cap near the base of the wall, the seawall needed to be stabilized and repaired.

A rock revetment was designed to be constructed along the exposed front of the seawall, to provide lateral stability in the event of an earthquake. The revetment was designed as a sloping mass of quarter-ton rocks, placed to reach a top elevation of 1.5 meter (5 feet) MLLW and a 2H:1V sloping geometry. The revetment rock would overlie the 0.61 meter (2-foot) isolation cap sand layer (with a foot-thick layer of filter gravel separating the rock from the underlying sand).
