CONSTRUCTION OF THE CAMPBELL SHIPYARD SEDIMENT REMEDIATION PROJECT, SAN DIEGO, CALIFORNIA

ABSTRACT

The Port of San Diego (the Port) was required by the California Regional Water Quality Control Board (RWQCB) to remediate contaminated sediments at the former Campbell Shipyard site. As was discussed in the previous presentation ("Design of the Campbell Shipyard Sediment Remediation Project"), the selected remedial alternative was to cap the sediments in-place in such a way as to prevent migration of the contaminants into the marine environment.

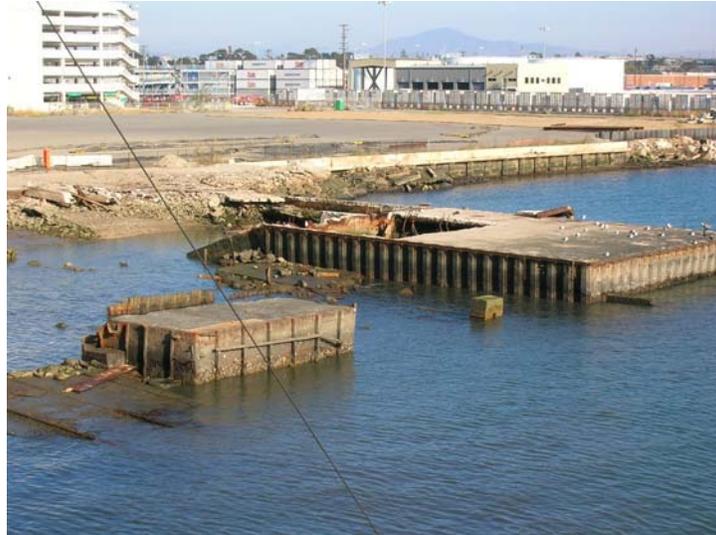
Figure 1. Condition of shipways area and mole pier following free product removal.

As the free product removal progressed, extents of the deposits were found to be more extensive than expected, so it also became necessary to remove some of the south mole pier as well (Figure 1). This in turn necessitated a modification to the project design and to the contractor's work scope. A key element of the project design was to stabilize the mole pier structure and retain its pre-existing geometry. This goal remained even after part of the mole pier had been demolished for the free product removal. The timing of the free product excavation was such that the total extent of mole pier removal was not known until after award of the sediment remediation contract, so the corresponding change in the contract's scope needed to be done as a change order.

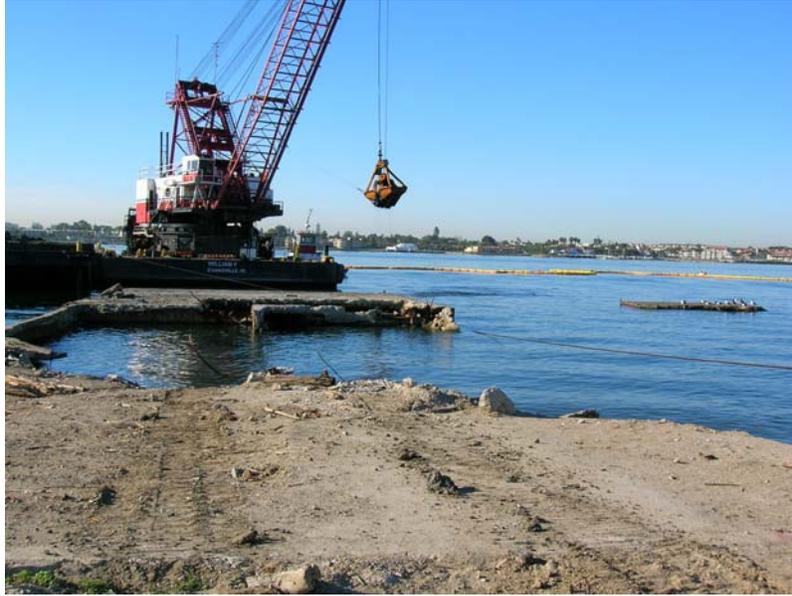
Figure 2. Demolition and debris removal underway (note partially excavated mole pier in foreground).

The contract documents identified specific features and items for demolition and removal, some of which had been removed during the precursor free product removal work described previously. All features that remained after that work were then demolished and removed by the sediment remediation contractor (Figure 2).

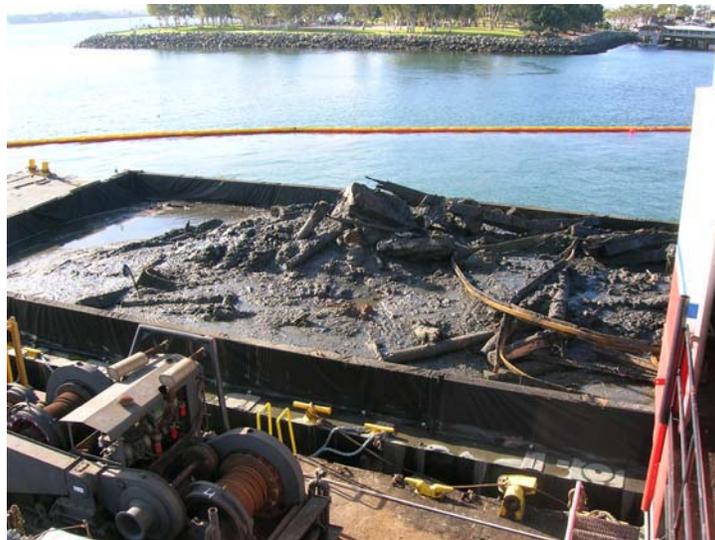
Figure 3. Barge load of debris shows accompanying sediment.

During this process, a significant amount of accompanying sediment was brought up with the debris (Figure 3). In some cases, the amount of accompanying sediment exceeded (by as much as a factor of two) the tonnage of the demolition debris itself.

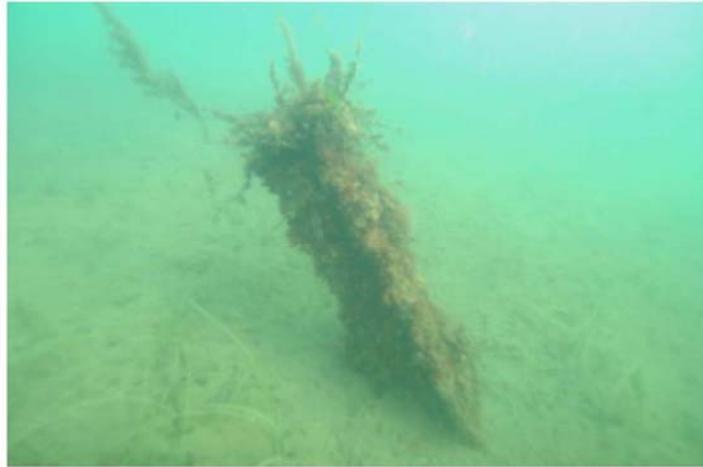
Photo 3 - steel rail, 27 in. vertical.

Figure 4. Example of debris requiring removal (diver photograph).

As demolition was completed in various areas, the Port conducted diver and side-scan sonar surveys to assess whether there was any remaining debris to be removed. These surveys did reveal additional debris items on seafloor

(Figure 4) that were large enough to hinder cap placement and function, and thus warranting removal. The contractor was required to remove these additional debris features under a change order.

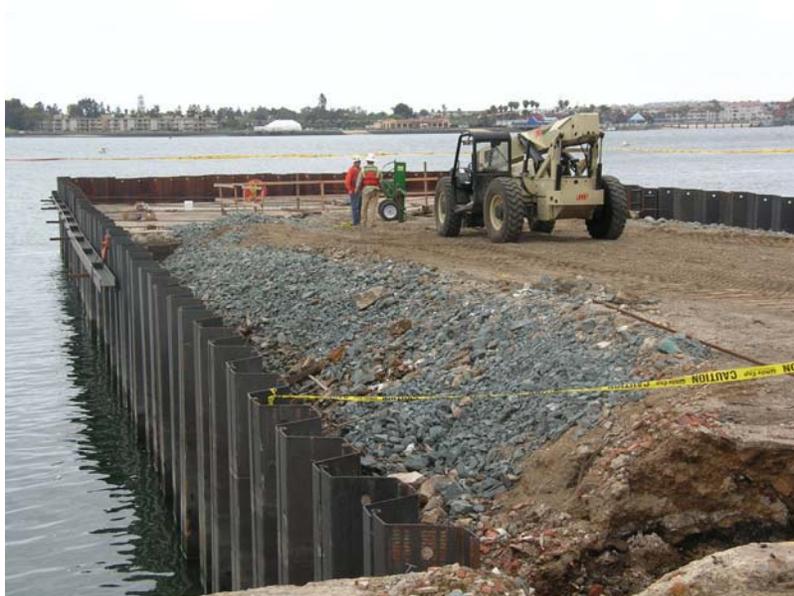
Figure 5. Mole Pier reconstruction underway.

As mentioned previously, the mole pier needed to be reconstructed since much of it had been removed during the hazardous waste removal operations. Figure 5 shows the new sheet piling installed around the mole pier's perimeter, and the rock fill that was used to backfill the areas that had been excavated earlier for free product removal.

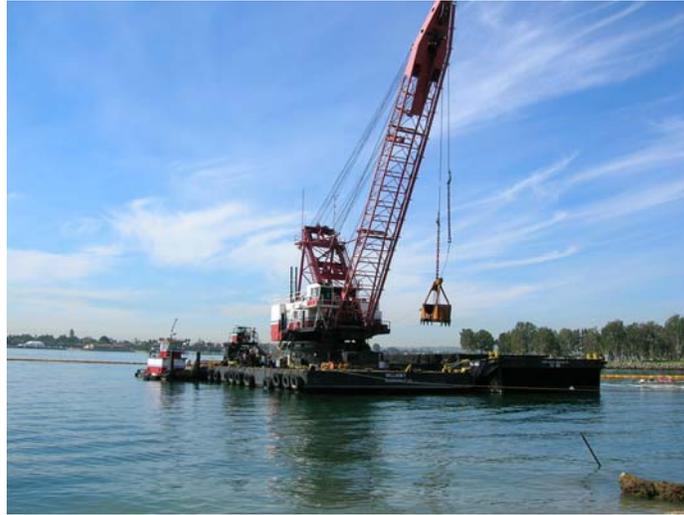
Figure 6. Dredging equipment in action.

Sediment was dredged using a toothed clamshell bucket and loaded directly onto flat-deck barges (Figure 6). Daily dredging rates were typically on the order of 153 to 229 cubic meters (200 to 300 cubic yards) per day, although the production rate increased to as much as 765 cubic meters (1,000 cubic yards) per day while dredging the area closest to TAMT, where the cut thickness was greatest (over 3.3 meter (10 feet)).

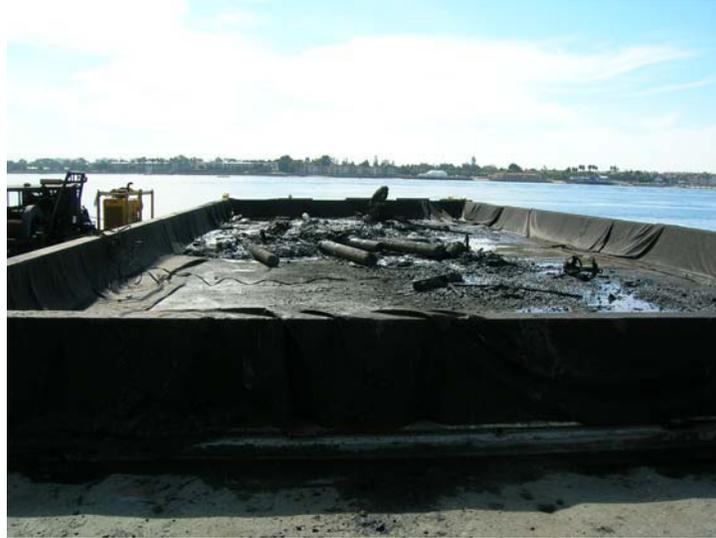
Figure 8. Barge being loaded with sediment and debris.

The barges had been equipped by the contractor with enclosures constructed with K-rail barriers (Figure 8). Sediment was permitted to drain from the barge directly into the Bay, through filter fabric-lined gaps under the rails, provided that water quality criteria were met at all times. To date, no water quality violations have been recorded (see section on Environmental Protection).

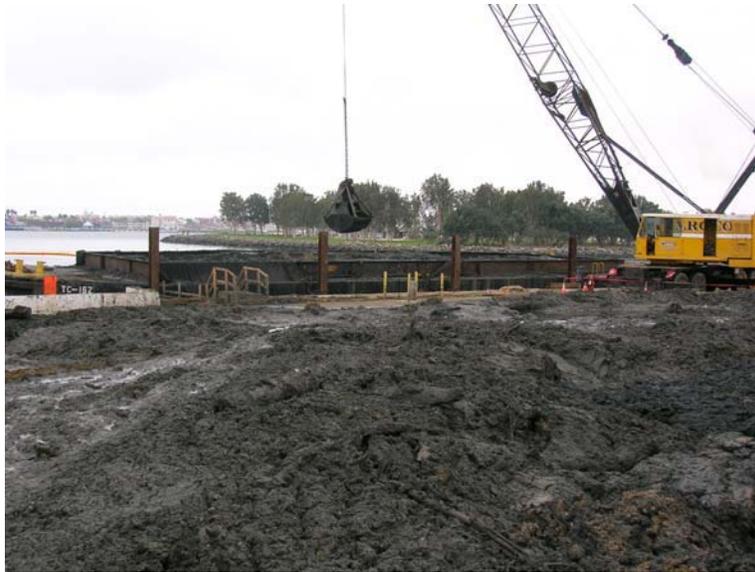
Figure 10. Offloading dredged sediment from barge into stockpiling area.

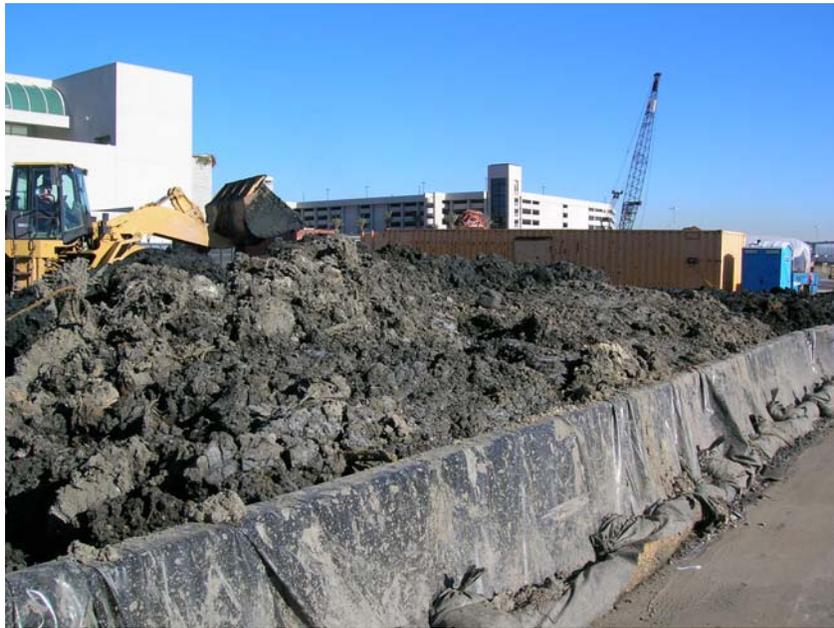
Figure 11. Rehandling within sediment stockpiling and dewatering area.

As was discussed previously, the Otay Landfill in Chula Vista accepted site sediment for disposal, provided that it was sufficiently dewatered to pass the “paint filter” test. Sediments were typically stockpiled within this area for a time period of 2 to 5 days, during which time it was regularly reworked using a rubber-tired front end loader to facilitate air-drying (Figure 11). This physical drying technique ended up being sufficient, as the landfill accepted all truck loads of material. As a result it was not necessary for the contractor to add any dewatering additives to the sediment.

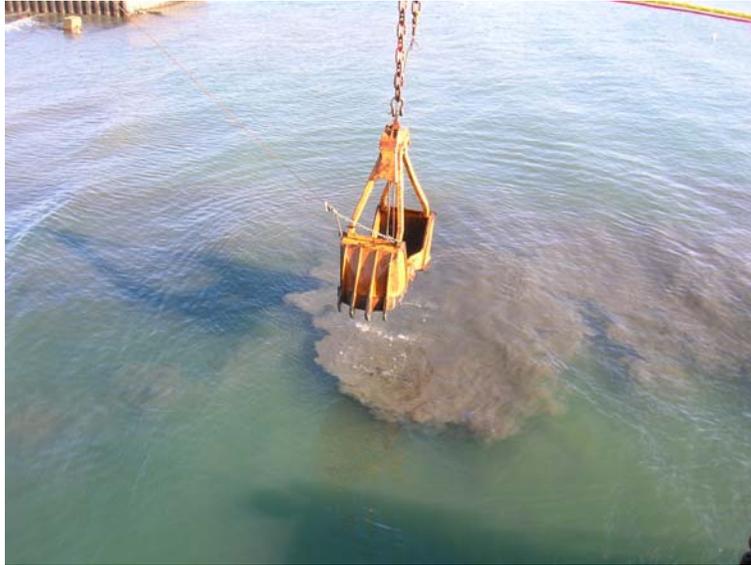
Figure 12. Typical example of turbidity generated during dredging and debris removal operations. Portion of perimeter silt curtains are visible in upper right corner of photograph.

The Port conducted water quality monitoring on a daily basis during in-water construction activity. Monitoring was conducted just outside the silt curtain enclosure and included observation and measurement of turbidity levels at the water surface and at mid-depth below the surface. The criterion for water quality was that turbidity (Figure 12) could not be more than 20 percent higher than ‘background’ turbidity measurements.

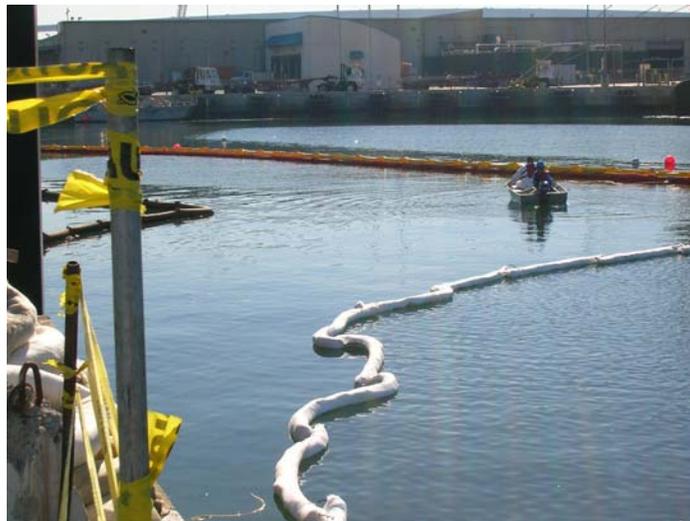
Figure 13. Oil boom deployment (near field) and silt curtains (far field).

In some cases early on during demolition and debris removal from along the seawall, minor amounts of sheen and potential product were noted on the water surface. In these cases, the contractor immediately informed the Port, and an environmental cleanup subcontractor was called out to the site to contain and remove the product and sheen. Skimmer pumps and absorbent pads were used for removal of visible sheen, with an oil absorbent boom in place for spill containment (Figure 13).

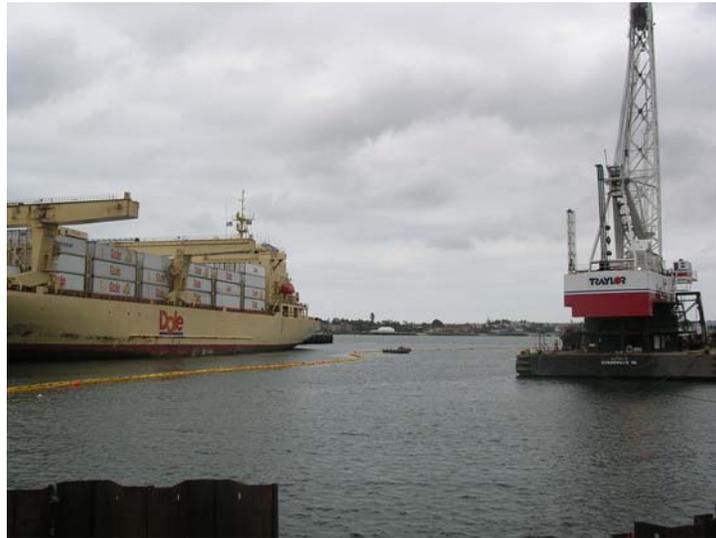
Figure 13. Dredging operations and silt curtains adjacent to TAMT (with Dole vessel in berth).

Daily communication was necessary between the Contractor and marine operations wharfingers at the adjacent TAMT, so that the Contractor could avoid interference with the terminal operations (Figure 13). Large container and breakbulk vessels called on the adjacent Berths 10-1 and 10-2 at regularly scheduled frequencies. During vessel berthing and departure, the contractor needed to make sure that their operations, anchor lines and silt curtain deployment did not interfere with the moving vessels or their tugboats. While dredging occurred on the south side of the project area (nearest to TAMT), the contractor had to temporarily “pull in” their silt curtains to avoid interference.

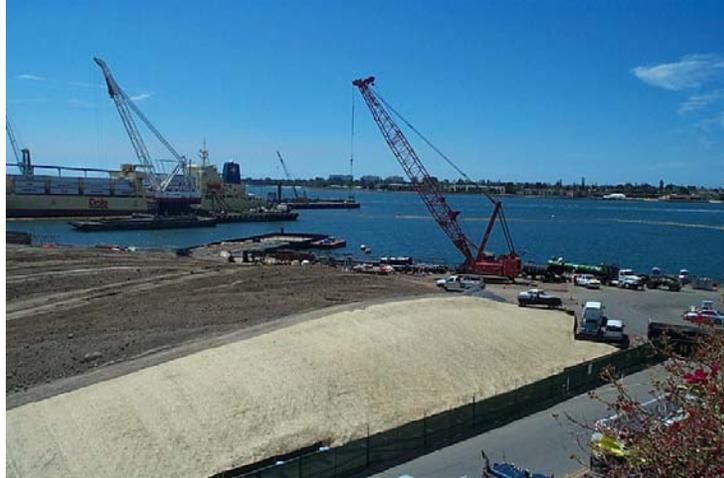
Figure 14. Campbell Shipyard Construction site and adjacent earthwork area for Hilton development (photo taken from top of Convention Center).

The upland portion of the former Campbell Shipyard site was the location of a new Hilton Hotel development (Figure 14). Hilton construction started in the early part of 2006. During this time the Campbell Shipyard contractor was given approximately 2 acres of paved space in the northern part of the uplands area, for their staging and sediment stockpiling activities. South of this, a 12.2 meter (40 feet) wide strip of land immediately behind the seawall was shared between the Campbell and Hilton contractors. Throughout the dredging work at Campbell, and through the time of this writing, the Hilton work primarily involved site excavation and foundation work, and did not require heavy use of this shared property, so its joint use went fairly smoothly.
