LOCAL SEDIMENT MANAGEMENT AT LEeward-GOING-THROUGH IN PROVIDENCIALES, TURKS AND CAICOS

Leaf Erickson,¹ Billy L. Edge² and Karyn M. Erickson³

ABSTRACT

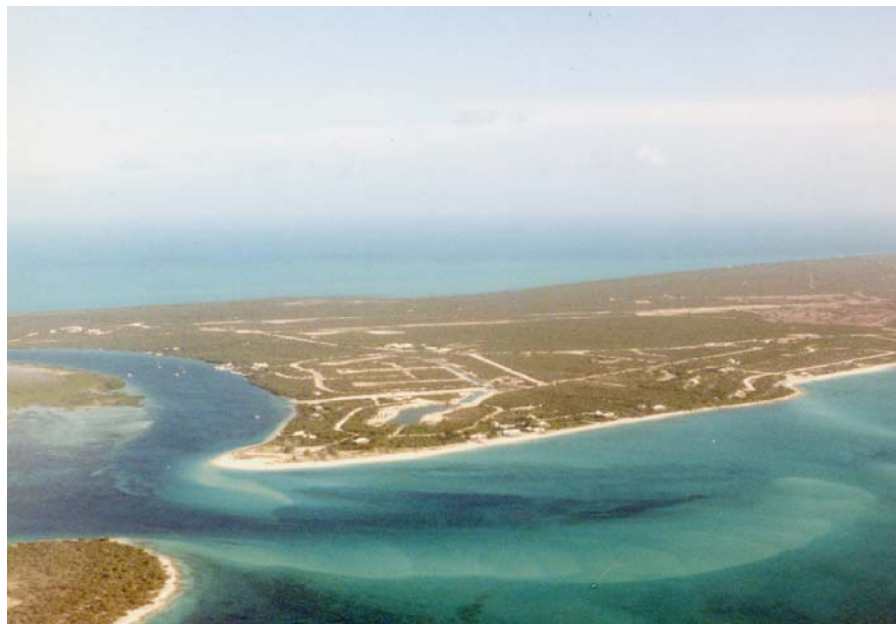
Figure 2. Leeward-Going-Through and Emerald Beach

A tidally influenced channel, Leeward-going-Through, that divides Little Water Cay from Providenciales, had significantly eroded shorelines. Since the closing of Donna Cut, the erosion along this length of shoreline has been extensive, threatening several homes and other structures. Other areas of Grace Bay have also been experiencing similar erosion problems without direct influence by significant tidal flows, so proper determination of causes was essential to an effectively engineered solution.

The dominant cause of sediment transport from Emerald Beach was Leeward-going-Through which has a relatively high tidal flow that dominates the movement of local sediments. During severe storm events, closing nearby Donna Cut, and natural ebb shoal evolution, the tidal flows from Leeward-going-through and Donna Cut were combined resulting in more scour and erosion between the Emerald Beach shoreline and the western end of the Little Water Cay. This channel has been historically stable but, as mentioned, strong storm events and subsequent changes in the local tidal flow patterns resulted in severe erosion along the adjacent shorelines. The erosion threatened many homeowners with losses in property and structures. Before nourishment, some sections of beach became seawalls, were divided by geotextile groins, and dead trees.

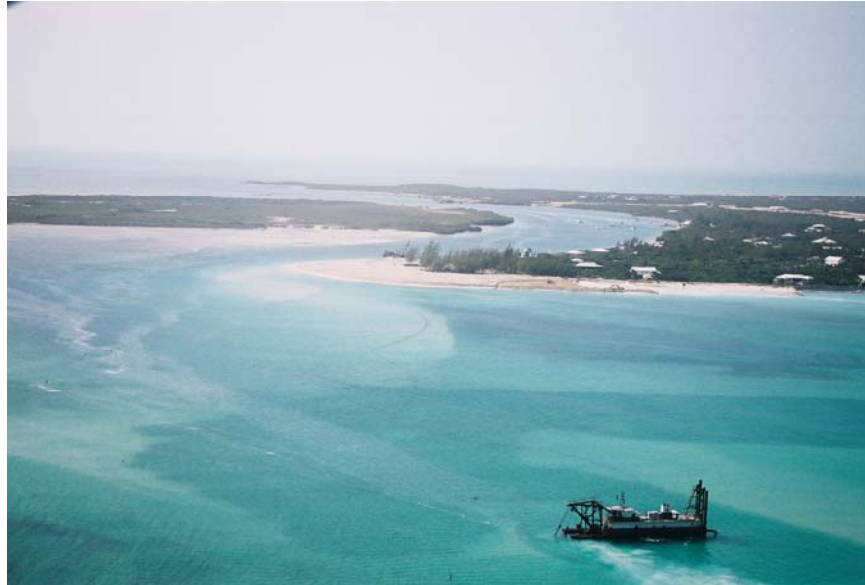
Figure 3. Dredge in operation with Beach fill and Leeward-going-through in background

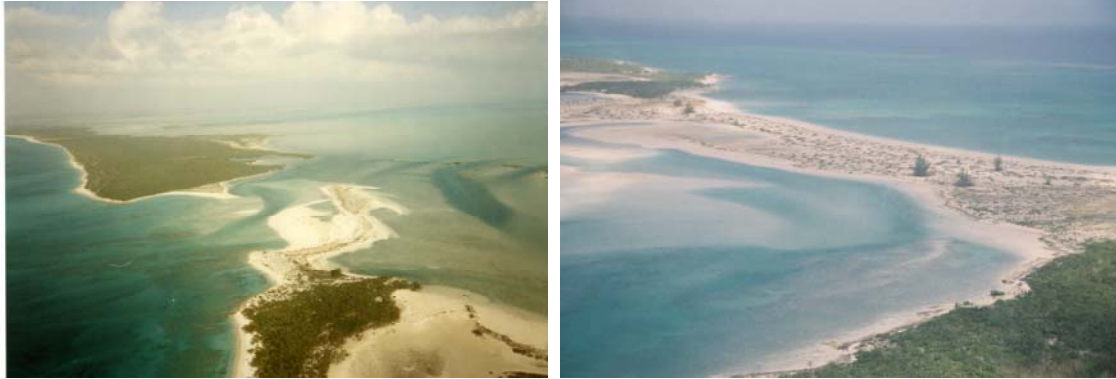
Figure 5. Donna Cut Open from the west (left) and Closed from the east (right)

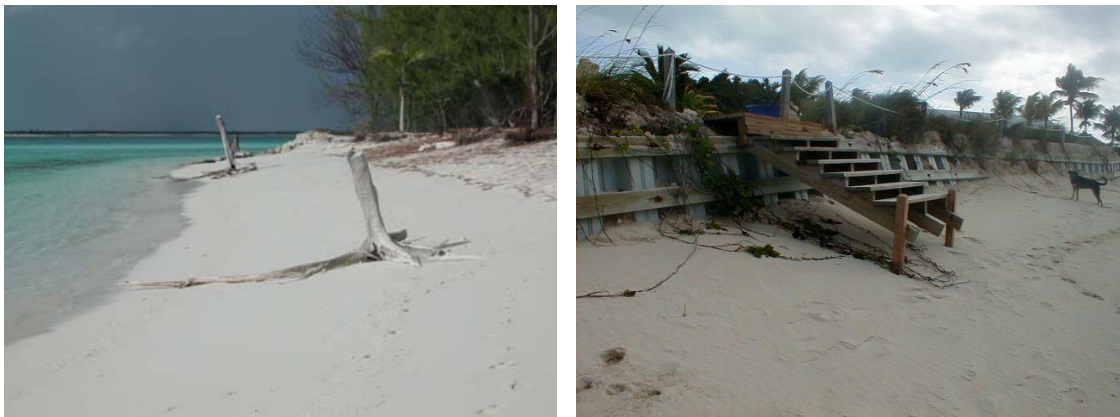
Figure 6. Emerald Beach erosion before dredging facing north (left) and south (right)

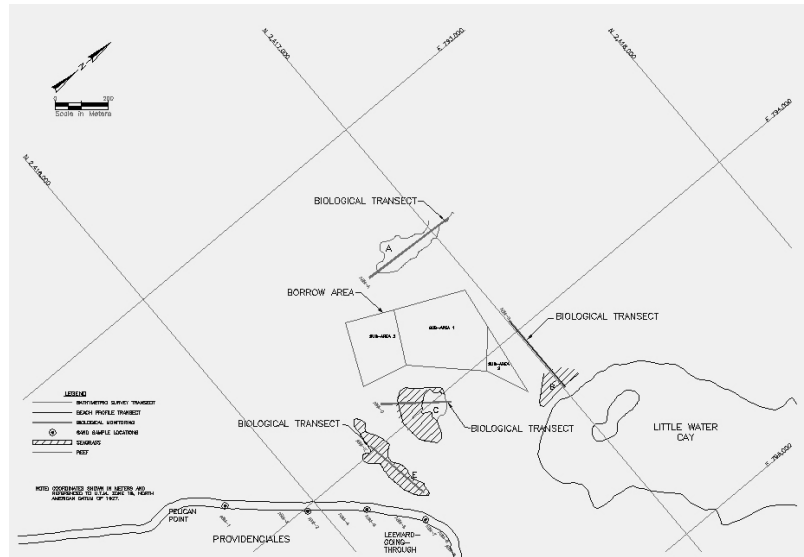
Figure 7. Biologic Monitoring Transect Locations

The project involved monitoring and management of both environment and contractor. Ecosystems surrounding the project area required careful planning as well as monitoring during the project to ensure no excessive impacts were caused by dredging activities. Turbidity was monitored at several locations and biologic transects were regularly surveyed to help keep a record and to protect the environment. Daily reports were produced by the engineer's site representative, contractor, and dredge captain to help keep

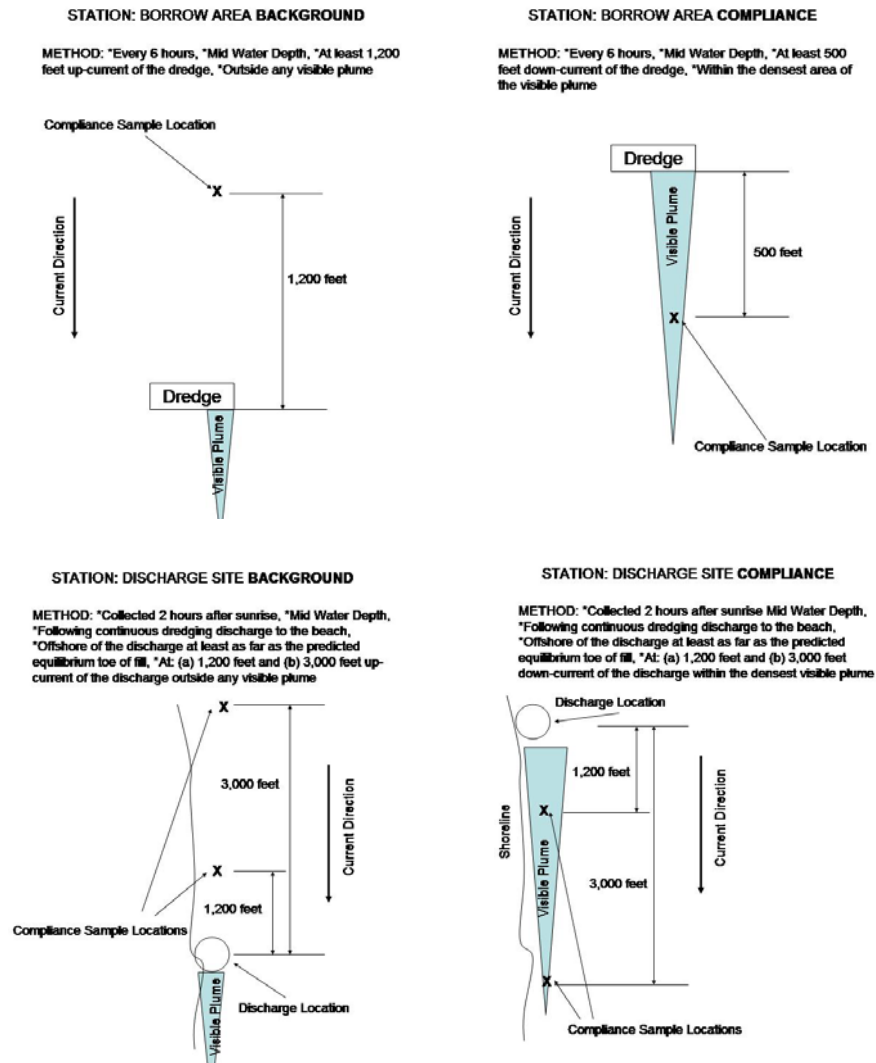
Figure 8. Monitoring Locations

Turbidity monitoring, government field approvals and permit compliance were the most significant areas of concern regarding water quality. The government required turbidity measurements twice daily and any time a significant plume developed, measurements beyond the established mixing zones of twenty-nine nephelometric turbidity units above background would have placed the project in violation of the permit requirements. Global positioning was used to determine all sampling locations relative to the discharge and dredge as they progressed through the borrow and fill areas, respectively. Turbidity as it is related to most dredging projects, especially one operating inside of a marine national park was a primary environmental concern but, did not present any major problems during the project. All plumes developed dissipated within the distances required by the permitted monitoring plan.

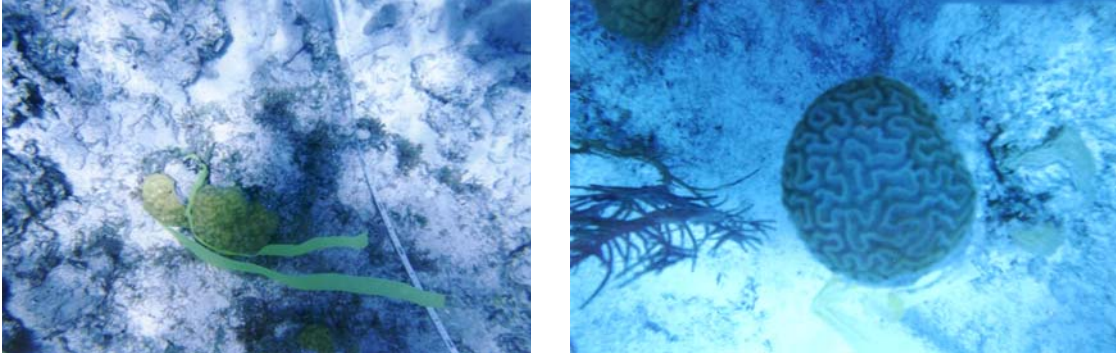
Figure 9. Reattached Mustard Coral and Brain Coral

Slight siltation was documented during regular monitoring intervals but, no major problems occurred for the first half of the project. Eventually, the high tidal currents caused the anchoring system of the pipeline to fail, allowing it to drag across a portion of a densely populated and productive patch reef. Repairs and compensation were made for the damages to the marine environment by the contractor but, once the anchor system was doubled in strength, no further problems occurred with pipeline movement.

The efforts of reattaching coral and sponges was found to be quite difficult for some of the same reason the pipeline damaged the coral in the first place, tidal currents were quite strong and anchoring them to the bottom proved difficult at best. To resolve the issue of the pipeline dragging, the anchoring system strength was doubled by using four additional twelve and six ton anchors. Once repositioned, dragging was no longer a problem with the pipeline, but at times the heavy currents would kink the pipeline like a garden hose. This could have been very damaging for the dredge as well as the pipeline but, no breaks in the pipeline occurred or pressure related damages were experienced by the dredge.

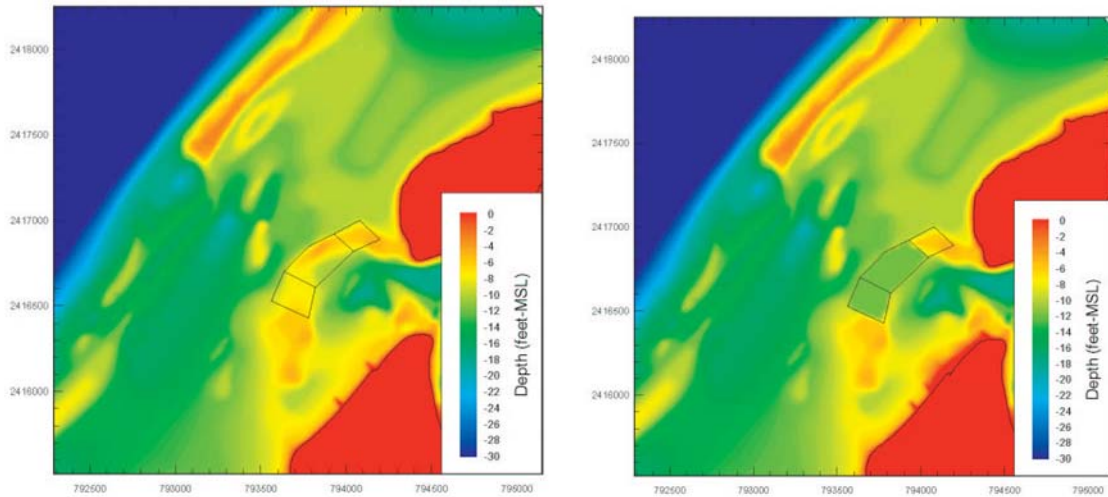
Figure 10. Before Dredge Survey (left) and After Dredge Modeled Bathymetry (right)

The new channel would provide a direct route for both tidal flows and local marine access to Leeward-going-through. The survey transects used to determine the before dredge bathymetry will be resurveyed after construction and used to ensure complete sediment removal. The same transects will continue being used to determine shoal evolution and migration for the remaining monitoring surveys. These surveys will be used to help determine the beach fill performance over the design life. The renourishment interval will be determined with these monitoring surveys but, with the borrow area sand almost identical to the beach fill the erosion will be primarily determined by the local flow regime.

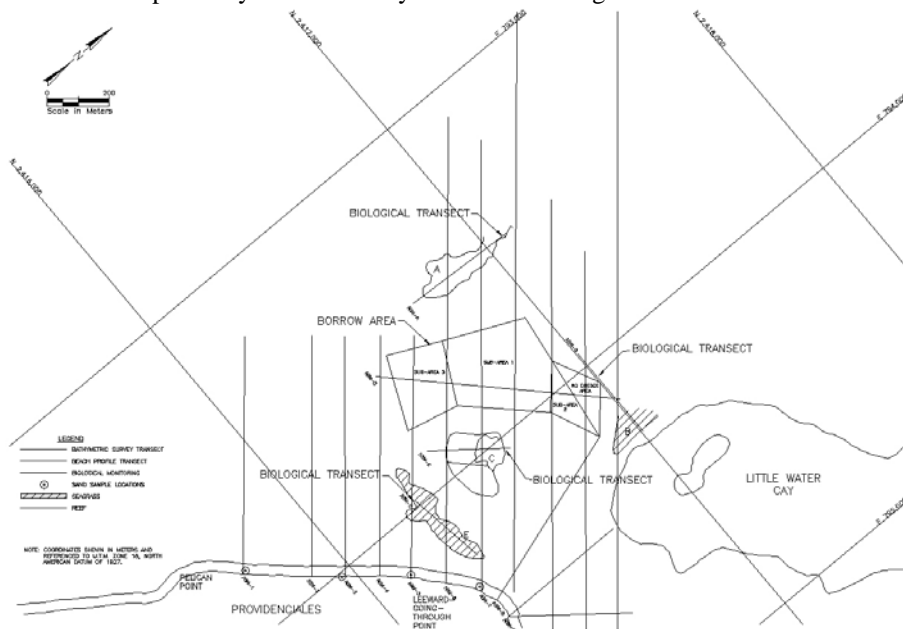
Figure 11. Construction Survey Monitoring Transects

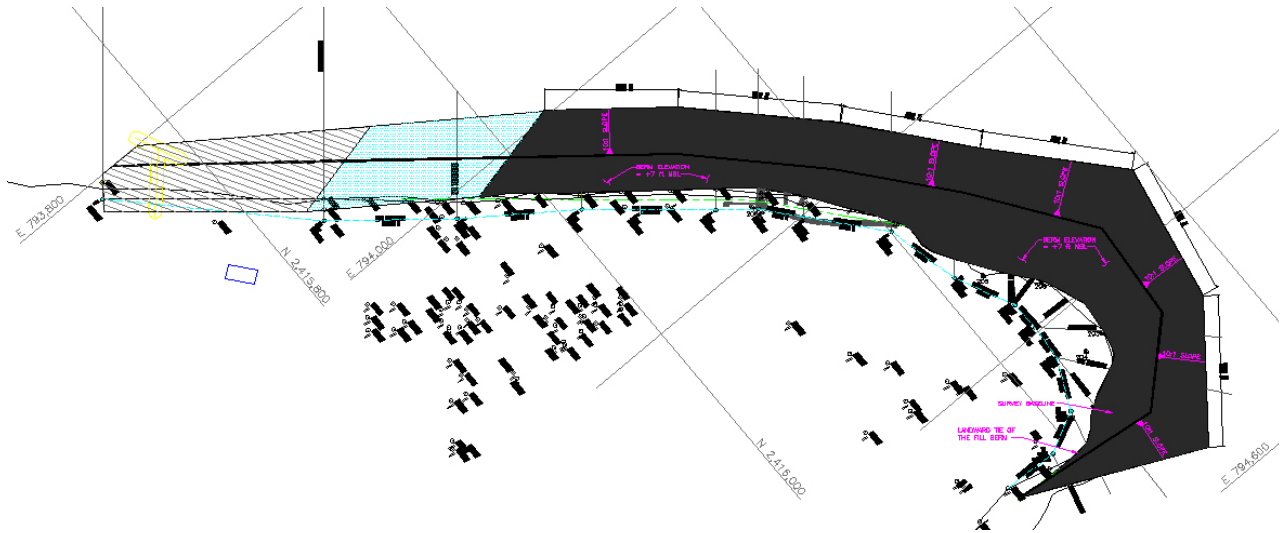
Figure 12. Extension of Beach Fill for two homeowners to the west

The originally permitted design included an option for extending the fill one homeowner property to the west, as is common for adjacent properties in many coastal projects. Interest was shown by the property owner beyond the designed extension to the west for beach fill, if permitting could be achieved. As this was not an option on the originally permitted design, permitting was needed and was quickly received with the same standard conditions as before. This required re-documentation of many formal standard public and legal notices.

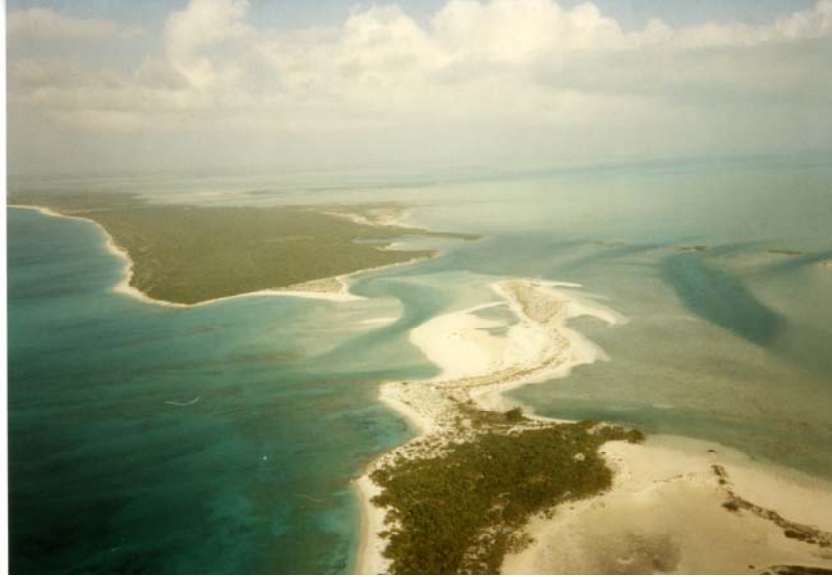
Figure 13. Aerial View of Donna Cut with Water Cay in the background

A resort development was planned for the island of Water Cay. The investors had been organized and construction of an access channel needed to be completed in order to begin any development of the property. Channel depth was to be sufficient in order to bring barges to shore and have enough area for maneuvering in a turning basin, allowing vessels to depart safely. Locally, fill dirt is expensive and all sediments excavated during the dredging project are sought to be confined in an upland containment area, to help in later site grading and development.

The channel was designed deep enough for an eight foot depth to remain at low tide, allowing for relatively deep draft vessels to safely navigate to shore. Three to one side slopes are chosen for the channel to limit slope avalanche failure and to help provide ease of construction for an oversized dredge on site. The dredge did allow for greater flexibility in placement of the containment area because of the higher pumping capacity associated with the equipment. The channel was designed to be longer than necessary in order to cross areas of beach quality sediments on the backside of a closed inlet, to help limit the overall impact to the ecosystem by crossing fewer seagrass beds, and for safer navigation because of smaller turns for vessels while during approach and departure.

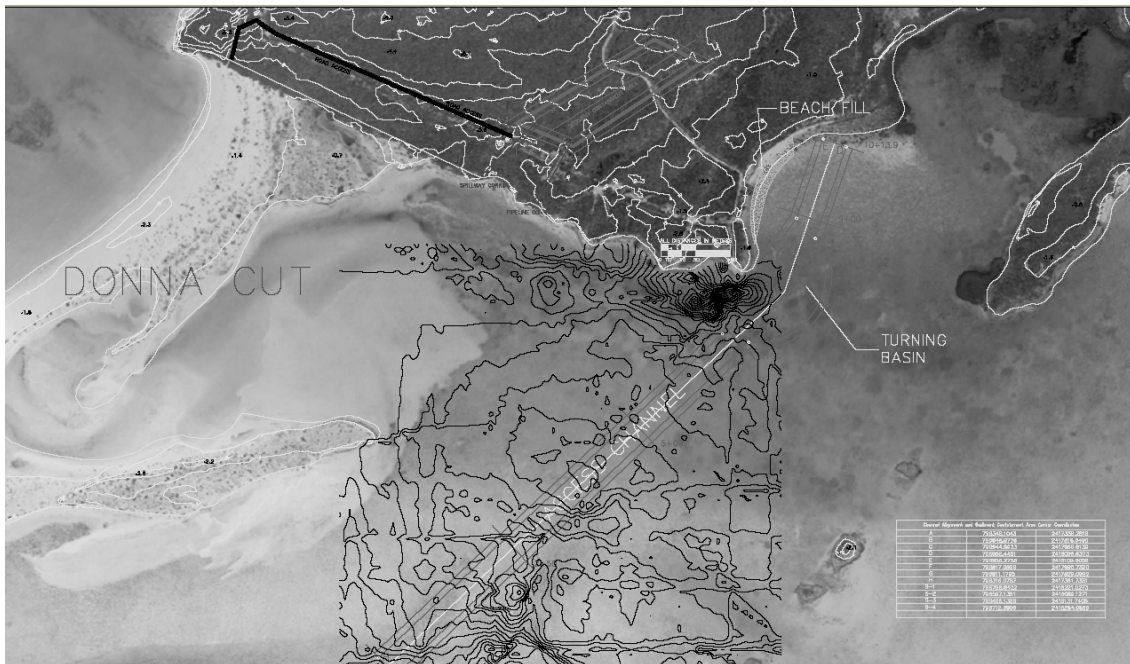
Figure 14. Water Cay Project Layout showing Channel alignment and Bathymetry

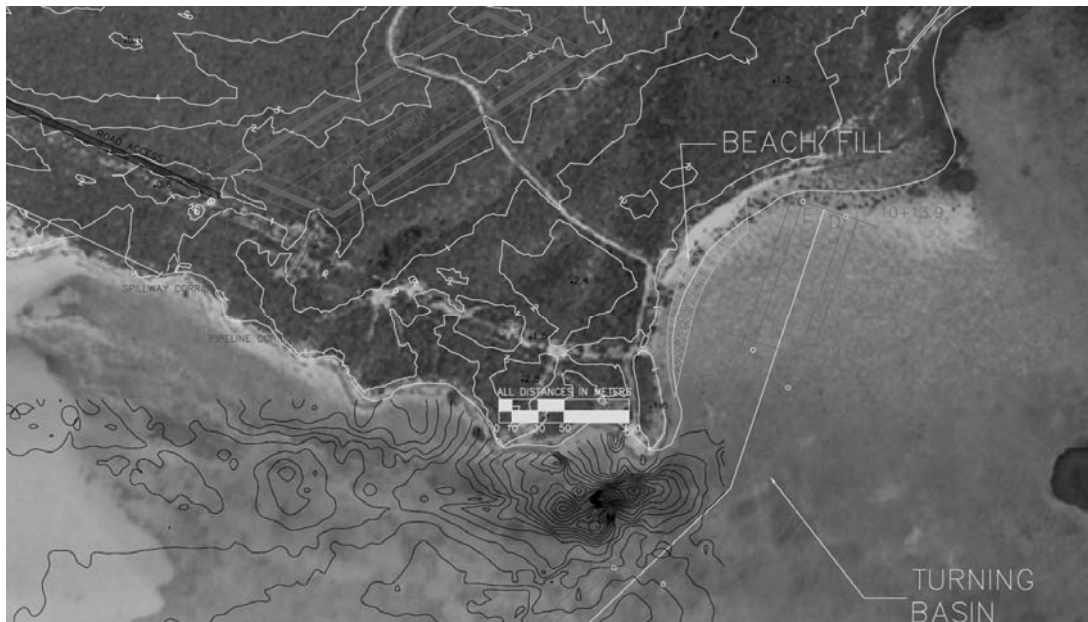
Figure 15. Water Cay Beach fill, Turning Basin, and Containment Area

In the short term, the process began with an engineering overview of the project and initial approval for the outline planning stage of the project. A large upland containment area with earthen dikes was designed to contain all sediments and associated overwash from channel dredging. The volume was difficult to estimate, but from vibracores taken in the area sediment depths, a general estimation was made. A maximum dike height of fifteen feet was established by the planning department in order for the fill to remain concealed behind a ridge when viewed from offshore, near the neighboring fringe reef. With an approximation for the area needed, the aerials of the property were consulted and initial locations were established. An environmental assessment of the upland impacts were made by an independent specialist which caused the final location to be moved inland of a freshwater marsh, relatively rare for the Caribbean, that contained plants designated as protected. Functionally, their marsh and wetlands areas are treated much like our domestic counterparts. After the areas of concern were designated, the site was briefly reviewed, by both the engineer's site representative and the contractor, for final containment area placement and estimation of land clearing and dike building needs.

The placement of all beach quality sand will be made to a section of beach fill designed for nourishment of the shoreline adjacent to the areas deepened by the dredging. Due to the relatively protected nature of this beach from storms, wind and wave impacts are limited. The relative stability of the fill placement was considered stable enough and would be unlikely to reenter the channel.
