THIRD GENERATION ROCK CUTTING SYSTEM FOR CUTTER DREDGES WITH 3000-6000 kW CUTTER POWER *FIELD RESULTS*

VOSTA LMG's concept for a new system was launched during the Europort 2003 and is since then tested on several cutter dredges in different kinds of hard soil. This paper describes the field results, experiences from the crews and the modifications made to improve the product even further.

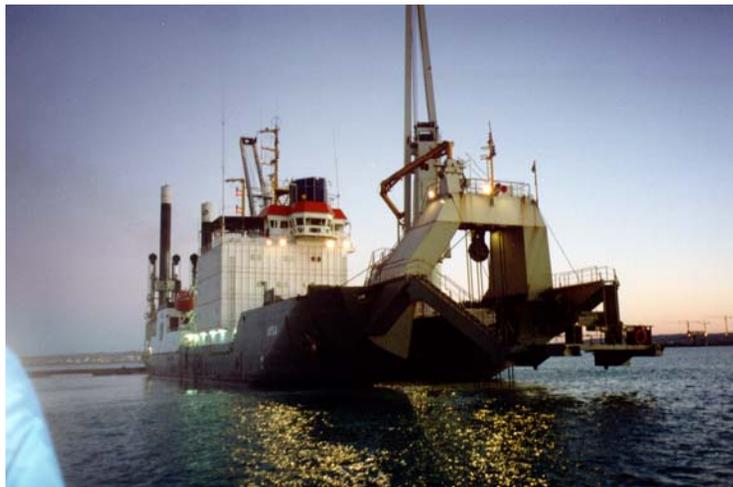
Deepening the harbor and entrance of Freeport. The soil was extremely hard. Several boreholes had a UCS higher than 60 Mpa, which normally is beyond economic dredging. Against everybody's expectations the T6 cutterhead survived these conditions with only one broken adapter after more than 25 days of operation, whereas the conventional cutterheads lasted just a few days in the same hard conditions. Then typically they had 2 broken adapters and 4 more cracked.

Goal of this test was to prove that the new system was the best selection for Dredging International's new jumbo cutterdredge with 28000 kW. As the outcome of the test was very positive, the new dredge will be equipped completely with T6 and T8 cutters. The T-8 cutter is now probably the strongest tooth system available on the market for dredge cutterheads.

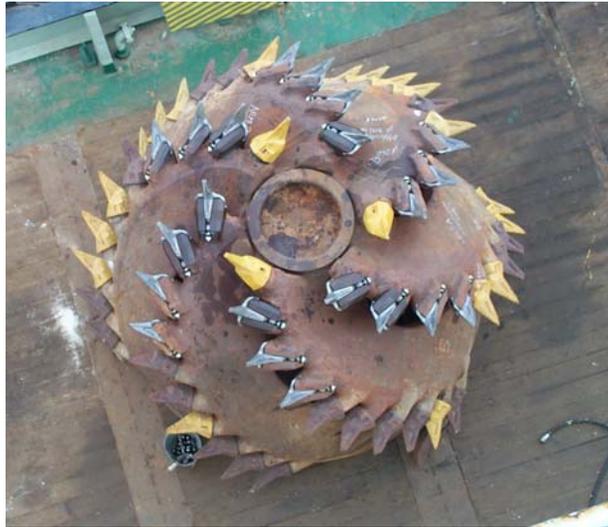
Figure 2. VOSTA D65 test cutterhead equipped partly with T6.30 tube adapters (prototypes)

Deepening of the newly developed harbor and supplying bottom material for the breakwater. The soil mainly consisted of cap rock with softer layer of cemented sand below. The VOSTA T6 cutterhead was mounted for approx. 6 weeks and needed no repairs at all when the job was finished. Only one tooth was recorded broken. Goal of the test was to prove to Boskalis the benefits of the new system. Upon the successful test Boskalis modified this cutterhead and some other completely to T6.

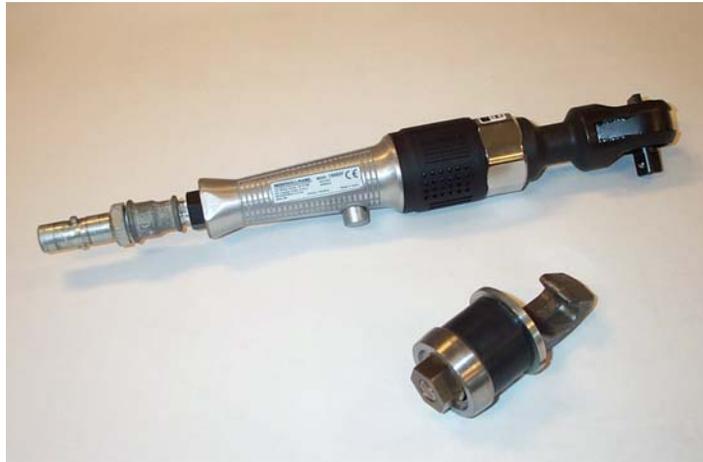
Figure 3. Airtool (weight approx. 1.5 kg) and locking

In the beginning many people were quite skeptic about the new method of replacing teeth. They did not believe that changing teeth could go much faster and easier than the conventional way using hammers and pins. This changed very quickly when the crew became used to the new method and saw the advantages of the airtool doing the heavy job and the lightweight (13.5 kgs instead of 18 kg) teeth which were much easier to handle. Tooth replacement times dropped with 30-50%.

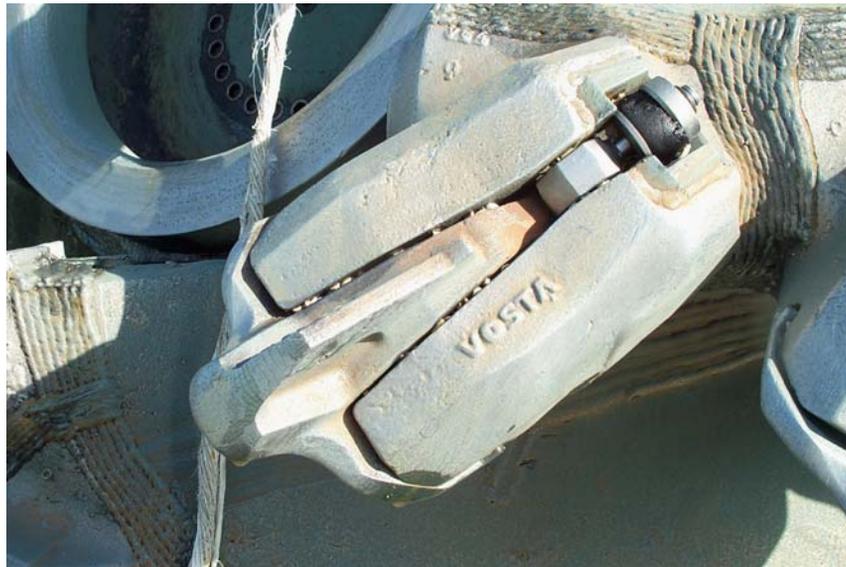
Figure 5. Top view on adapter showing the slots that create the flushing effect. The few small particles in the open slots have no influence.

Now we know that this is caused by the open slots on the topside of the adapter, which allows water to come in. The water leaves the adapter on the rear-side, flushing along all sides of the locking. Minimum rotational velocity of the adapters through the water is approx. 1.8 m/s. Maximum rotational velocity is approx. 6.7 m/s. This creates sufficient flow for the flushing.

As the open spaces between tooth and adapter are flushed, there is no material which can cement to the tooth or adapter, which can lead to a situation that the tooth cannot be replaced any more. During the test in Iran and Jubail this problem occurred on some conventional cutterheads. The teeth had to be replaced using flame cutting equipment or extreme hammering.

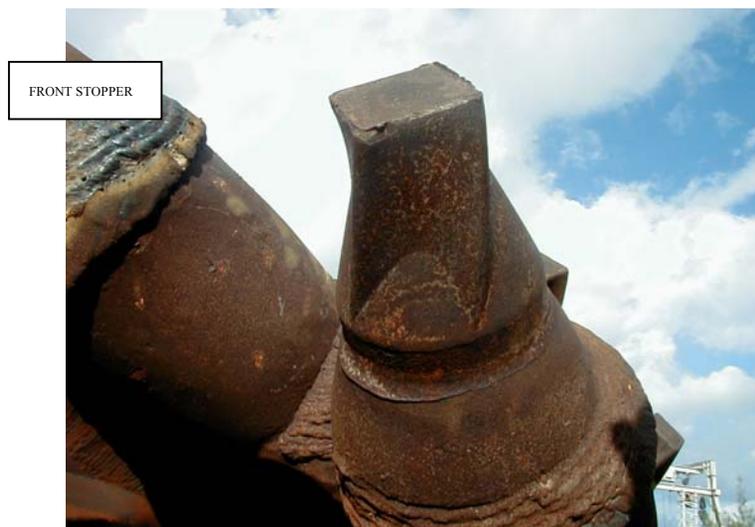
Figure 6. Wear on front stopper resulting in reduction of pretension on the locking

The operational time of the cutterhead at least doubled compared with conventional systems. This can be explained by the following (see figure 06 and 07).

The conventional systems have the highest wear on those surfaces, which also determines the axial position of the tooth. The tooth is only allowed to move a few mm's axially, otherwise the locking will not have enough pretension and will be lost resulting in losing the tooth and damaging the adapter.

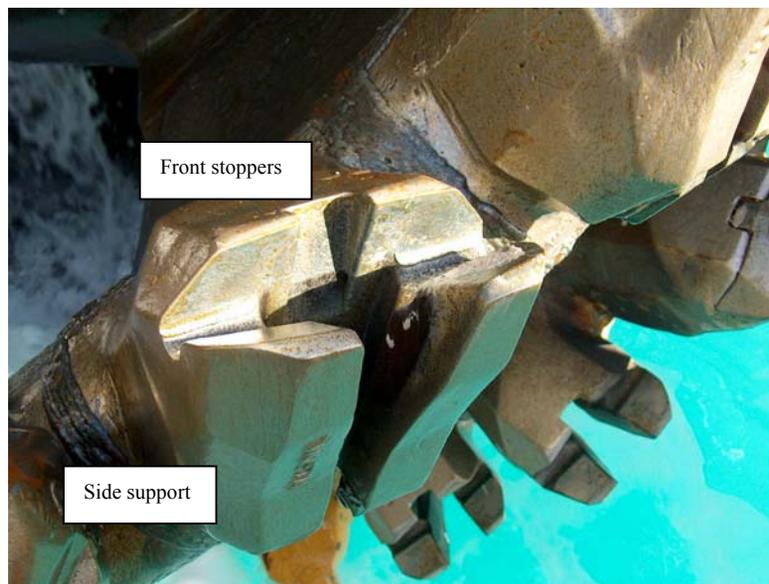
Figure 7. Negligible wear on the front stopper of the T6 adapter

In the new system the maximum wear is on other surfaces which are not critical for the axial position of the tooth. Furthermore the design of the locking is such that it will always have sufficient pre-tension. Even if the teeth would go backward 5 mm.

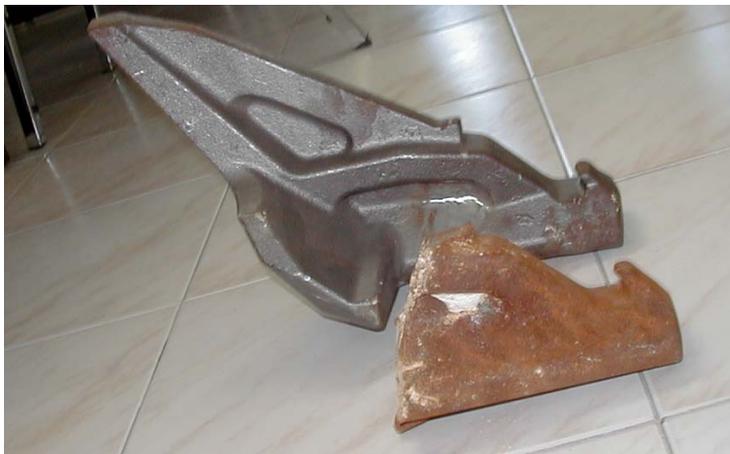
Figure 9. Tooth broken in the coupling part

However some teeth were found broken in the coupling part of the adapter, which is not favorable as such a tooth does not protect the adapter anymore. Investigation showed that this happened at extreme overloads (much higher than the design loads) with partly worn teeth. With new teeth the point would break and not the lower part. Investigation of the breakage showed also that the cracks started at spots with high stress concentrations (see figure 10). By changing the radii at the critical spots, the tooth bottom part has become much stronger.

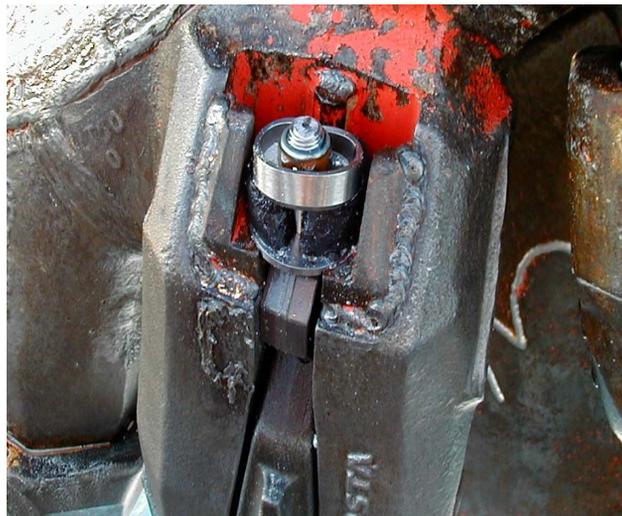
Figure 11. Showing damaged locking ring and rubber

Several lockings were damaged on the rear side. The ring was bended and the rubber damaged. (see figure 11). This was probably caused by big rock parts, which had another direction then the majority of the material flow. Although this did not jeopardize the functioning of the locking, it was reason enough to strengthen the ring and lower the recess of the locking to get it more in the shade of the adapter and teeth. A new one can now easily replace the rubber element when it is damaged.

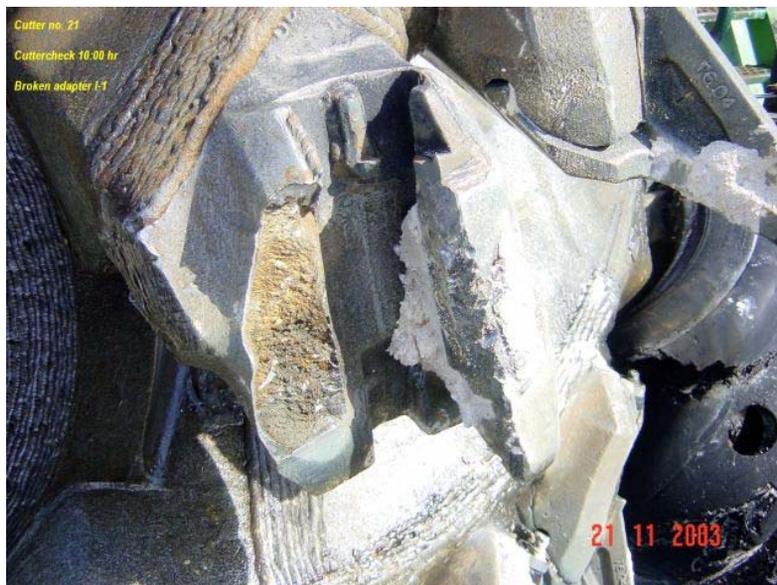
Figure 12. Showing the broken side support of the adapter

Two tube adapters were broken due to overload as per figure 12. FEM analysis showed that there are high stress concentrations in the area where the crack started. The radius in this area is now increased to reduce the stresses. One adapter was ripped off from the blade. All these adapters were on POS 1 and will be replaced by the stronger TWIN adapter.

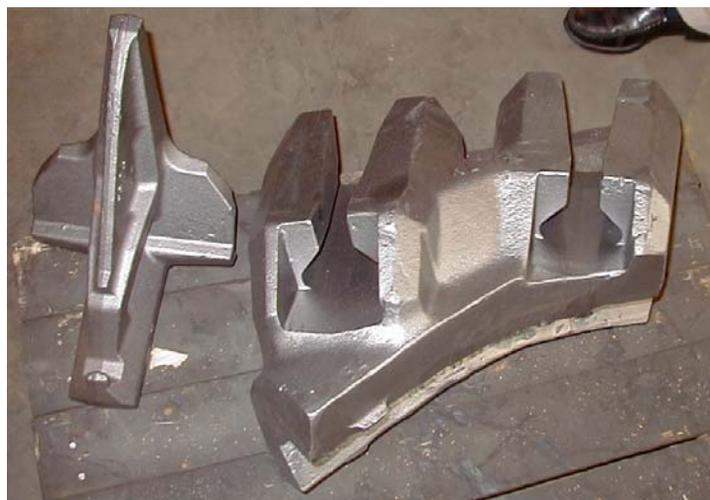
Figure 13. The twin adapter for the teeth on POS 1 and 3

Brainstorming with the technical department of an end-user resulted in solving the thirty-year-old problem of the short lifetime of adapters on POS 1 when working in hard rock. (The top position is typical the worst place on the cutterhead for an adapter as it gets the highest loads, especially when stepping forward). The outcome was the TWIN adapter in which two teeth can be mounted. The twin adapter is used for the top position only.

- Much stronger weld to the blade. Normally the top position has the smallest weld (see figure 14)
- Optimum positioning of pos 1 and 2
- Improved opening between the arms
- Easier fitting of the top adapter.
