TARGETED DREDGING OF NEAR-SHORE DEBRIS AND SEDIMENT, UPPER TRENTON CHANNEL, DETROIT RIVER: A CASE STUDY

M.J. Erickson, P.E.¹, R.K. Mohan, P.E.², W.J. Dinicola³, and M.R. Henderson⁴

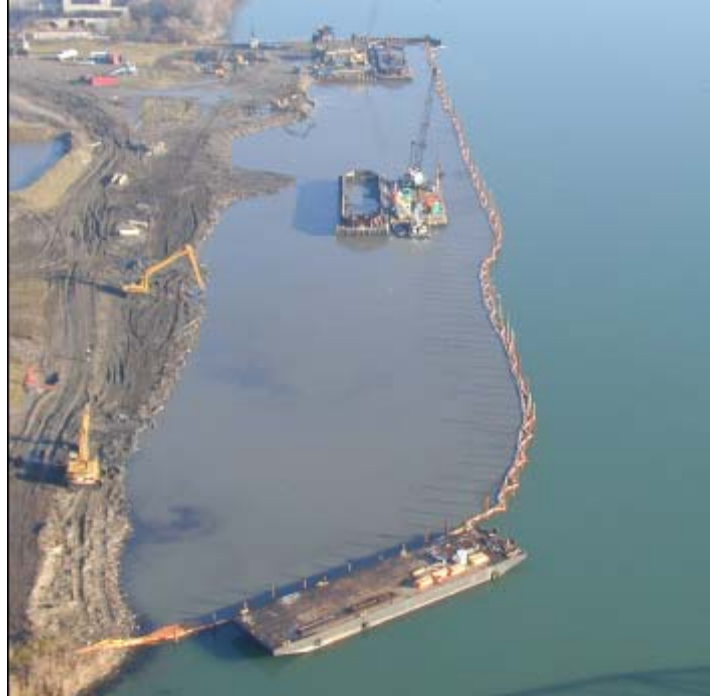
The turbidity control system worked well (Figure 5). Minor turbidity releases from the point of attachment to the sheet pile wall occurred early in the project but corrective actions reduced this. No turbidity exceedences during dredging operations occurred that were not explained by other causes (e.g. small fish caught in the sensor apparatus cage, algal mass buildup, or temporary disturbances of the sensor, etc.).

Figure 5. Aerial photo of sediment removal area during dredging.

Dredging employed shore-based long reach excavators and barge mounted cranes (See Figure 5) operating clam shells and the Cable Arm environmental clamshell. Transport of near shore dredged material was by dump truck loaded directly from the shore-based excavators. Two dredge scows were used to transport dredged material removed by barge-based cranes to an off-loading area at the upstream end of the Site where a second crane (American 5299C) unloaded the barges to transport trucks. Free water from the barges was pumped to an infiltration lagoon near the center of the Site. Ultimate debris volume was between 30 and 40 percent of dredged material volume and exceeded expectations due to incomplete characterization of the thickness of the debris layer along the shoreline. The original dredge plan involved separation of debris using a grizzly screen; however due to the type (debris included steel cable, steel banding, and re-enforced concrete) and amount of debris, this was abandoned and truck loads containing primarily debris were unloaded in a debris stockpile area. When sediments were dredged, these materials were dumped into an earthen-bermed lagoon confined within the cap and barrier wall groundwater containment system scheduled for later construction (Figure 7).

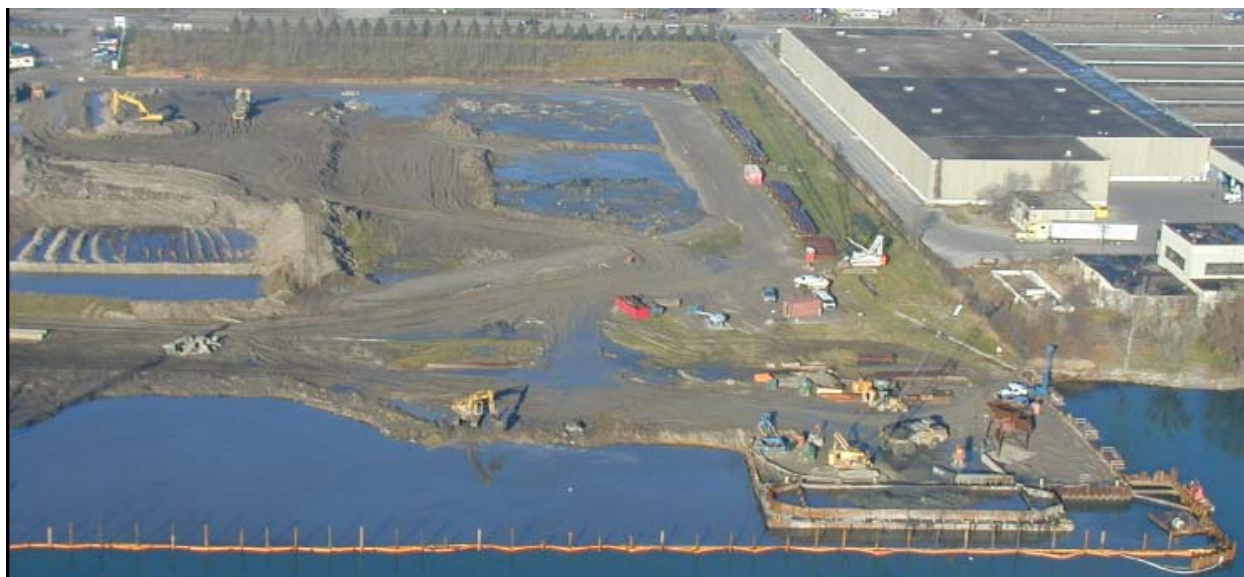
Figure 7. Dredged material off-loading area.
