# SPECIFYING AND VERIFYING CONSTRUCTION PERFORMANCE FOR REMEDIAL CAPPING—A CASE STUDY FROM SAN DIEGO BAY, CALIFORNIA

A sediment remediation project is currently being completed by the Unified Port District of San Diego at the former Campbell Shipyard site on San Diego Bay. Following site demolition and localized dredging, the project involves the construction of a sediment isolation cap comprised of multiple layers: a filter fabric base, a 0.6-meter (2-foot) layer of sand for chemical isolation, a layer of filter gravel and a protective surface layer of armor rock.

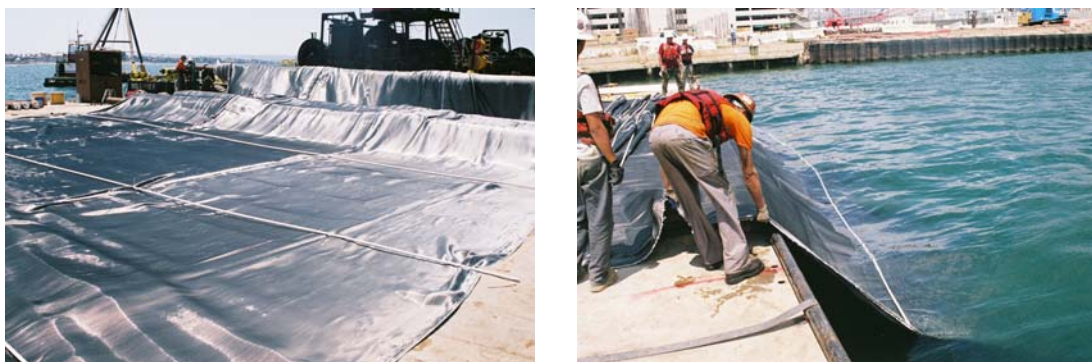
**Figure 4. Geotextile is unrolled and lowered into the water.**

Prior to placement of capping materials, a layer of woven geotextile was laid down over the sediment surface. The purpose of this geotextile layer was to provide a stable base upon which the cap would be built, to prevent intermixing of cap sand with contaminated sediment, and to minimize the occurrence of mud waves in the underlying soft subgrade.

The geotextile was mounted in 14-meter (45-foot) wide rolls on a floating platform, and as it was unrolled, a series of rebar lengths (encased in PVC) were attached to the fabric at about 8-meter (25-foot) intervals. These rebar lengths acted as ballast to keep the geotextile weighted down as it was lowered into the water. The geotextile was laid down off the edge of the floating platform as the platform moved slowly forward. Figure 4 shows the geotextile placement operation.

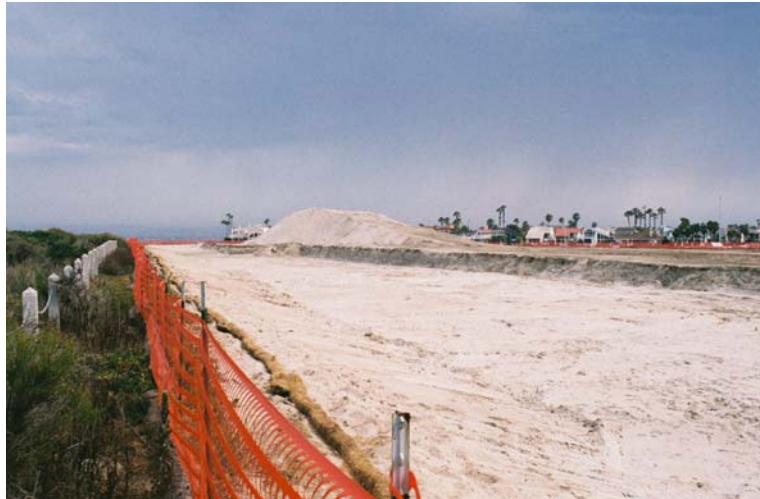
**Figure 5. Excavation of sand from Grand Caribe Island borrow site.**

Material for the sand cap was excavated from nearby Grand Caribe Island, an undeveloped, Port-owned parcel within the Coronado Cays residential area south of Coronado. This was an example of incorporating beneficial reuse into the project, as the Grand Caribe excavation represented the first stage of a separate Port project to create an intertidal marshland at that site. Figure 5 shows the excavation of sand from the Grand Caribe Island site.

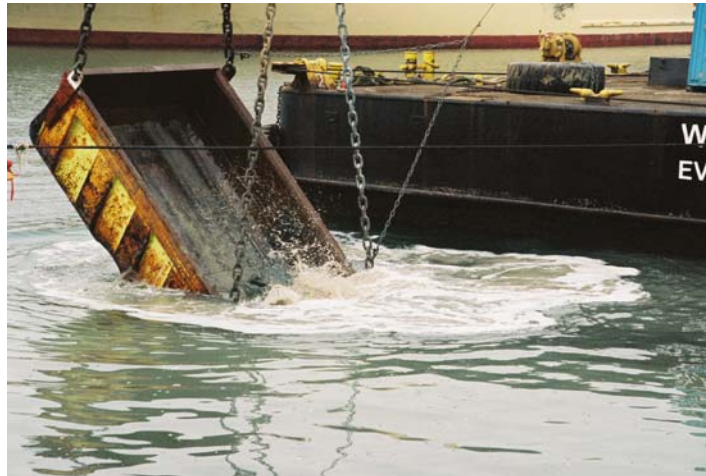
**Figure 9. Placement of sand using skip box.**

The Contractor's initial method was to place the sand base cap layer using a 9-cubic-meter (12-cubic-yard) skip box. The intention was to load the skip box with a known tonnage of material, position it over a known location, and slowly "sweep" the box while releasing materials into the water to cover a defined area. Figure 9 shows sand being placed using a skip box.

As sand placement proceeded, daily surveys indicated that the layer thickness was highly irregular. Sand thicknesses were observed to range from 0.3 meters (1 foot) to more than 1.8 meters (6 feet) in some cases. Some of this variability was attributed to control of the Contractor's initial baseline survey, as a few feet of initial survey offset led to anomalous thickness indications on sloping areas. The Contractor reworked the sand layer by using a clamshell bucket to remove areas with excessive overplacement, although this removal method was only partially successful as it oftentimes had a tendency to excavate too far into the sand layer.

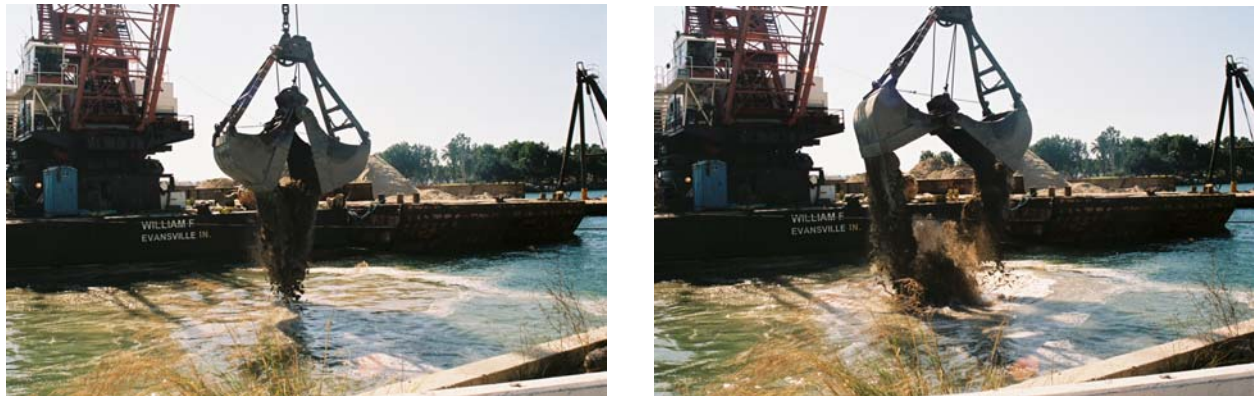
**Figure 10. Placement of base cap sand using clamshell.**

Capping operations were restarted in a different area of the site, immediately north of the eelgrass habitat area (shown on Figure 2). Here, there were no restrictions on final grades, which appeared to make it easier for the Contractor's placement operations. In this area, the Contractor shifted to sand placement with a clamshell bucket rather than the skip box and also improved the control on their baseline progress survey. In this area, the Contractor built up the sand layer in a more gradual fashion in an effort to better control overplacement. Figure 10 shows the use of a clamshell bucket for sand placement.

The base cap sand was placed with less variability of the final surface than it was in the Pilot Cap area. It was observed to undergo a “self-leveling” effect in which it tended to achieve a relatively flat surface, even over irregular topography. A seemingly related effect was its apparent tendency to preferentially build up in low areas as opposed to higher areas.
