# **BENEFICIAL USES OF DEAD END CANAL DREDGING IN COMBINATION WITH SPECIAL USE MATERIALS FOR EROSION CONTROL**

Nicholas De Gennaro <sup>1</sup>

## **ABSTRACT**

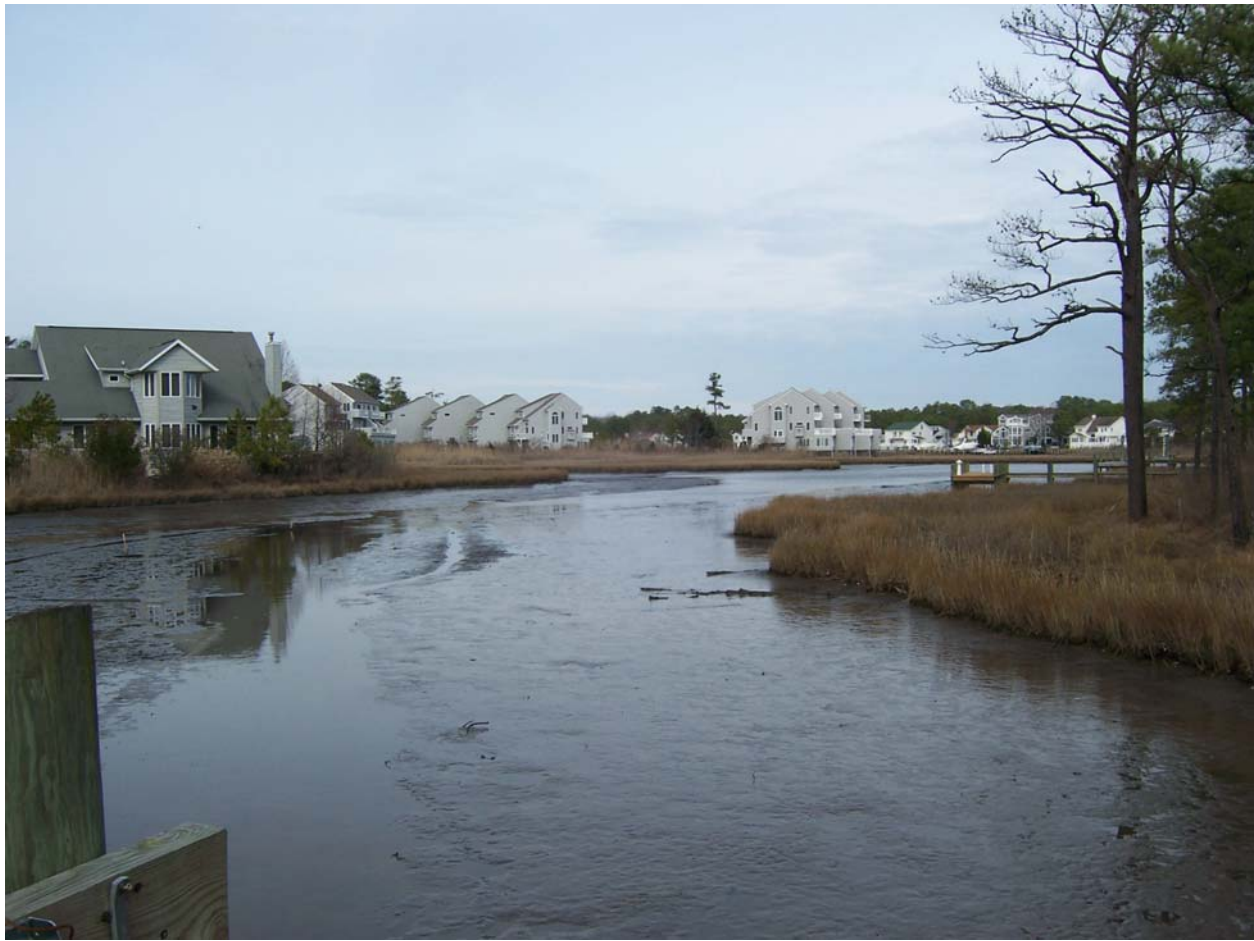
**Figure 1. Typical dead end canal tidal creek in Worcester County, Maryland.**

Examples of this are plentiful throughout coastal communities. Figure 1 shows a typical flushing channel off the St. Martin River (which empties into Assawoman Bay in Worcester County, Maryland). Note organic silty sediment building up. Phragmites is taking over much of the natural vegetation. This channel was much healthier when there was less sediment. It is extremely likely that the sediment will continue to accumulate and the tidal marsh will change its characteristics. In a recent Worcester County public meeting to review the possibilities of dredging this channel as well as a few others, I pointed out the likelihood of the continued degradation and the growth of the phragmites unless something was done. Some in the audience yelled out “Let it grow”. Such ignorance is hard to overcome. The project failed to gain approval.

There are several dead end canals at the southeast end of the Ocean Pines Community in Worcester County, MD. Most are bullheaded and used for boating. There are some that are left in a more natural state. There is some evidence from aerial photos that these canals were dredged for drainage in the 1950's and 60's. However there has been no maintenance performed on these canals in the last 40 years. One example is shown in Figure 1.

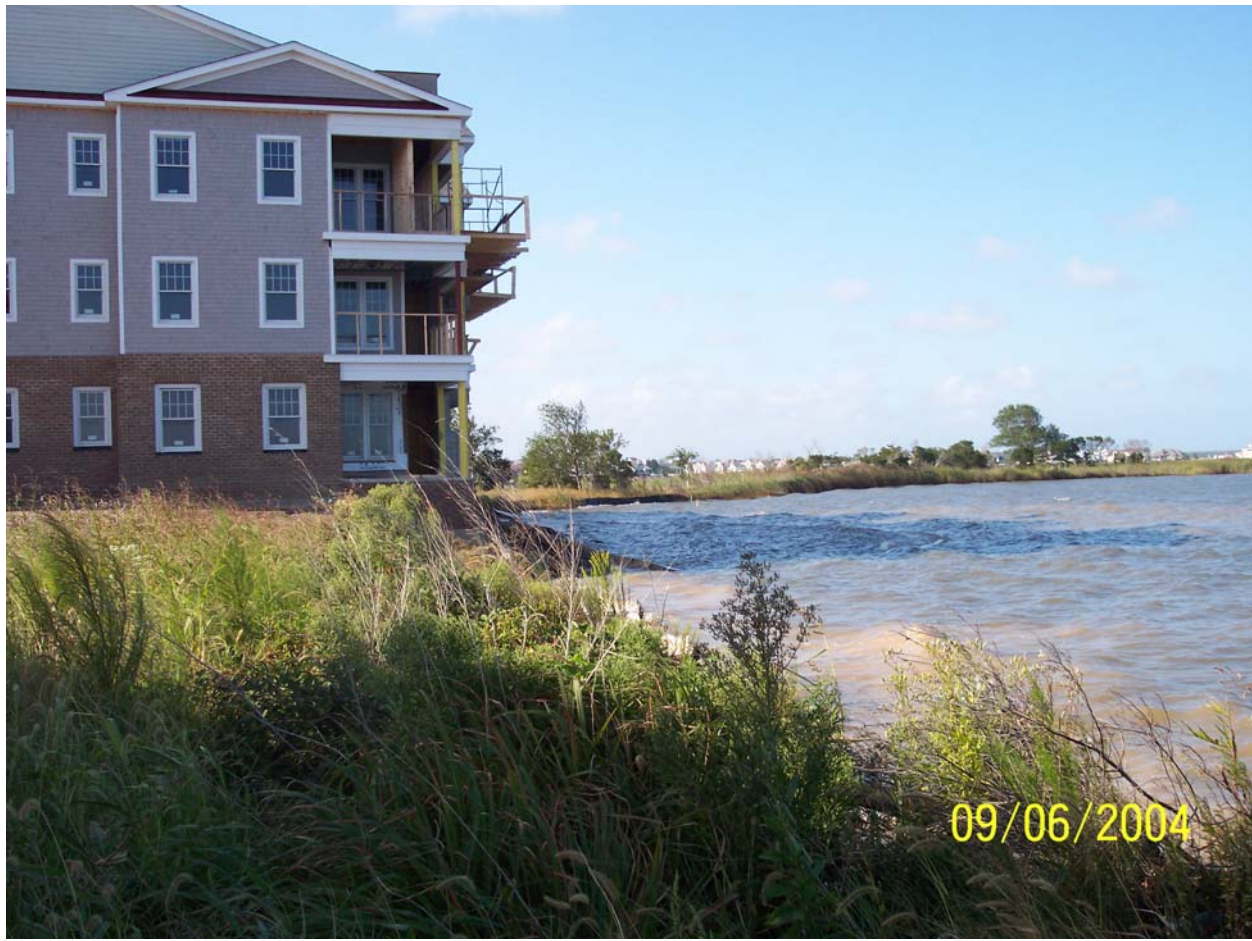
**Figure 2. Pre-conditions of shoreline at project site.**

The biggest obstacle to overcome was the deposit of the dredge spoils. There was an eroding shoreline on Assawoman Bay in front of two townhouse complexes. The shoreline eroded 30' to 45' in eight years and was threatening the foundations of one of the buildings (See Figure 2). It was proposed to place geobags on the eroding shoreline and fill them with the dredge sediment. The center of eroding shoreline was approximately 1,000 meters from the dredge sites. Other alternatives for the dredge spoils included building a wetland island in the St. Martin River 200 to 2,000 meters from the dredge areas. The third option considered hauling the dredge sediment off site to an upland fill area.

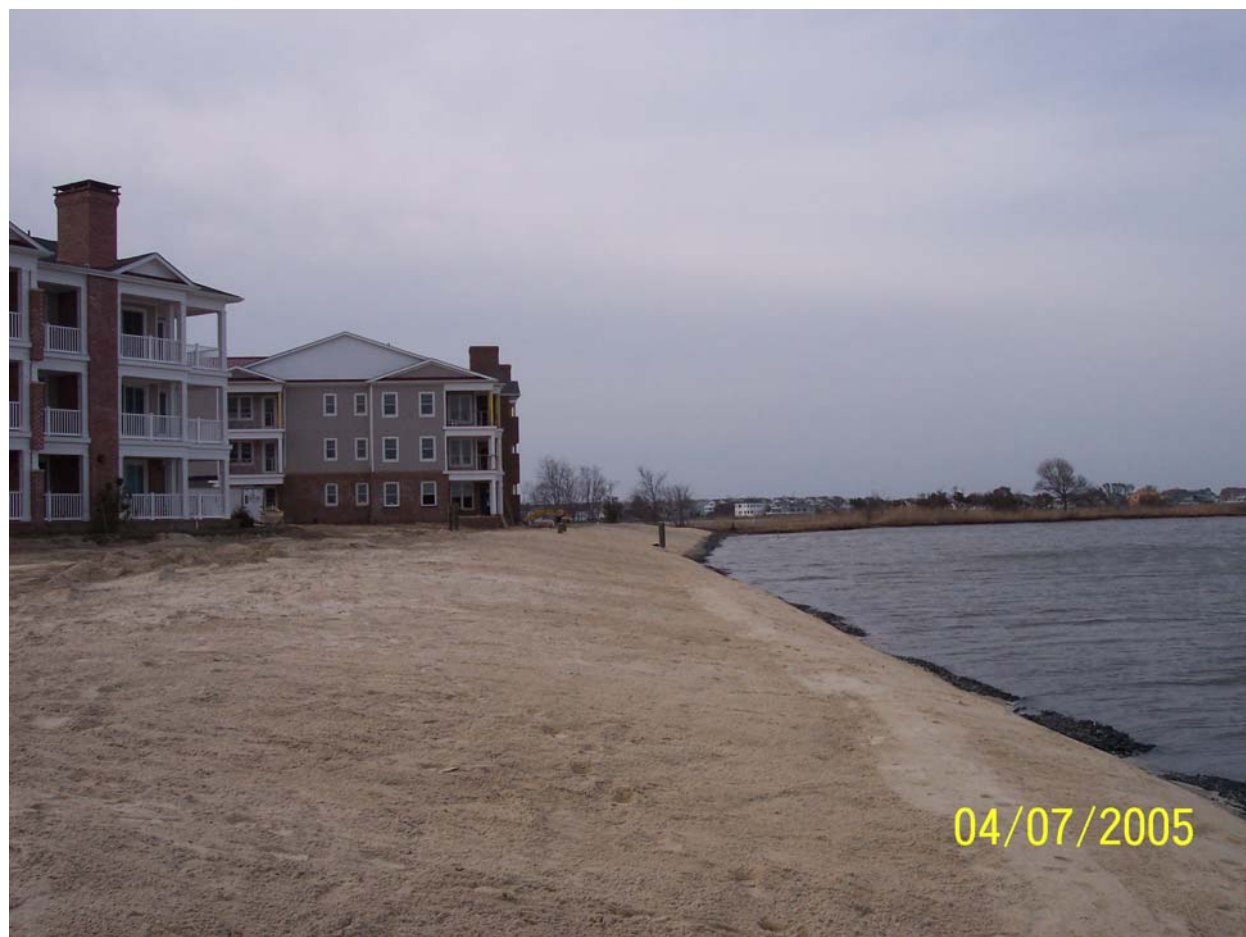
**Figure 6. Finished revetment.**

The final treatment of the revetment width included 4 meters of ABM and 7 meters of PHPTM. The increased quantity of HPTM had significantly decreased the cost while enhancing the natural appearance of the revetment. The system did not significantly sacrifice the erosion potential. One of the goals of the project was to develop as natural as possible stable shoreline. The PHPTM could be planted with dune grasses and salt tolerant shrubs while the matrix of the mat held the soil from erosion. The final look of the project before planting is shown in Figure 6. (Compare to Figure 7 to Figure 2 looking in the same direction.)

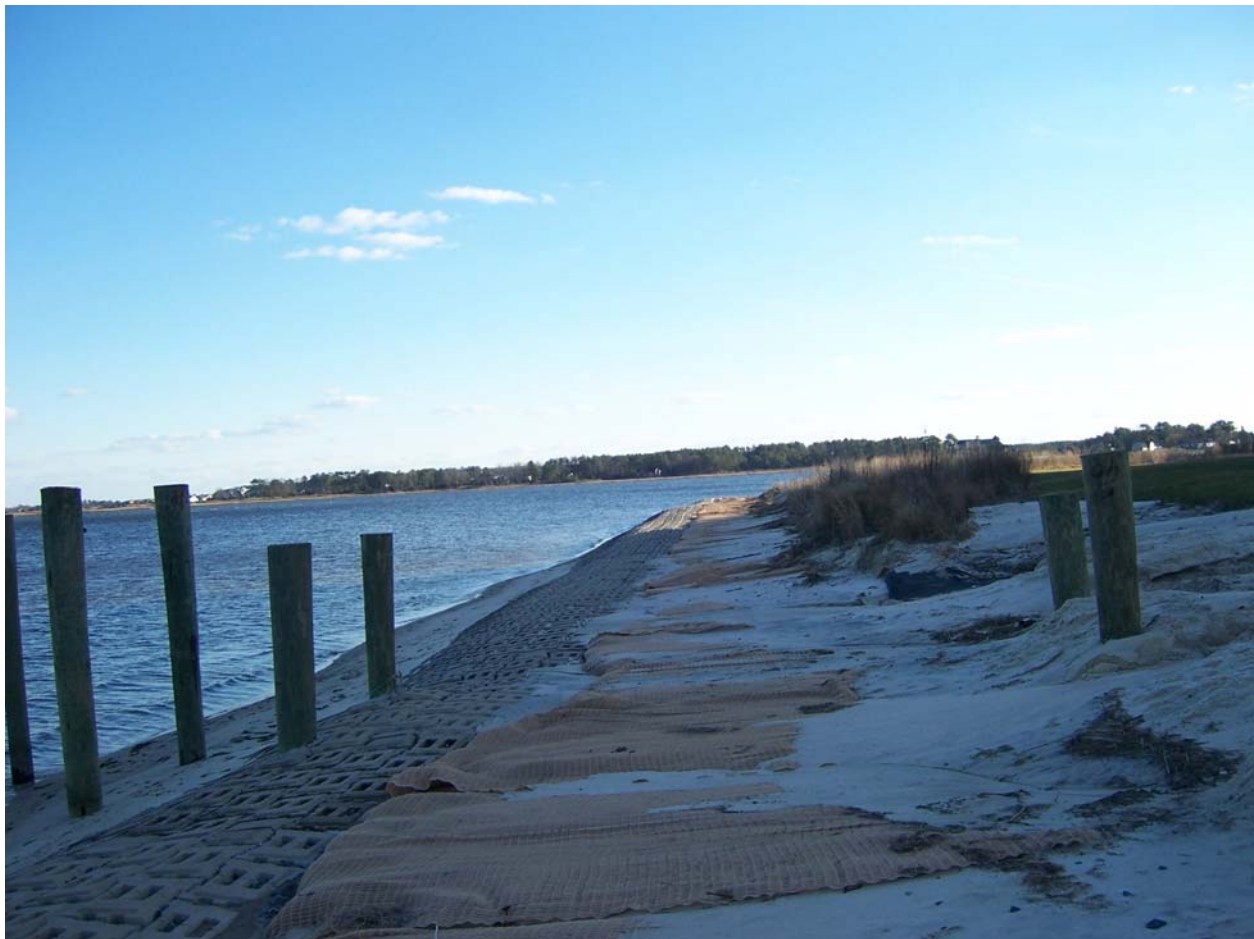
**Figure 7. ABM with PHPTM after twenty-two months.**

The PHPTM has performed very well over the last 22 months that the project has been completed. The toe and upper anchor trench is 95% in place, even after 3 or 4 nor'easter storms and two tropical storms with wave heights of 1.2 meters and water level elevations 1 meter over mean high tide. See Figure 7. On inspection it was noted that the failure areas occurred where careful attention was not paid to properly tie the PHPTM to the anchor.

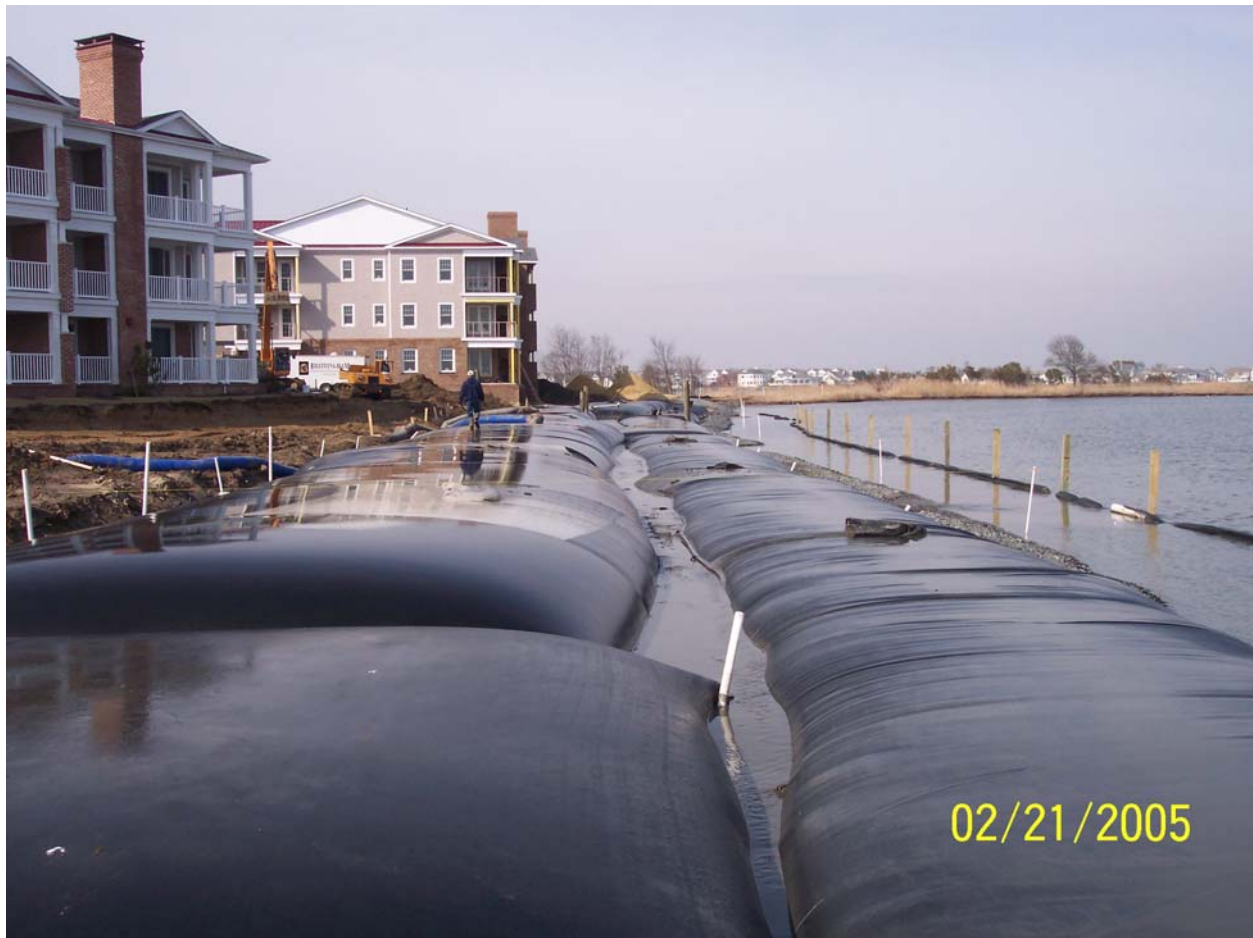
**Figure 8. Geobags being filled.**

Early on in this project the main focus was to dredge the canal and fill the geobags with the sediment from the canal. The process did not go smoothly. The biggest issue was to develop a process to continue dredging while filling the geobags. The contractor gave the impression he was familiar with putting dredge spoils into a geobag. This was not apparent on the site. Only two geobags were set up in the early part of the project. A polymer injection system to help with settlement of the fines was installed but not monitored. The two bags filled with water and binded almost right away. It took five weeks of trial and error to get the right number of geobags and the correct polymer ratio injected to get a reliable smooth filling process in place. Figure 8 shows geobag filling in full operation. Future projects should integrate the responsibilities of the polymer manufacturer, geobag manufacturer and the contractor in the performance contract. Such contracts should require a complete submittal to show complete understanding and cooperation among the partners.
