# THE ROLE OF CONSTRUCTION QUALITY ASSURANCE (CQA) IN SEDIMENT REMEDIATION

The St. Louis River/Interlake/Duluth Tar (SLRIDT) Superfund Site is located in Duluth, Minnesota, on the St. Louis River, an estuary and international port at the southern tip of Lake Superior. Its three bays contain approximately 400,000 m<sup>3</sup> of fine-grained sediments, contaminated with polycyclic aromatic hydrocarbons at concentrations up to 35,000 mg/Kg. The selected response action includes dredging with on-site disposal and capping. This paper describes how quality is assured during the complex construction of the remedy.

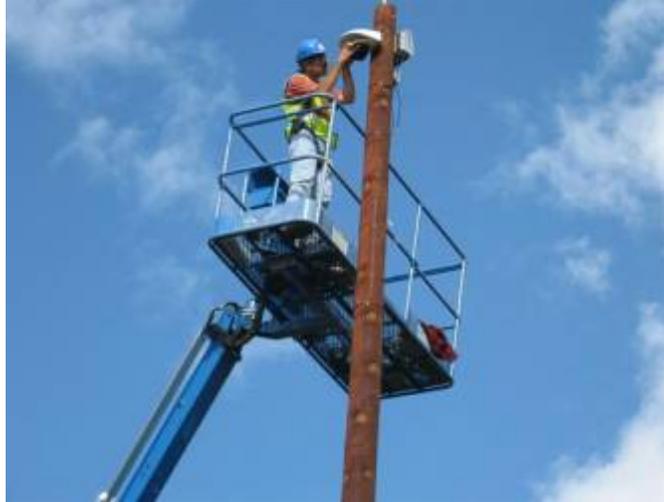
**Figure 1. Construction quality assurance cameras were used to supplement observations by field personnel.**

The CAD end dike and surcharge cap construction activities completed in 2006 at the SLRIDT site were on different portions of the site, approximately 400 meters apart, so CQA monitoring often involved having to be in two places at once. In addition to having field personnel observing the RAC activities, the CQA/environmental monitoring engineer installed, operated and maintained two pole-mounted CQA cameras (Figure 1). One camera was installed to observe the CAD end dike construction and one camera was installed to observe the surcharge cap construction. Two additional cameras were installed at the project entrances for site security purposes. The site security cameras were programmed to record based on motion sensors built into the camera. The cameras were integrated with an on-site mesh network used to collect and upload the real-time air quality data to the web page, to allow viewing of the cameras by authorized users. The air monitoring data and camera images were transmitted to the project site computer via the same network but each had a different end use. The air data was available for viewing by anyone who visited the [www.slridt.com](http://www.slridt.com) web page, but the camera images were only for authorized project personnel, whether on-site or in their office.

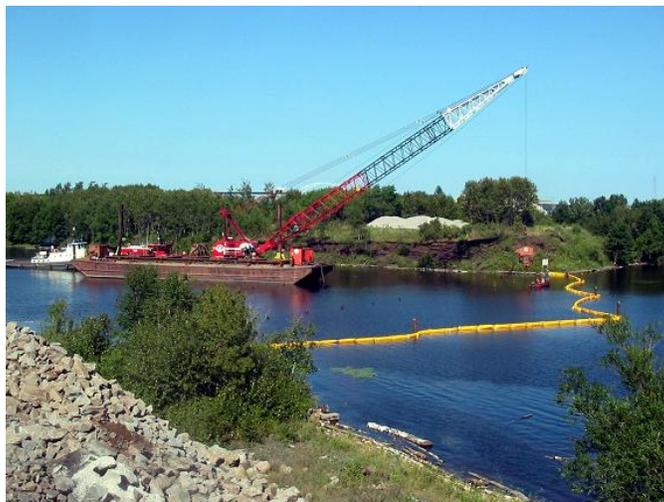
**Figure 2. A crane barge with on-board GPS capabilities was used to install the pipe piles – and subsequently to place rock and gravel, which comprised the CAD end dike.**

Pipe piles were installed below the CAD end dike for stability, due to soft sediment conditions (Figure 2). In addition to approving the pipe piles prior to use, the CQA/environmental monitoring engineer provided the RAC with the coordinates for each pile, which were entered into the RAC's onboard GPS software. A GPS antenna on the tip of the crane, directly in line with the suspended pile and hammer, allowed the CQA/environmental monitoring engineer to observe and verify the pipe pile placement locations in real-time on the GPS computer screen used by the crane operator.

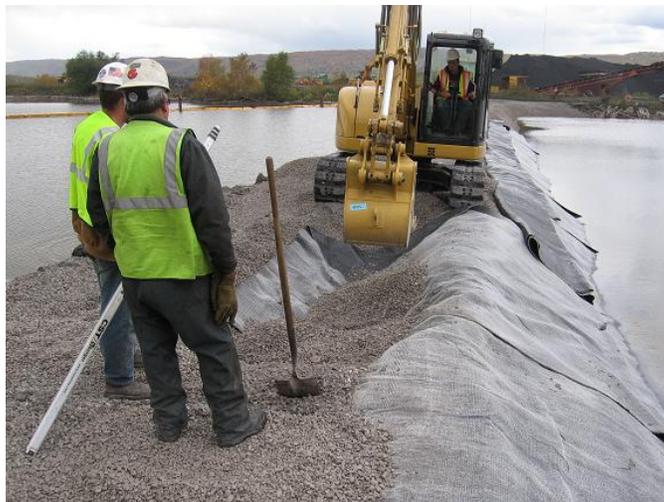
**Figure 3. An alternative geotextile clay liner (GCL) tie-in and CAD end dike top completion was successfully approved through cooperative project management channels.**

A GCL was installed on the CAD side of the end dike to ensure hydraulic isolation and containment of the contaminated sediments (Figure 3). The design called for this liner to completely cover the north face of the End Dike, with a minimum 60 centimeter overlap of each of the 4.5-meter GCL panels, and 6 meters of GCL past the toe of the End Dike slope and wrapping around the each edge of the CAD End Dike onto the pre-existing land. The GCL was placed on a 30-centimeter bed of gravel to prevent pressure points from the underlying rock, and covered with an additional 30 centimeters of gravel for ballast and surface protection. The GCL panels were held in place at the top by digging a trench along the top of the CAD end dike and keying-in the GCL. Because much of the GCL installation was completed in deep water, the CQA/environmental monitoring engineer could not observe the installation to document and approve overlaps and ballast coverage. The RAC utilized divers to ensure the overlaps were carried the length of the slope and out past the toe, and the divers provided video and audio of the installation for the CQA/environmental monitoring engineer to review. The CQA/environmental monitoring engineer surveyed the top elevation of the end dike during liner key-in to ensure that the proper elevations would be achieved and approved an alteration of the completion to allow a wider top for long-term project traffic considerations, allowing small trucks and equipment (less than 2.5-meter-wide) to access each side of the completed CAD.

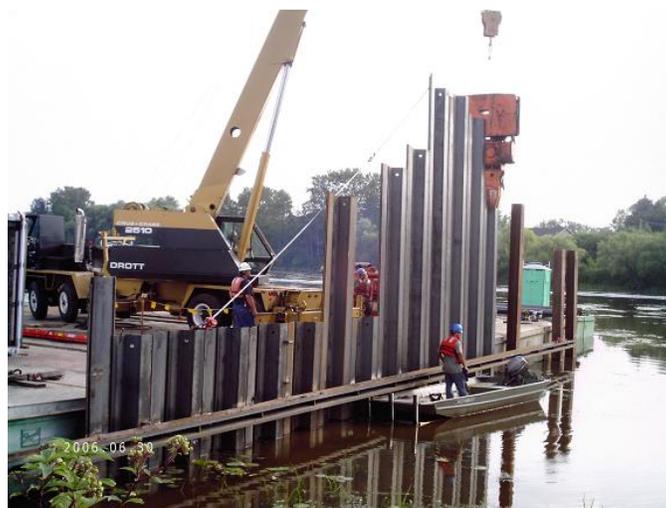
**Figure 4. Environ designed and installed a sheet pile wall, which was constructed to contain a surcharge sand cap designed by the SERVICE.**

The first phase of construction consisted of the sheet pile wall installation (Figure 4), for which the CQA/environmental monitoring engineer conducted visual monitoring of the wall construction, and received detailed daily summaries of sheet numbers and locations from the RAC. Issues arose such as wall alignment and shoreline tie-ins, and were resolved through weekly CQA meetings and daily on-site discussions with the project construction manager, the CQA/environmental monitoring engineer and the RAC.

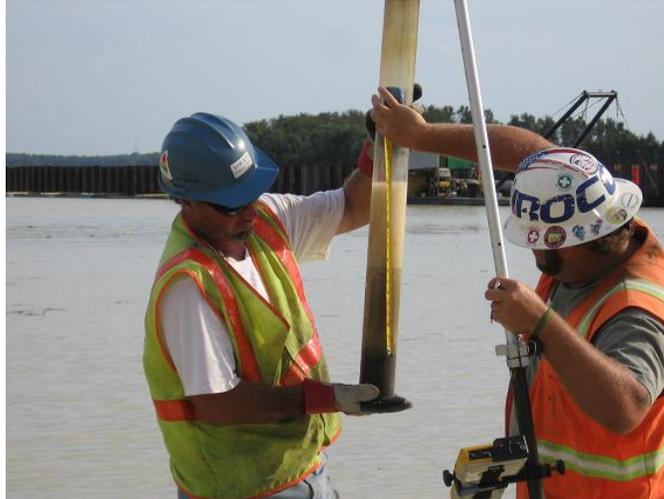
**Figure 5. The CQA/environmental monitoring engineer and the RAC worked cooperatively to evaluate the first, critical sand cap lift.**

The cap and surcharge design called for an initial 15-centimeter sand lift prior to placement of the ACM. The CQA/environmental monitoring engineer and the RAC performed approximately 100 cores to define the degree of sand/sediment mixing and determine that a sufficient initial 15-centimeter cap lift thickness was attained (Figure 5). Portions of the initial cap lift, which were not sufficient, based on the drop core evaluation, were supplemented by additional sand placement by the RAC, re-cored, and approved.

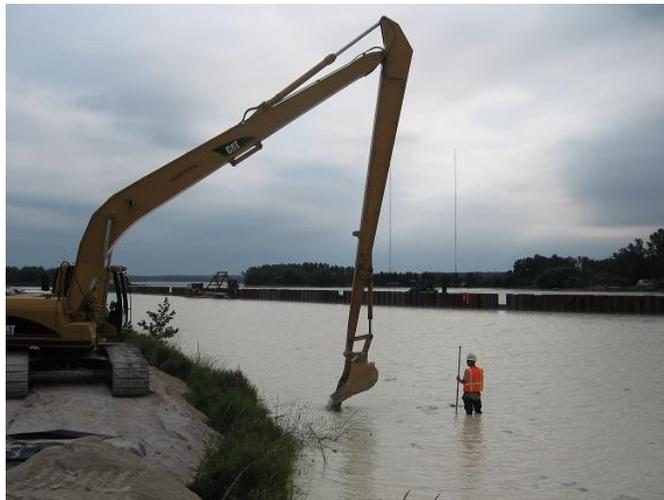
**Figure 6. An alternative shoreline cap placement method, approved by the CQA/environmental monitoring engineer, included placement of uniform lifts by the RAC using a long-stick excavator.**

Specialized techniques for sand placement at and near the shoreline using long-stick excavators to place sand without disturbing the soft, contaminated sediments, were developed by the RAC, presented and approved by the project construction manager and CQA/environmental monitoring engineer for implementation to ensure a uniform cap (Figure 6).

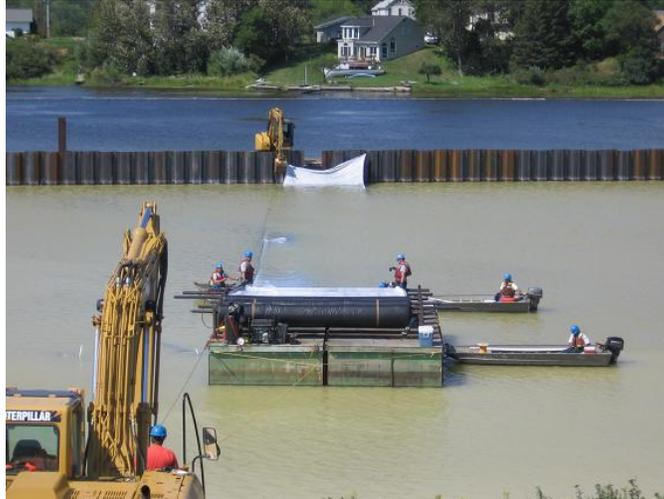
**Figure 7. Activated carbon mat (ACM) was installed by the RAC after the first sand cap lift, based on the CQA/environmental monitoring engineer's cap design.**

After approval of the first sand lift, the entire surcharge cap area was covered with ACM, placed by the RAC (Figure 7). This fabric was designed to filter contaminated pore water from consolidating sediments. The ACM panels, manufactured by CETCO, were approximately 5 meters wide by 26 meters long. The design called for an approximately one-meter overlap along the shoreline, and an approximately 30-centimeter overlap in the remainder of the surcharge cap area. The CQA/environmental monitoring engineer visually observed and mapped each panel, ensuring that the appropriate overlaps were achieved, and performed in-place inspections of the ACM after it sank below the water surface.

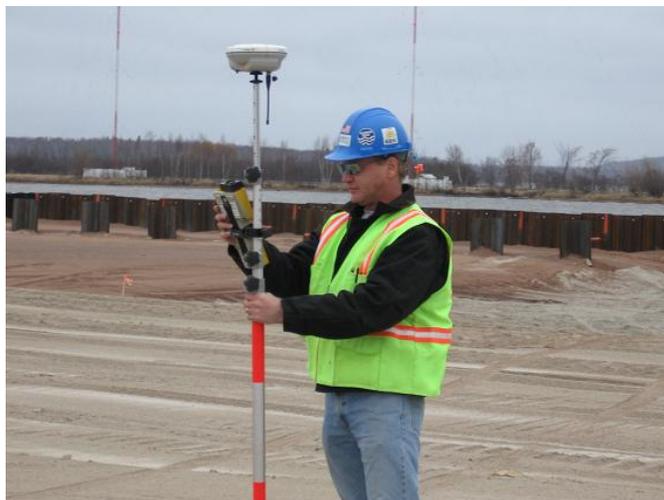
**Figure 8. The CQA/environmental monitoring engineer surveyed each cap lift thickness to ensure compliance with project specifications.**

Subsequent sand lifts could not be cored for thickness verification due to the presence of the ACM, which could not be compromised, so the CQA/environmental monitoring engineer performed surveying, combined with extensive settlement measurements, to identify lift thicknesses for approval (Figure 8). Since sub-aqueous capping operations were performed 24 hours per day, 7 days per week, the RAC, CQA/environmental monitoring engineer and project construction manager coordinated survey and capping activities to minimize sand-placement equipment downtime. Typically, surveys could be completed and interpreted in one portion of the surcharge cap area, while capping equipment was operating elsewhere.

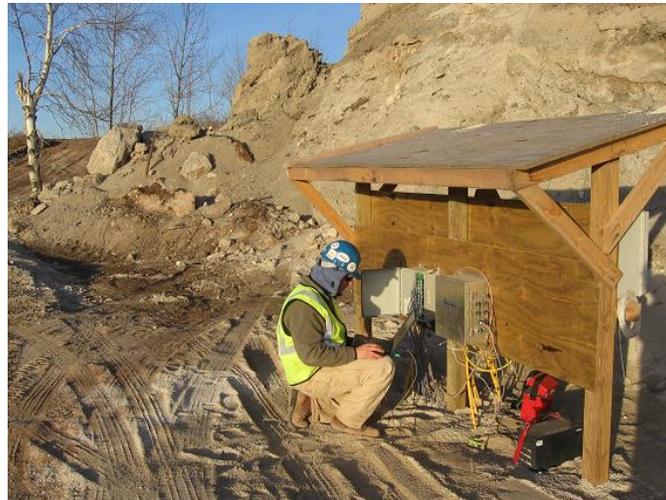
**Figure 9. The CQA/environmental monitoring engineer monitors geotechnical instruments installed by the RAC weekly, with data submitted for analysis by engineers from both organizations.**

As additional sand cap lifts were placed, the CQA/environmental monitoring engineer collected and distributed geotechnical data collected from the instruments (Figure 9) so the project engineers could keep a close watch on the data for signs of sediment weakness or sheet pile wall movement. Once it was determined that the sediments were

not gaining strength sufficient for wall stability, sand placement procedures were modified as necessary to ensure sheet pile wall integrity. The modified sand placement procedures included a joint determination by the RAC and CQA/environmental monitoring engineers, in consultation with the project construction manager, that a management zone (MZ) should be delineated. The RAC determined the size and shape of the MZ and the appropriate thickness of sand to be applied after several meetings and teleconferences with the project construction manager and CQA/environmental monitoring engineer, who evaluated the slope stability to calculate the appropriate taper slope from the MZ to the full cap thickness areas. Coordination between SERVICE and Envirocon engineers was critical to institute these safety factors in order to ensure the integrity of the sheet pile wall while not impacting project schedule goals, with winter fast approaching in Duluth (Figure 10). The project engineers are maintaining the cooperation during on-going sheet pile wall alignment, cap settlement and sediment strength gain monitoring over the winter, with the goal of placing the remaining surcharge cap in Spring 2007.

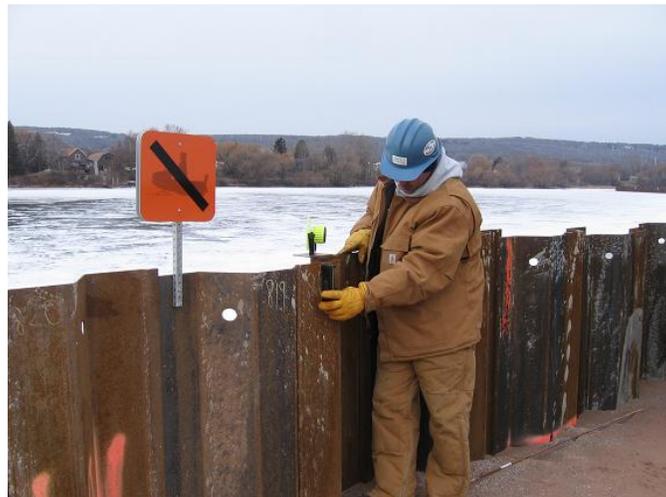
**Figure 10. The integrity of the sheet pile wall is monitored by the CQA/environmental monitoring engineer due to soft underlying sediments.**
