Recontamination and Remediation of Sediment Underlying the Murray Morgan Bridge in Tacoma, Washington

2015 Pacific Chapter WEDA

Jessi Massingale, P.E., Floyd | Snider
November 6, 2015

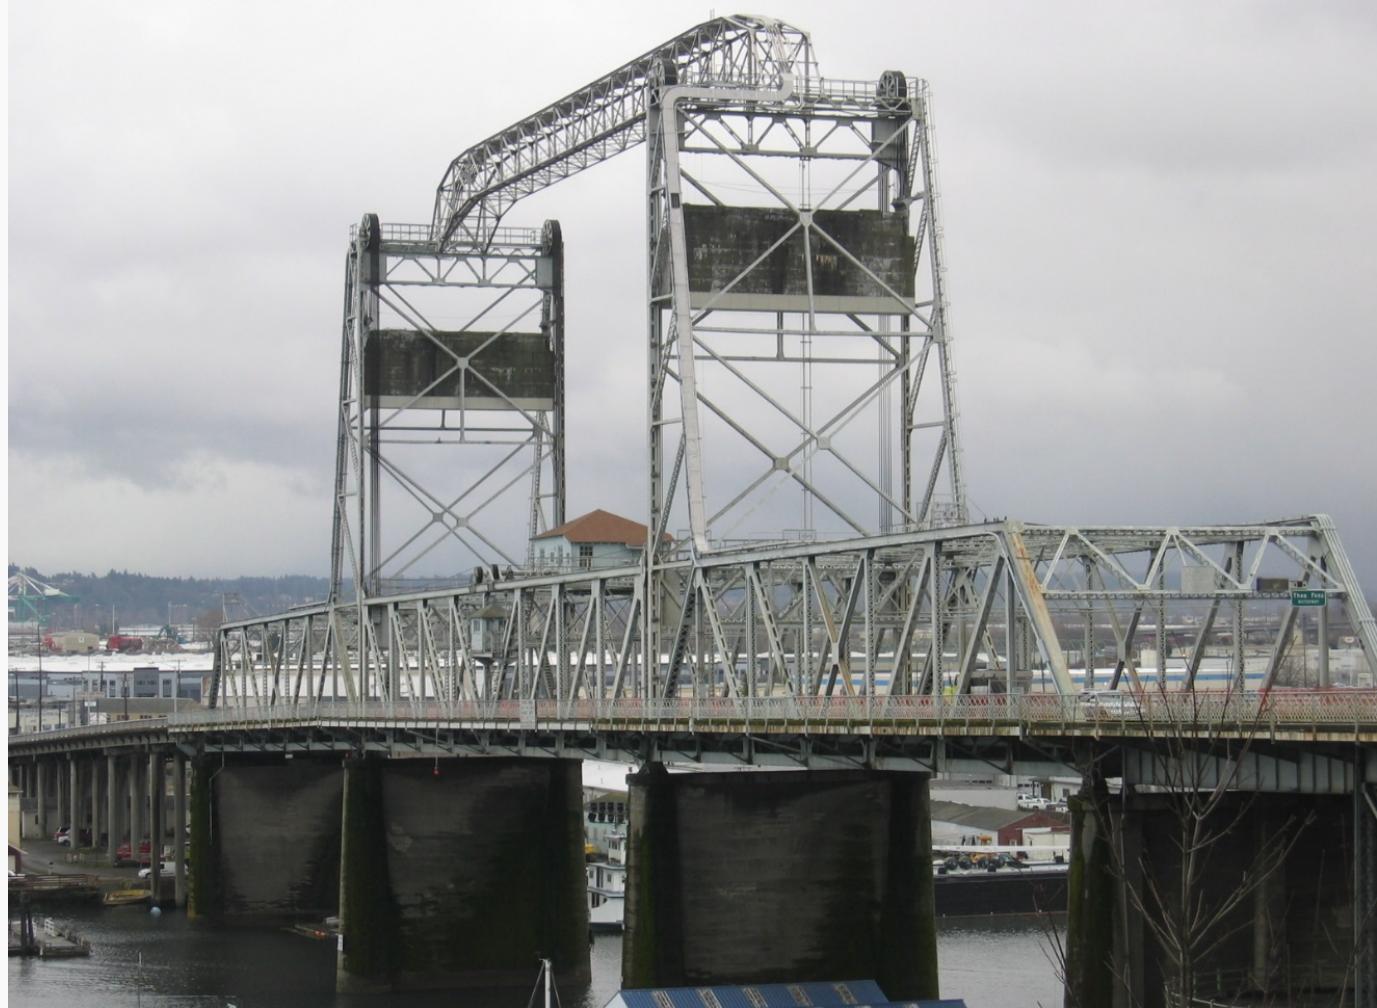
Rehabilitation of the Murray Morgan Bridge

- 1913 unique vertical lift span bridge
- Bridge rehabilitation construction by City contractor: 2011–2013
- Breach of containment following sandblasting
- Over-water pressure washing and discharge to waterway
- Metals recontamination to underlying Superfund Site sediments

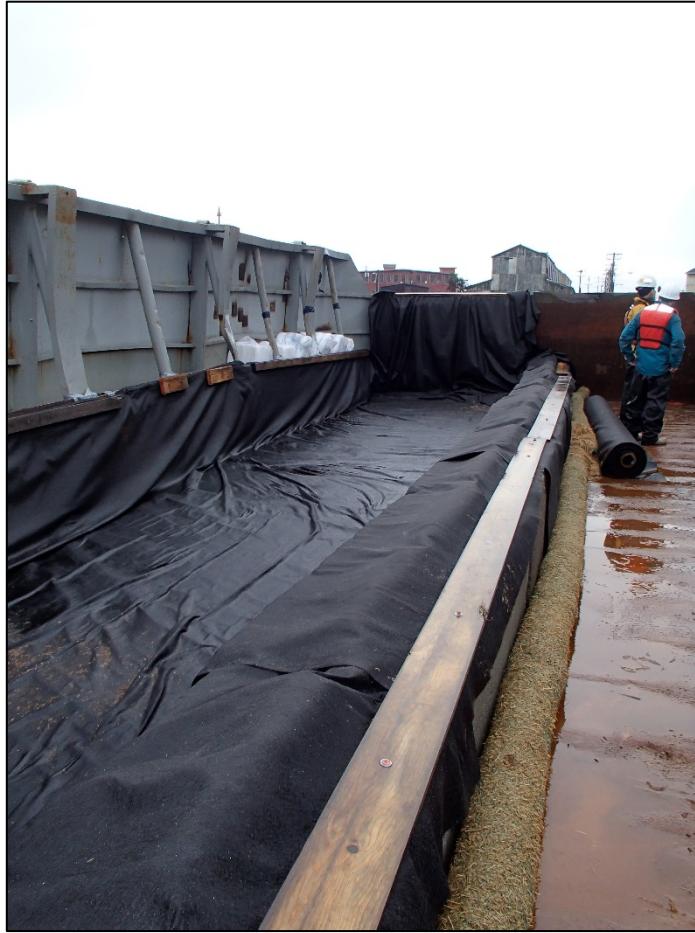
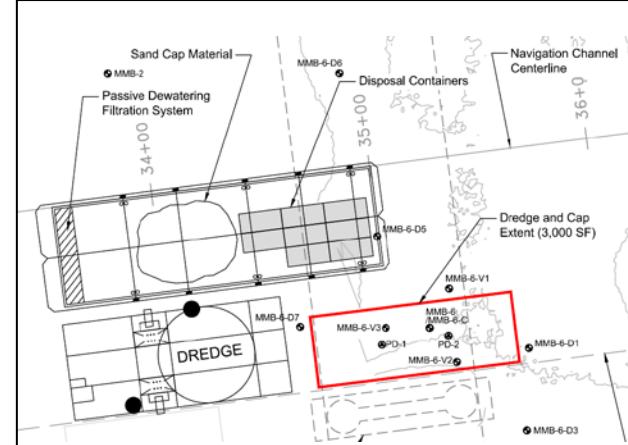
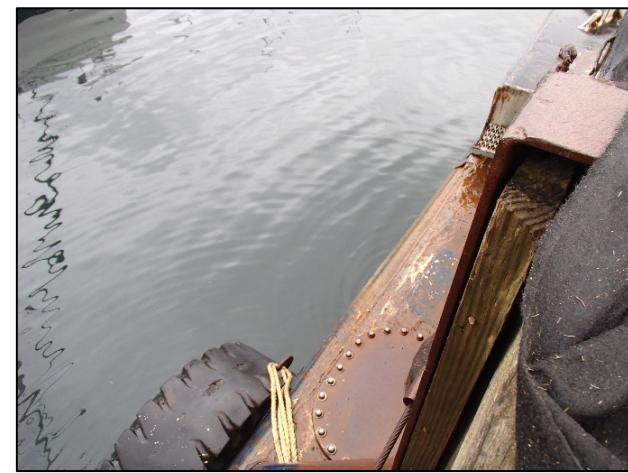
In-Water Dewatering and Turbidity Monitoring

- Passive dewatering of ~15,000 gallons
- One brief exceedance during dredging at 150-foot point of compliance
- Turbid discharge on occasion
- Slowed pump rate and additional BMPs
- Substantial USEPA coordination about water quality concerns

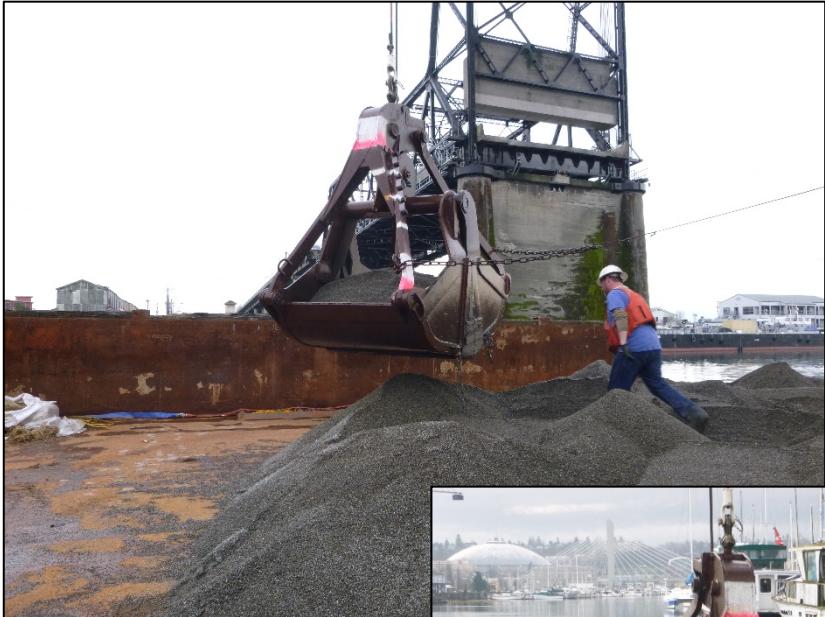
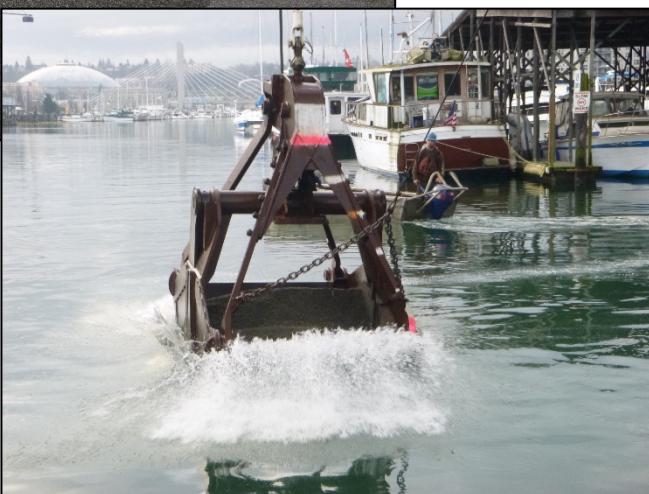
Sand Cap Over Dredge Area

- Cap to limit dredging to surface sediments within natural recovery area and unknown subsurface sediment quality
- Manual grid system used
- Remedial action and cap material consistent with original Thea Foss Superfund Site sand cap specifications
- 170 CY of 0.1% activated carbon amended sand cap

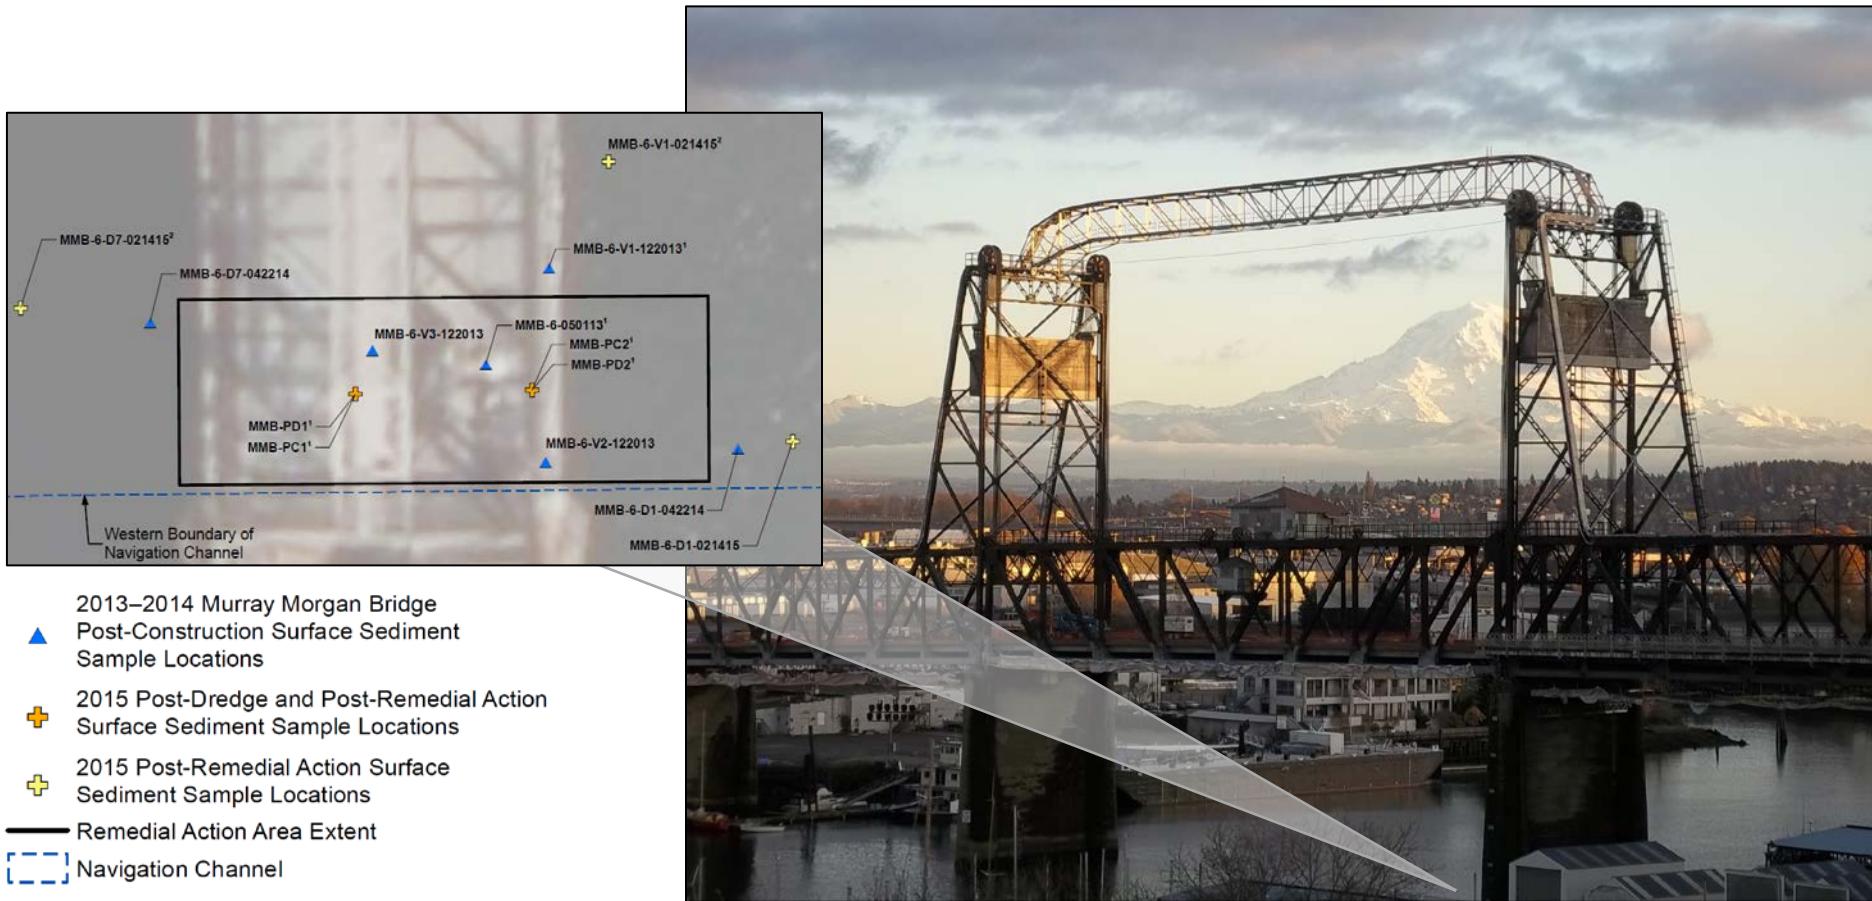
Surface Sediment Grab Sampling – No Dredge Residual Issues

- Samples from within and outside remedial action area
