A STICK IN THE MUD: U.S. COAST GUARD, SLIP 36 DREDGING AND REBUILD, SEATTLE, WASHINGTON

P. Leon¹, and S. Stirling²

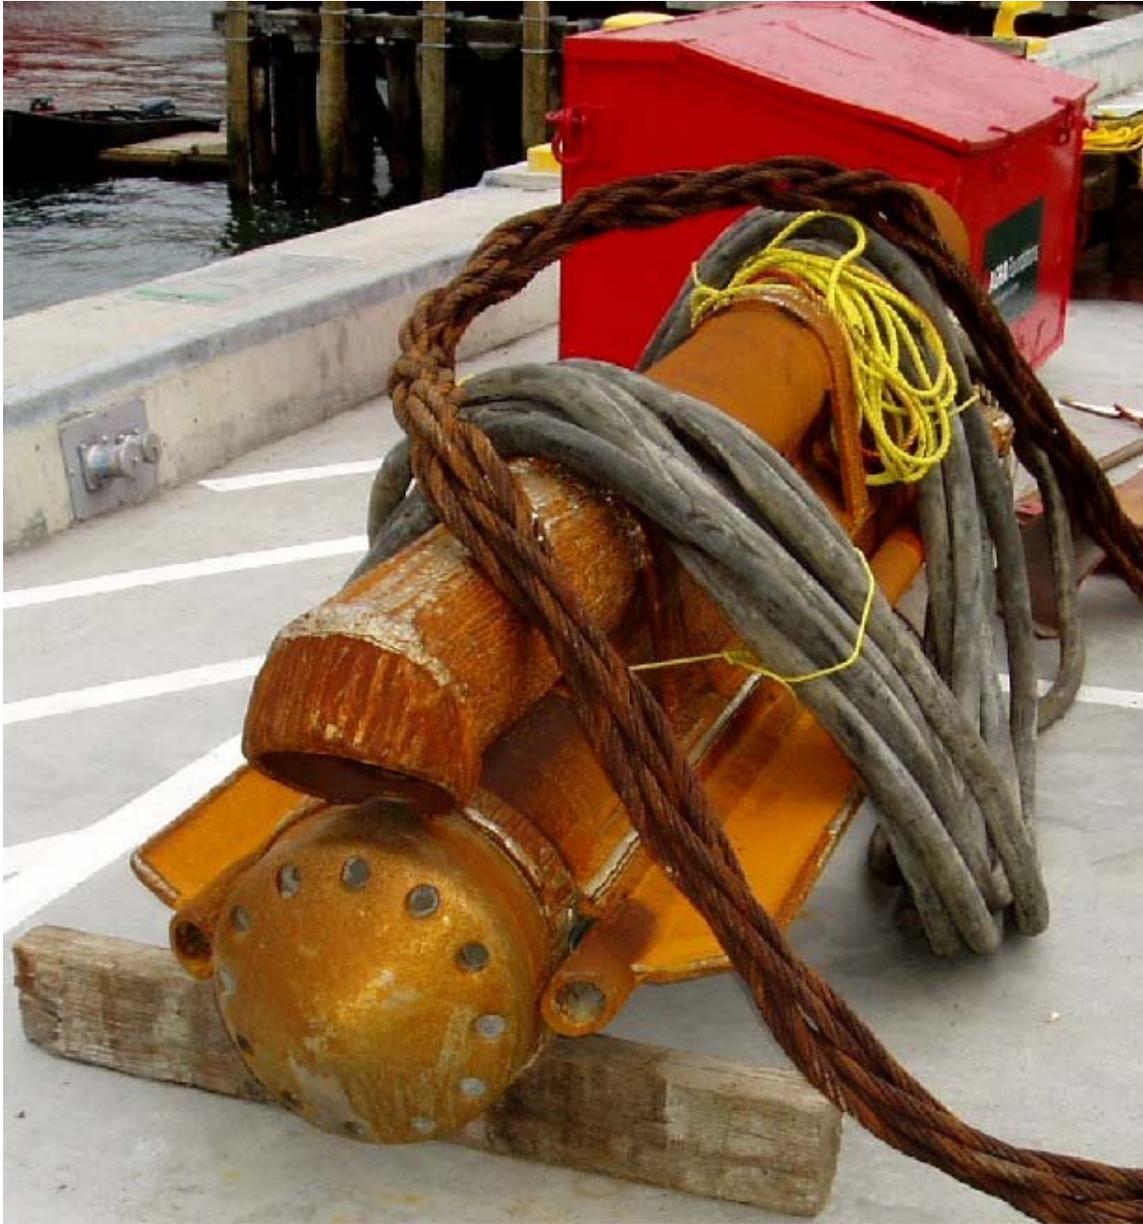
Figure 1: This is an extra head for the gravel column construction probe, which was stored temporarily on the new pier. Note the large, angled pipe pointing toward the center of the probe. Gravel is injected into the sediments through this pipe. Both air and water are forced through the smaller pipes on either side of the probe to scour material from beneath the probe head as needed.
