MILE POINT TRAINING WALL  
JACKSONVILLE, FL

Geotextile Tube Installation

**MILE POINT TRAINING WALL RECONFIGURATION**  
**JACKSONVILLE, FLORIDA**

*2017 WEDA Midwest Chapter Meeting*

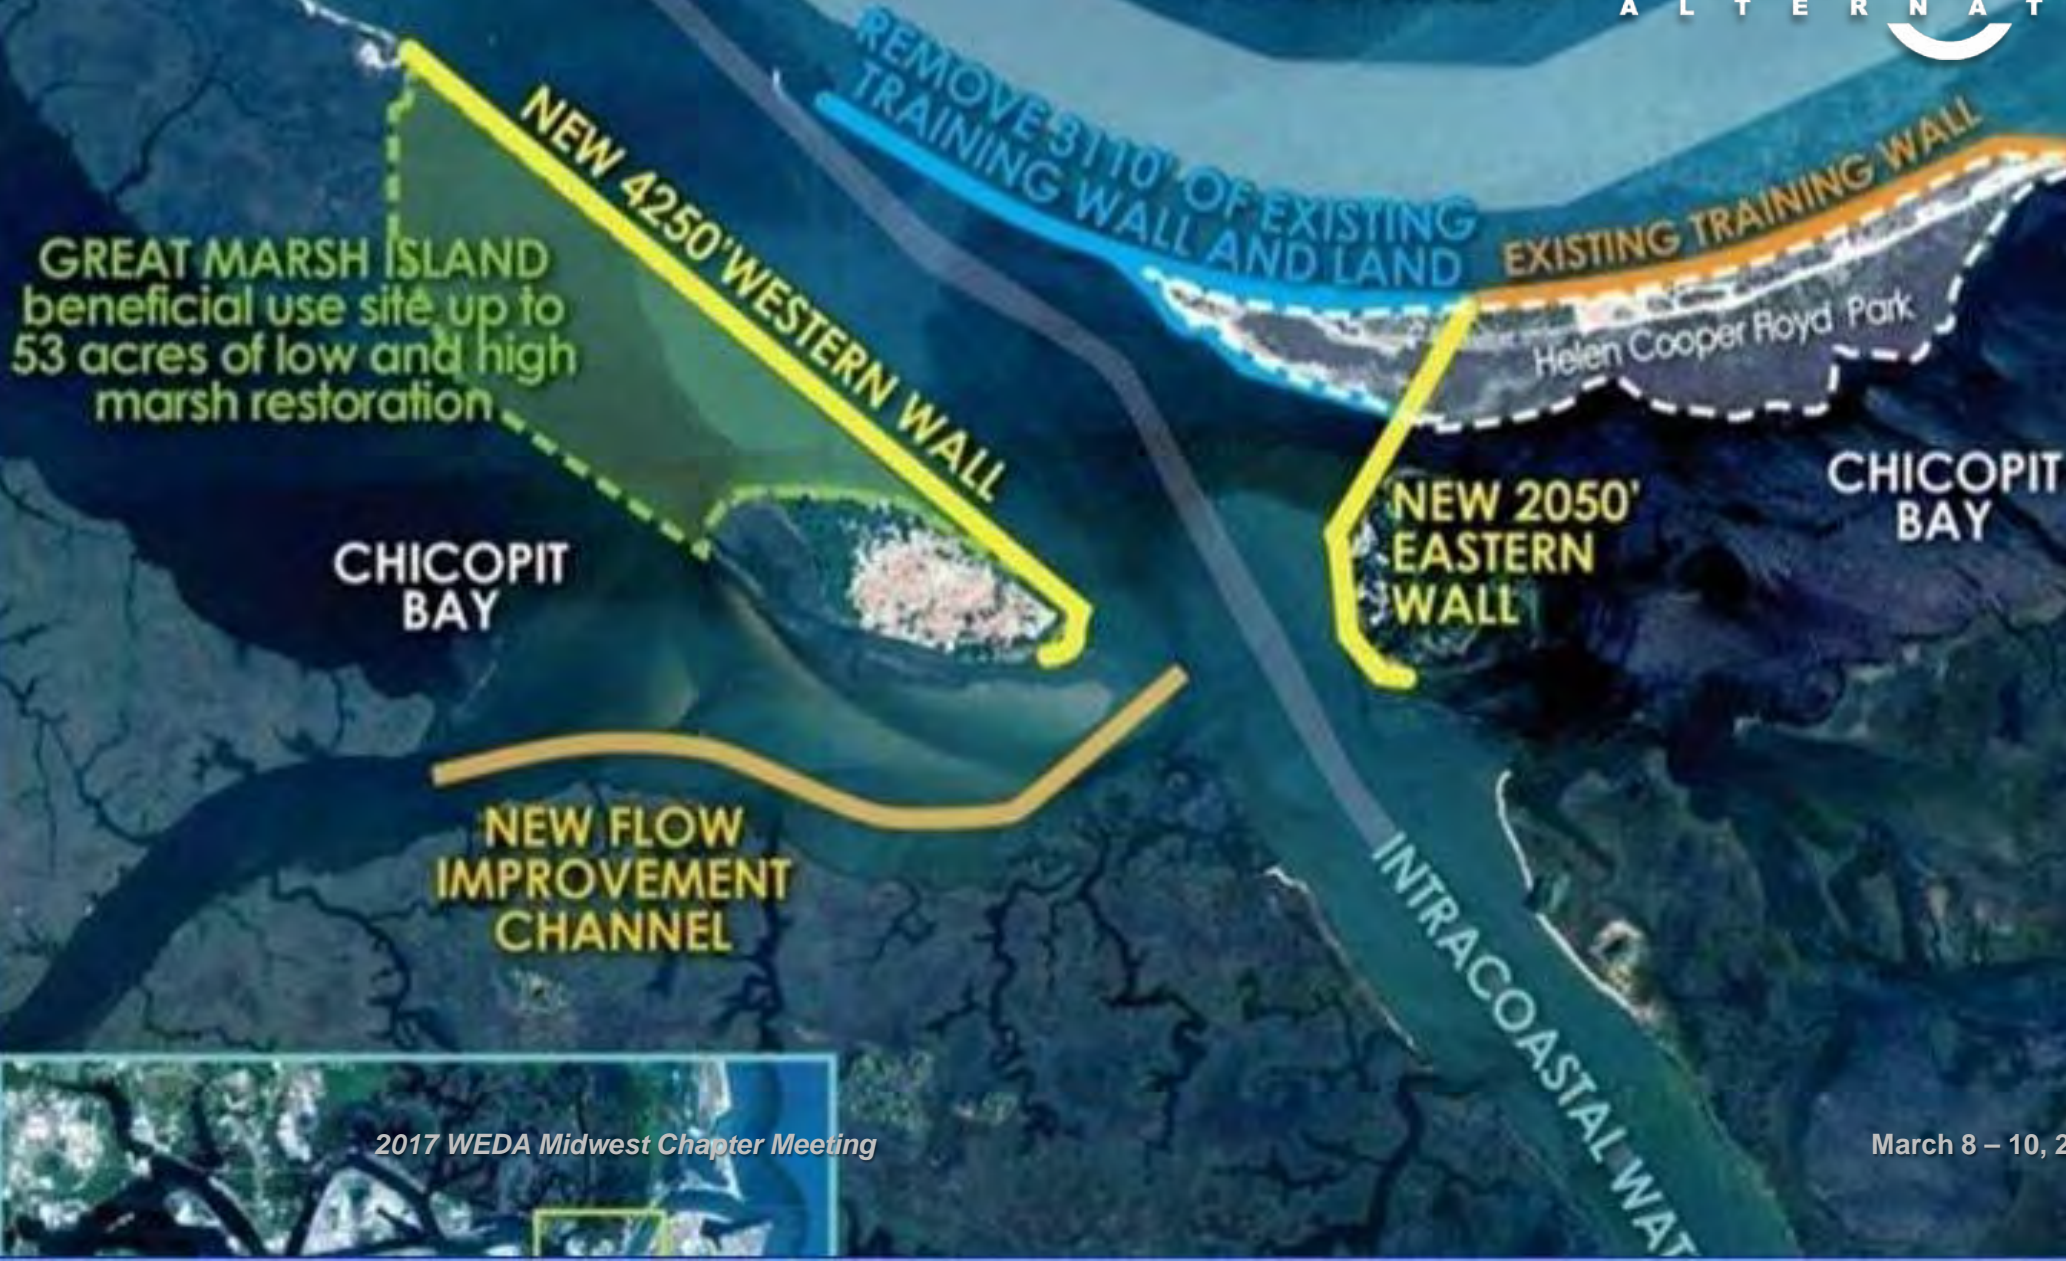
ST. JOHNS RIVER

## PROJECT DESIGN

- Remove portion of existing training wall
- Construct new eastern and western training walls
- Deepen new flow improvement channel
- Restore Great Marsh Island

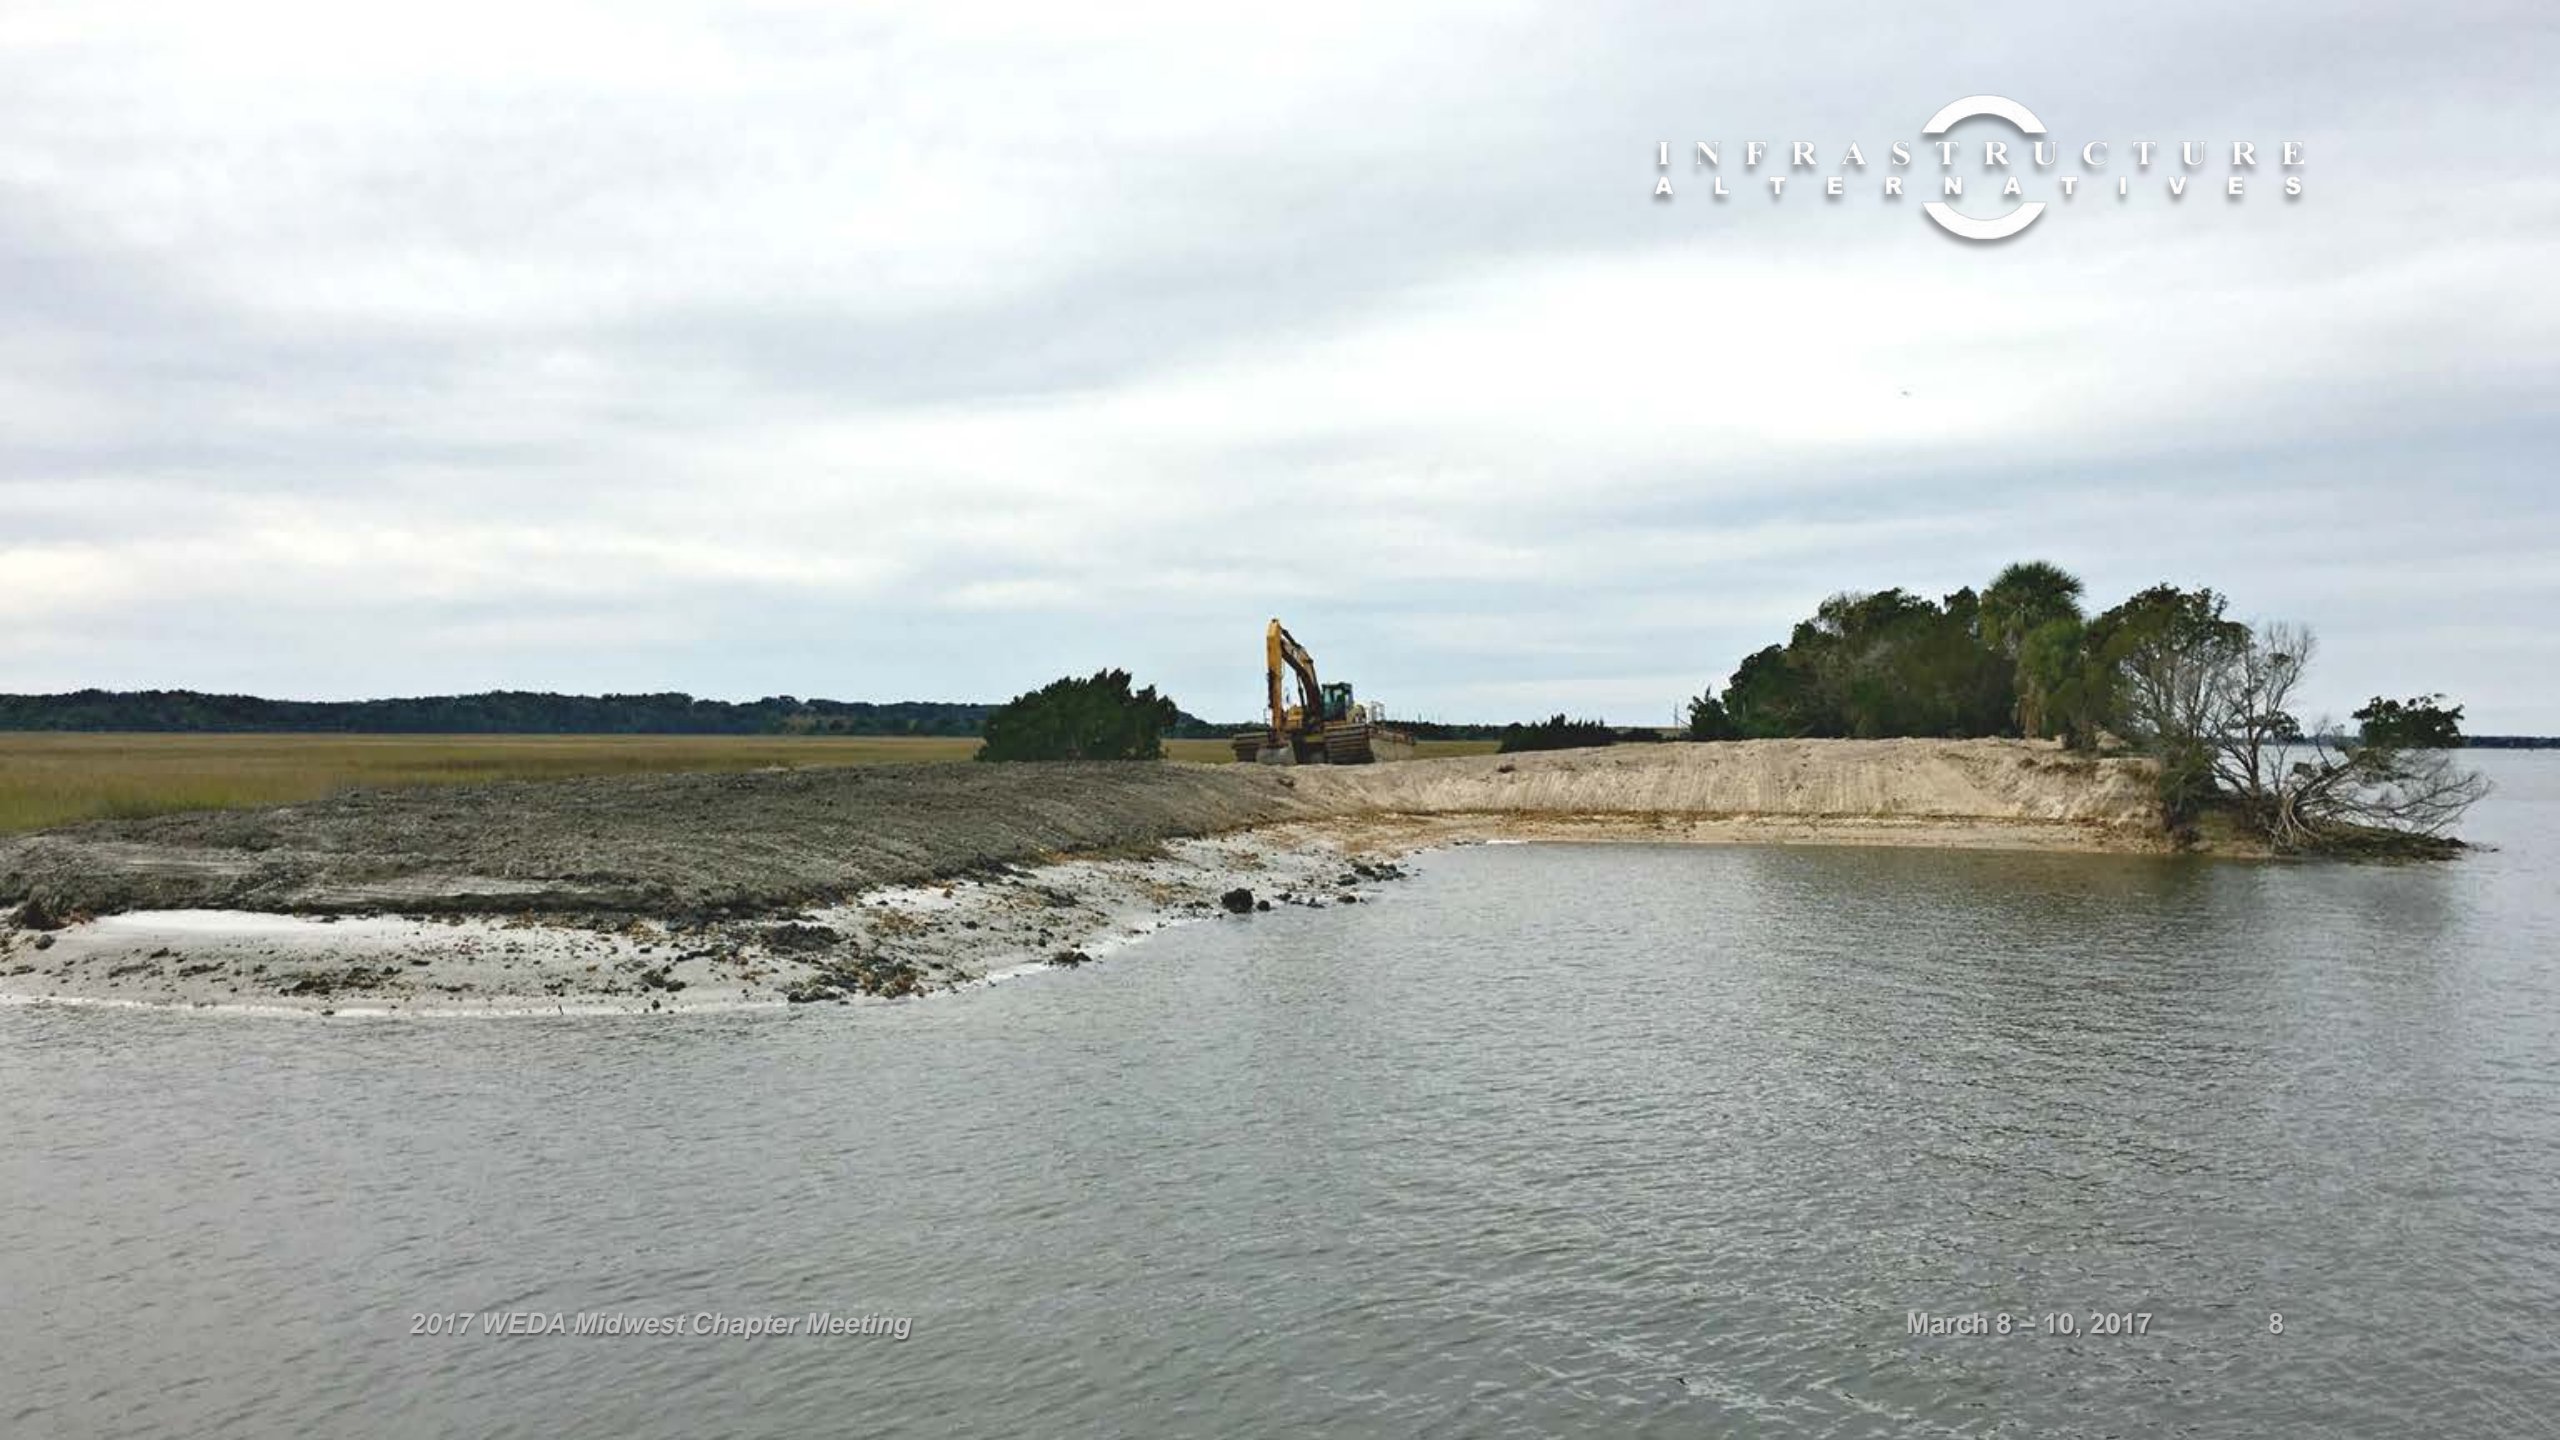
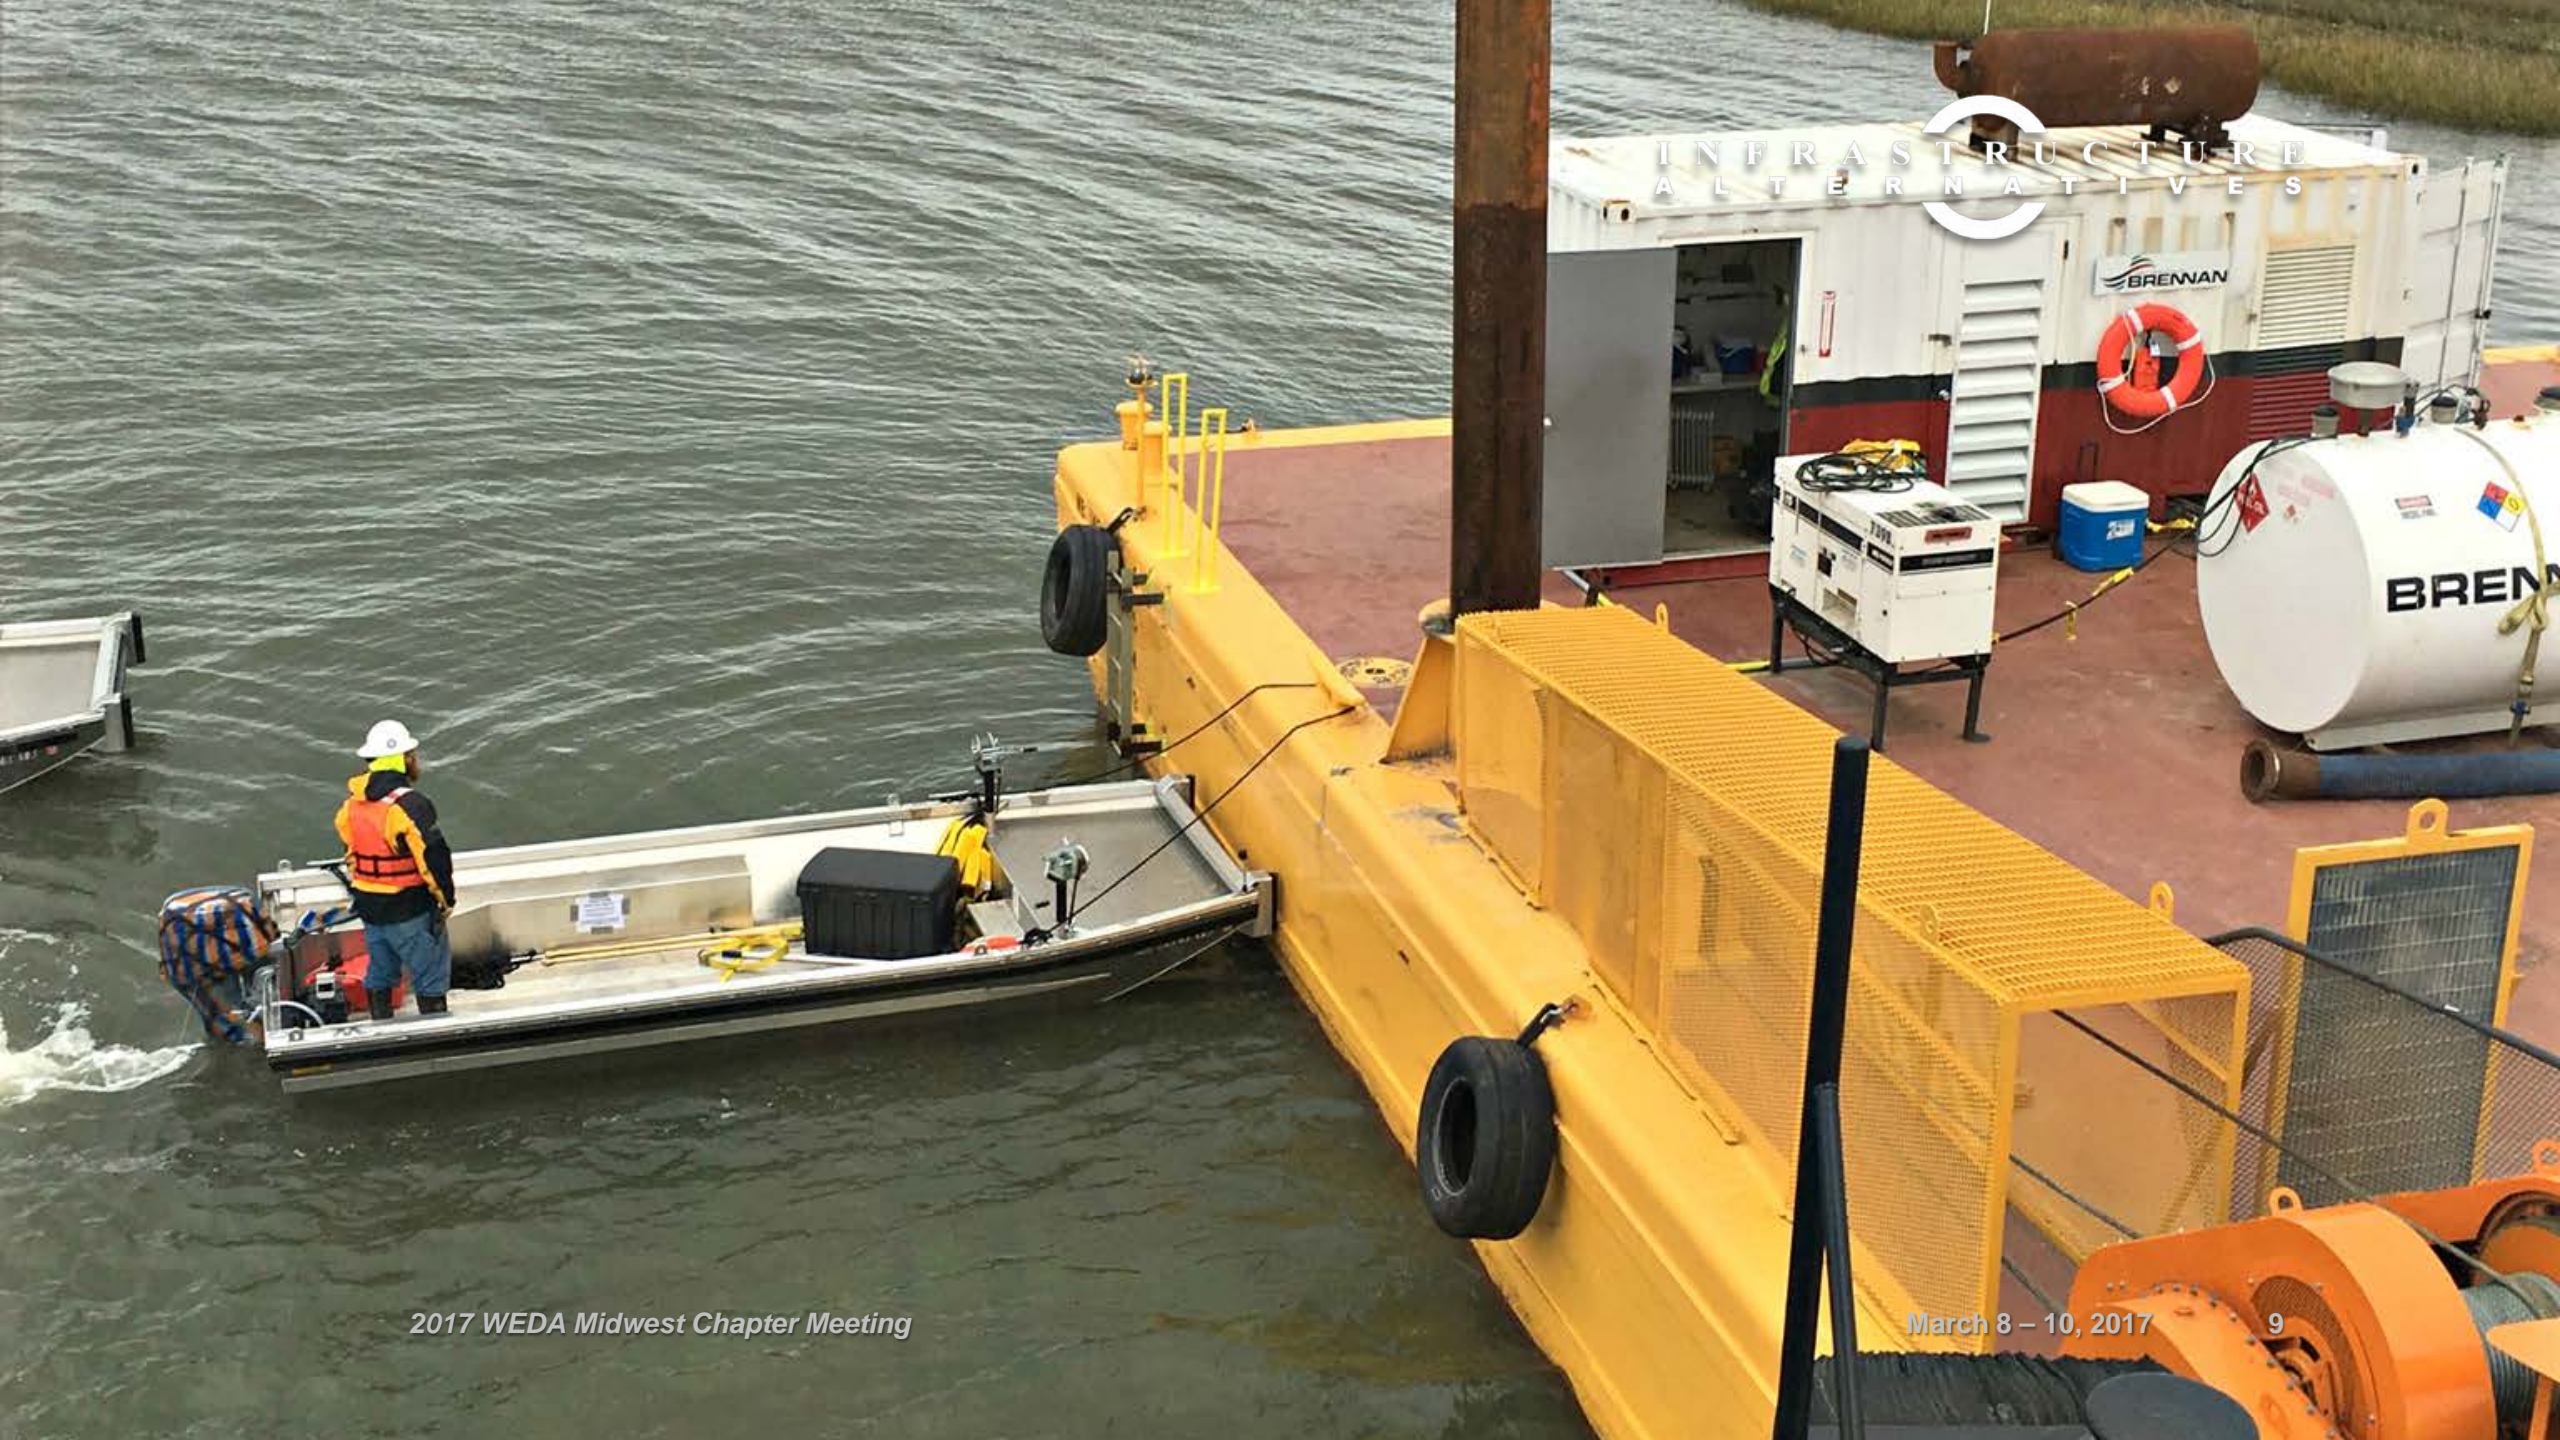
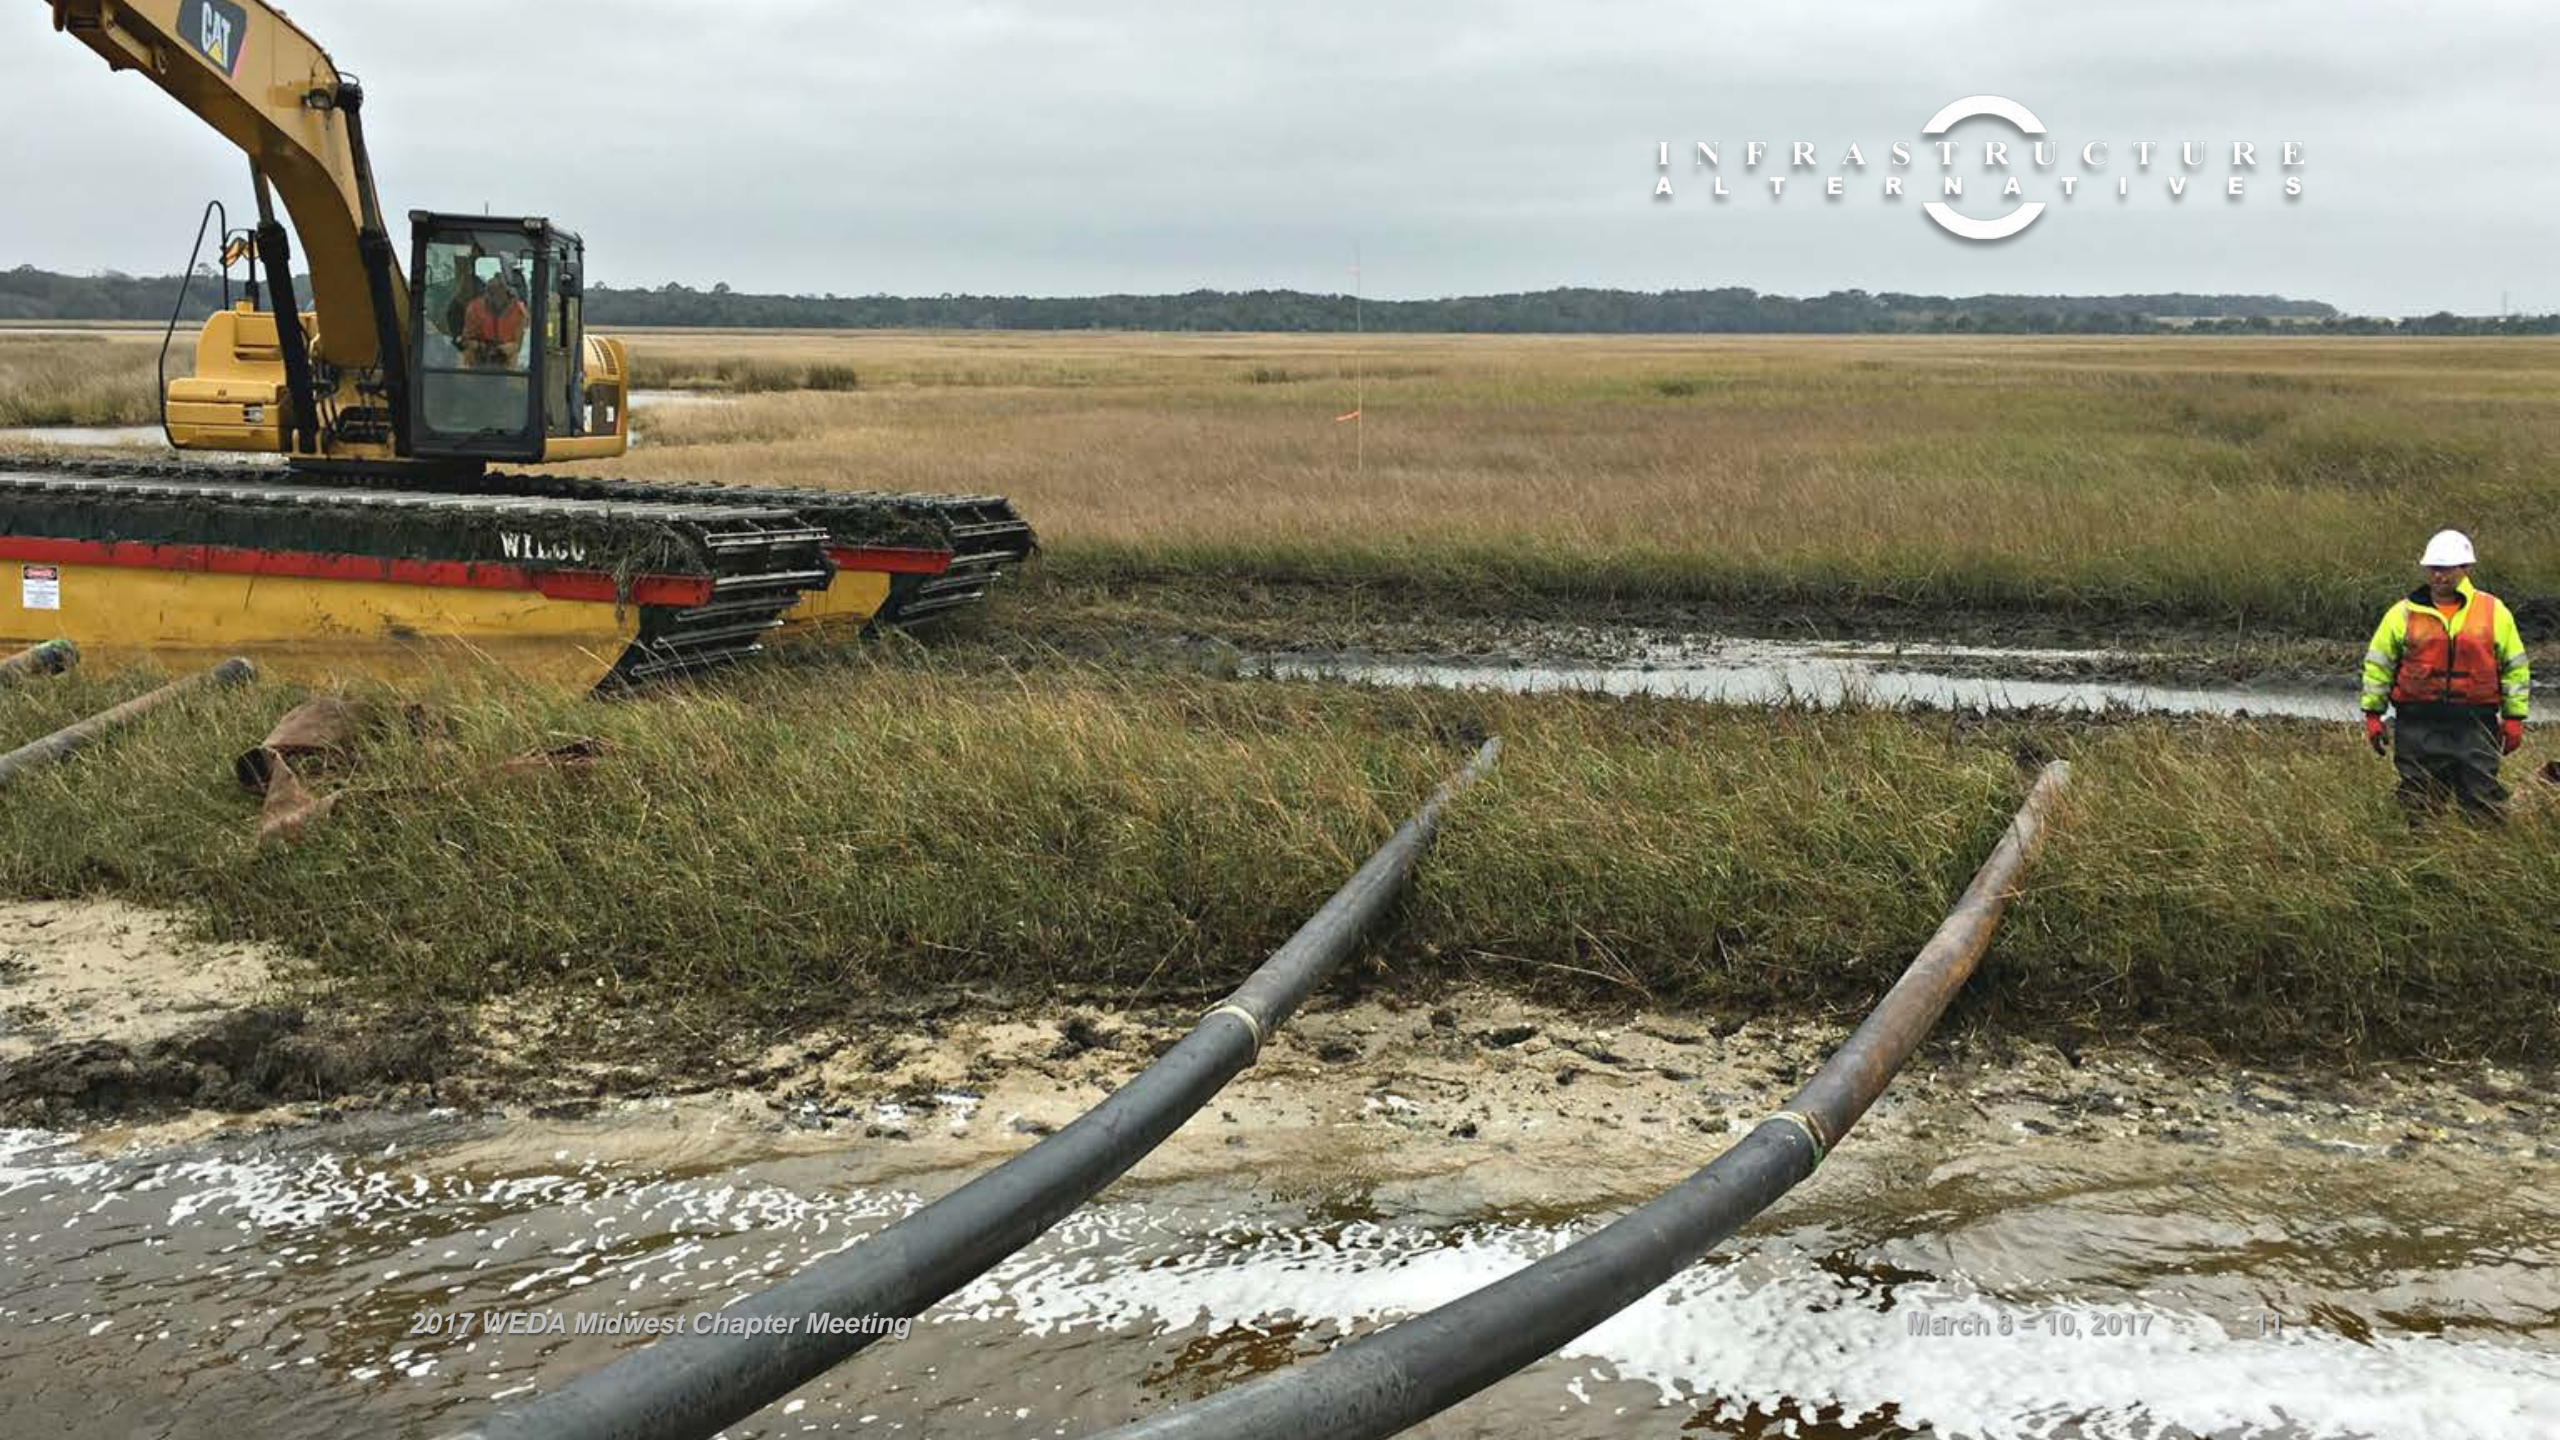
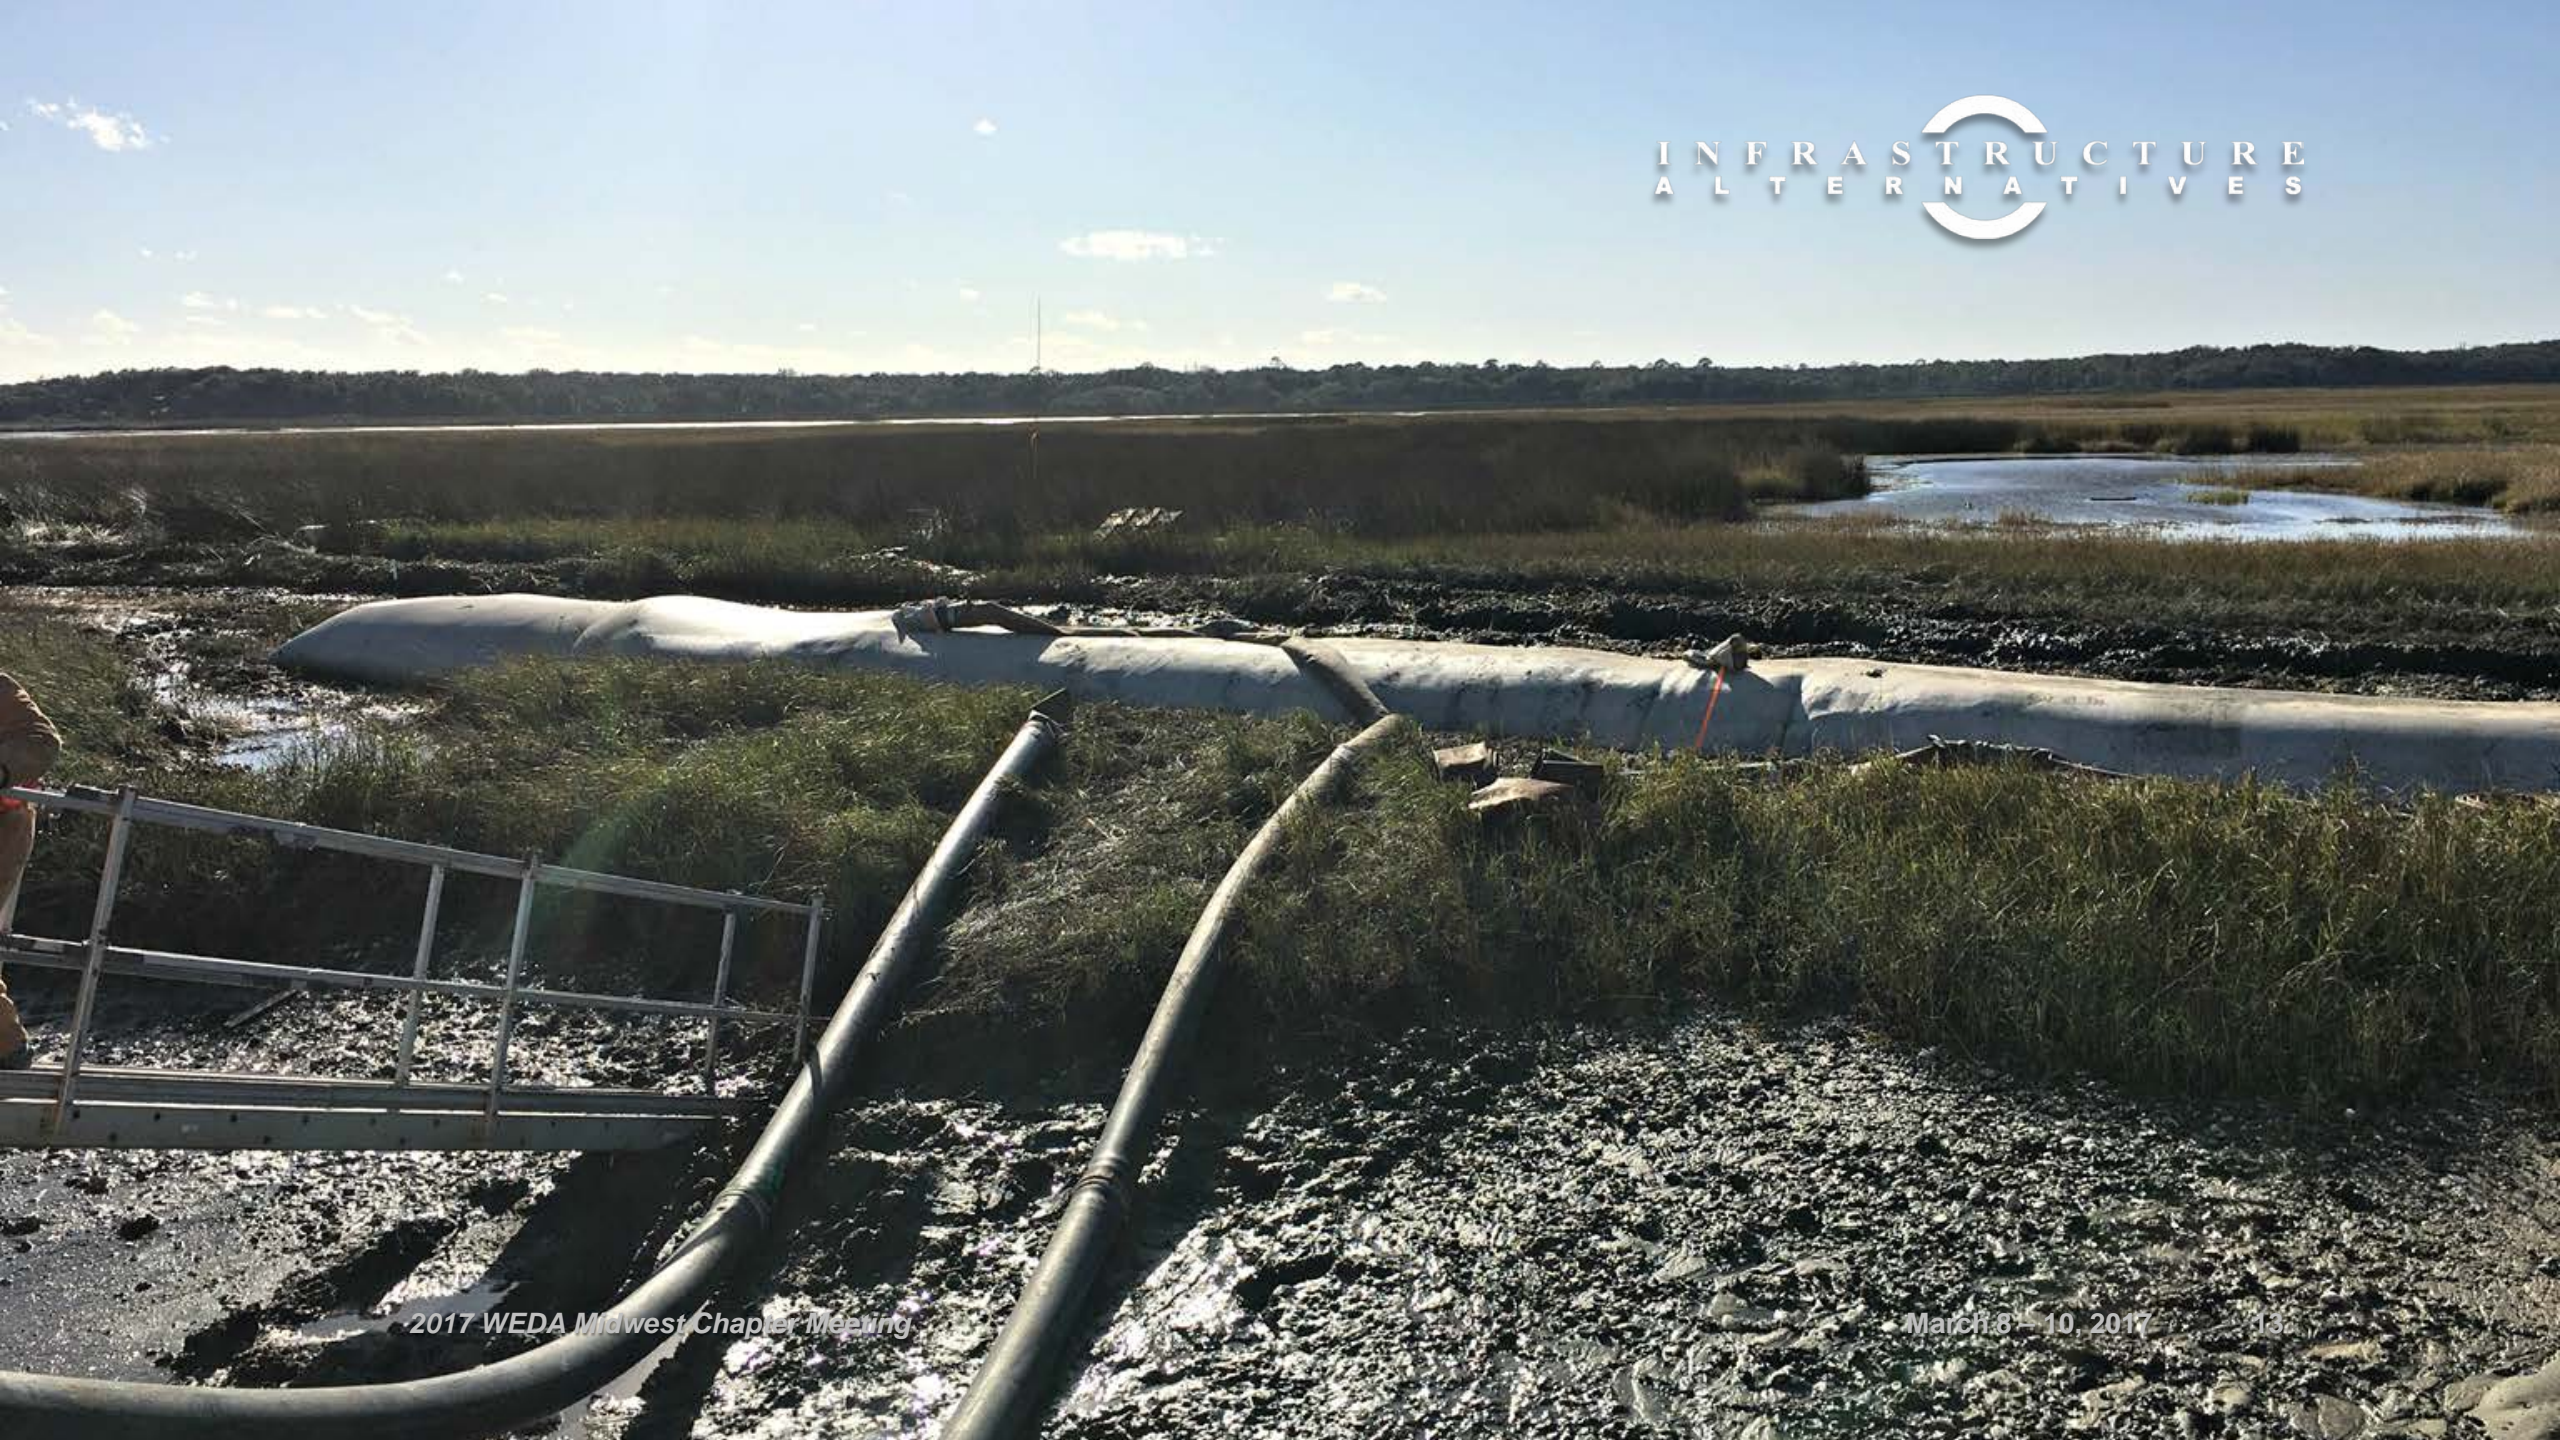
## AREA 1 – STATIONS 0+00 TO 13+00

- 17-ft. circ. X 210-ft. long geotextile tubes
- Min. fill height: 5 ft. MLLW
- Deployed several from boats due to tides
- Tide swings, 5 – 7 feet
- Work could only be performed in daylight hrs.
- Placement of the header barge was critical; tides limited draft to move them

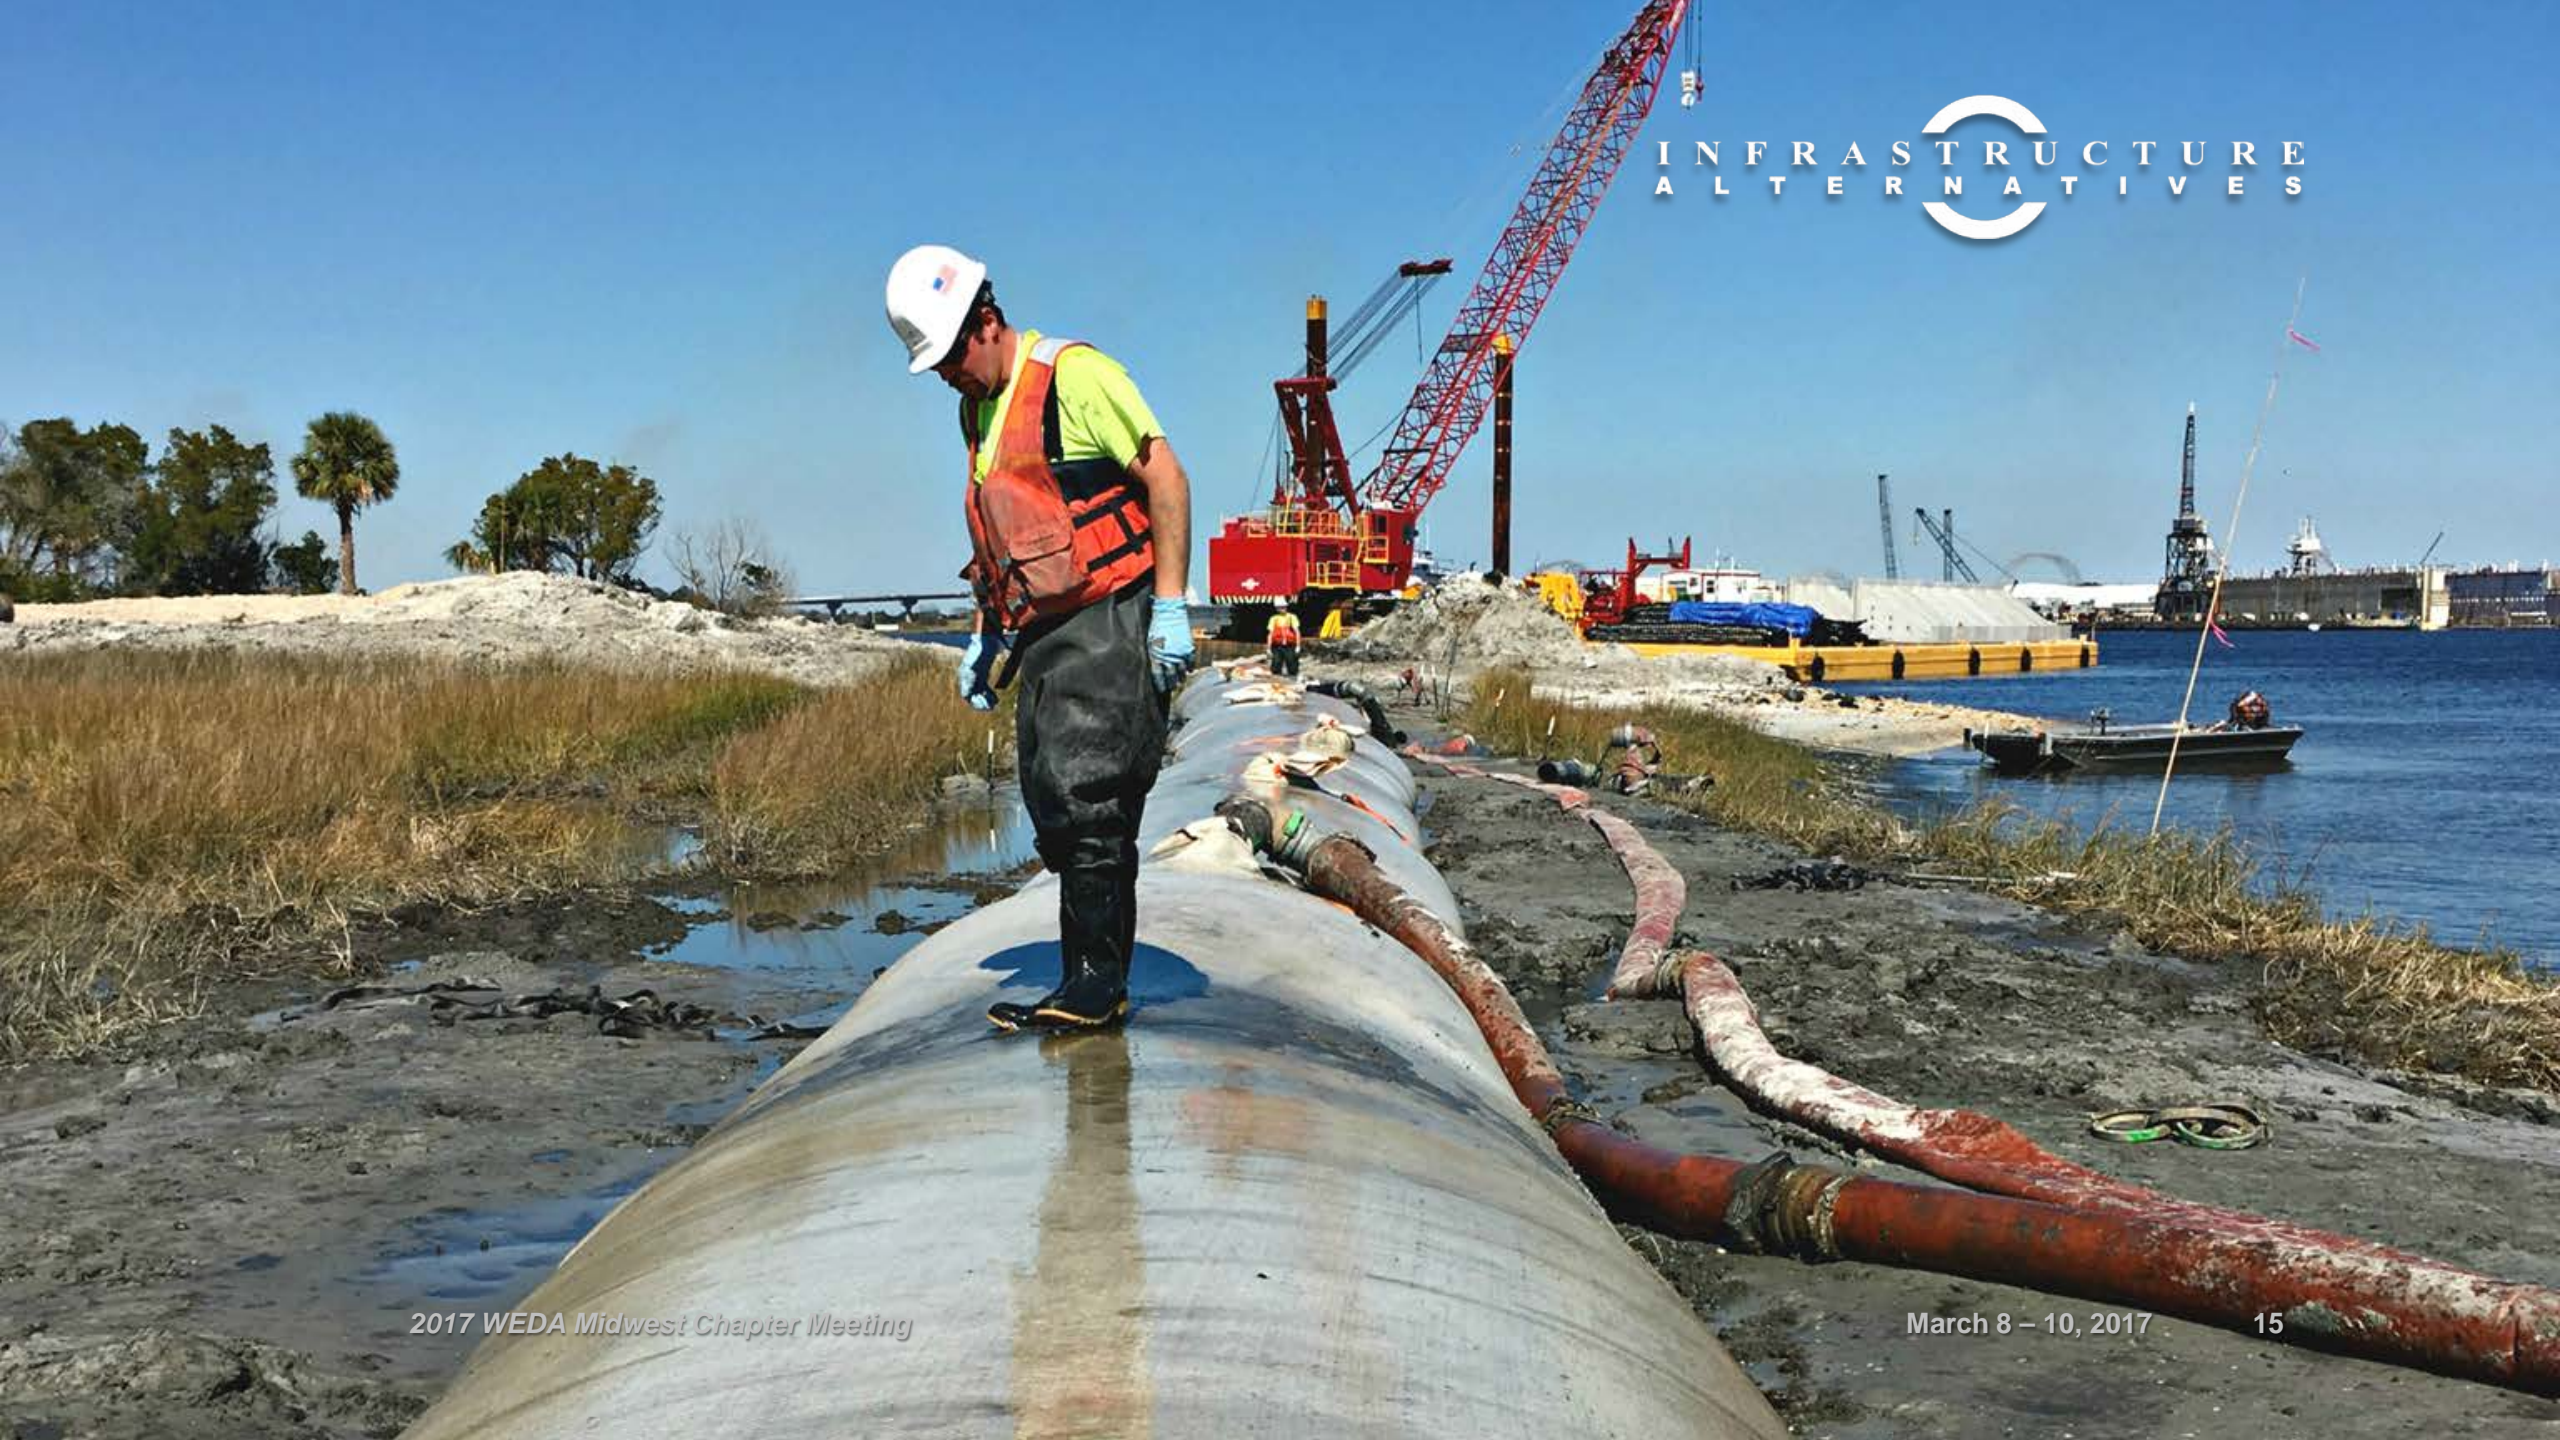
## STATIONS 3+00 TO 5+00

- Challenging, unstable foundation
- First 400-ft. of tubes filled quickly and were level at 4-ft. height
- Next a.m., tubes had sunk into the foundation
- Conducted surveys
- Placed sand to stabilize foundation
