MILE POINT TRAINING WALL  
JACKSONVILLE, FL

Geotextile Tube Installation

**MILE POINT TRAINING WALL RECONFIGURATION**  
**JACKSONVILLE, FLORIDA**

*2017 WEDA Midwest Chapter Meeting*

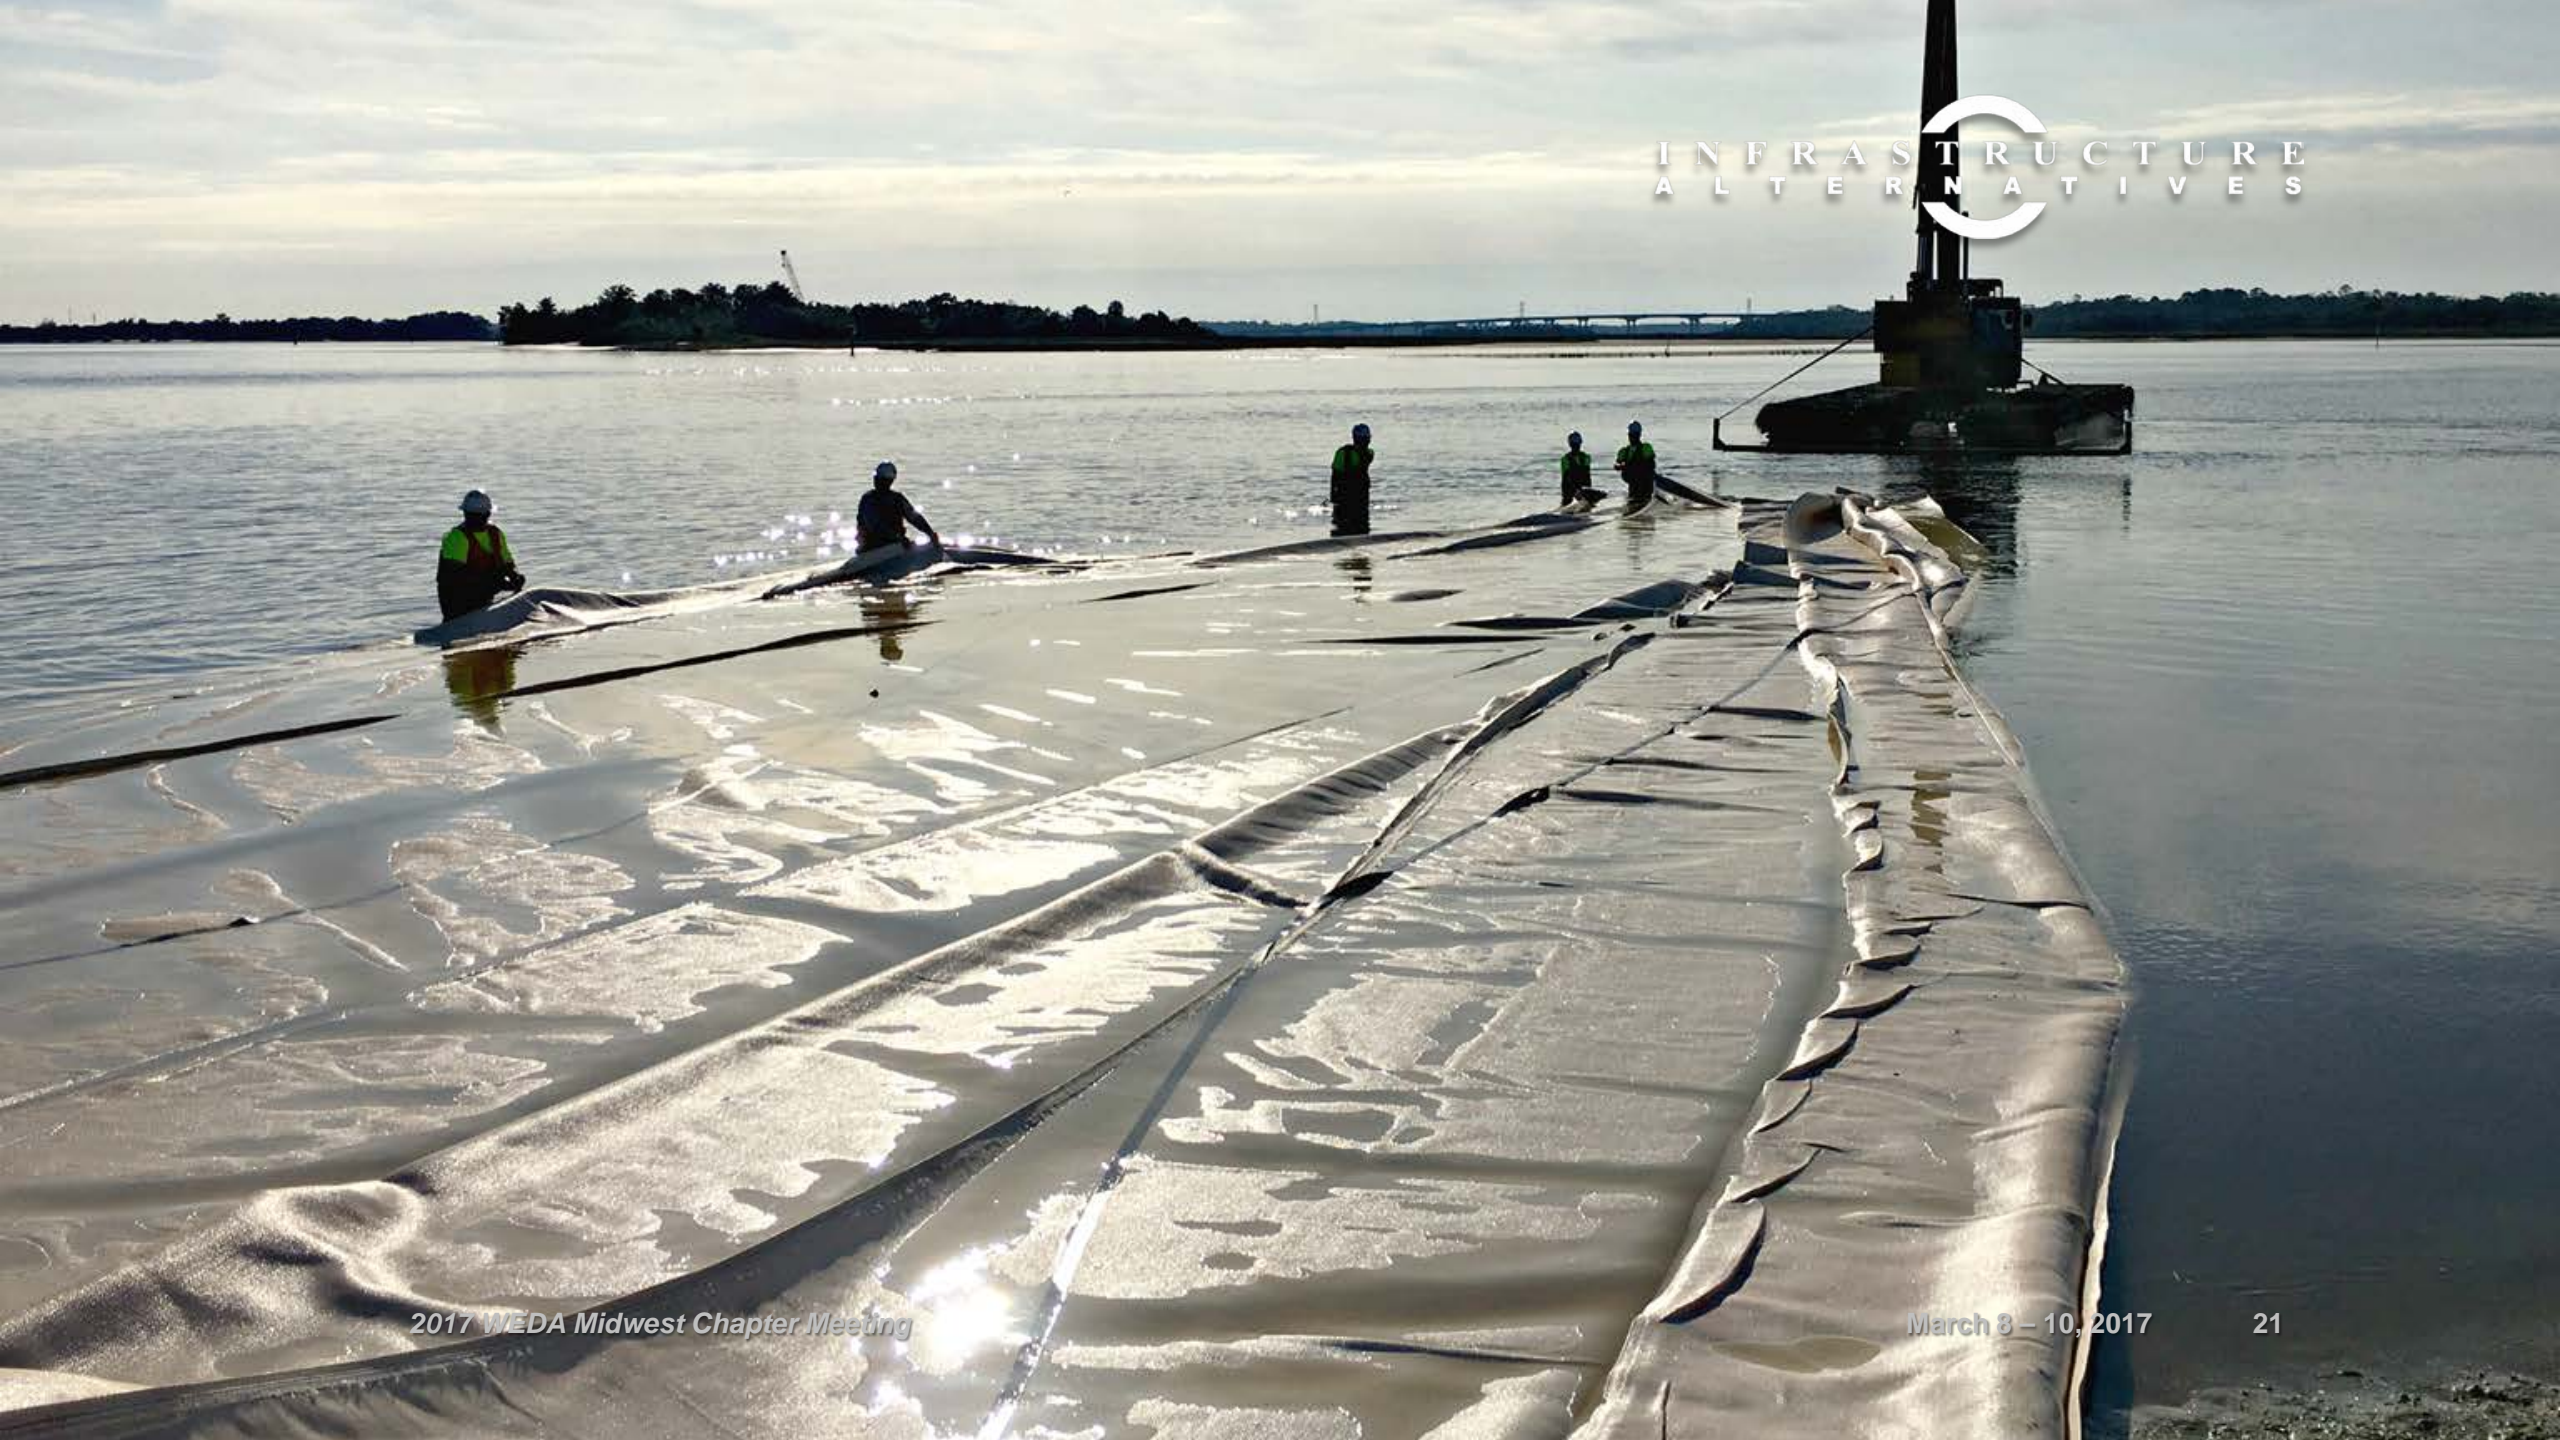
## SCOUR APRONS

- 75-ft. wide by 210-ft. long
- Protect the foundation, where the tubes will be placed
- Prevent wash-out of the base beneath the geotextile tubes

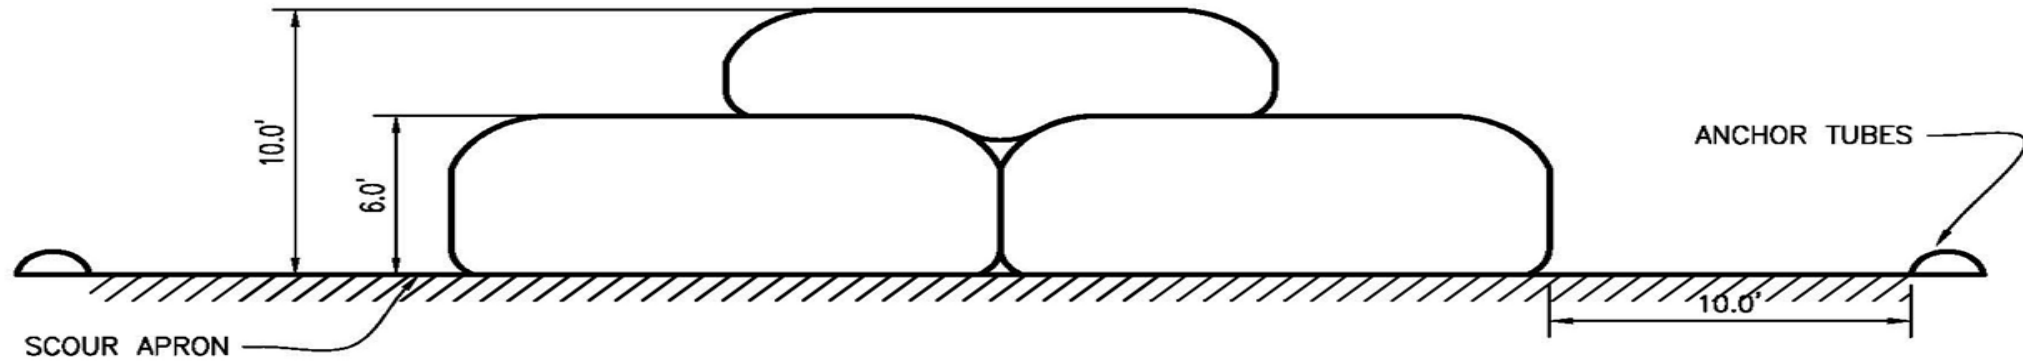
**STACKED CROSS SECTION**

## STACKED GEOTEXTILE TUBES

- In some areas, we had to stack three layers of tubes to achieve the target elevation
- Tubes ranged from 34-ft. to 60-ft. in circumference depending on the depth of water to maintain the 6-ft. MLLW
- At high tide, the top level tubes are nearly under water
- In a storm event, during high tide, the entire stack of tubes is submerged

## 34-FT. CIRCUMFERENCE

PROFILE DRAWING - AREA 3

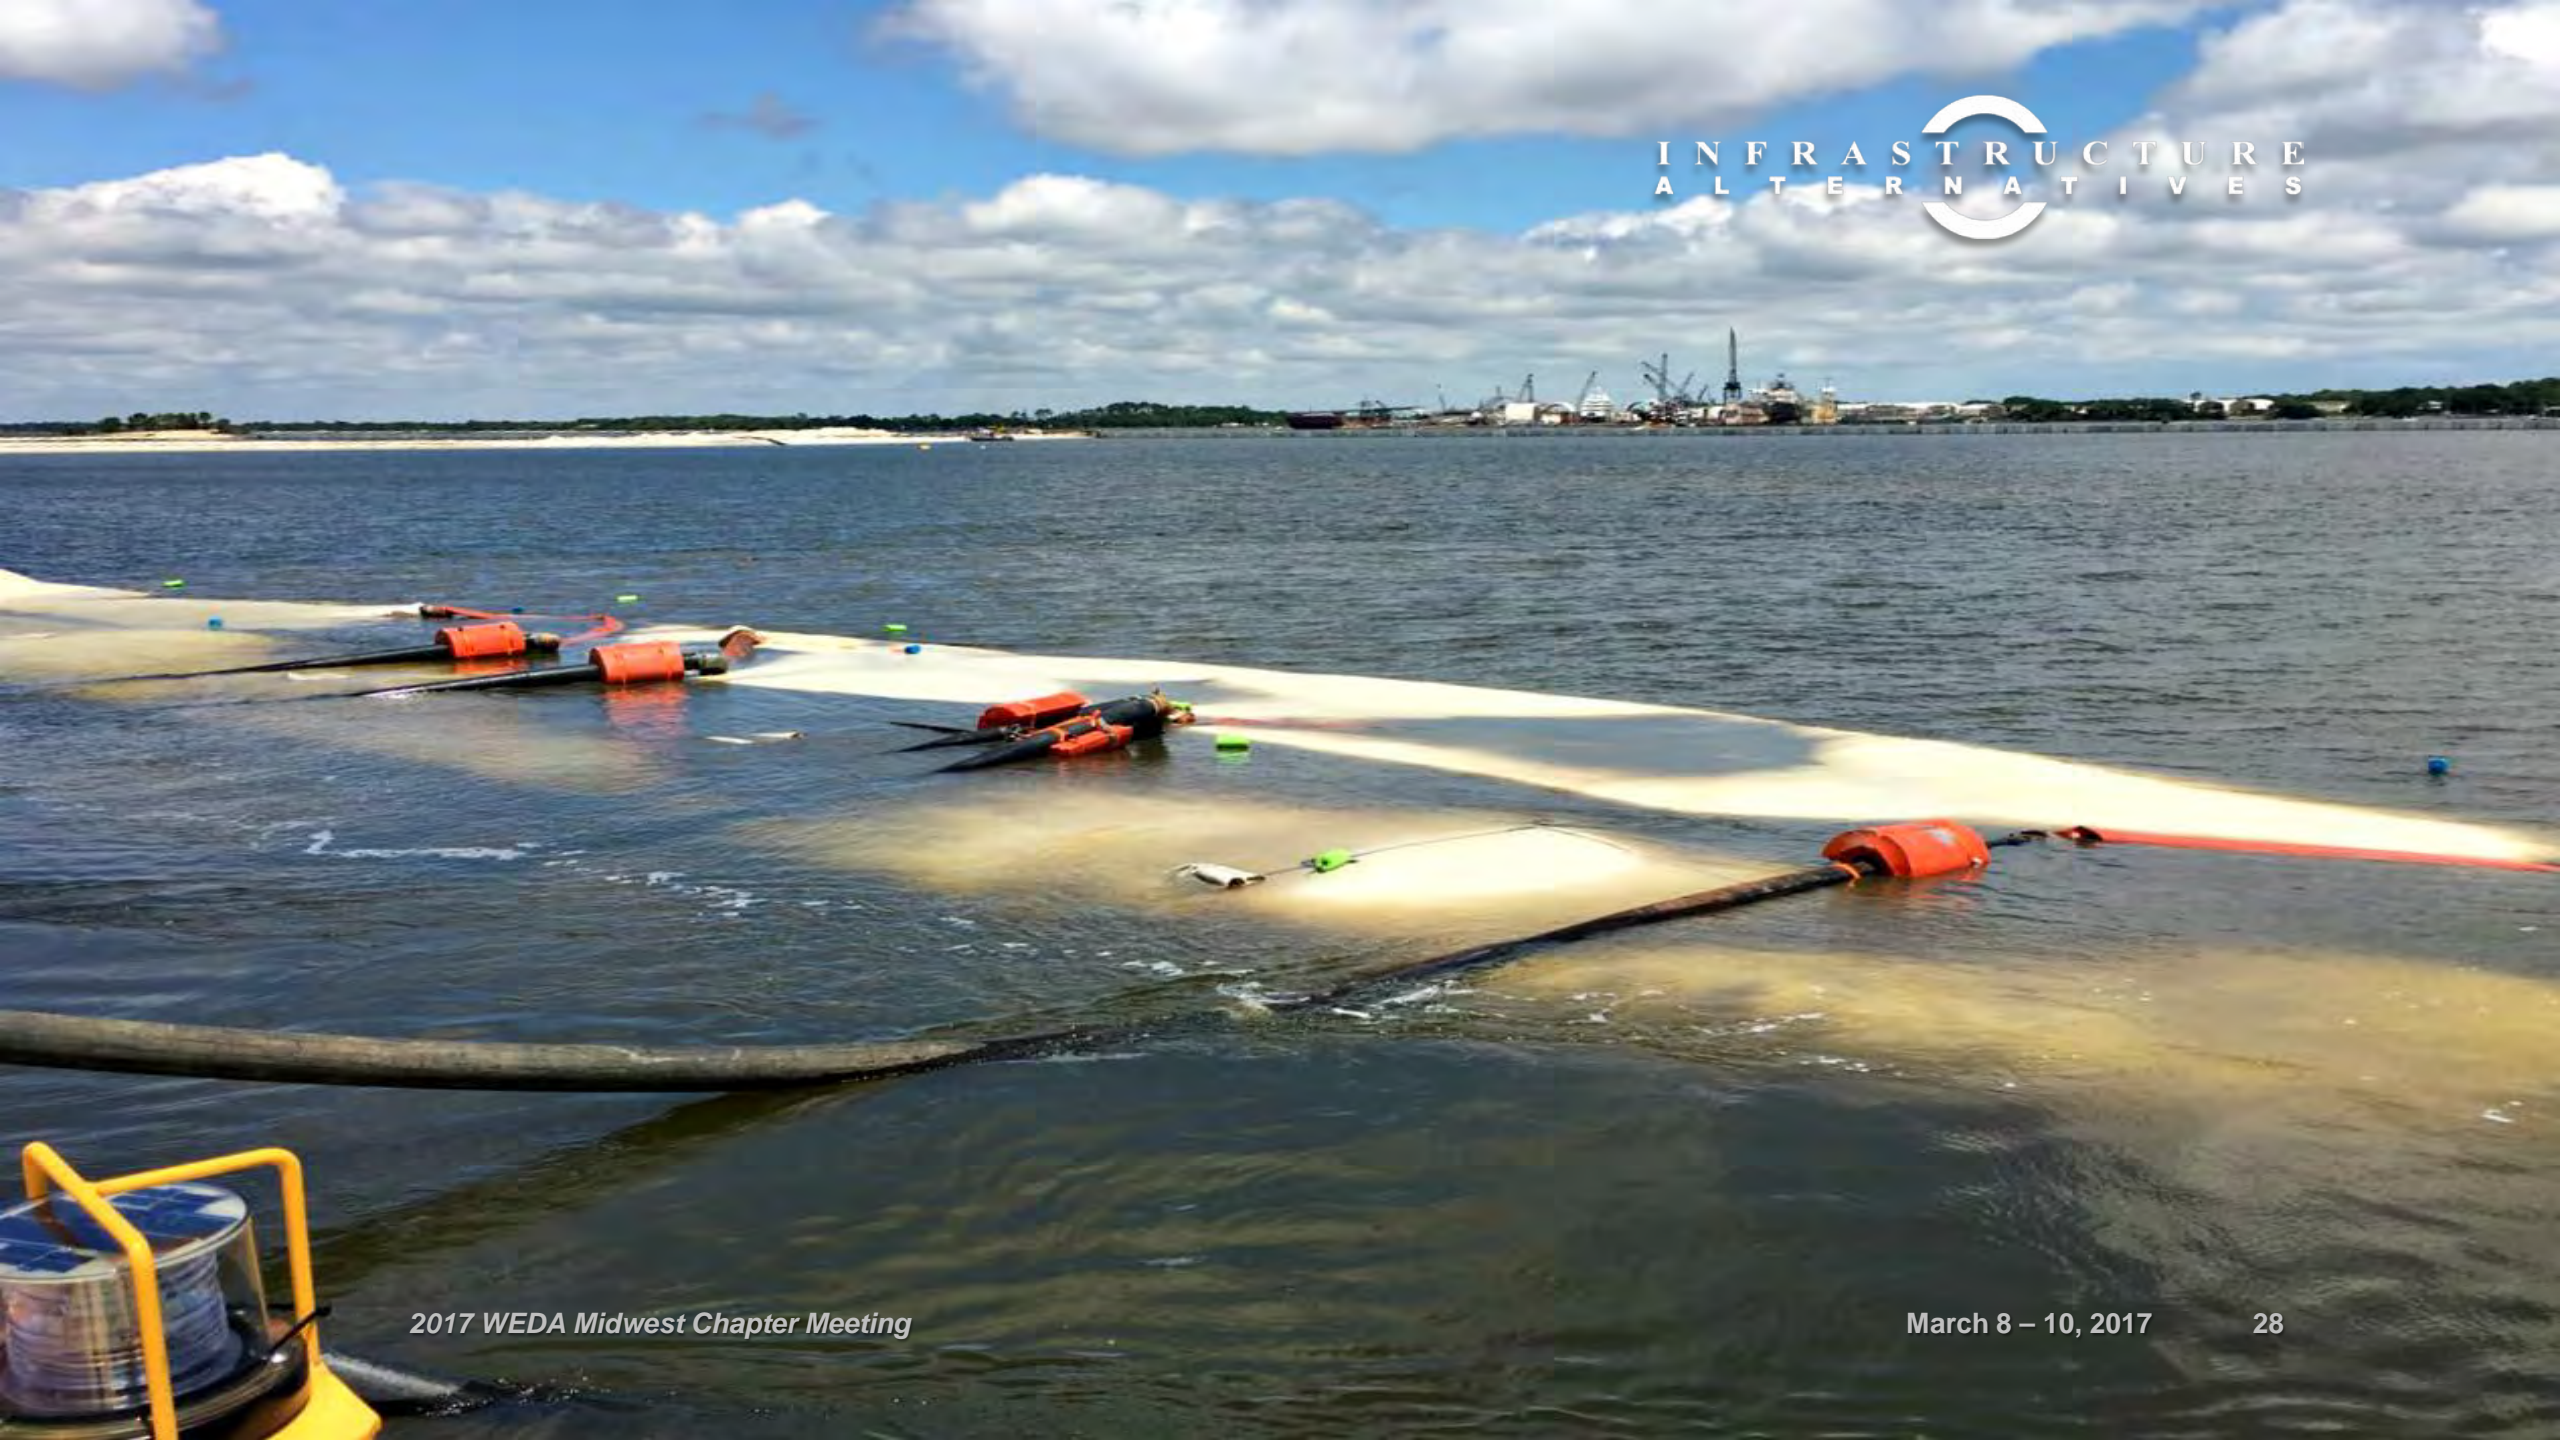
## FLOATS

- Orange floats attached to header lines as the water was up to 11 feet deep in areas
- Blue and green floats attached to loops on the scour aprons or lower layer tubes to secure the upper layer tubes in place

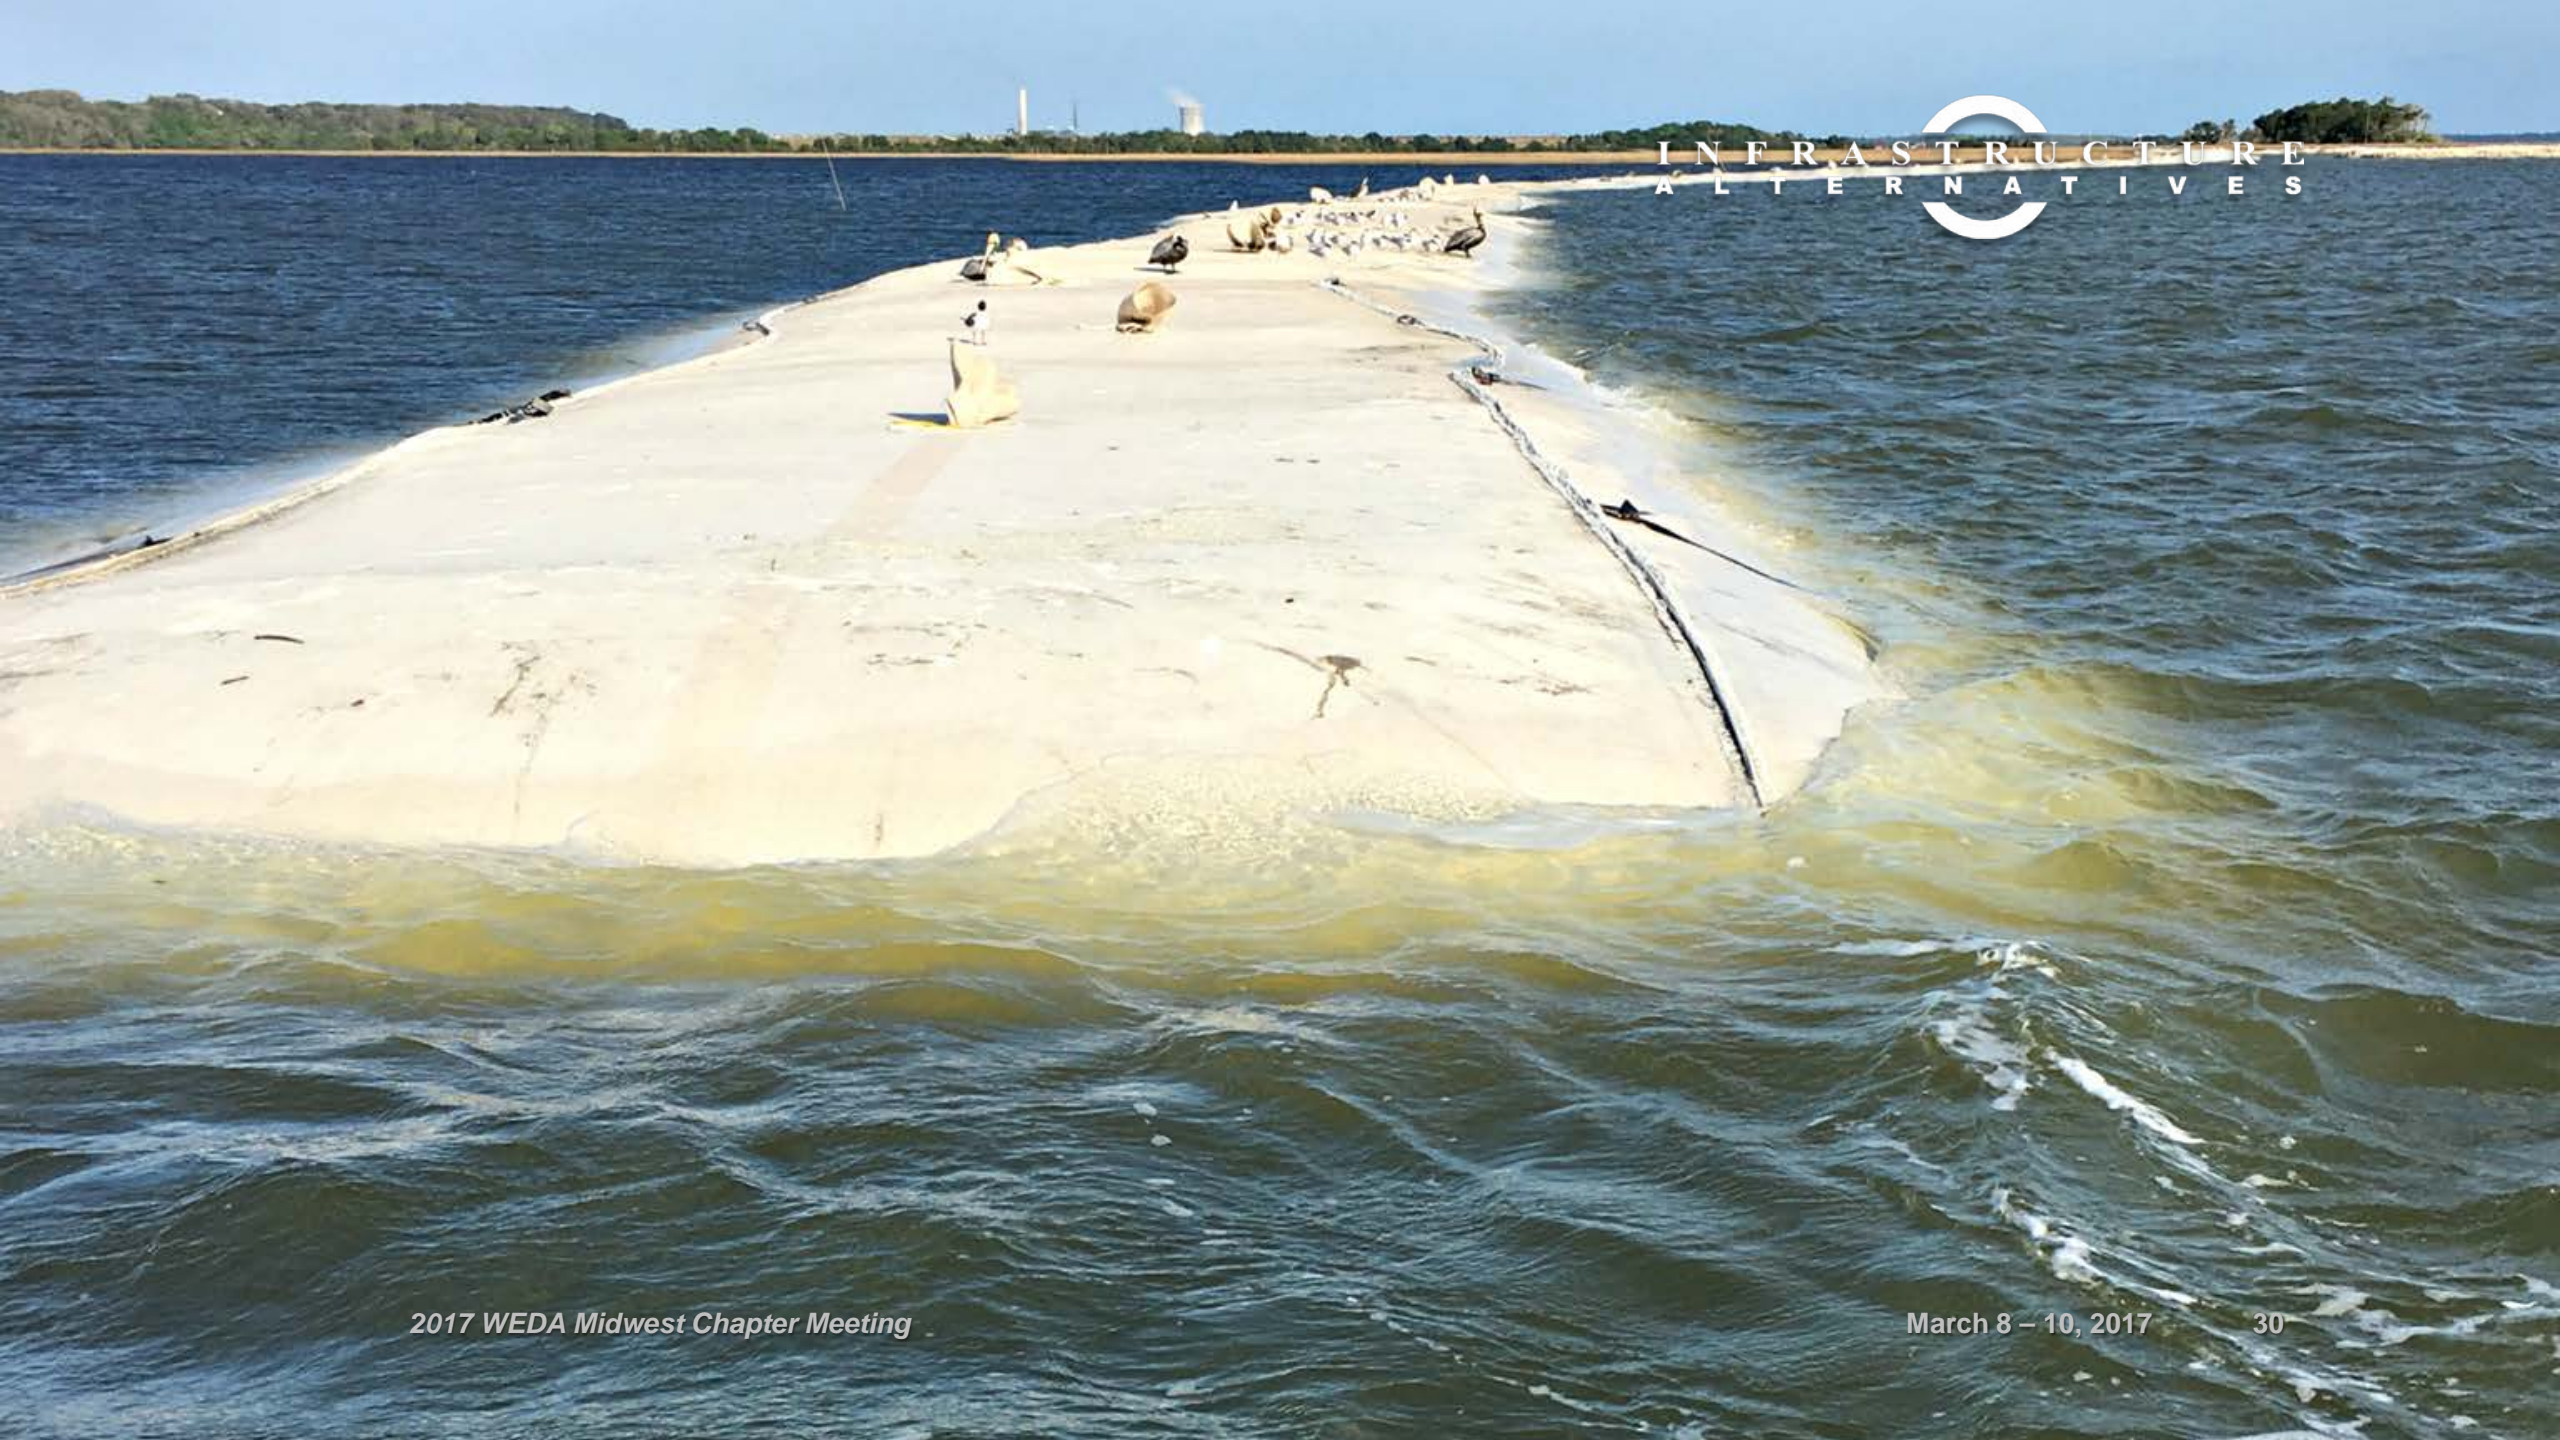
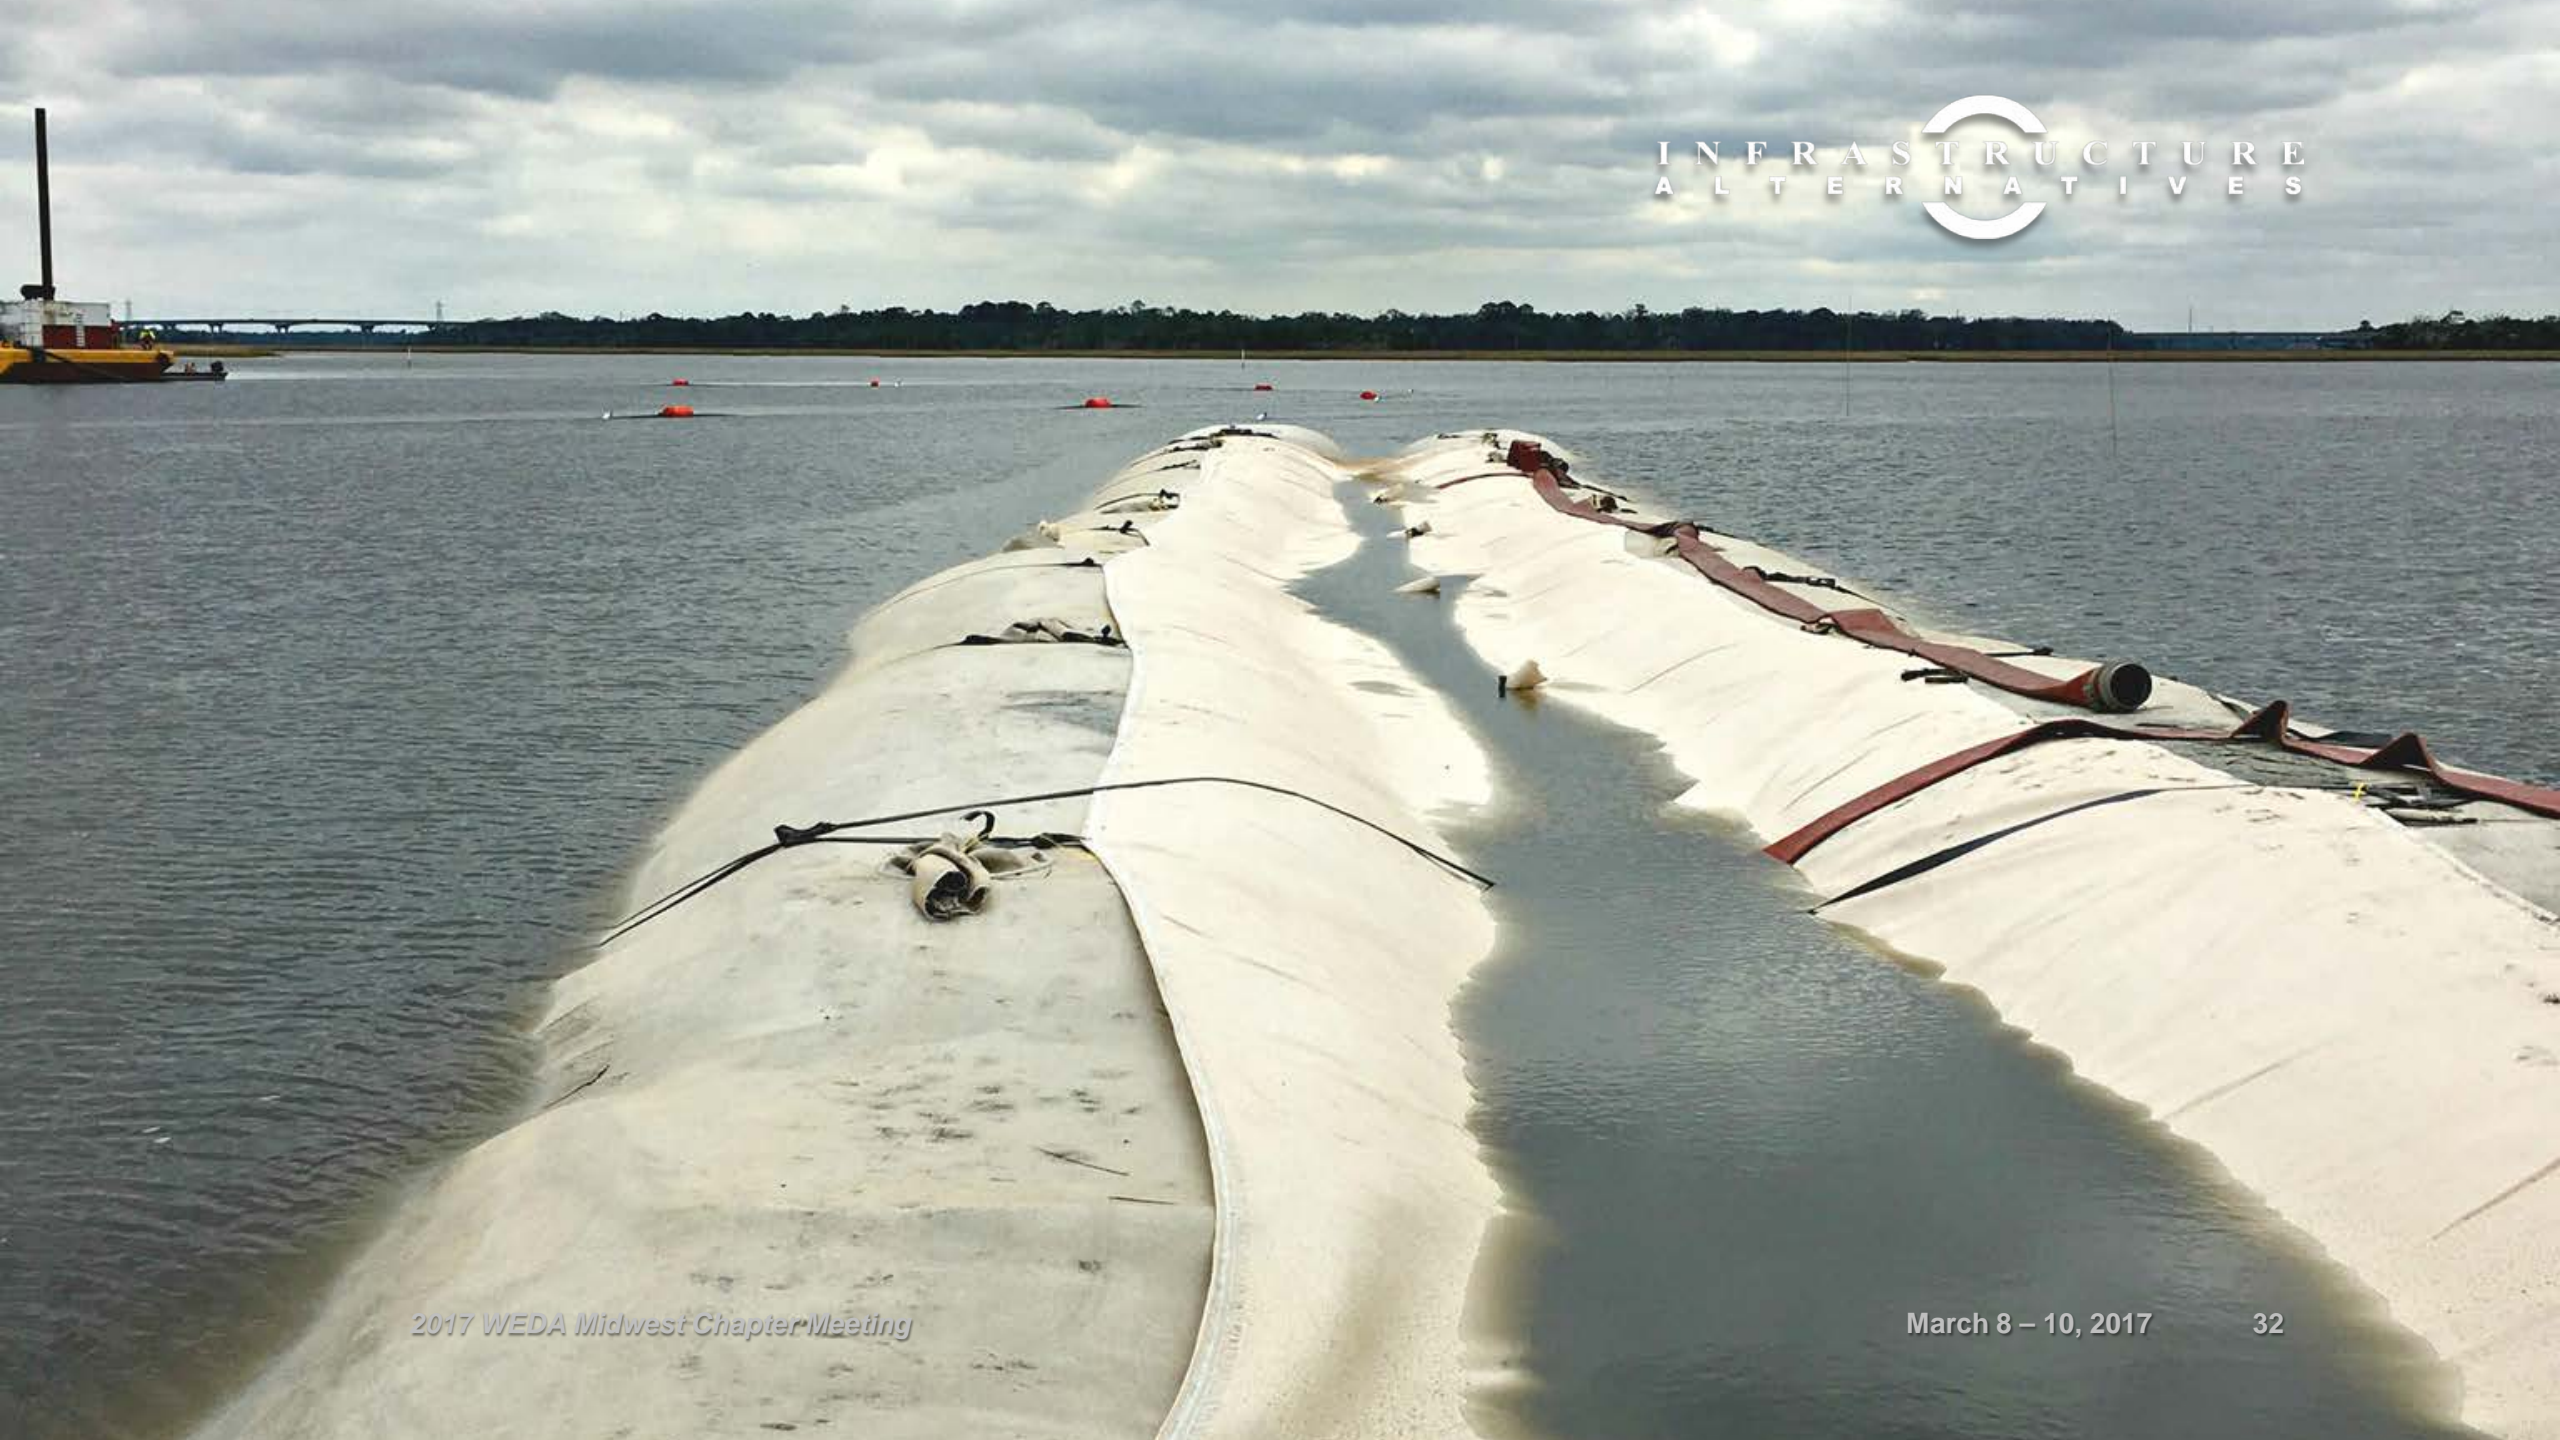
## STATION 19+00 – 25+00

- Geotextile tube dimensions: 60-ft. circumference x 210-ft. long
- Min. fill height: 6-ft. MLLW.
- +/-1 ft. tolerance in this area
- Needed to maintain desired elevation at high tide

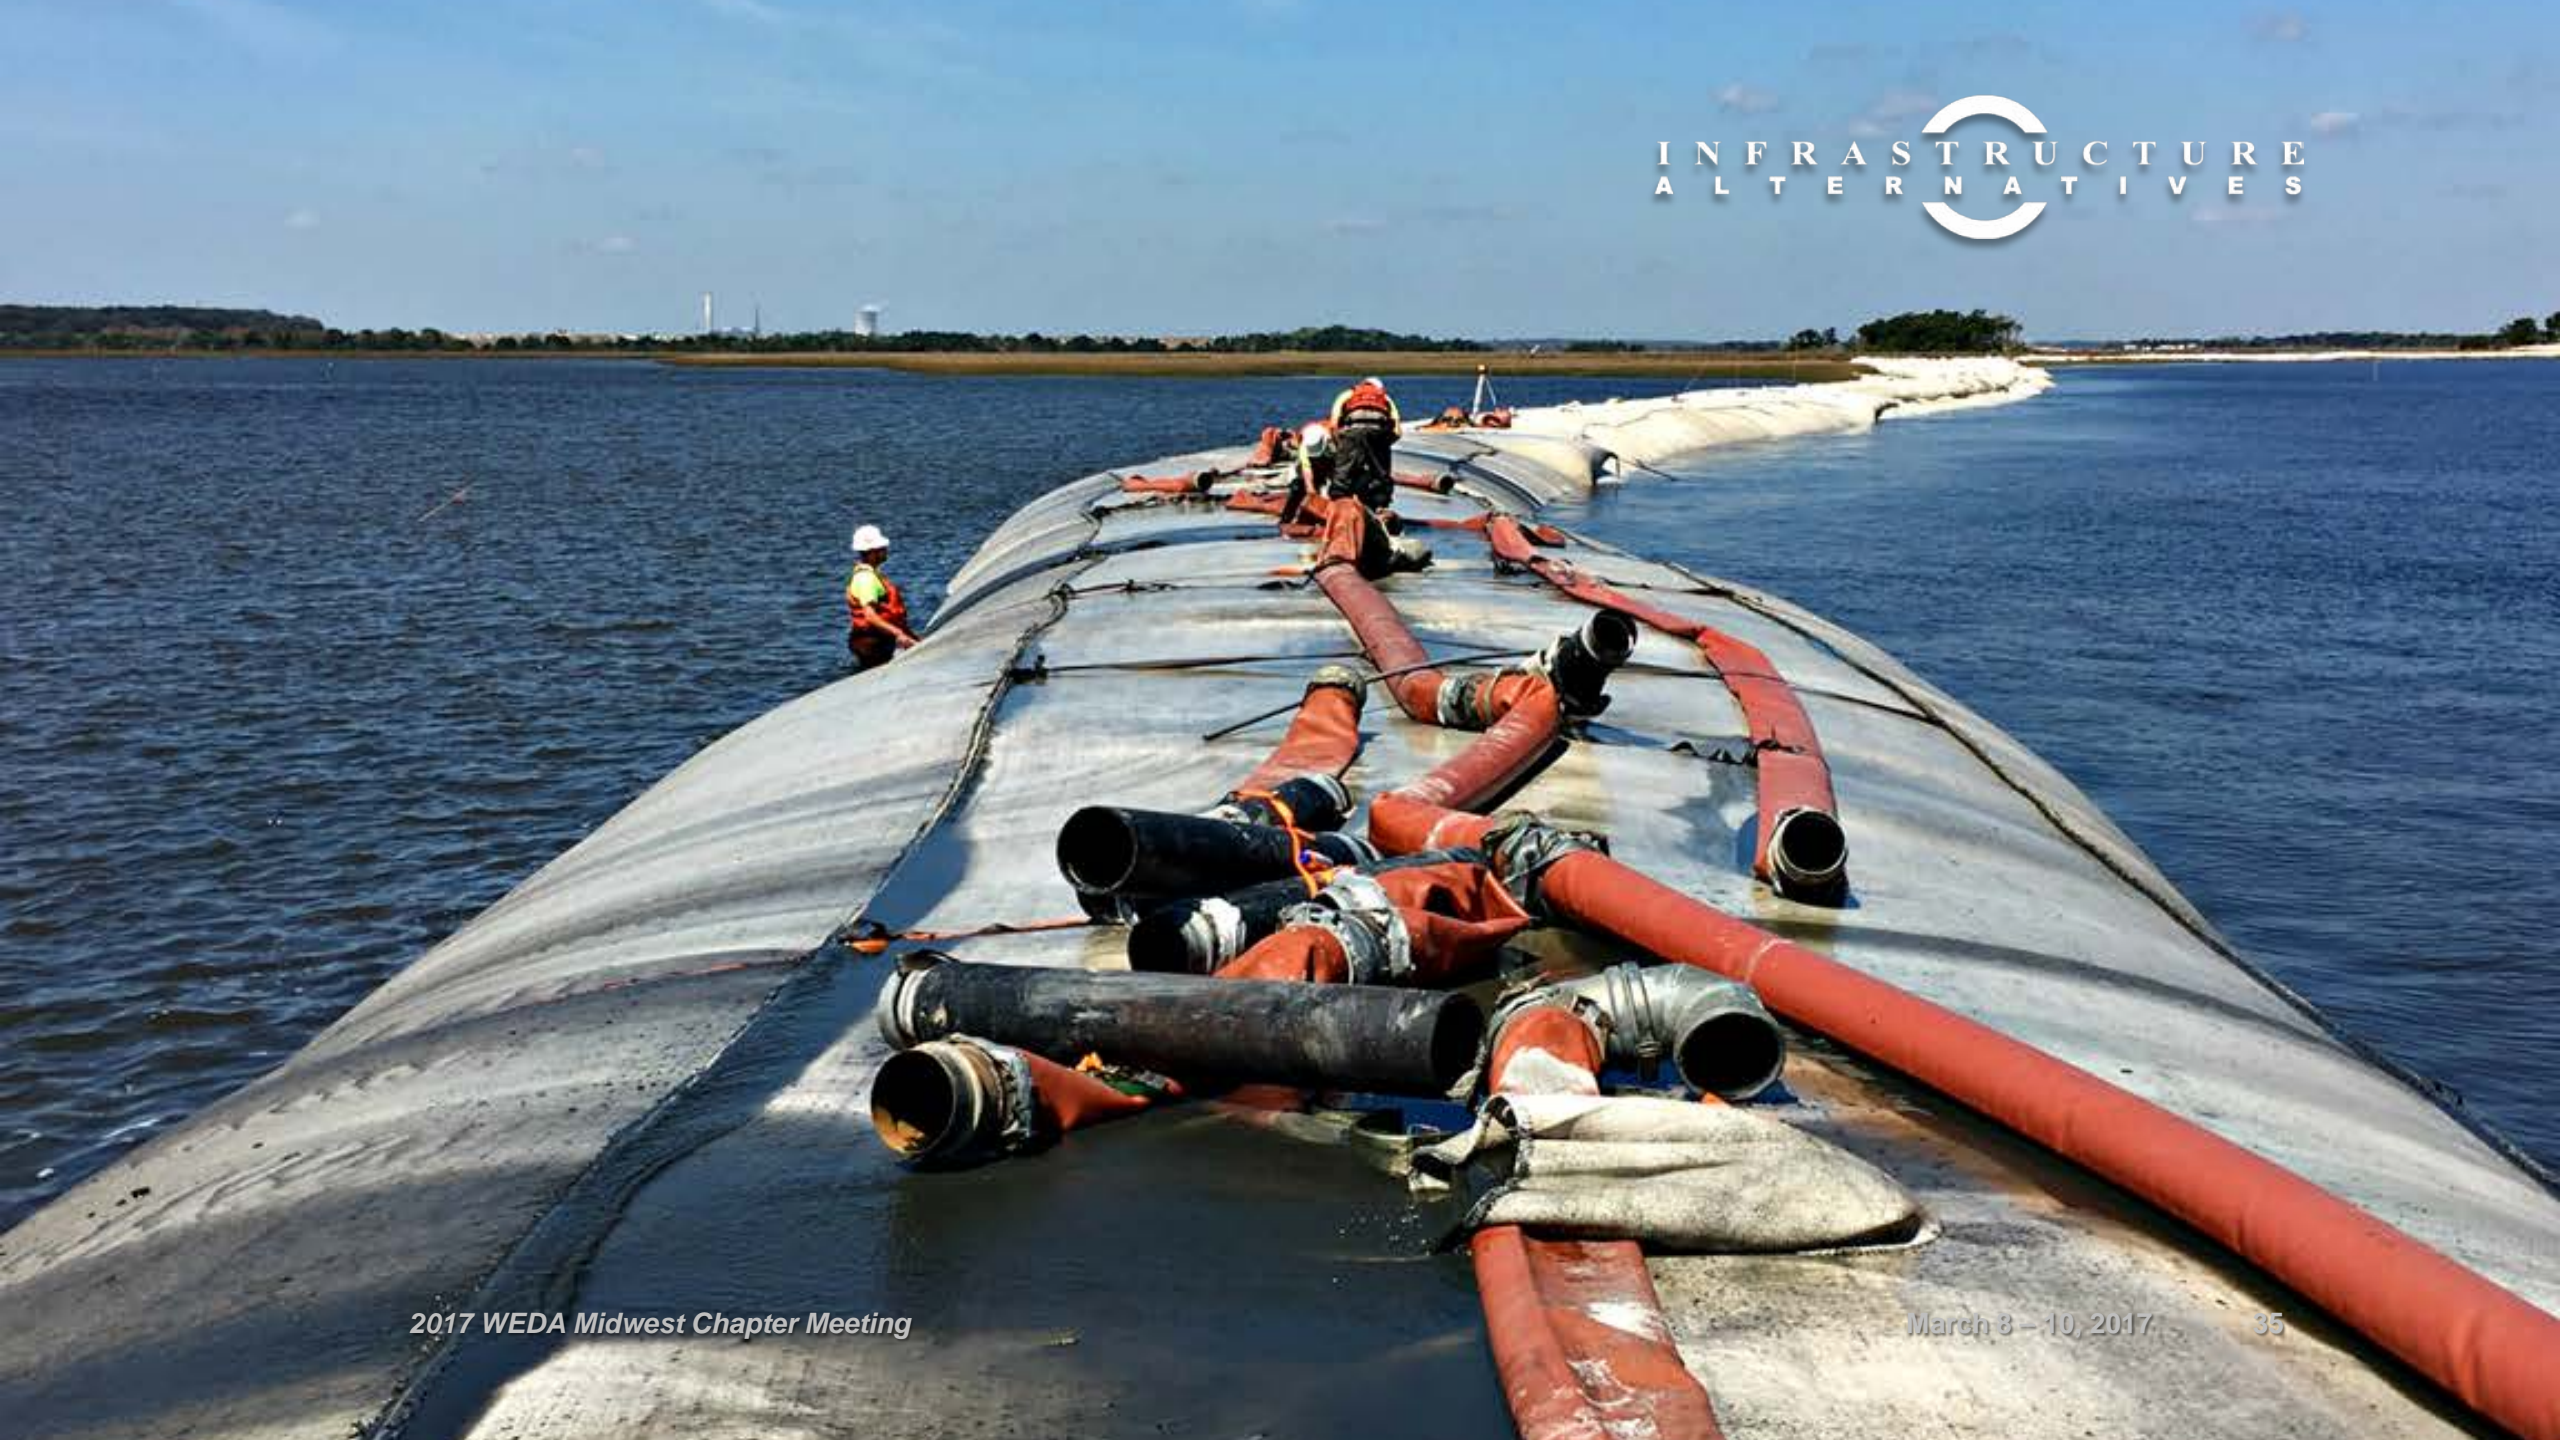
## SEQUENCE OF OPERATIONS

- 400-ft. sections were filled at a time
- Header lines and hoses had to be flushed, rolled up & secured each night
- Frequent high winds
- Tidal cycles
- Center line of the design was followed with 1 - 2 feet.
