ROWING LINE DREDGING FOR PAN AMERICAN GAMES 2007 RIO DE JANEIRO–BRAZIL

The Rodrigo de Freitas Lagoon, simply called Lagoa (Lagoon), has been chosen to house the Pan American Games – 2007 rowing, canoe, kayak, and water skiing competitions. Especially concerning the rowing competitions, the Lagoon had to be submitted to some improvements. Although the sculling boats have a small draft, for hydrodynamics purposes, the Olympic Committee demands lanes at least 3 m below water level. After the bathymetric surveys, it was found that in order to achieve the desired depth of the rowing line; about 100.000m³ of sediment dredging would have to be performed, in order to meet the Olympic Authority requirements.

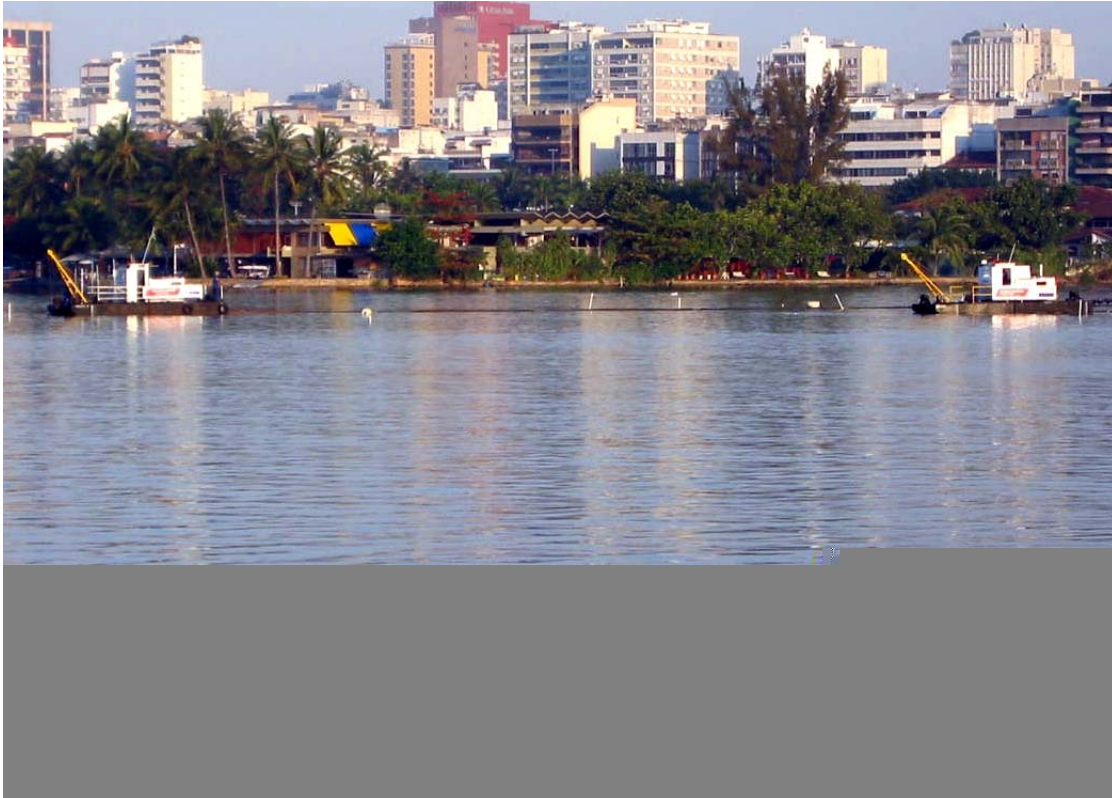
Figure 11. Two “Eco Dredges” with auger cutter and dustpan draghead.

The pneumatic system only proved to be efficient for fluid clays of low strength. The dredge with a Dustpan head type had to be changed by another one with an AUGER cutter. Even with the dredges already equipped with a active cutter system of the AUGER type, there were tested several tooth angles until obtaining the maximum output regarding the soil to be dredged in the lagoon.

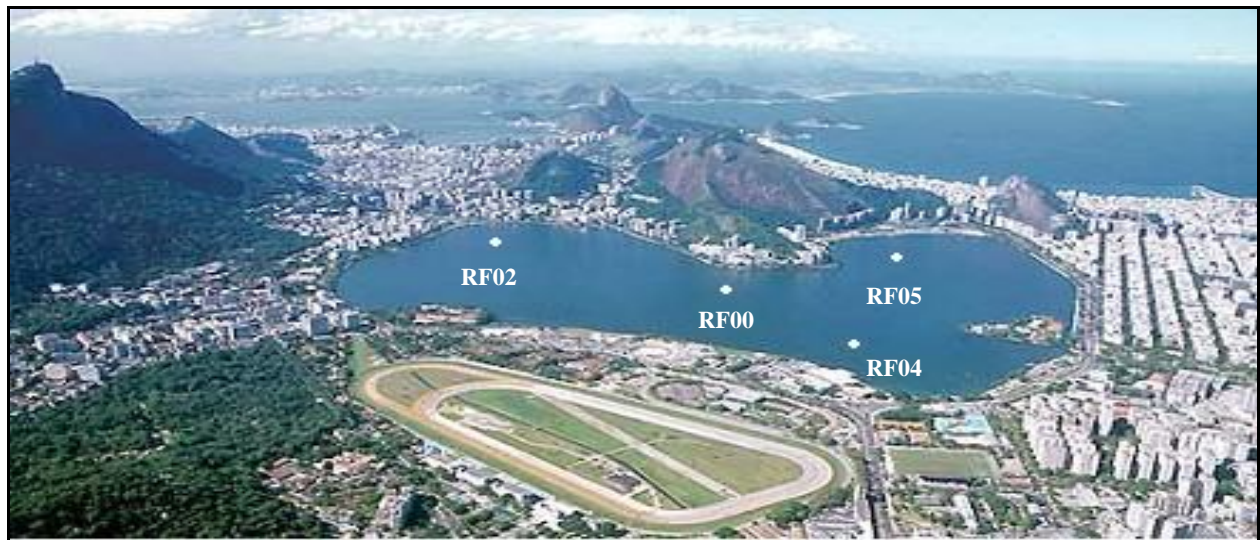
In the following are presented tables with the data of the analyzed spots before and after dredging. The spots RF 02 and RF 00 are located in the dredging area.

Figure 14. Water monitoring locations.
